## **Morphodynamic Feedbacks During Vegetation Colonization of Tideflats**

W. Gregory Hood  
Skagit River System Cooperative  
PO Box 368  
LaConner, WA 98257  
phone: (360) 466-7282    fax: (360) 466-4047    email: [ghood@skagitcoop.org](mailto:ghood@skagitcoop.org)

Award Number: N00014-08-1-1008  
<http://www.tidalflats.org/>

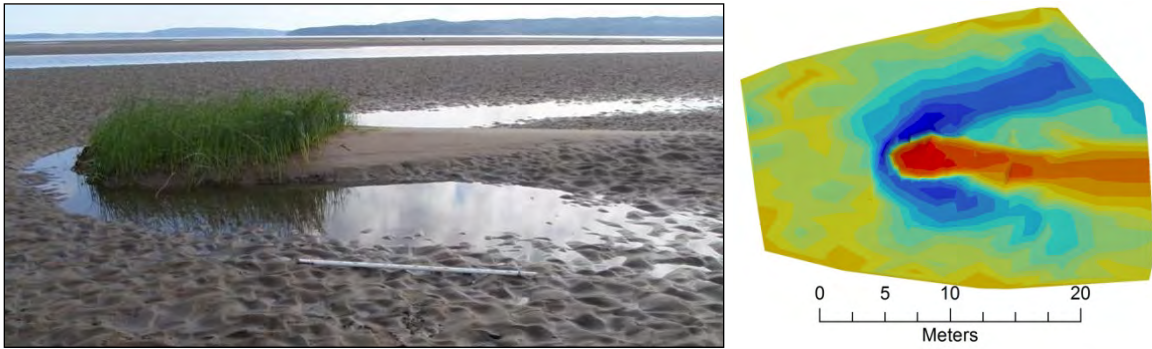
**Figure 1.** U-shaped scour and deposition tail (smooth ridge to right of island) associated with new *Schoenoplectus americanus* island at low tide. Survey rod in foreground = 1.5 m. Dominant flow is from left to right. To the right is a TIN model of the same island, where cold – warm colors represent low – high elevations. The U-shaped scour pool is in blue; the vegetated island is in red; the depositional sediment tail is in orange.

The project approach includes GIS change analysis, RTK-GPS topographic surveys, a space-for-time substitution sampling design, quantification of vegetation and sediment quality, and development of conceptual and statistical models of colonization processes and consequences. GIS change analysis was used to identify patterns and rates of channel change and vegetation development. It included analysis of orthophotos from 2004, 2006, 2007, and 2009 with pixel resolution ranging from 15cm to 45cm. RTK-GPS topographic surveys identified the topographic circumstances that characterize the locations of various species of marsh vegetation, on new islands as well as reference marshes. Additionally, these surveys (at 0.25 to 1.0 m grid resolution depending on island size, and 2 cm horizontal, 3 cm vertical accuracy) identified topographic features and patterns associated with colonizing vegetation, e.g., U-shaped scour channels and island lee deposition tails (Figs. 1, 2).

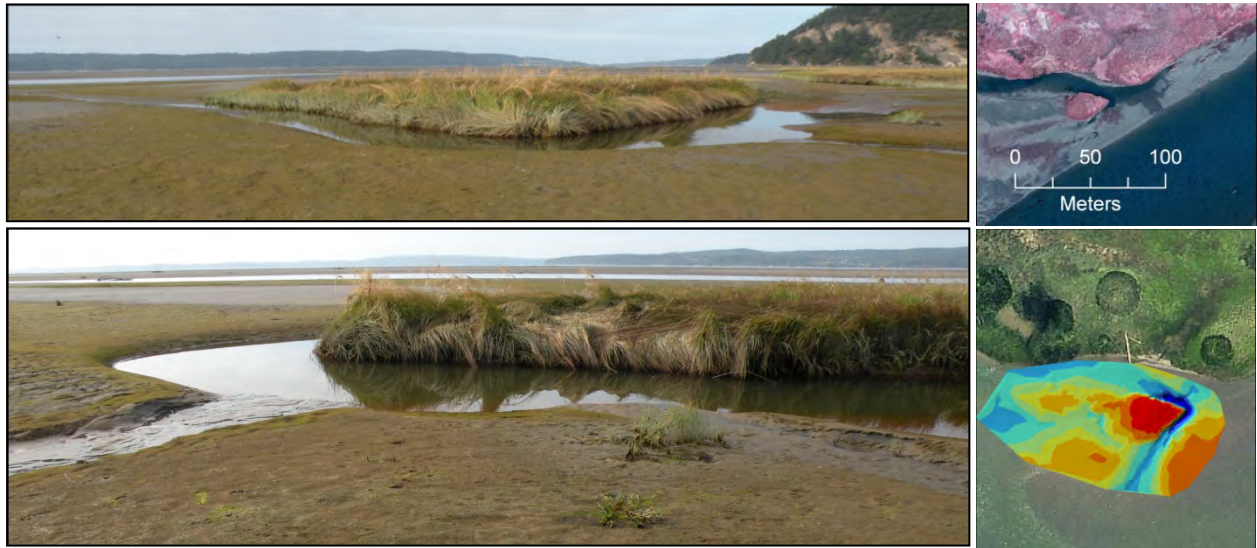
**Figure 2.** Left frames: Two perspectives on the same U-shaped scour associated with a relatively large (31m long), multi-species island at low tide that is visible in aerial photos as old as 1972 and 1980. The upper right frame shows the disposition of river distributaries relative to the island in 2004. The island likely received significant ebb tide and high river discharge flow during high water tide stages, and these would account for the scour pond. The lower right frame shows a TIN model of the same island (2007 background photo), where cold – warm colors represent low – high elevations. The U-shaped scour pool is in blue; the vegetated island is in red; the depositional sediment tail is in orange.

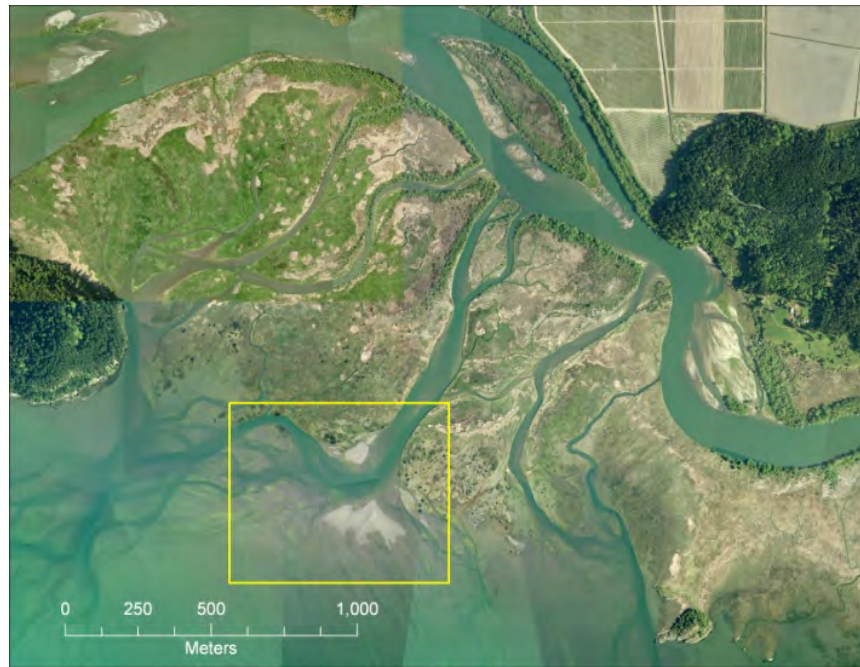
***Figure 3. General location of the study area (yellow rectangle), relative to the principal distributary of the North Fork Skagit River. Photo is from the spring, 2009.***

The project focused on small, incipient, marsh islands in tidal flats near the outlet of the principal distributary of the North Fork Skagit River (Fig. 3). Most of these islands are located in a region where the course of the distributary outlet has recently been very dynamic. RTK-GPS surveys have been made of 8 incipient marsh islands ranging in size from  $0.64\text{m}^2$  to  $1180\text{m}^2$  and has included simultaneous notation of vegetation species associated with each survey point. Vegetation surveys have also included characterization of mature tidal marsh as a reference to colonizing vegetation. Work during the current project year has consisted primarily of data analysis and manuscript writing (e.g., publication of Hood 2010).

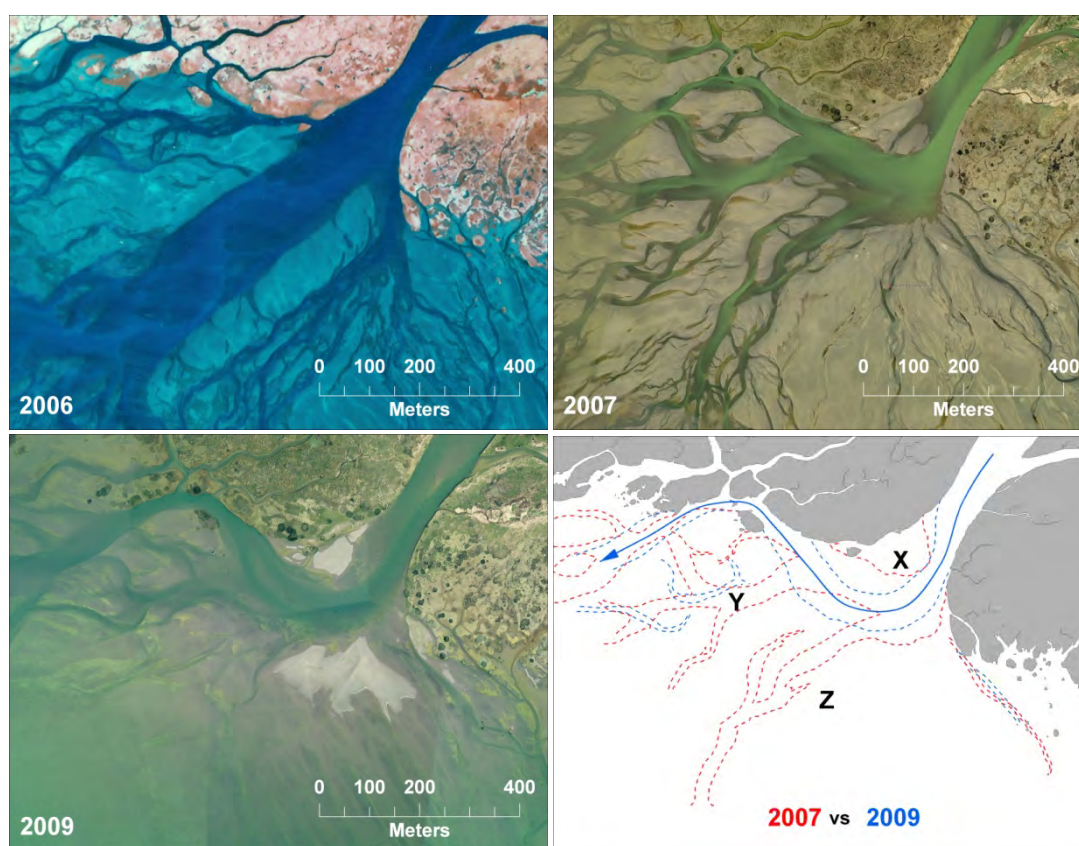
**Figure 4.** Comparison of the course of the study area distributary across the tidal flats. North is to the top of each frame. The main course of the distributary flows straight toward the SW in 2006, but bends to the west in 2007. The lower right frame illustrates growth in a point bar (X) from 2007 to 2009, which caused the channel bend curvature to tighten and the channel bend to migrate slightly. Digitized channels are limited to larger tide flat channels. Secondary tide flat channels diminish in some areas (Y) and disappear entirely where the main course of the distributary was located in 2006 and earlier years (Z). Note high elevation of dry sandy areas in the 2009 photo, as indicated light gray color in the point bar and opposite bank, indicating significant accumulation of sediment in these areas.

Historical aerial photos from 1956 to 2006 (eight photos: 1956, 1965, 1972, 1980, 1990, 2000, 2004, 2006), without exception, show the study area distributary continuing straight on its course from the tidal marsh across the tidal flats. However, in 2007 the channel suddenly changed course at a nearly right angle to the west (Fig. 4). Observing eight photos without a significant change in channel course is probable ( $P > 0.10$ ) only if the straight course occurs at least three times more frequently than the westward-bending course. The likely cause of the sudden shift in the course of this distributary appears to be a large windstorm on 15-16 November 2006 which sustained winds from the south-south east (148-153 degrees) of 80 to 100 km/h for 10 hours, with gusts up to 115 km/h. River flow during this storm was 2-3 times mean annual flow.

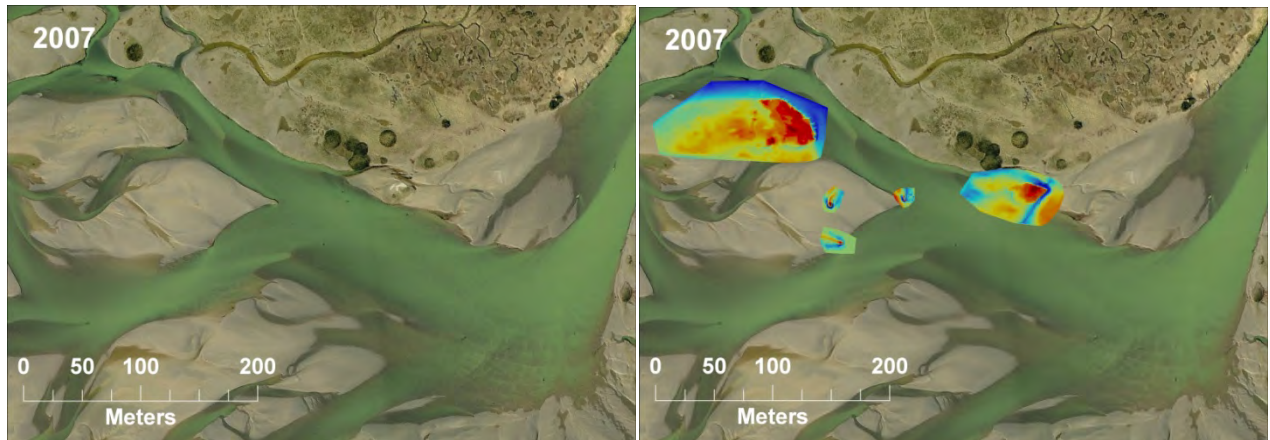
**Figure 5. Five of eight study islands are located in the area of river distributary dynamism. TIN models of island topography (right frame); cold – warm colors represent low – high elevations. The second island from the right is located at the apex of a sandbar (compare with left frame), suggesting the resistance provided by this vegetated point facilitated a split in channel flow.**

Most of the incipient marsh islands investigated in this study are located in this area of recent channel dynamics (Figs. 5). Island topography has varied with the shifting course of the study area distributary (Fig. 6). The island tails, on the downstream side of the island, are formed by accumulations of flow-borne sediment deposited in the lee of the islands. Thus, these tails are indicators of recent dominant flow directions. The islands in this dynamic area have acted like weather vanes; the depositional sediment tails have shifted direction with shifting channel courses and flow direction. Fieldwork in 2010 indicated significant changes in channel course are continuing and these may also be related to wind forcing. The cut bank of the distributary bend had an interesting break where the east half of the bank has moved north, encroaching on the older channel course, while the west half of the bank has moved south and west. Either the river is dropping sediment in the east half, sediment is being pushed from the bay flats into the east half by waves, or both are occurring. Additionally, three of the small study island in this area were eroded away by channel migration. Channel migration has also changed the angle at which current flow is impinging on two other study islands and this is affecting island topography and vegetation colonization.

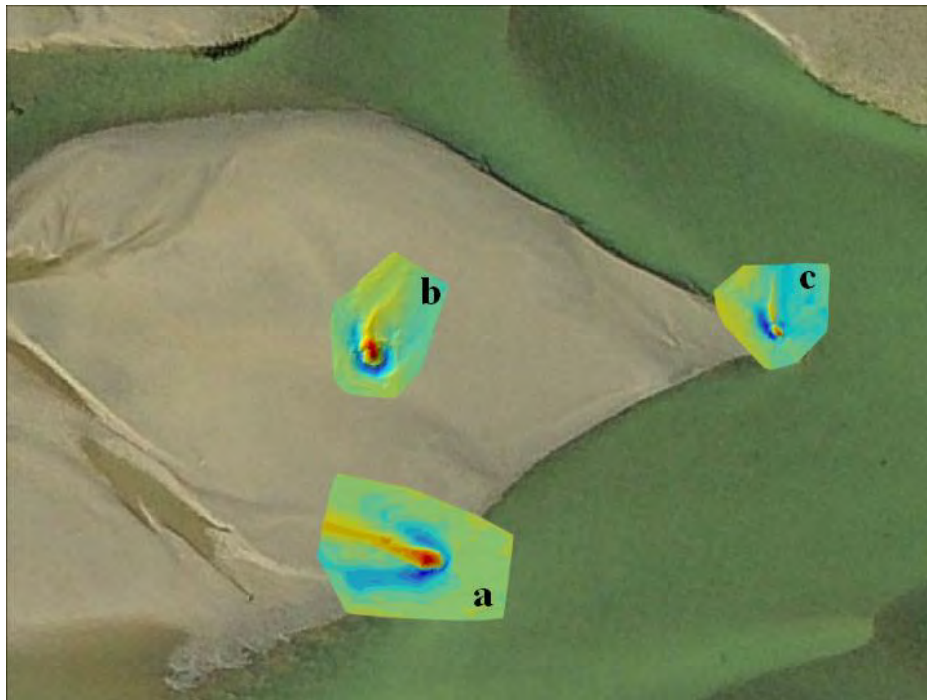
**Figure 6. Three weather-vane islands – close-up of the central portion of Figure 3. The background photo is 2007. Island “a” was surveyed in 2008; the direction of its depositional tail and the location of its scour pool reflect a transition in flow direction from 2007 to 2008. Island “b” was not surveyed in 2008, but its less prominent tail and scour pool were situated similarly to those for island “a”. In 2008, islands “a” and “b” were on a sand flat at low tide with the main distributary channel to their right. Island “c” was in the center of the channel and was a navigation hazard. Islands “b” and “c” were surveyed in 2009 when the distributary had shifted so that islands “a” and “b” were in the channel at low tide and island “c” was on a point bar. The tail for island “a” disappeared by 2009, apparently eroded by flow normal to the tail. All three islands disappeared entirely in 2010, eroded by the shifting course of the river distributary.**

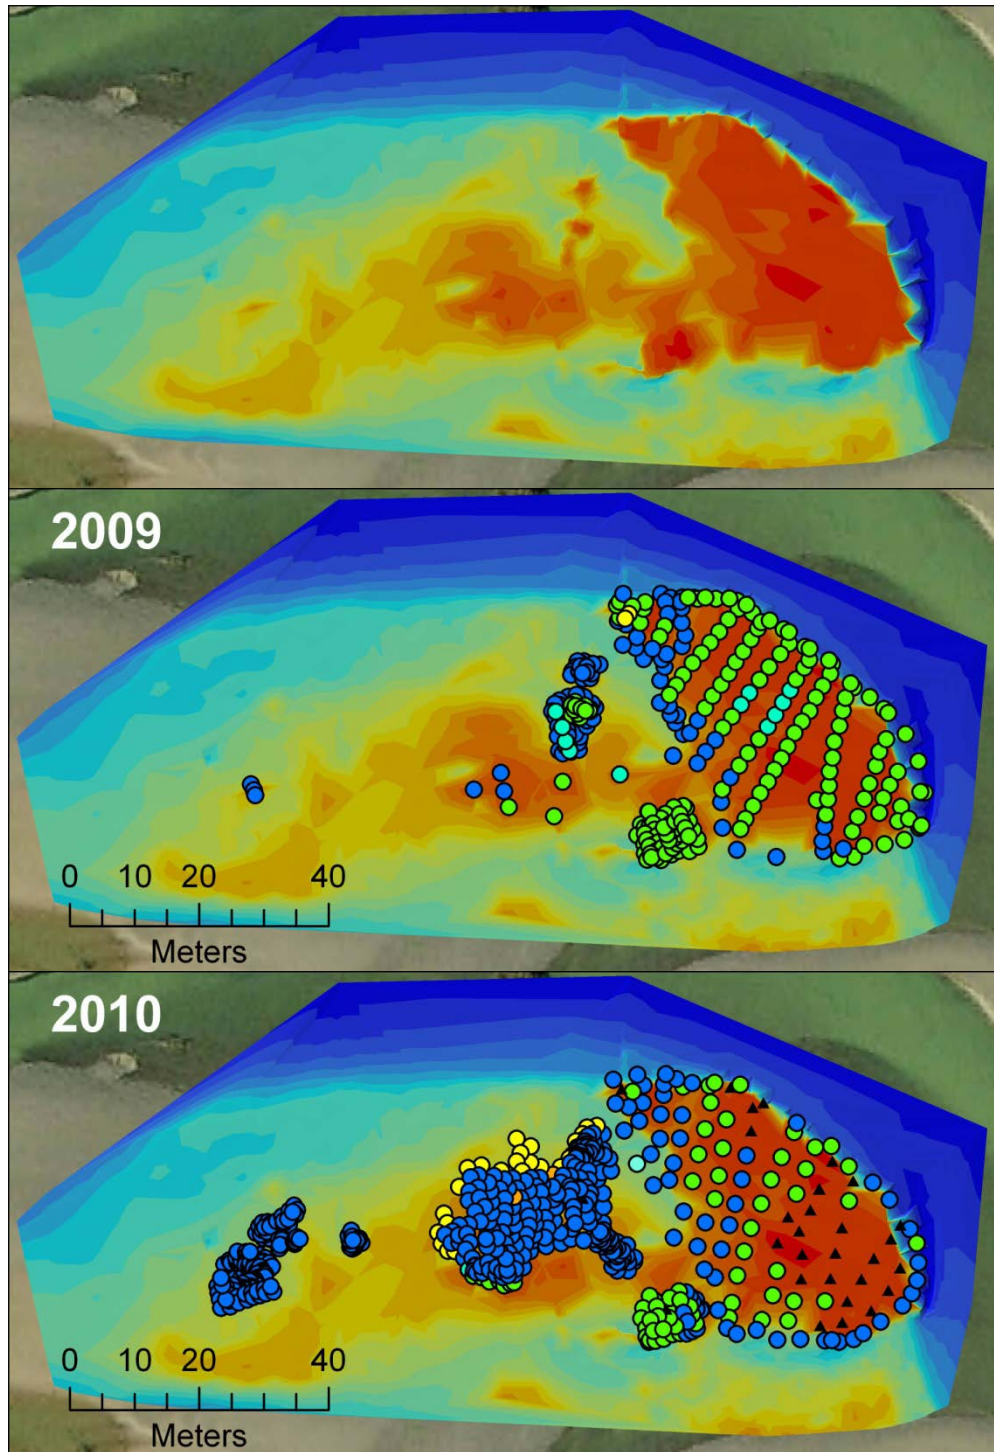
**Figure 7. Island topography and vegetation.** Top frames are for reference to unobstructed view of background image and TIN model. Bottom frame includes overlay of RTK-GPS points of vegetation from 2009 to 2010. Green points are *Carex lyngbyei*, blue are *Schoenoplectus americanus*, orange are *S. tabernaemontani*, light blue are *Eleocharis palustris*, yellow are *Juncus balticus*, black triangles are *Deschampsia caespitosa*. Colonizing vegetation is generally located on the relatively high-elevation, downstream, depositional sediment tail of the island.

The depositional sediment tails on the downstream side of the islands are being colonized by low density marsh vegetation. The most dynamic example of this is seen in the largest island surveyed, where significant vegetation expansion occurred from 2009 to 2010 on the sediment tail of the island (Fig. 7). *Schoenoplectus americanus*, typical of lower elevations, was the principal colonizing species. At higher elevations the marsh island vegetation transitioned from *Carex lyngbyei* to *Deschampsia caespitosa*, suggesting an increase in island elevation through sedimentation, although RTK-GPS point samples have exactly the same mean elevation (2.02 m, NAVD88) in both years (n = 45 and 32 in 2009 and 2010, respectively, in the relevant portion of the island head).

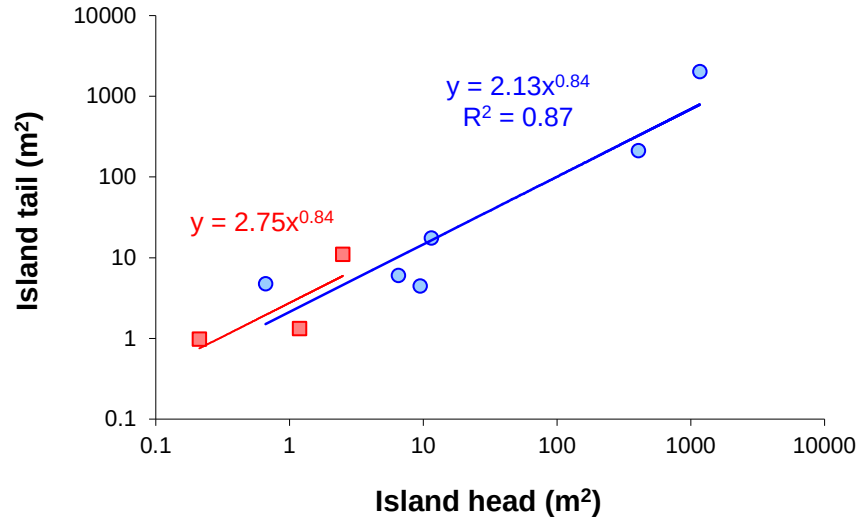
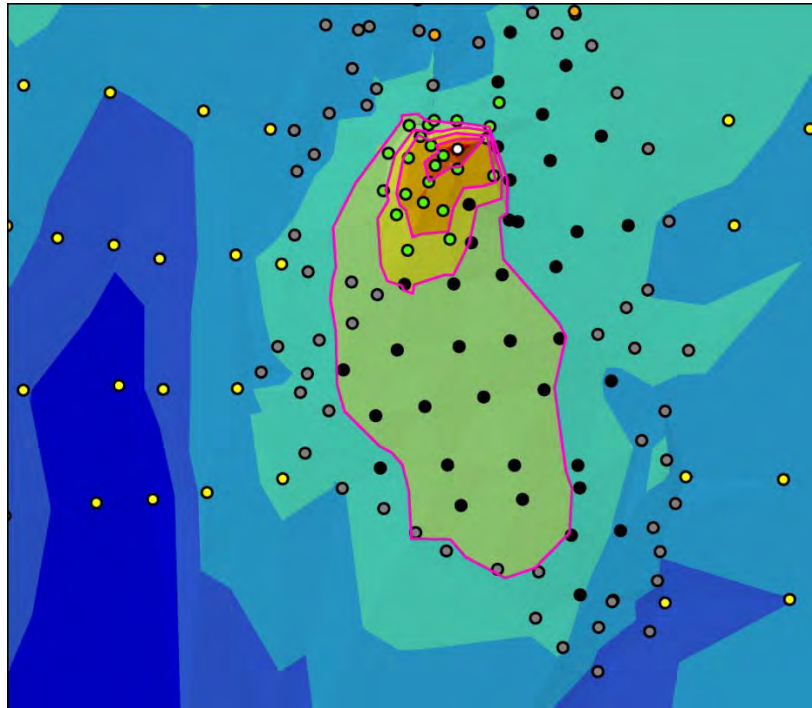
**Figure 8.** Allometric scaling of sediment tails with island heads for a variety of incipient marsh islands in the North Fork study area (blue circles, top frame). Similar scaling (red squares) is observed for a series of vegetation patches and “tails” in an individual island (bottom frame), where a patch of *Deschampsia caespitosa* (white circle) is followed by a tail of *Juncus balticus* (light green circles) which is followed by a tail of *Schoenoplectus americanus* (black circles). Gray circles represent low-density colonizing *S. americanus*; yellow circles represent bare sand. Background image is a tin representation of island topography, with vegetated isopleths used in the allometric analysis outlined in pink.

Historical traces of similar island colonization patterns can be inferred from allometric analysis of island form. Regression of sediment tail surface area on vegetated island surface area produces a strong scaling relationship (Fig. 8). Interestingly, a similar scaling pattern occurs within a single island (as indicated by identical power function exponents), where areas associated with the presence of different vegetation species and island-scale elevation bins fit the same allometric scaling patterns found among islands and their sediment tails. For example, in one small island, the highest point is occupied by clumps of *Deschampsia caespitosa*, followed by a lower “tail” of *Juncus balticus*; the “island” of *Deschampsia* and *Juncus* is in turn followed by a “tail” of *Schoenoplectus americanus*. Scaling of these successive pairs of vegetation patches and tails suggests sequential phases of vegetation colonization of the island as it grows in size and elevation, analogous to what is being observed on the much larger island depicted in figure 7.

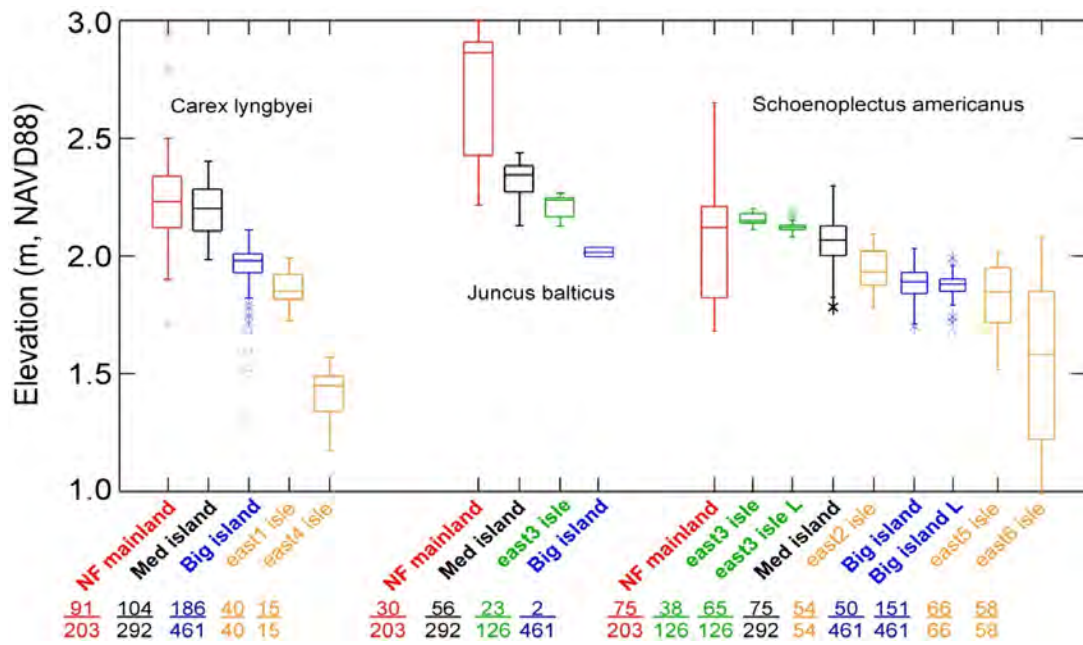
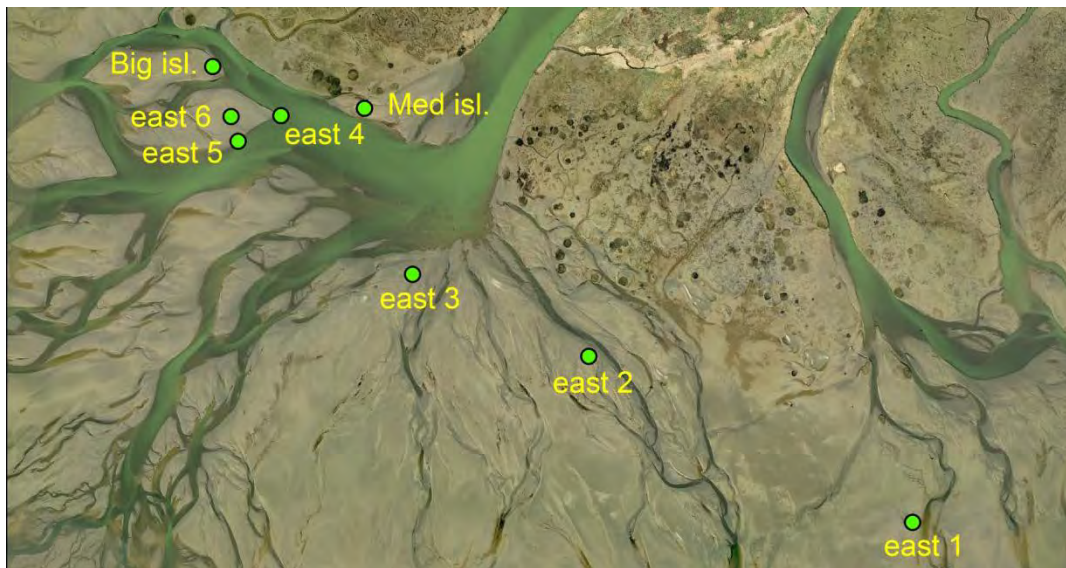
**Figure 9.** Box and whiskers plots of vegetation distributions in the North Fork mainland marshes and small marsh islands bayward of the mainland marsh (top frame). Fractions associated with island labels represent the sample size of the species depicted (numerator) and of all vegetation points sampled on the island (denominator). The locations of the islands are depicted in the lower frame.

Vegetation generally grows at lower elevations on the incipient marsh islands than in the mainland marsh (Fig. 9). The exception is the second largest island surveyed (Medium Island). On this island *Carex lyngbyei* and *Schoenoplectus americanus* grow at similar elevations as in the mainland marsh; *Juncus balticus* at only slightly lower elevation as in the mainland marsh. This exceptional behavior may be due to the surprisingly old age of Medium Island. It is clearly present in photos dating to 1972 but not 1965, making it approximately  $43 \pm 4$  years old. In contrast, the largest island surveyed (Big Island) is visible in the 1998 air photo but not in the 1980 photo, making it approximately  $22 \pm 9$  years old. Another factor that may affect the elevation at which island vegetation is observed to grow may be proximity to the distributary outlet. Medium island and island East 3 are both at the outlet of the largest North Fork distributary; East 3 island is located in an area where abundant new sand deposition has been observed over the last two years, with pre-established vegetation probably growing through newly deposited sand. Vegetation distributions are generally characterized in mature marshes, but newly colonized islands of *Carex lyngbyei* and *Juncus balticus*, in particular, appear to have significantly different elevation distributions from mature marsh. This may be due to differences in soil development or in scope for competition between species.
