**STRUCTURAL HEALTH MONITORING OF M1114 HIGH MOBILITY  
MULTIPURPOSE WHEELED VEHICLE ARMOR SYSTEM**

THESIS

AFIT/GEM/ENV/12-M19

In Partial Fulfillment of the Requirements for the  
Degree of Master of Science in Engineering Management

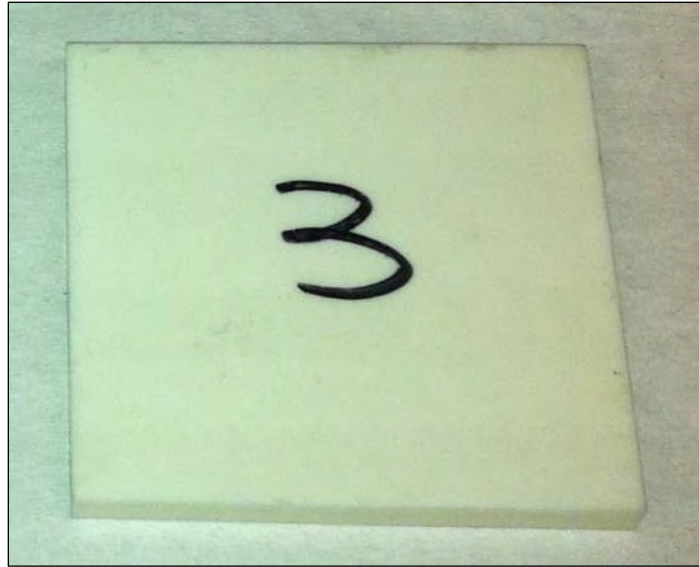
Figure 2.1. Ceramic Frontal Plate

Alumina (Al<sub>2</sub>O<sub>3</sub>), used in the form of ceramic tiles, is light, hard, and strong in compression. Figure 2.1 is an example of a alumina ceramic frontal plate. When a ceramic tile sustains a ballistic impact, the face of the tile experiences compressive forces, against which ceramics are extremely strong and typically will not fail. Erosion of

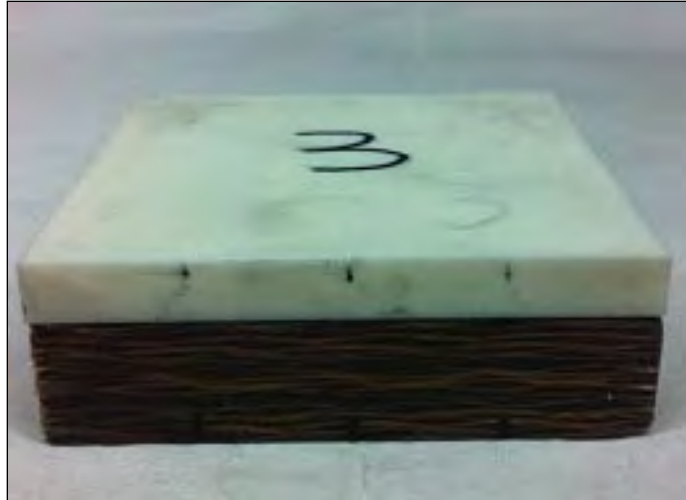
The composite backing material (HJ1) serves a dual purpose; it carries the bulk of the load when the armor is used for structural applications in addition to ballistic protection. It also absorbs the kinetic energy of the armor-piercing projectile once its tip is blunted. The kinetic energy is absorbed through a combination of fiber strain and fracture, fiber pullout, and composite delamination. Figure 2.3. illustrates a coupling of the ceramic and composite as an armor system.

Figure 2.3. Two Layer Armor with Ceramic Frontal Plate and HJ1 Composite

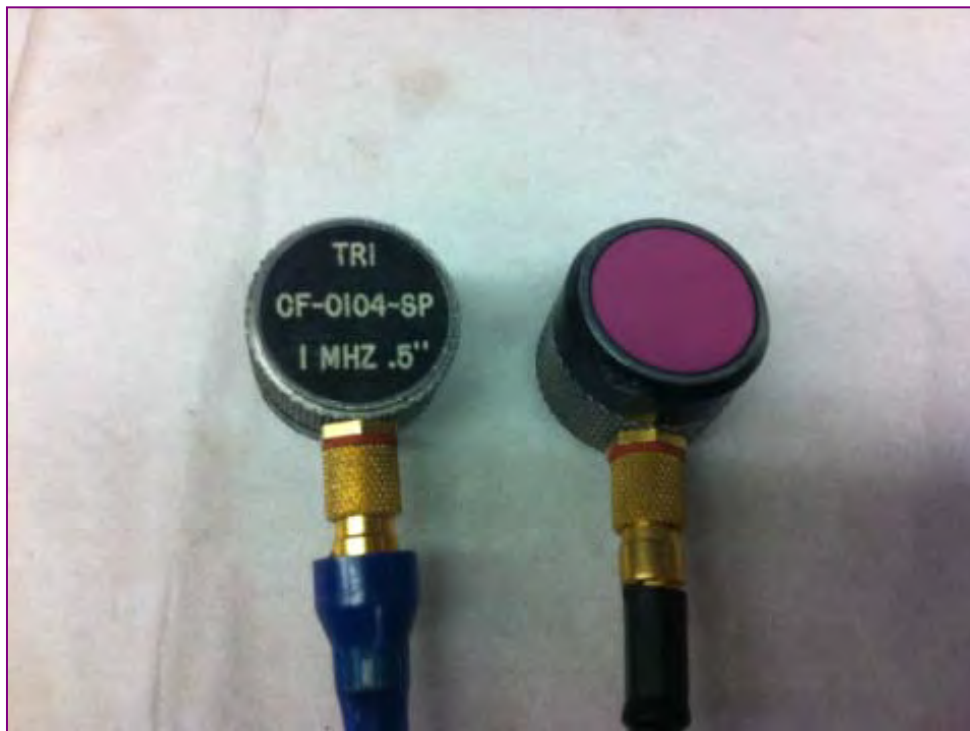
Figure 2.5. PZT Sensor used to Induce and Collect Wave Propagation

Lead zirconate titanate also referred to as PZT, these sensors are used to induce and receive ultrasonic Lamb waves, see Figure 2.5. PZT materials exhibit an effect whereby they expand or contract in the presence of an applied electrical field (Gautschi, 2002). The electrical source can be a waveform generator like the one on Figure 2.6. The propagated waves received by the PZT sensor will be outputted to the oscilloscope to collect data, see Figure 2.7.

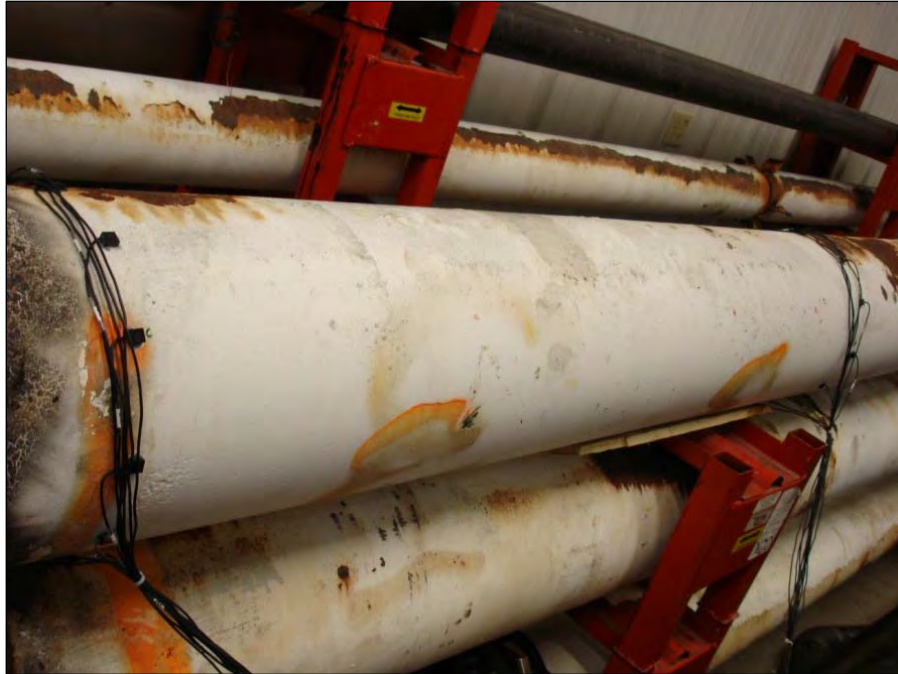
Specific uses of ultrasonic Lamb waves on tomographic reconstruction have been used to monitor the structural integrity of pipelines. On Figure 2.10, PZT sensors are placed to form two vertical arrays around the circumference of a 10" steel pipe (schedule 40) at two different axial positions 48" apart (Royer, Velsor & Rose, 2009). Ultrasonic waves are induced and acquired between the two boundaries using all possible combinations of pitch-catch patterns between inducing and receiving sensor. Preliminary data sets were collected as a baseline data set for an undamaged pipe. Material was removed to form damage and new data sets were collected from the PZT sensors. A tomographic image was reconstructed by comparing the undamaged and damaged data, see Figure 2.11.

Figure 2.10. Photo Showing One Setup for Using CT Approach for Pipeline Health Monitoring (Royer, Velsor & Rose, 2009)

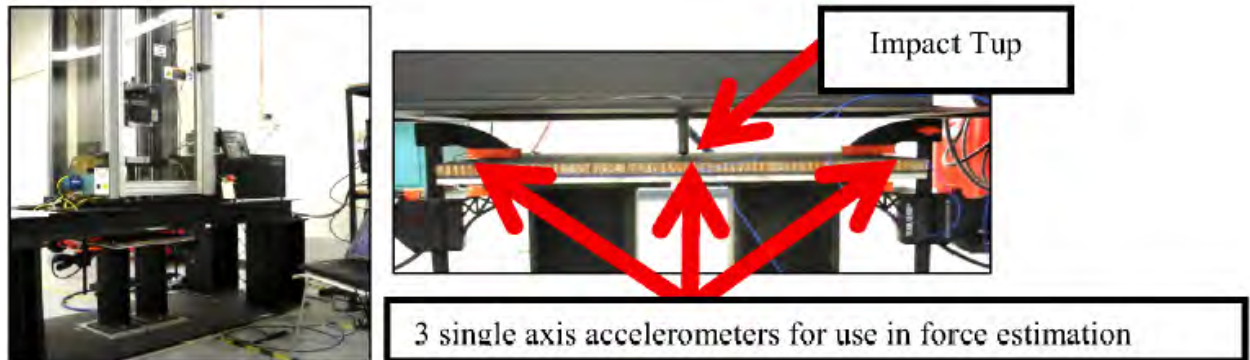
In an experiment conducted by facility of University of Purdue in conjunction with the US Army Research Laboratory, vibration-based structural health monitoring was successfully conducted on one layer S-2 composite system, see Figure 2.14. The researchers were successfully able to passively identify the external force, identify the amount of damage, and quantify damage (Stities, 2007). Damaging impact energy (weighted hammer test) was applied to the test specimens and the passively measured frequency response of the armor was used to produce a dynamic model of the specimen

and the subsequently estimate calculate the level of damage on the specimen (Brush, D.E., Zwink, & Walsh, 2009).

Figure 2.14. Passive Structural Health Monitoring on S-2 Composite Armor

The researchers were able to correctly identify the location of the impact 93.4% of the time, while 100% identification was produced within a 1” of the actual impact location. Impact identification was done using a single tri-axial accelerometer to calculate the force impact. The major limiting factor of this research is that the impact was completed by dropping 4.5, 5.25, and 6.0 lb. weights on to the S-2 composite. This produced a small amount of damage compared to a .30 AP projectile. It is also limited to single layer sensing instead of two layers.

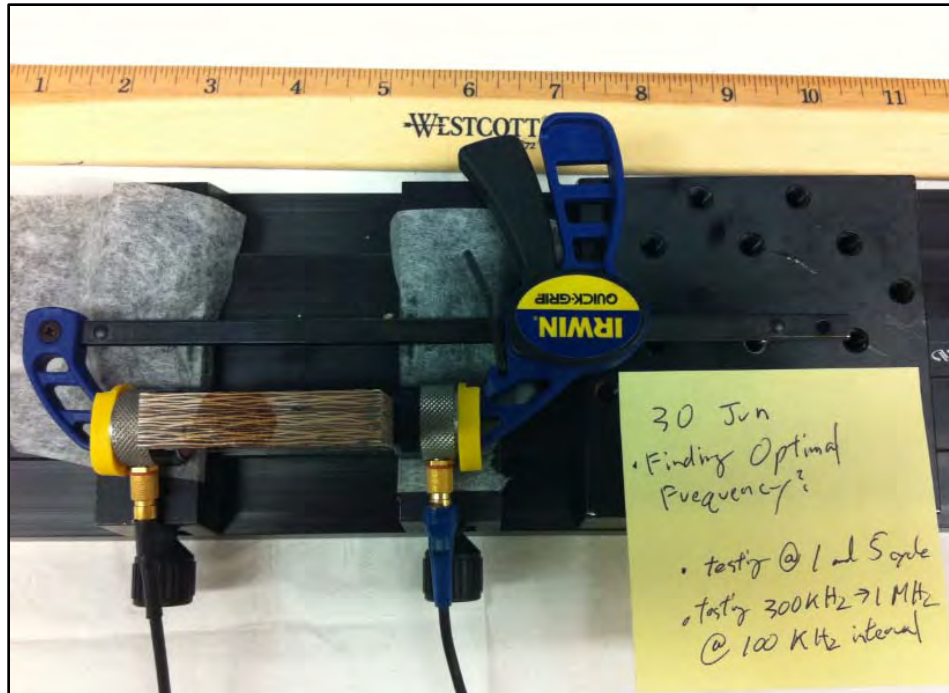
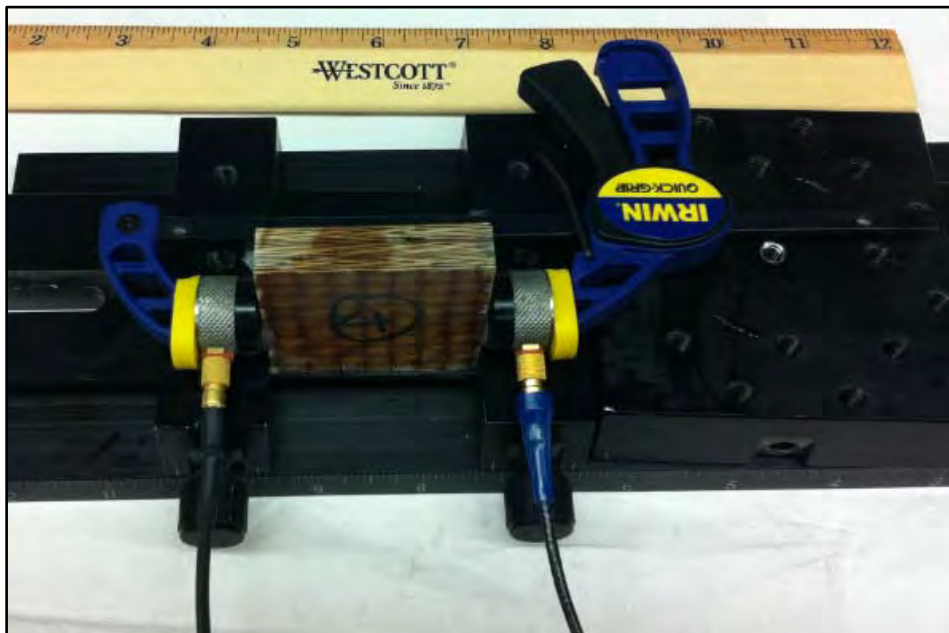
- I. Place the composite on the secured mounting platform.
- II. Place a PZT sensor on each side of the composite with a small amount of coupling grease.
- III. Ensure that the PZT sensors are placed in a straight line to optimize capturing of the wave propagation data.
- IV. Use the Irwin Quick-Grip to secure the sensors in place.

Figure 3.18. Top View of the Composite Coupon on the Mounting Platform with PZT Sensors Clamped on to the Coupon

Figure 3.19 Another top View of the Composite Coupon on the Mounting Platform with PZT Sensors Clamped on to the Coupon

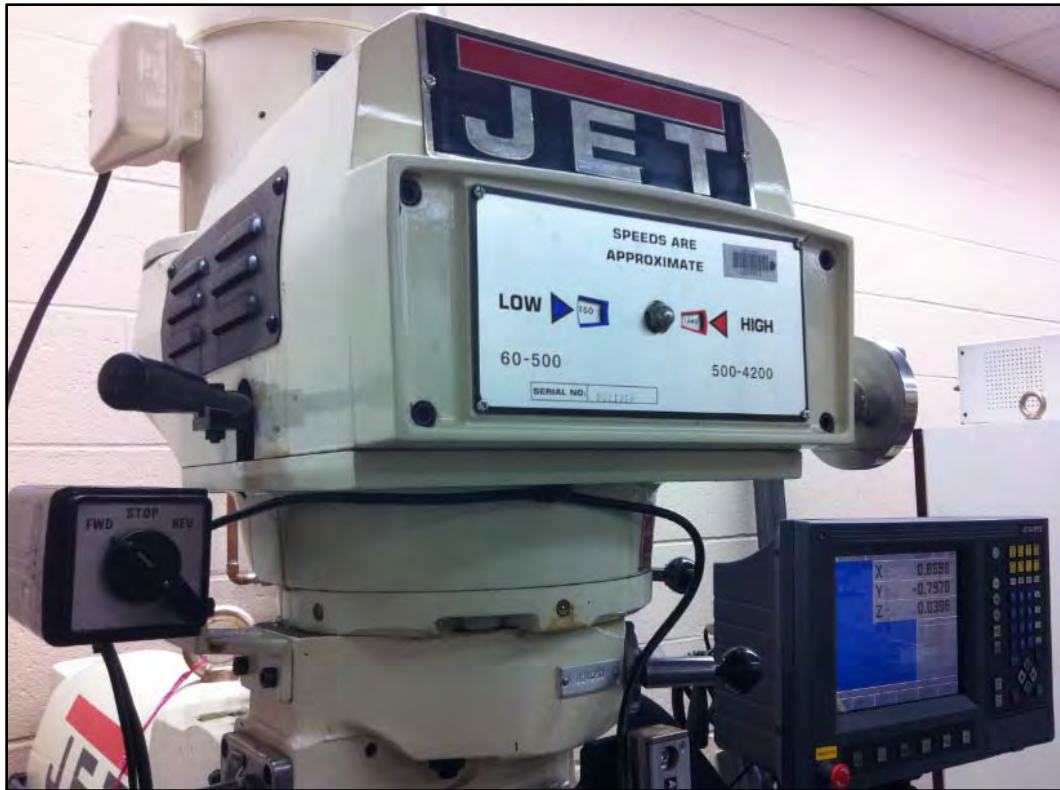
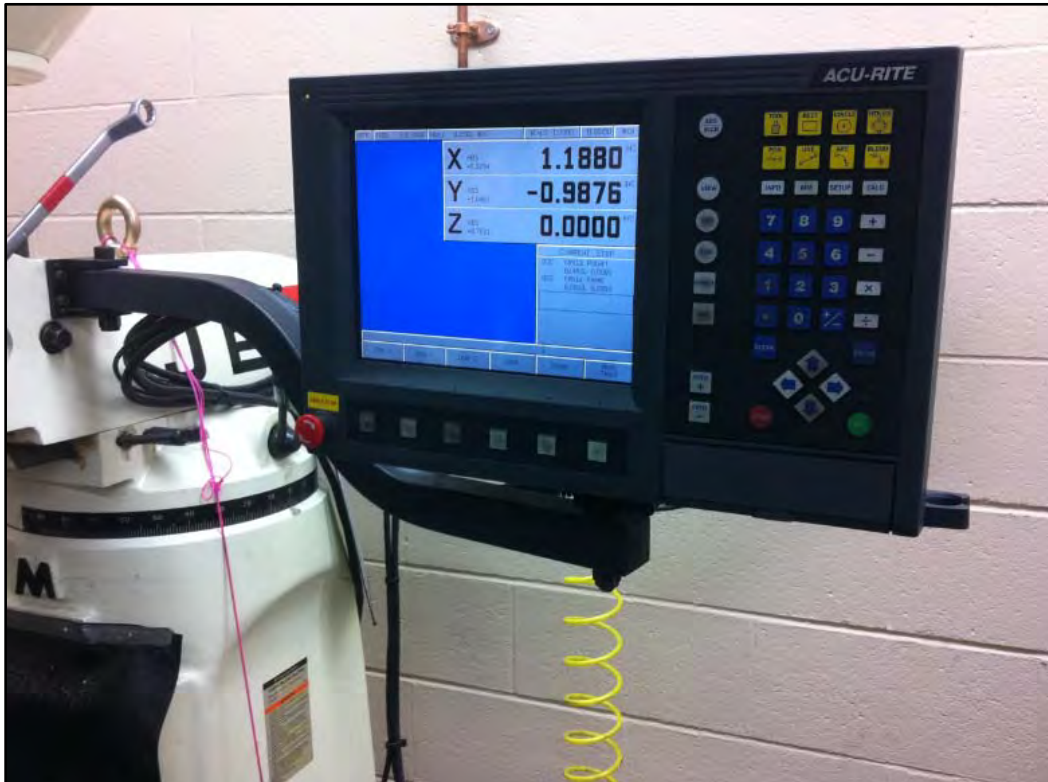
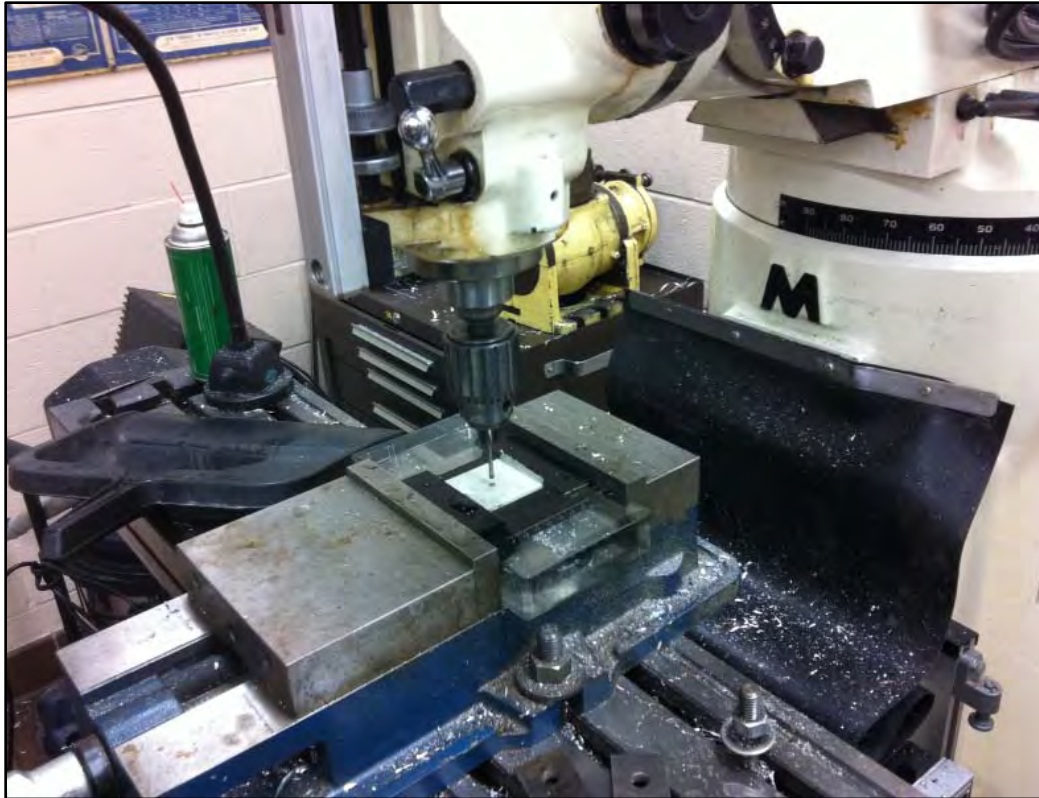
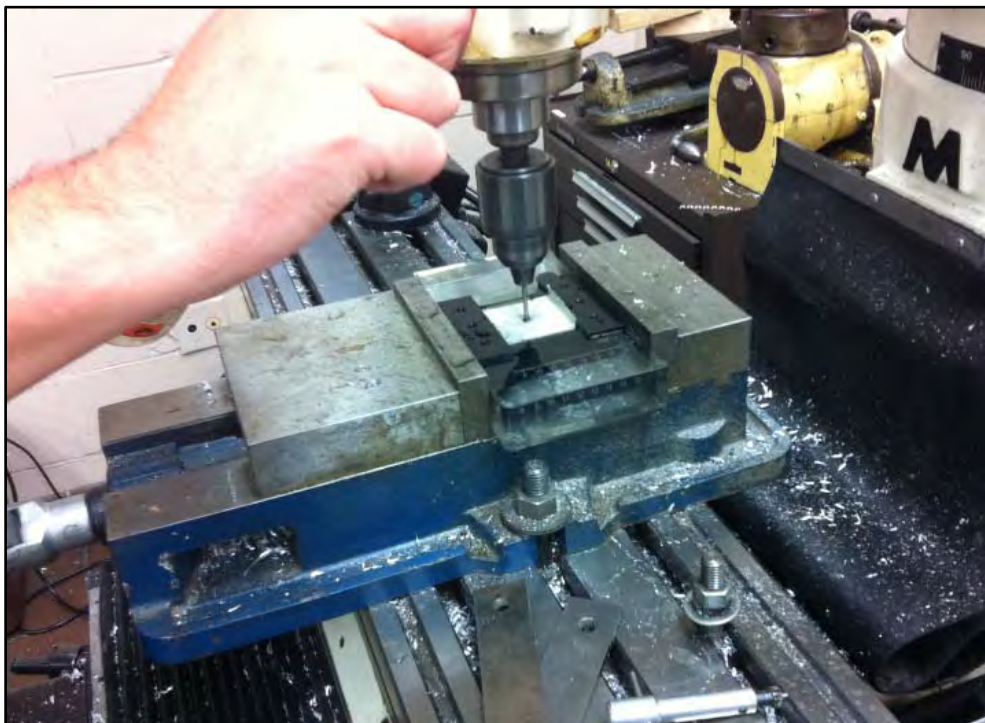
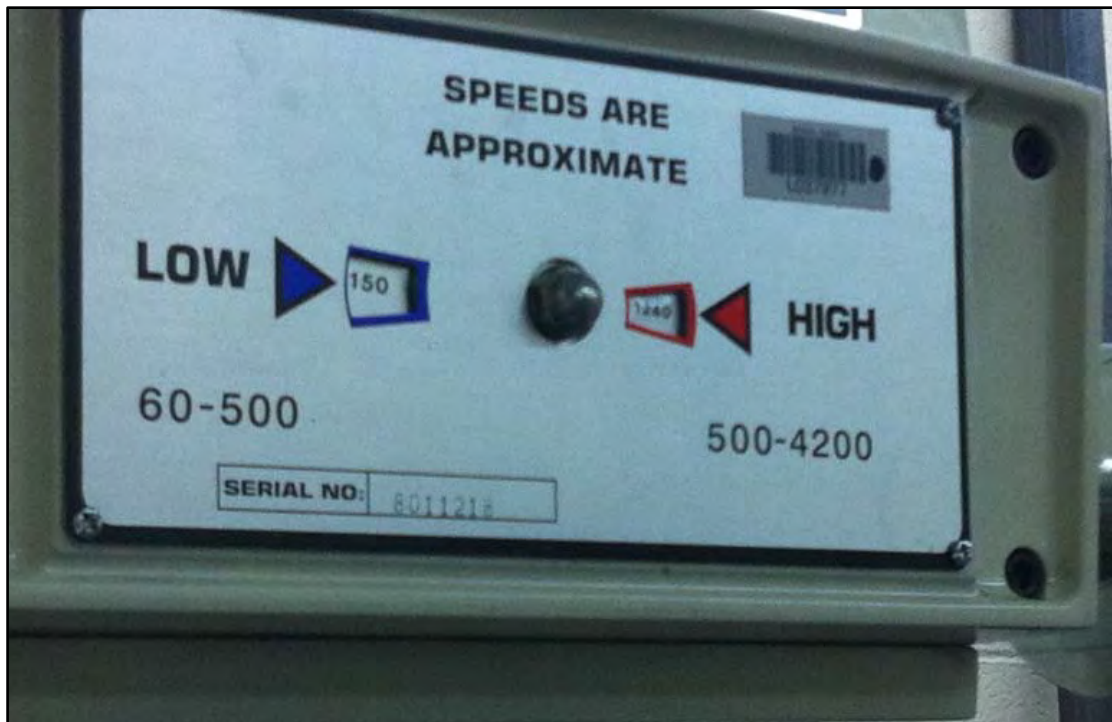
- 12) Repeat step 11 on the ceramic coupons.
- 13) With the Starlite diamond tipped drill bit and JET mill, drill 1.52 mm into the center of the ceramic, see Figure 3.28, 29, and 30.
  - I. The ceramic and the mounting structure was kept submerged in a container of water to dissipate the heat from the drilling, see Figure 3.31
  - II. Set the low speed to 150 and high to 1240, see Figure 3.32.

Figure 3.29. Acru-Rite Display Used to Control Location and Depth of the Drill Operation

Figure 3.31. Ceramic Coupon in a Holding Mount Submerged in Water

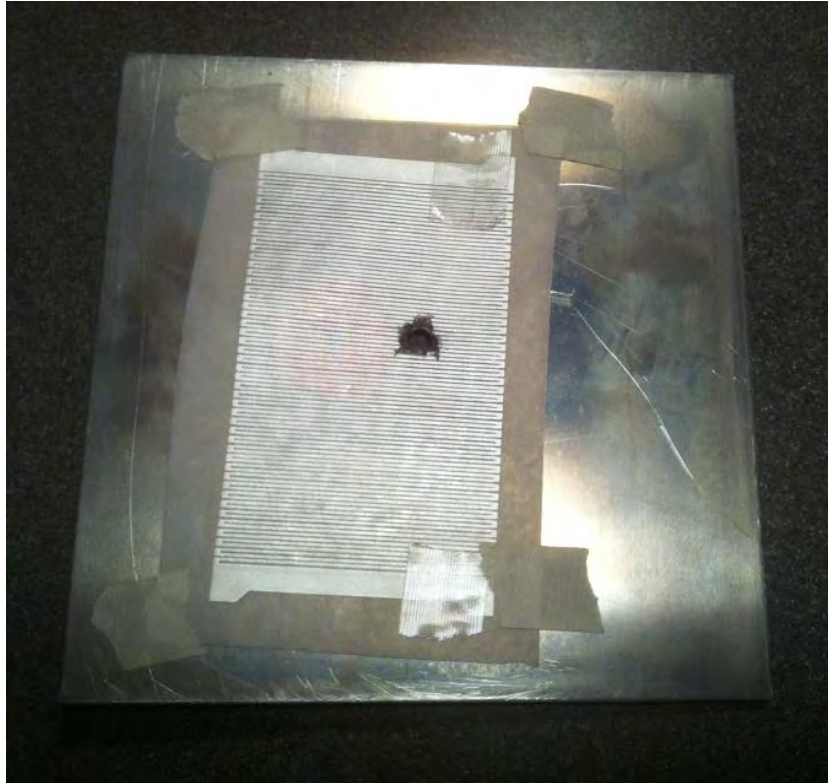
The equipment test fire on the sheet of aluminum was a success, see Figure 4.10. The test fire ensured that the slow motion cameras and the timing system were functioning properly. The target was struck dead center mass and at a zero degree angle of strike. The test did indicate that the maximum achievable velocity for the ballistic range was 834.8 meters/second instead of the goal of reaching 948 meters/second.

Figure 4.10. Successful Test Fire for Equipment Check

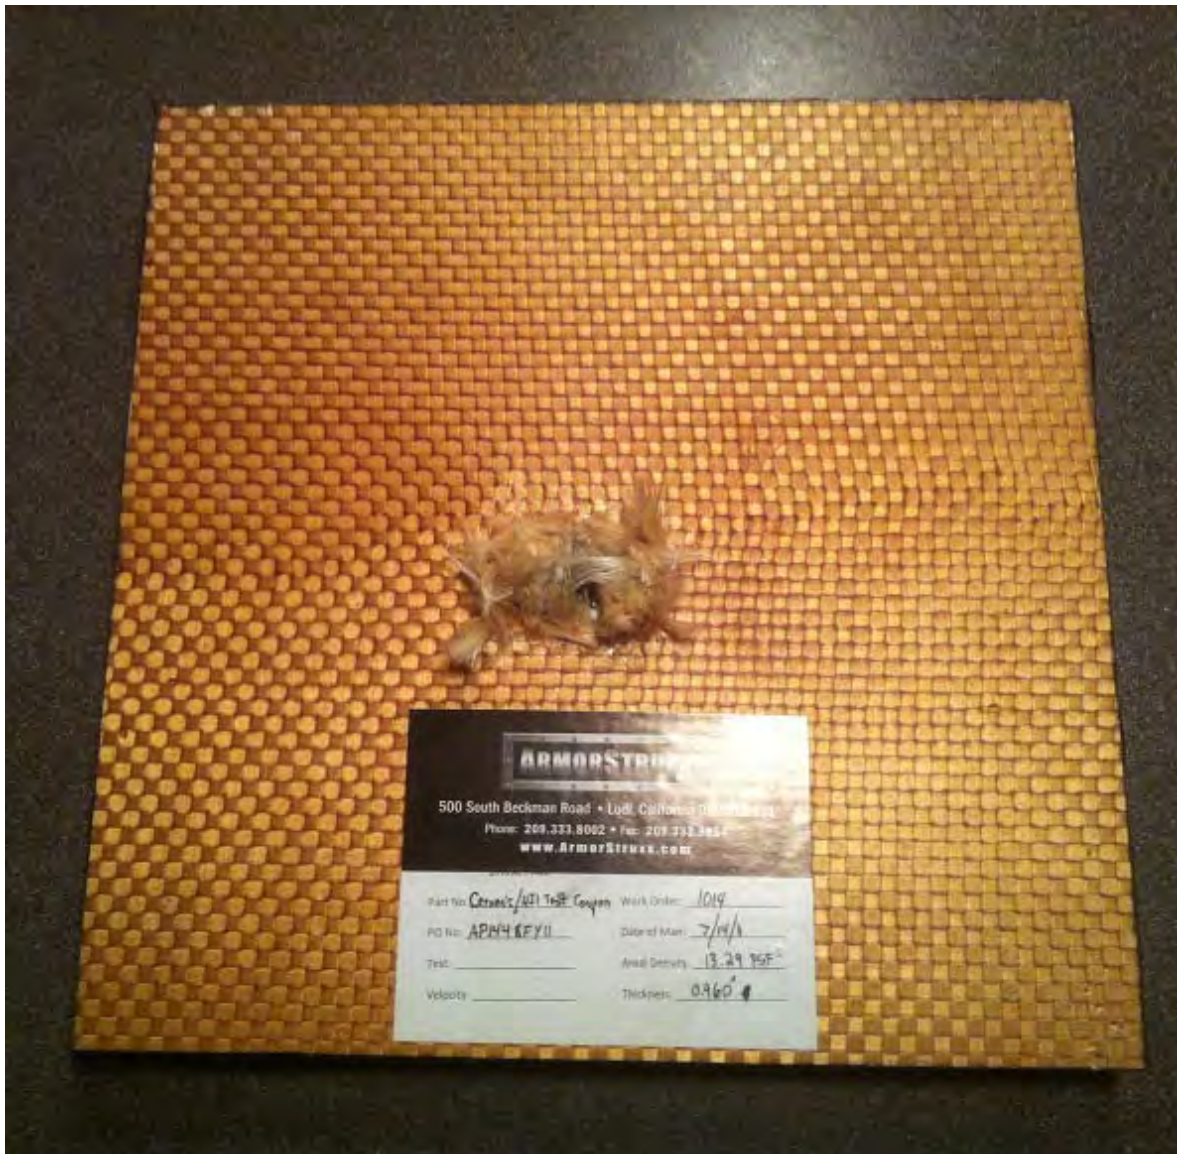
The ballistic was successful just like the test fire. The two layer armor in Figure 4.11 was struck center mass with a zero degree angle of strike. The ceramic frontal plate functioned as it was designed to do so. The ceramic's high mechanical strength, hardness, and stiffness absorbed the majority of the kinetic energy from the armor piercing projectile. The ceramic's structural integrity breaks as it deforms the tungsten core of the projectile. The HJ1 composite absorbs and dissipates the remaining energy in the layered structure of the composite. There is a bulge on the back side of the armor system, but there was no penetration through the HJ1 composite. Figures 4.12 -15 provides a top view of the ballistic impact testing. Figures 4.16 -19 provides a top view of the ballistic impact testing.

Figure 4.11. Successful Ballistic Test on the Two Layer Armor
