**MAINTENANCE OPERATIONS DEGRADATION OF  
AIRFIELD PAVEMENT MARKINGS**

THESIS

In Partial Fulfillment of the Requirements for the  
Degree of Master of Science in Engineering Management

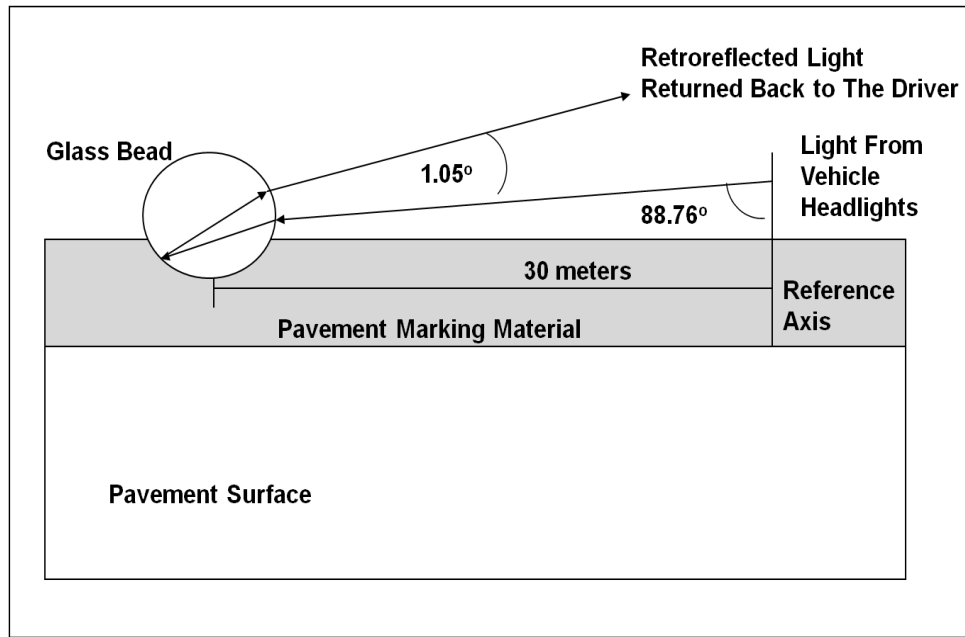
The ASTM specifies a 30-meter geometry for measuring retro-reflectivity for roadway markings. The geometry is based on the driver sitting 1.3 meters above the ground seeing the pavement marking 30 meters in front of the headlight. Figure 1 shows the corresponding angles of refractance and reflectance at the bead location (Needham, 2011). The ASTM specified 30-meter geometry provides a consistent basis for obtaining measurements. Even though the position of a light on an aircraft is much lower than the pilot, and the pilot sits much higher than a car driver, the USAF and FAA use the 30-meter geometry as the standard for measuring pavement marking retroreflectivity (Cyrus H. M., 2003).

**Figure 1 : Illustration of Retro-reflectivity**

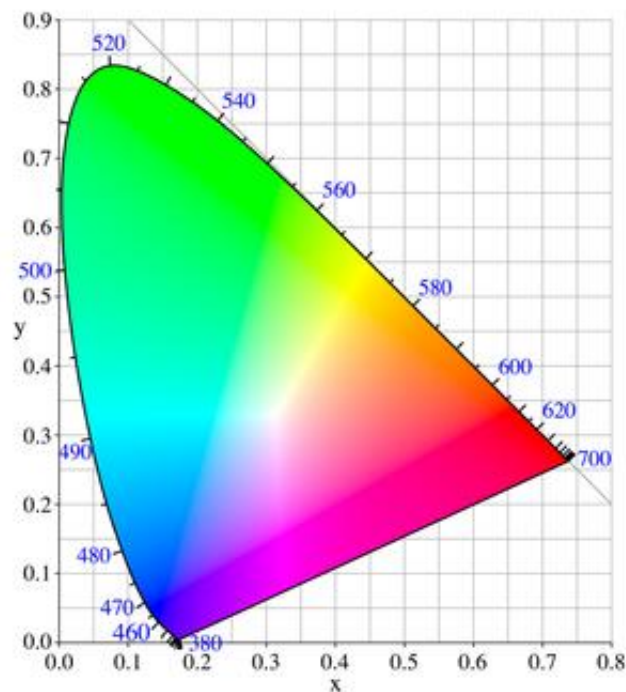
Chromaticity is a measure of the quality of an object's actual color regardless of the luminance. The International Commission on Illumination (CIE) developed a color chart to plot true color in  $xyY$  space where  $x$  and  $y$  are coordinates on the color chart and  $Y$  denotes the color temperature; for this research we use a color temperature of 6500 Kelvin based on the standard set by the FAA. This color space provides a traditional  $xy$  coordinate system, within a given  $Y$  color temperature. Figure 2 shows the chart developed in 1931, which is still the standard today. This specific  $D_{65}$  color chart provides how a color is perceived to the human eye when the color is under direct sunlight at 6500 Kelvin. Direct sunlight is used because it provides the entire color spectrum, and is as close to white light as nature provides. The sunlight then renders the

**Figure 2: CIE 1931 D<sub>65</sub> Color Space Chromaticity Diagram**

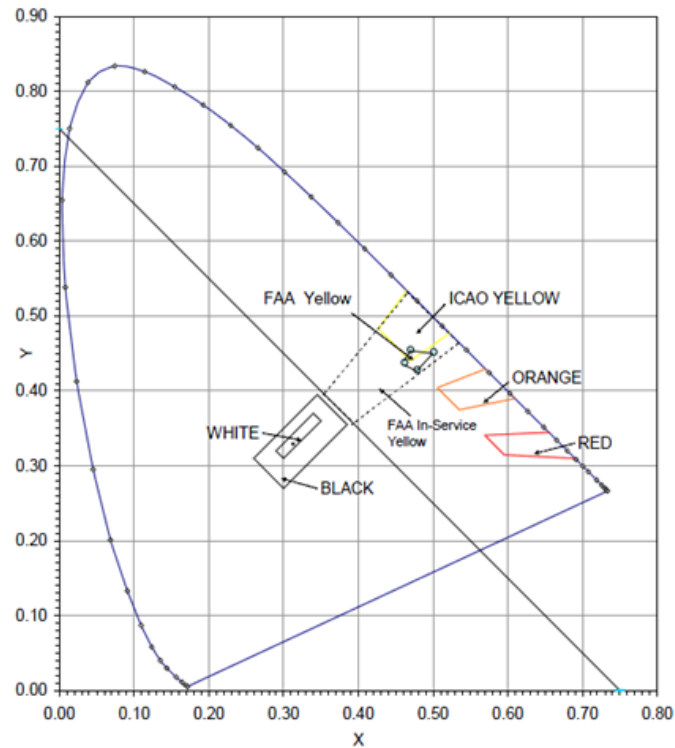
The FAA has established standards for the different colors of markings used on airfields. Each color has a box on the D<sub>65</sub> color chart. For a particular color to be within standards, the sample must fall within the specified corner points. Figure 3 shows the

FAA standard D65 color chart used for evaluating a pavement marking's failure. This research effort focuses on just the white color region.

**Figure 3: FAA Standard Illuminant D<sub>65</sub> Color Chart**

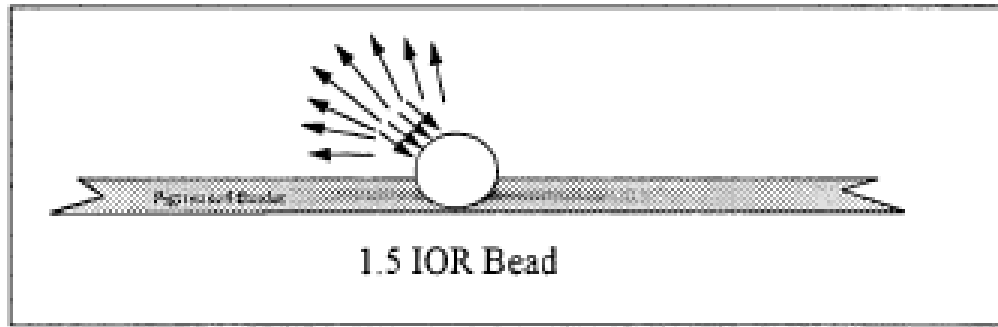
**Figure 4: Type I Bead Retroreflectance Characteristics**

The study team concluded that even though the Type III beads had higher retroreflectance, a smaller amount of light was actually making it back to the pilot's eyes. This was due to the light entering the bead being returned in a very narrow band. Thus, unless the observer was in the narrow reflection band, the reflectance values would be very small. Opposed to this, Type I bead disperses the light in a wider range as shown in Figure 4 and Figure 5 and are thus easier to detect outside of a narrow band (Ates, 1995).

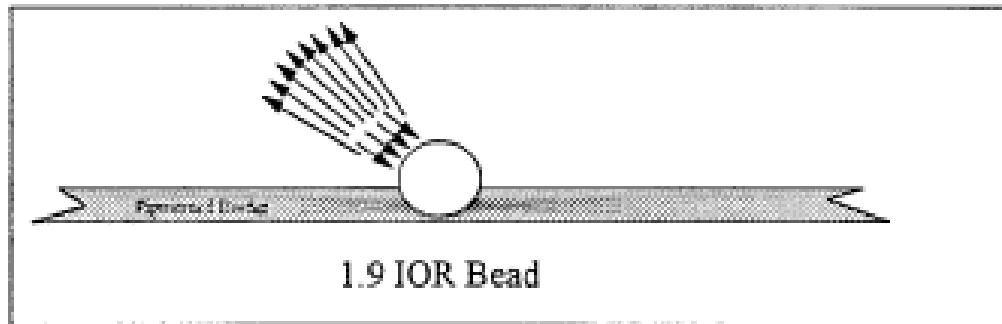
**Figure 5: Type III Bead Retroreflectance Characteristics**

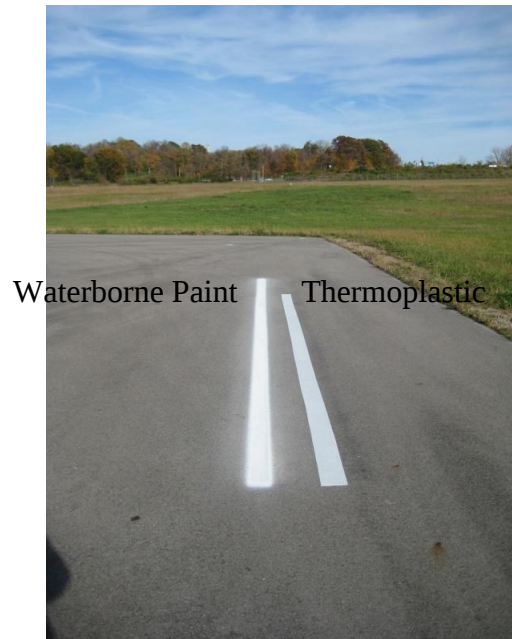
The experiment consists of two test decks of pavement markings. Each deck contains a stripe of waterborne paint and thermoplastic. The stripes of material are 30 ft long and 6 inches wide. The markings within each deck are spaced 12 inches apart. Figure 6 and Figure 7 show the test decks as placed on the asphalt runway for the National Museum of the United States Air Force on Wright-Patterson Air Force Base Area B. The runway is a semi-active runway with approximately ten take-offs and landings per year. The test decks have a sufficient buffer around them to allow for movement of machinery without having to traverse over the markings. Thus, the only factors affecting the markings are the applications of the prescribed treatments. Initial retroreflectivity and chromaticity readings were taken before any treatments were applied.

**Figure 6: Chemical Treatment Test Deck**

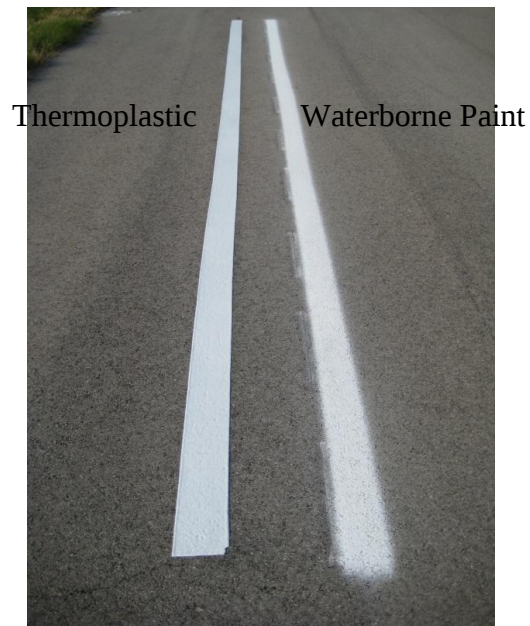
**Figure 7: Sweeper Treatment Test Deck**

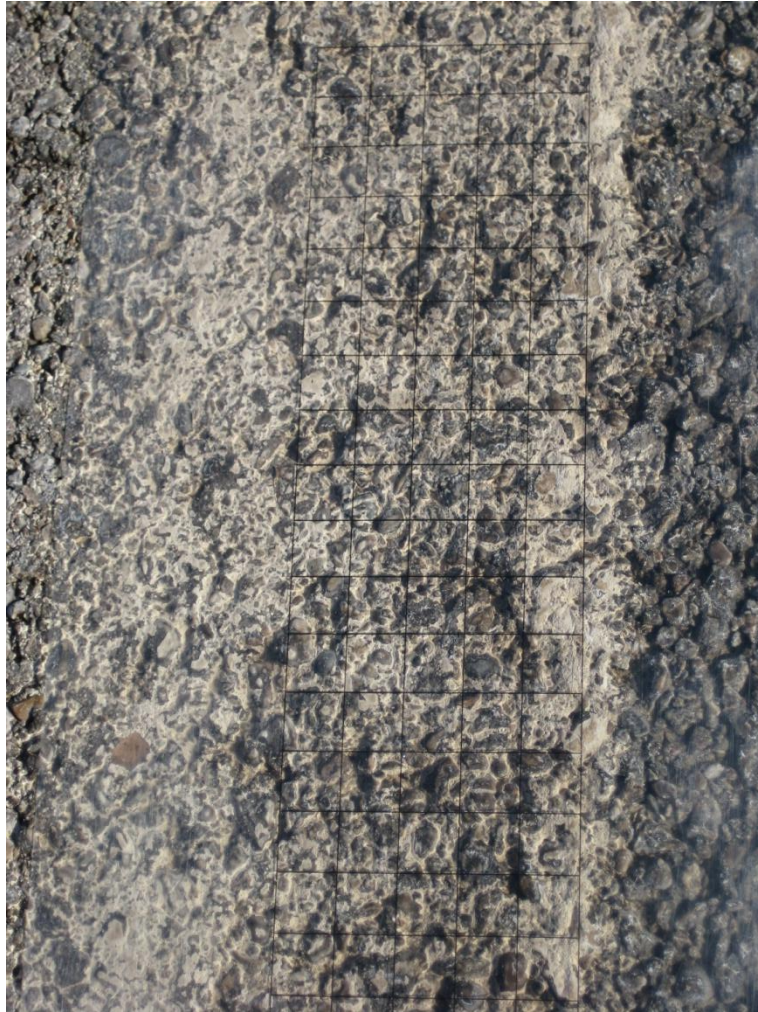
Coverage is evaluated using a 25 square inch transparent sheet. The sheet is divided into 100 blocks, each 0.25 inches square, with 20 rows and 5 columns. The researchers placed the sheet on the sample marking and counted the number of squares which showed pavement instead of just marking material as demonstrated in Figure 9. The number of squares showing more than 50 percent pavement was subtracted from 100 to give the percent coverage remaining. If the overall coverage is less than 50%, the marking fails.

**Figure 9: Transparent Grid Used for Measuring Coverage**

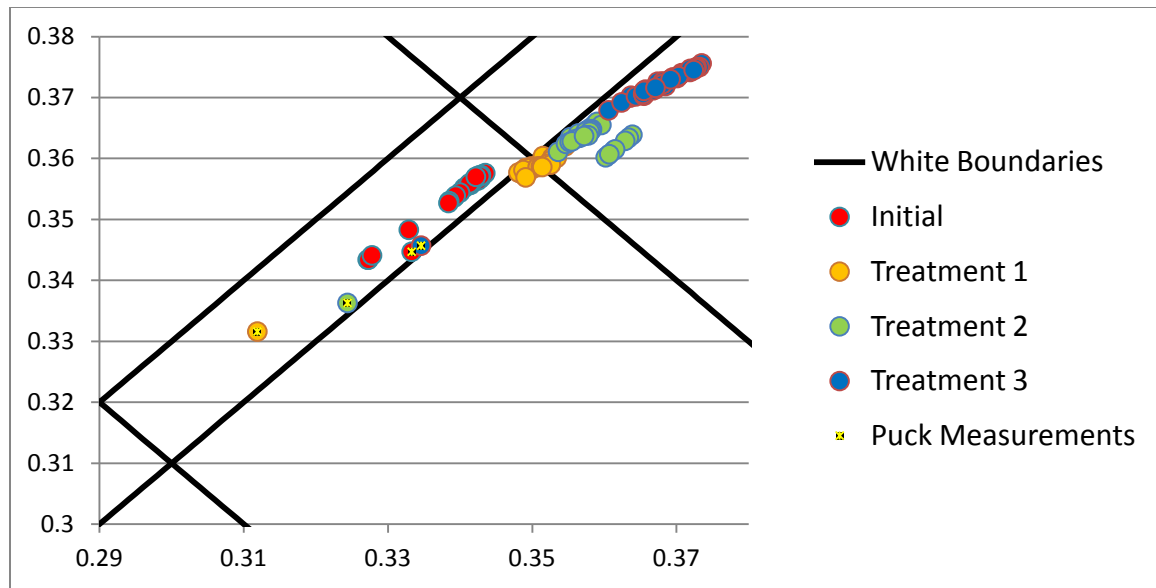
The paint which experienced the chemical treatment failed after the first treatment application. The retroreflectivity started with a mean above 200 mcd/m<sup>2</sup>/lux, but after the first treatment the mean had dropped below 90 mcd/m<sup>2</sup>/lux; a failing level according to both the USAF and the FAA. Additionally, the chromaticity levels which had started within the specified range had moved outside the range after every treatment application. Figure 10 shows the chromaticity values for the paint marking. The black box outlines the FAA approved area for a white pavement marking. Note the tendency of the marking to migrate to the upper right after each subsequent treatment. The only test which the paint did not fail was the coverage test. Visual inspection of the marking shows that even after the third treatment application, the marking was still above 80%, well above the specified 50% standard. On just a visual inspection the marking would have been considered passing on all accounts, but using retroreflectivity and chromaticity measurements, the marking failed after the first application.

**Figure 10: Chemical Treatment Test Deck Waterborne Paint Chromaticity Measurements (nominal units)**

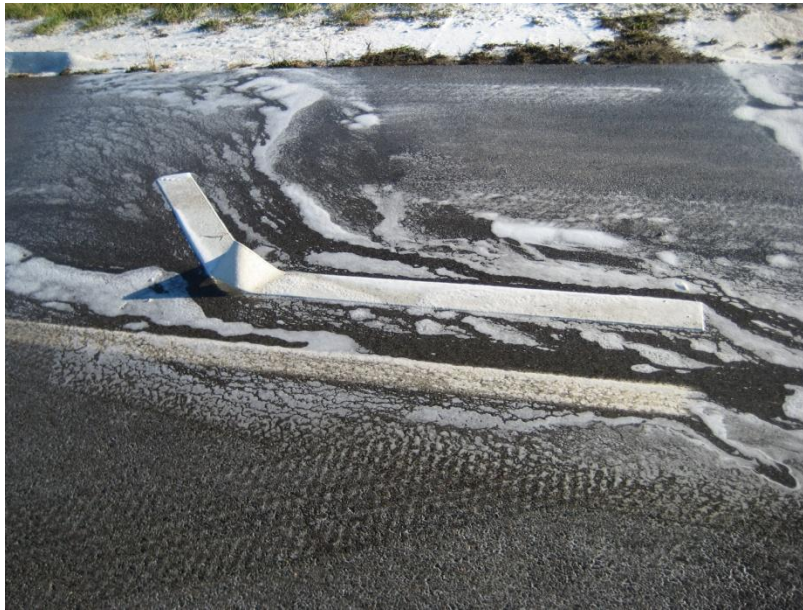
The thermoplastic marking which experienced the chemical treatments reacted vastly different than the paint marking. Throughout all the treatments, the thermoplastic maintained a passing level for retroreflectance. After the third treatment, the marking still maintained an average of  $123 \text{ mcd/m}^2/\text{lux}$ . However, this value was only obtained using three data points. During the washing process after the third treatment, most of the thermoplastic material experienced a catastrophic failure due to problems with surface bonding and peeled up from the asphalt surface as shown in Figure 11. The water pressure from the fire engine hand line, acting perpendicular to the pavement marking, dislodged the material and forced it off the asphalt. For future efforts, the water should be applied in parallel to the markings, not perpendicular. After the washing was complete, only the first three feet of the marking remained intact. Because of this, the

**Figure 11: Catastrophic Failure of Thermoplastic**

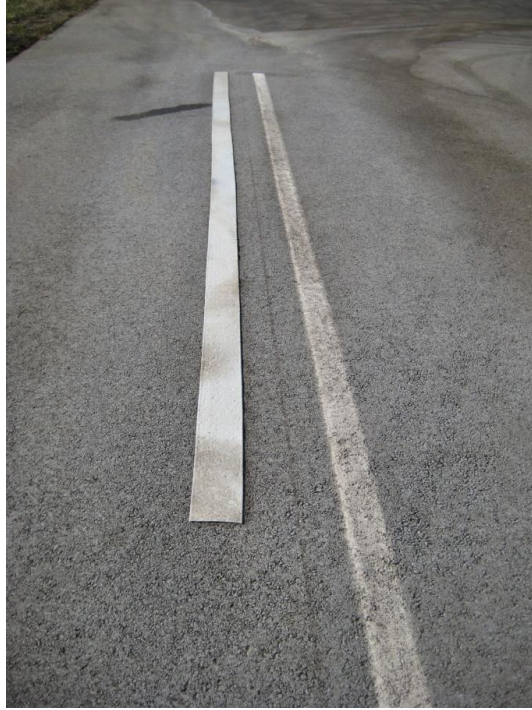
**Figure 12: Thermoplastic Repositioned After Failure**

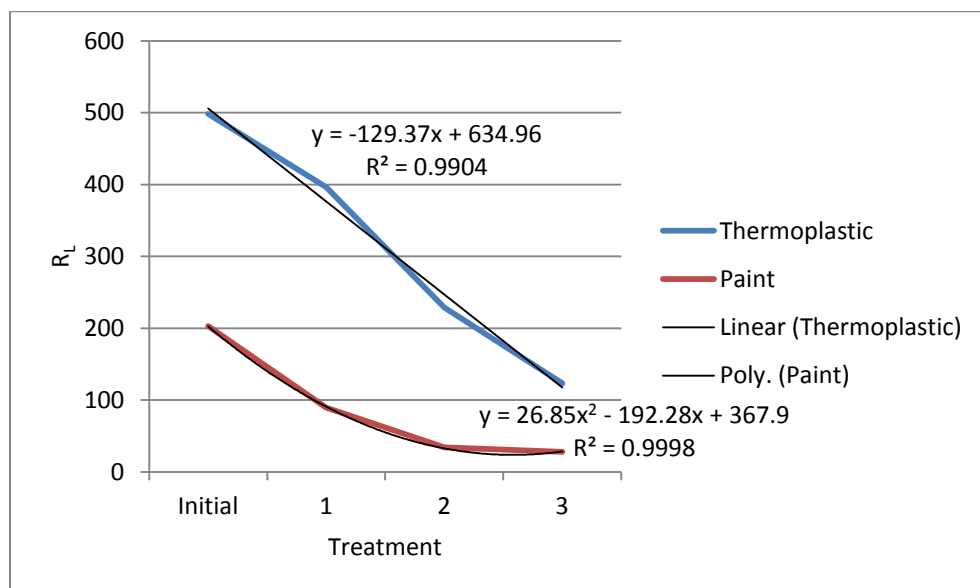
researchers could not obtain retroreflectance readings on anything but the first three feet. However, we were still able to collect chromaticity readings for the material which had peeled up. Figure 12 shows the material laid down in order to obtain the chromaticity readings. The researchers graphed the degradations for retroreflectance, and chromaticity in the x and y directions for both the waterborne paint and thermoplastic. The graphs and corresponding best fit regression lines with  $R^2$  values are shown in Figure 13, Figure 14, and Figure 15.

**Figure 13: Chemical Treatment Retroreflectance (mcd/m<sup>2</sup>/lux)**

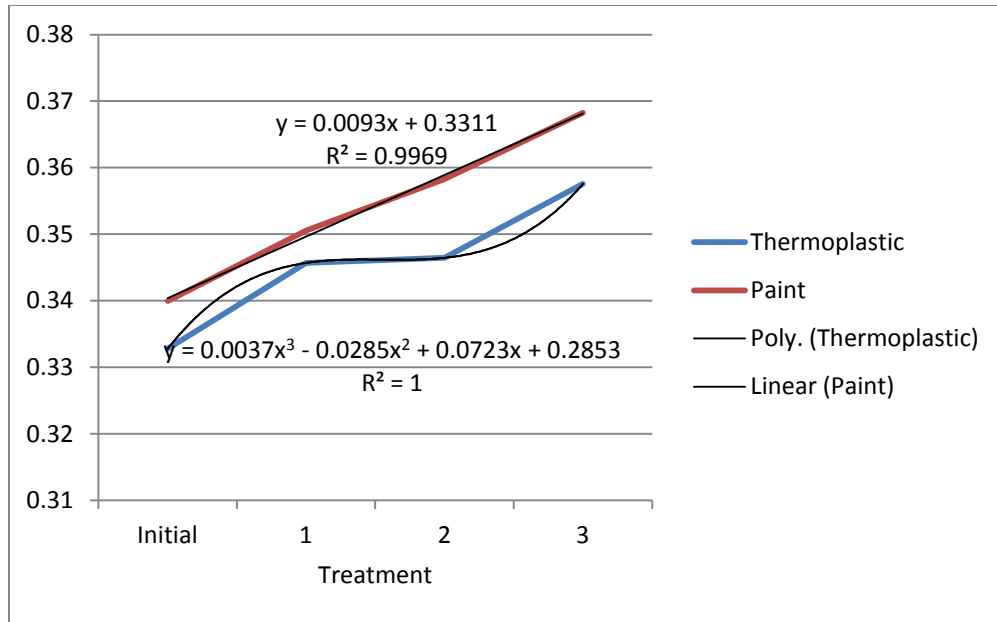
**Figure 14: Chemical Treatment Chromaticity x**

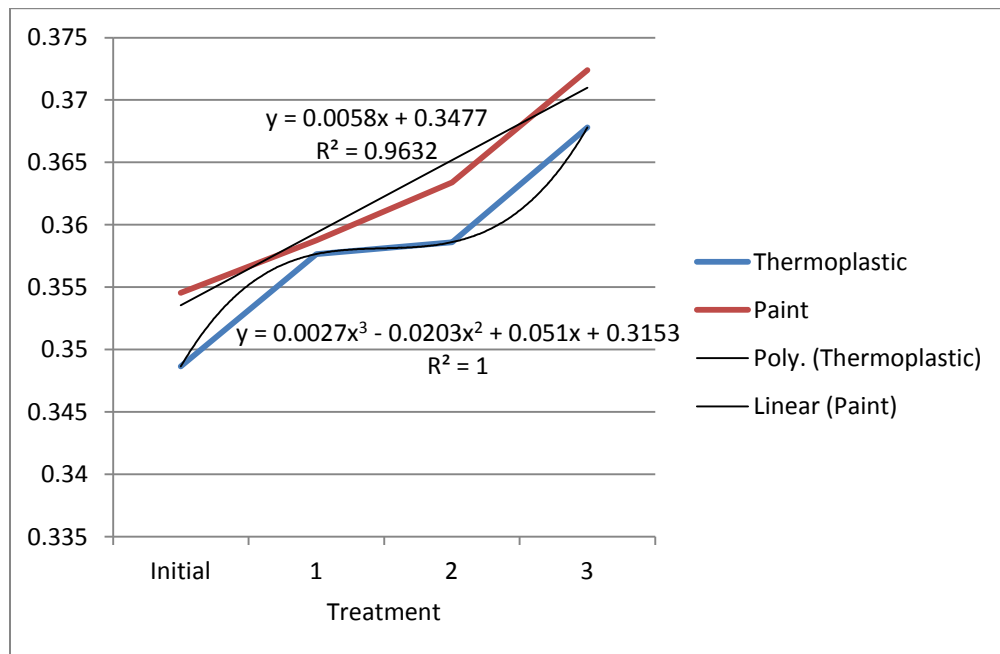
**Figure 15: Chemical Treatment Chromaticity y**

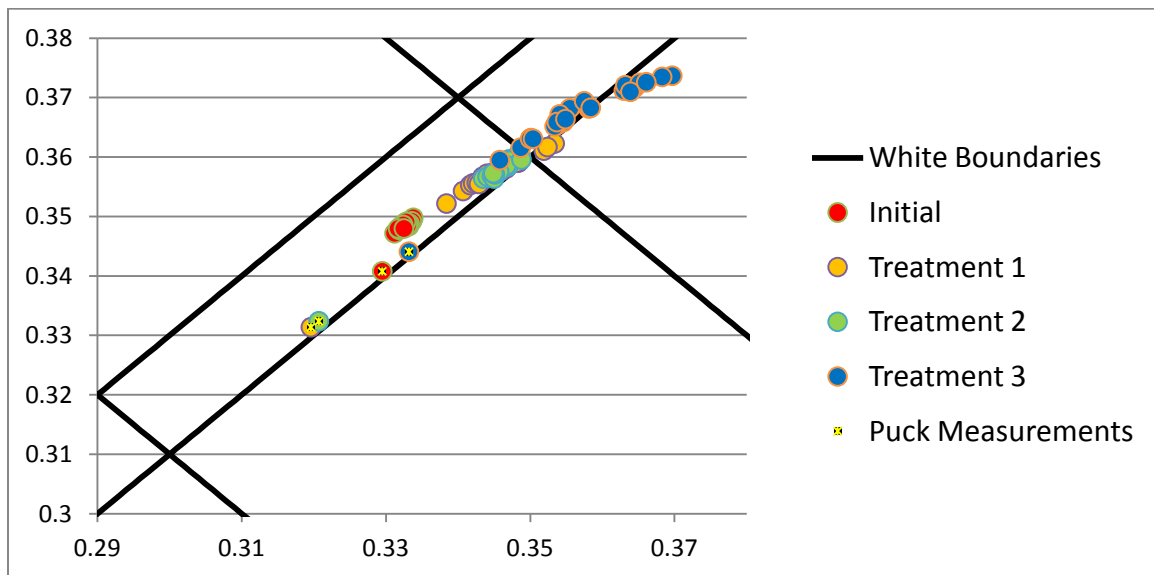
Charting the chromaticity readings reveals that after the third treatment, the marking was no longer inside the specified ranges. Figure 16 shows that the thermoplastic displays a similar trend to that of the waterborne paint in that the chromaticity readings tend to the upper right as chemical treatments are applied. A visual inspection of the thermoplastic material cross-section showed that the material retained a large majority of the reflective beads throughout its thickness. The main concern with this material is its adherence properties to the runway surface. This is consistent with what the FAA found in their evaluation of the material (Cyrus & Previti, 2008).

**Figure 16: Chemical Treatment Test Deck Thermoplastic Chromaticity Measurements**

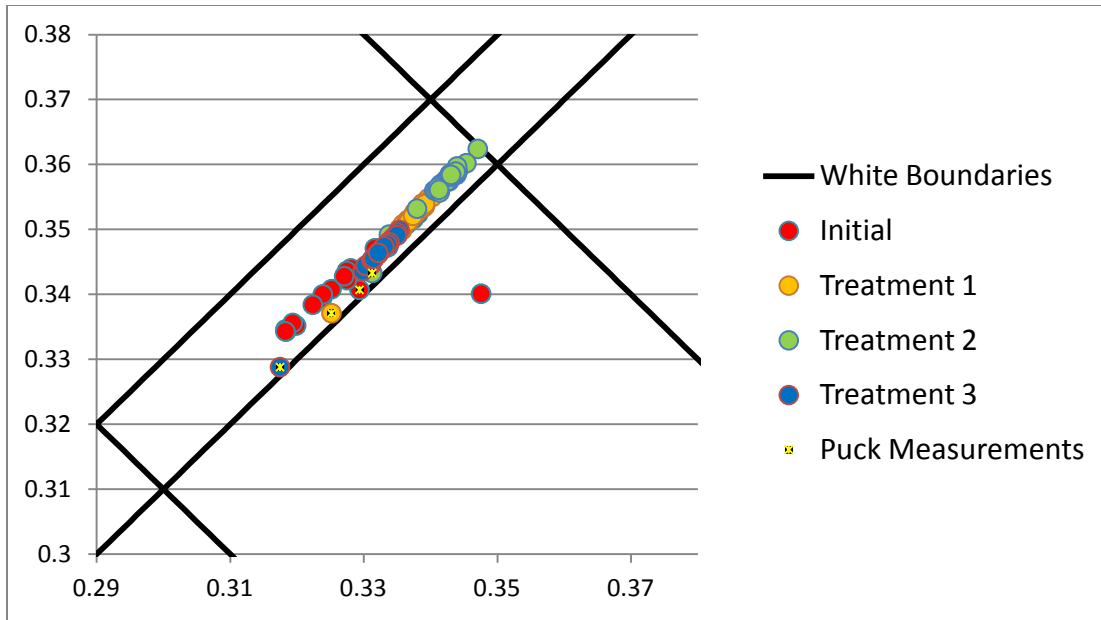
Upon a visual analysis of the marking materials, both the waterborne paint and the thermoplastic performed well. After the last application of the treatment, both materials still retained most of their coverage. However, the thermoplastic did chip up a bit, losing approximately 16 inches from one end. Due to the lack of debris in the area, we assume the sweeper broke the material into small pieces and ingested those pieces. Both materials still appeared white after the third treatment, and both appeared to have acceptable amounts of retroreflectance. Figure 17 and Figure 18 show that the markings' color did not deviate much from the initial values, and all stayed within the acceptable white range.

**Figure 17: Sweeper Treatment Test Deck Waterborne Paint Chromaticity Measurements**

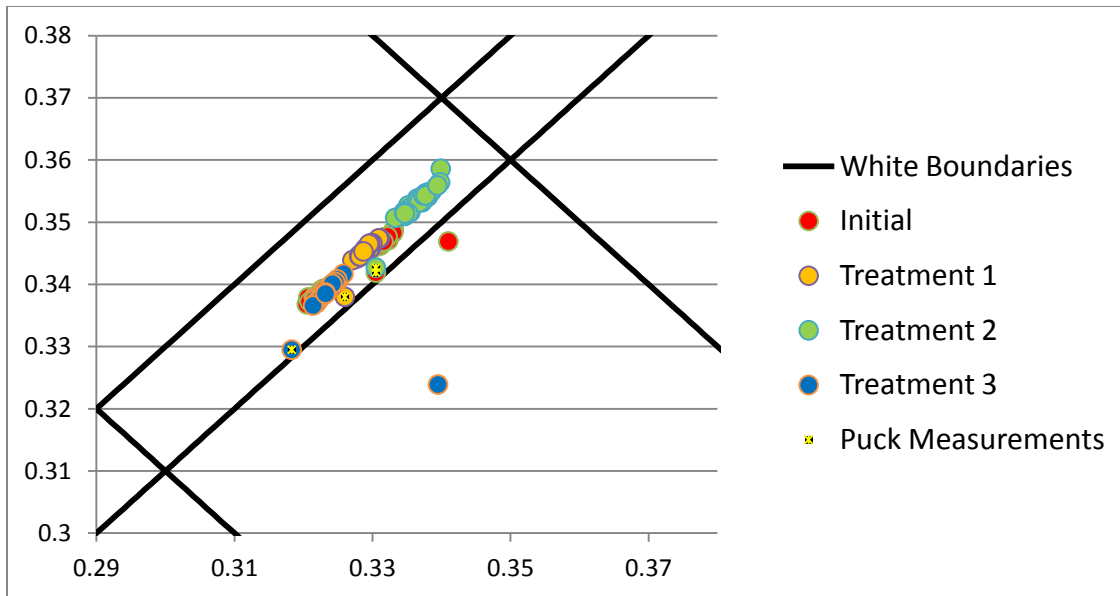
**Figure 18: Sweeper Treatment Test Deck Thermoplastic Chromaticity Measurements**
