# First Year Morphological Evolution of an Artificial Berm at Fort Myers Beach, Florida

*by Katherine E. Brutsche and Ping Wang*

**PURPOSE:** This Coastal and Hydraulics Engineering Technical Note (CHETN) documents the sediment characteristics and first year morphological evolution of an artificial berm placed just offshore in Fort Myers Beach, Florida, based on a series of field data collection periods during the first year after the berm construction.

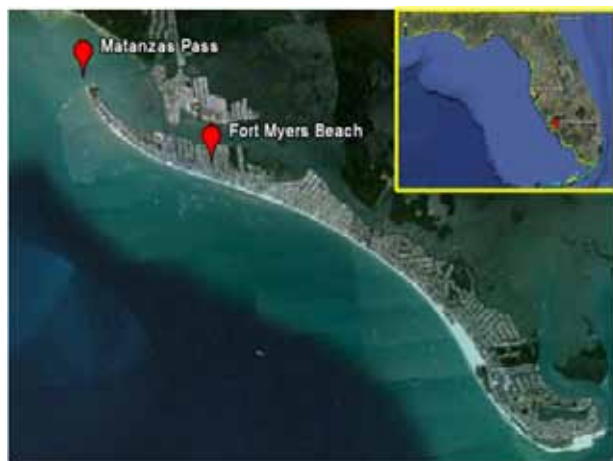
Figure 1. Fort Myers Beach and Matanzas Pass at the north end of Estero Island, Florida.

Matanzas Pass (Figure 1), located along Fort Myers Beach at the northern tip of Estero Island in west-central Florida, is a federally maintained navigation channel. The inlet has been dredged in 1986, 1996, and 2001, with the dredged sand placed along the adjacent beaches, as well as in the nearshore zone. Since the dredging in 2001, the channel had shoaled to the extent of blocking the entire channel, which prompted a new dredging cycle in 2009 (Florida Department of Environmental Protection, 2009). A hydraulic dredge was used and the material was placed in the form of a nearshore berm, 1.5 miles southeast of the dredging area (Figure 2). This report documents the sediment characteristics of the berm and examines the first year morphologic evolution.

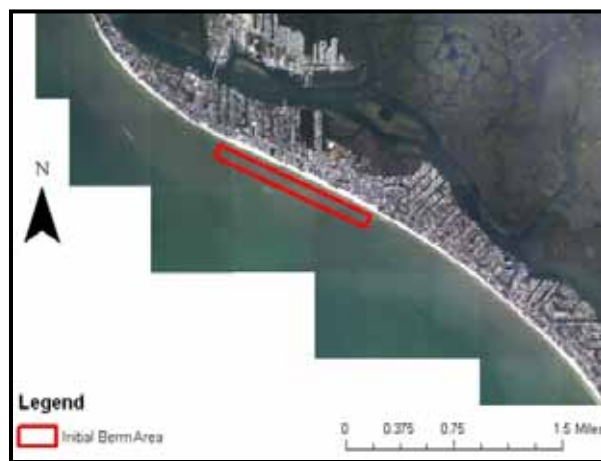
Figure 2. Designed berm placement location.

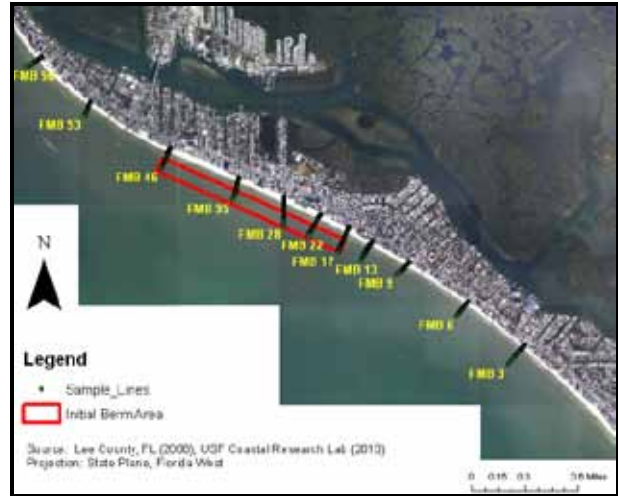
Figure 4. Locations of the sediment-sampling transects.

**METHODOLOGY:** This study is based on sediment and morphology data collected in the first year. An initial post-construction survey was conducted by the Jacksonville District (USACE) in October 2009. Since April 2010, an intensive field data collection method was conducted by the Coastal Research Lab at the University of South Florida (USF). The USF study area includes the artificial berm area and control areas 1 mile northwest and southeast of the berm, respectively (Figure 3). Beach profiles in the control areas were set at roughly 600 ft intervals, while lines over the artificial berm were set at about 150 ft intervals. The 57 beach profiles, extending to roughly 8 ft water depth, were surveyed using an electronic total station following standard level-transect procedures. Two time-series surveys were conducted in April 2010 and October 2010. Surface sediment samples were collected along 11 of the 57 beach profiles, including 5 across the artificial berm and 6 in the control areas (Figure 4).
