| REPORT DOCUMENTATION PAGE | | | | Form Approved<br>OMB No. 0704-0188 | |
|---|---|---|---|---|---|
| 4. TITLE AND SUBTITLE<br>Technical Report on Ammunition Can Strap Verification Tests | | | | 5a. CONTRACT NUMBER<br>N/A | |

## **Technical Report on Ammunition Can Strap Verification**

**24 MARCH 2012**

U.S. Army Tank Automotive Research,  
Development, and Engineering Center  
Detroit Arsenal  
Warren, Michigan 48397-5000

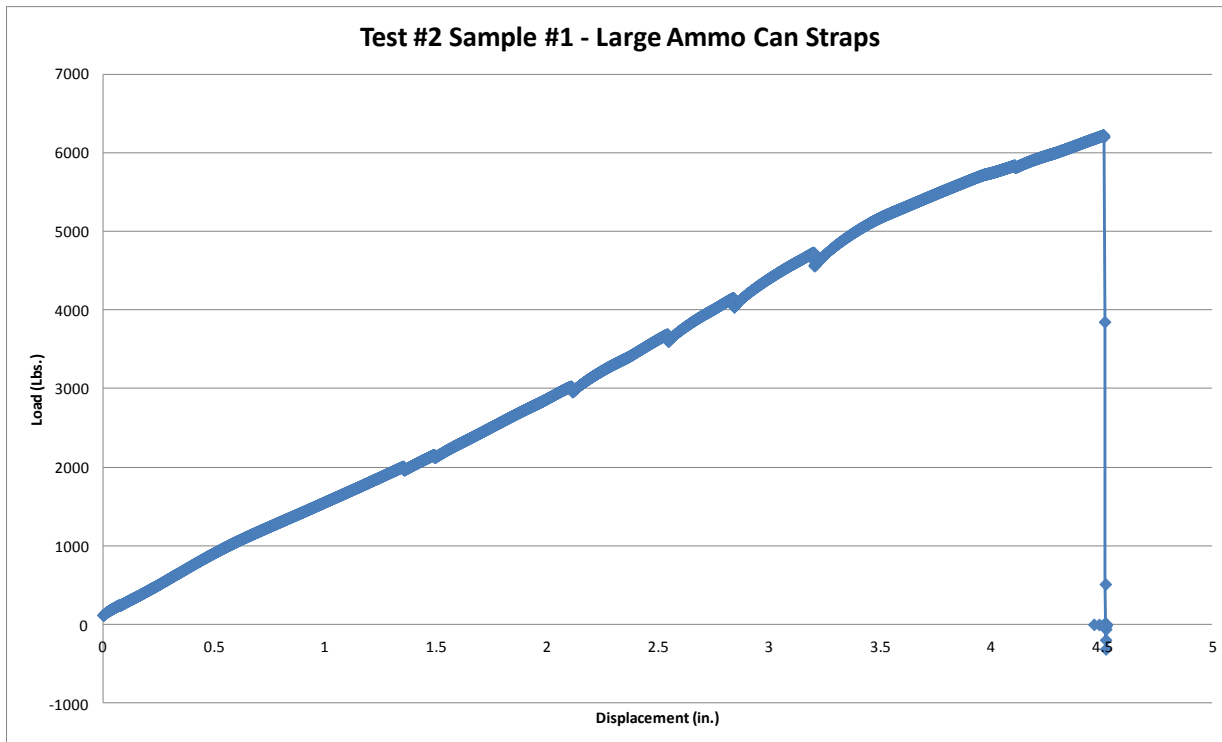
Test 2 (Large 1-3/4" Straps):

Sample Number: 1

Belt Preload: 120.7 lbs.

Figure 4. Graph for Test 2(Large Straps).

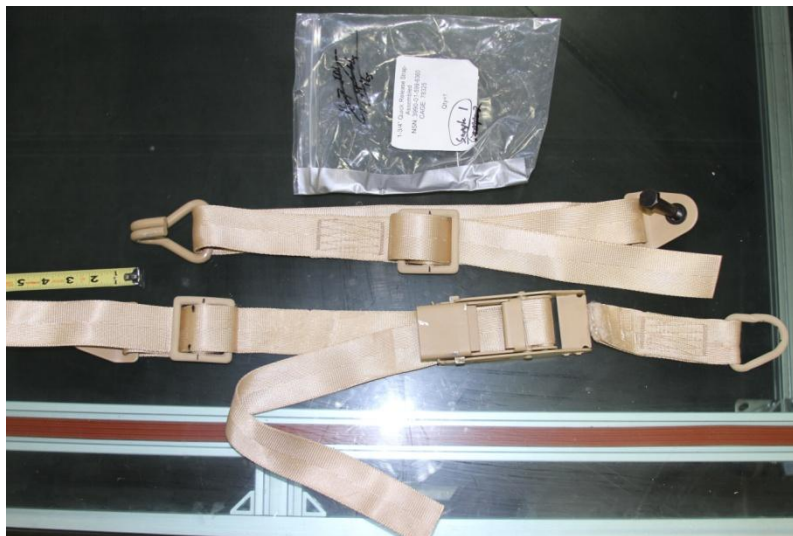
Figure 5. Sample 1 After Failure.

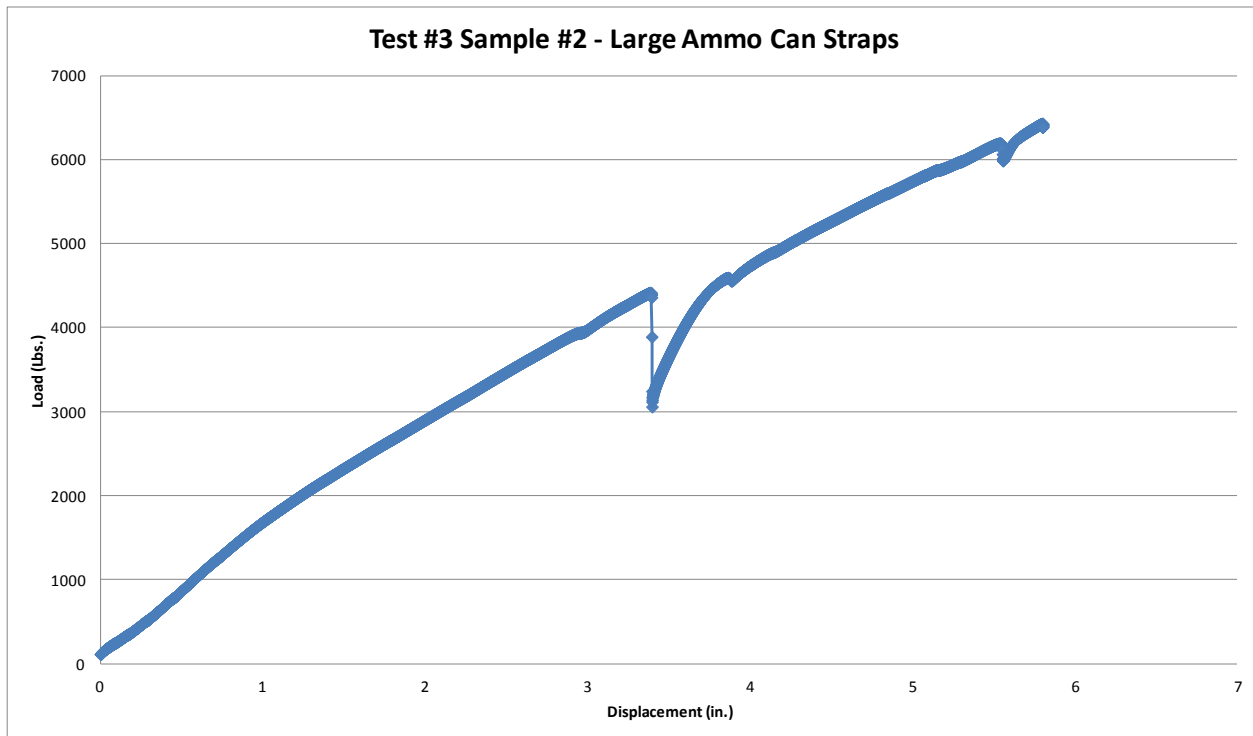
## Test 3 (Large 1-3/4" Straps):

Sample Number: 2

Belt Preload: 115.25 lbs.

Figure 6. Graph for Test 3(Large Straps).

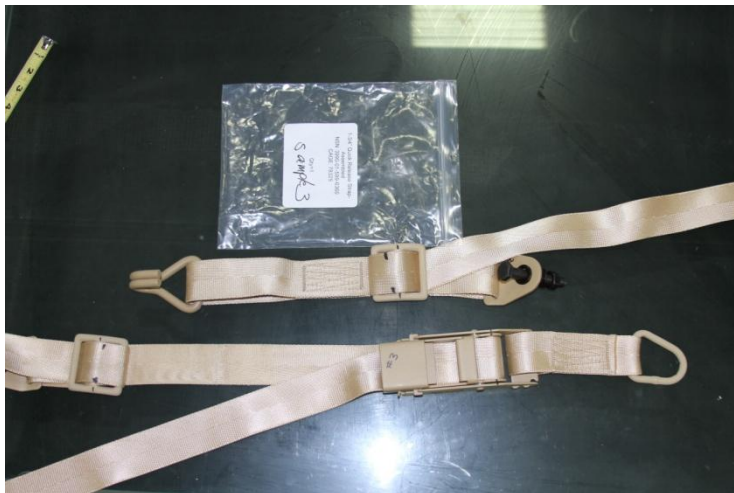
Figure 11. Sample 3 After Failure.

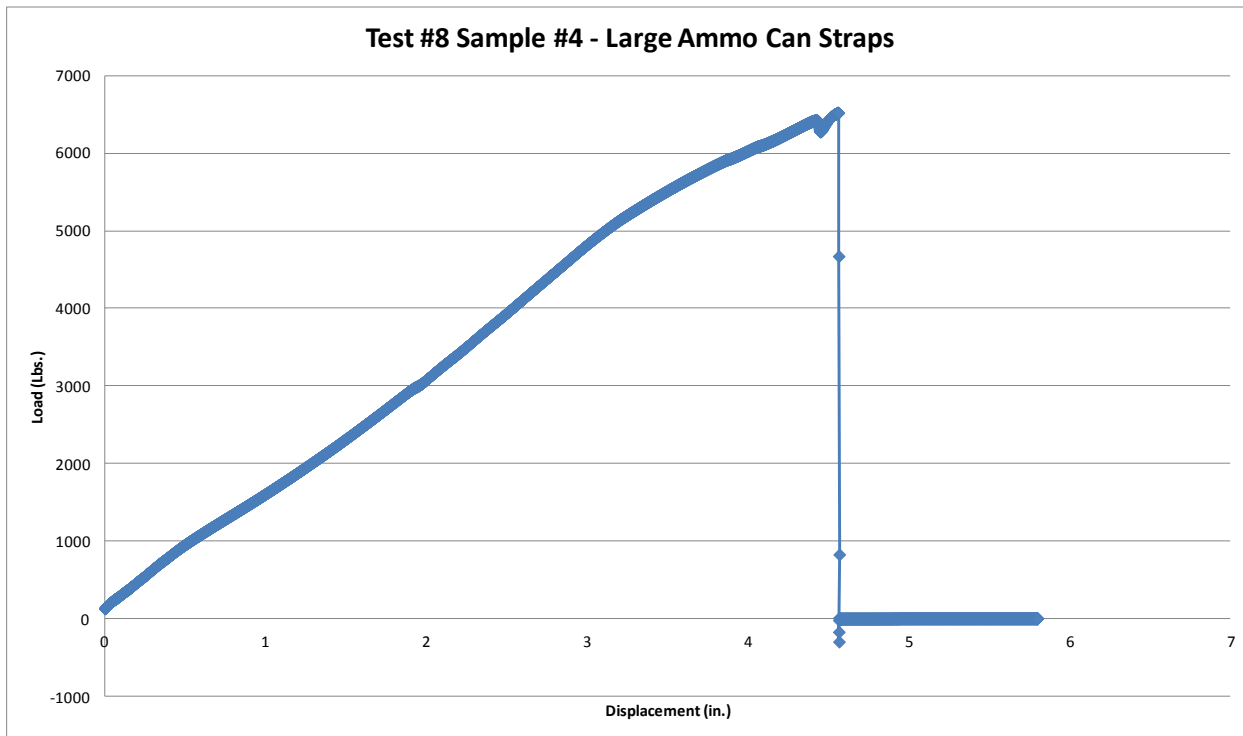
Test 8 (Large 1-3/4" Straps):

Sample Number: 4

Belt Preload: 133.1 lbs.

Figure 13. Graph for Test 8(Large Straps).

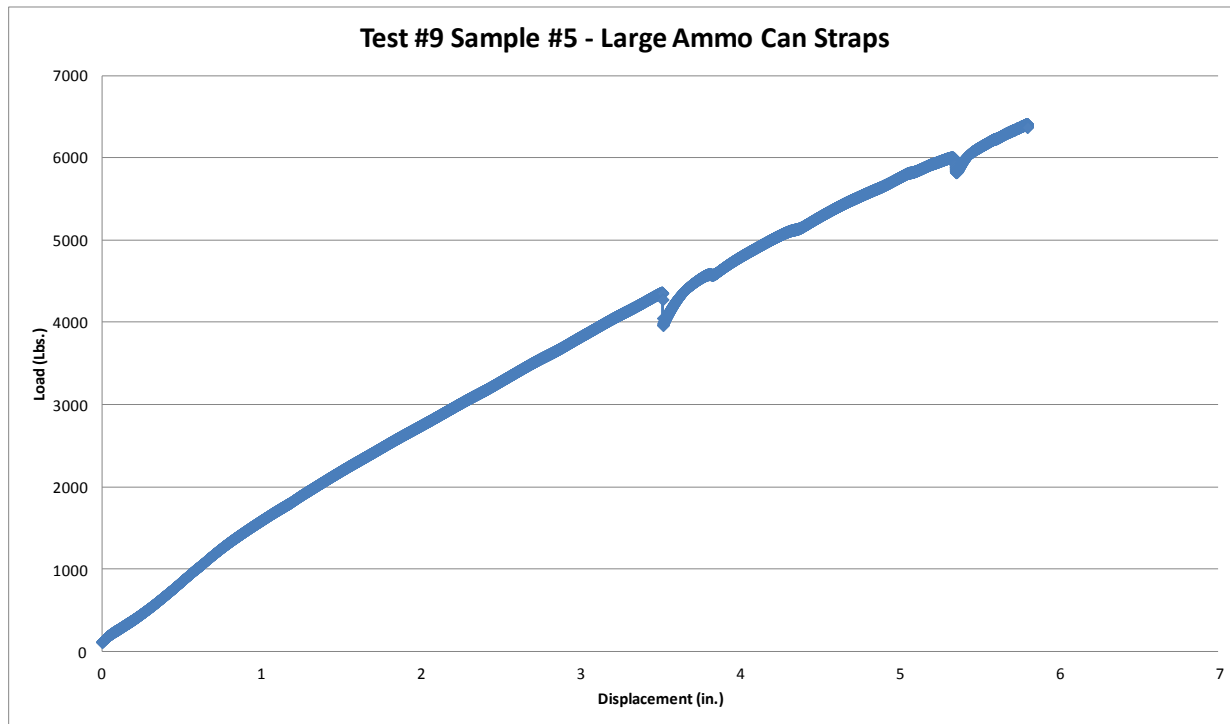
## Test 9 (Large 1-3/4" Straps):

Sample Number: 5

Belt Preload: 116.6 lbs.

Figure 15. Graph for Test 9(Large Straps).

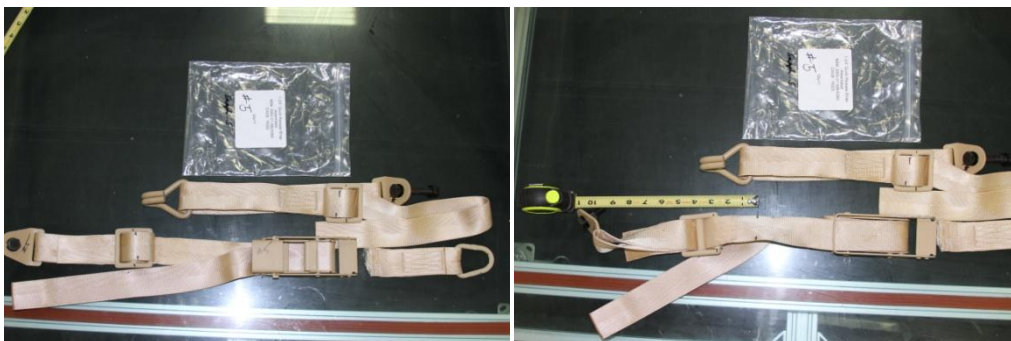
Figure 17. Sample 5 after failure.

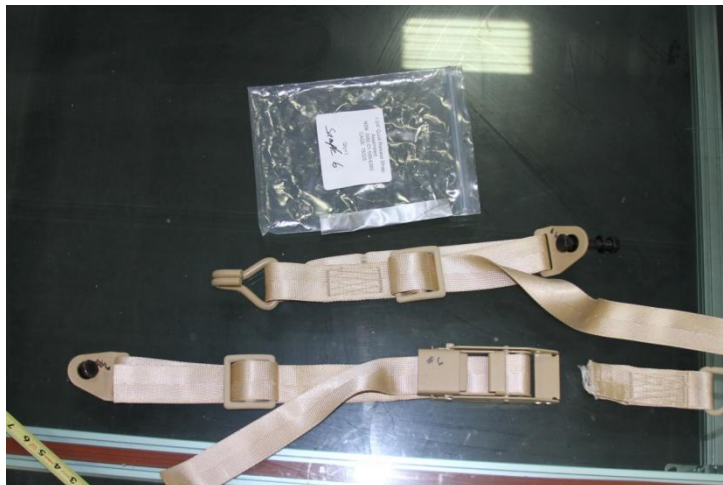
Figure 19. Sample 6 after failure.

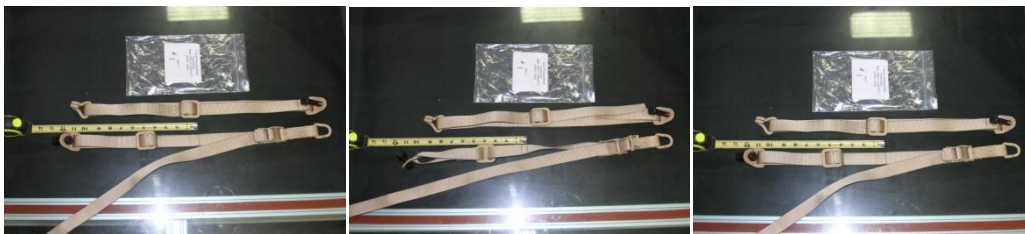
Figure 22. Sample 1 After Failure.

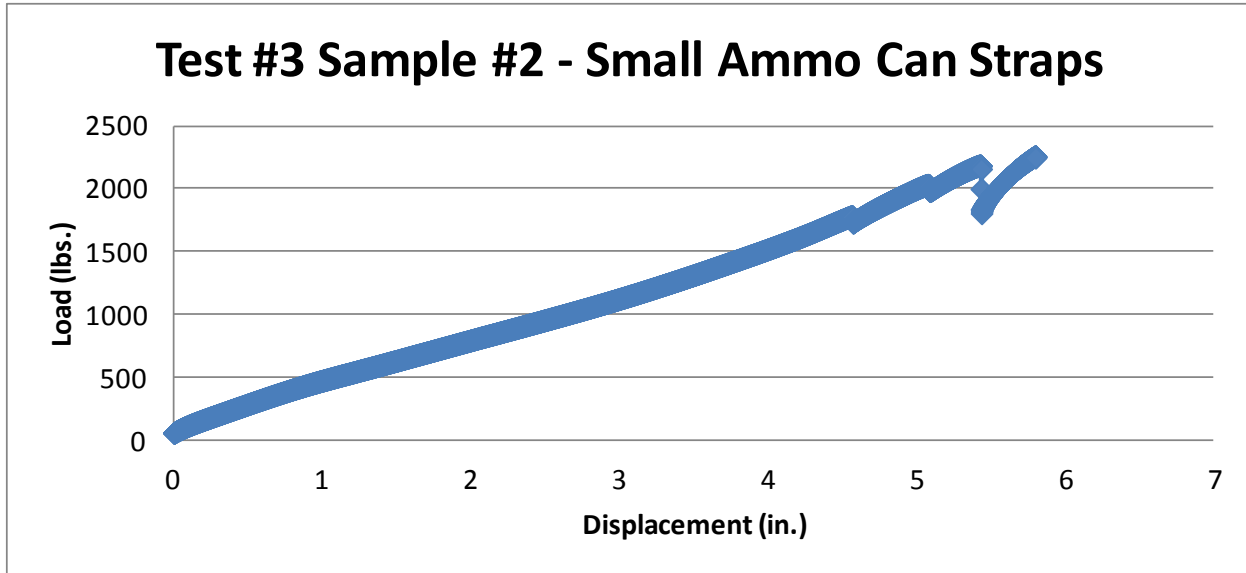
Test 3 (Small 1" Straps):

Sample Number: 2

Belt Preload: 59 lbs.

Figure 23. Graph for Test 3 (Small Strap).

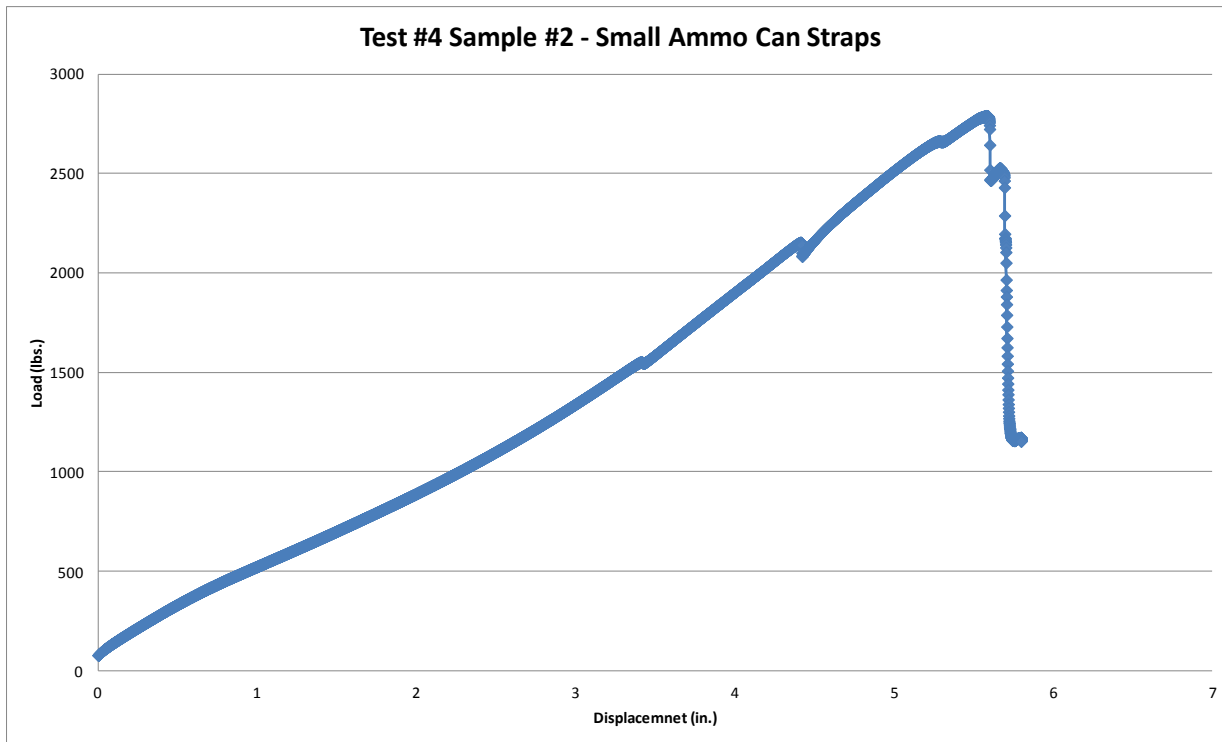
Test 4 (Small 1" Straps):

Sample Number: 2

Belt Preload: 78 lbs.

Figure 24. Graph for Test 4 (Small Strap).

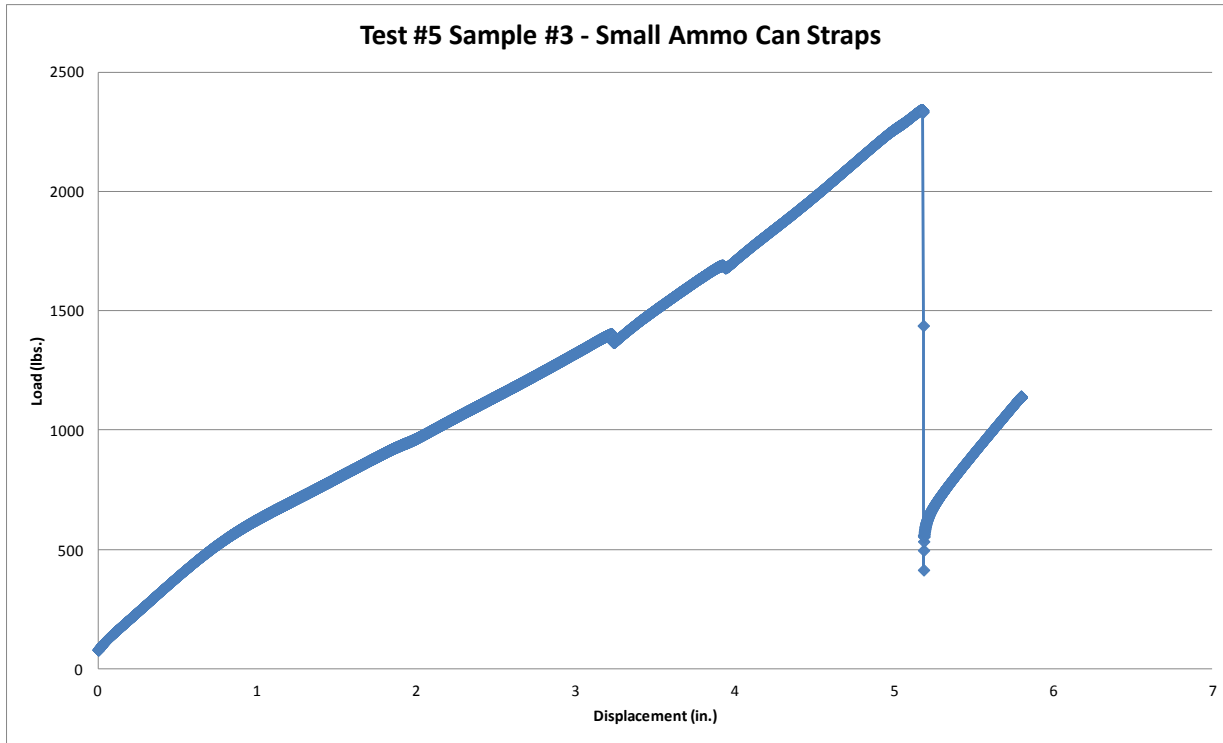
Test 5 (Small 1" Straps):

Sample Number: 3

Belt Preload: 79 lbs.

Figure 26. Graph for Test 5 (Small Strap).

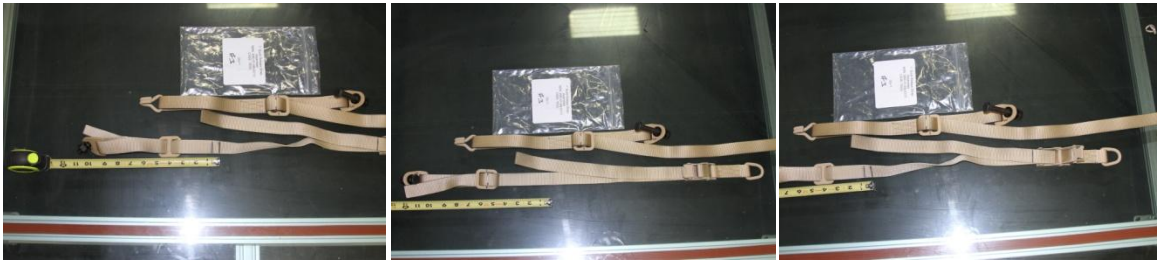
Figure 27. Sample 3 After Failure.

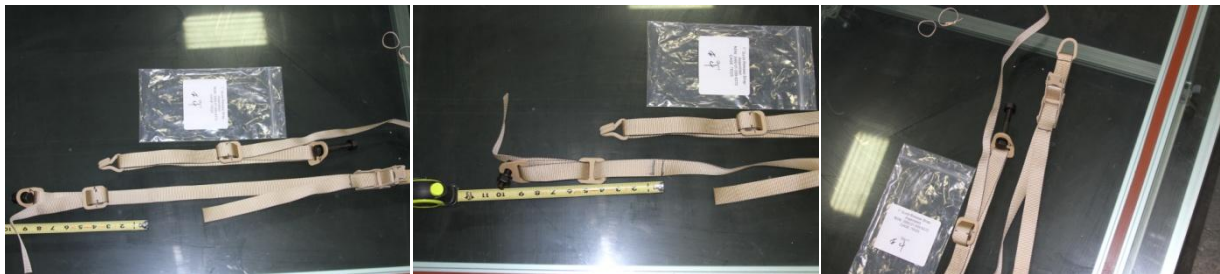
Figure 29. Sample 4 After Failure.
