**Damage Study in an AA 2024 T3 Panel Subjected to
Explosive Loading**

ARL-RP-369

*A reprint from the Materials Science and Technology 2011 Proceedings, Columbus, OH,
16–20 October 2011, pp. 902–909.*

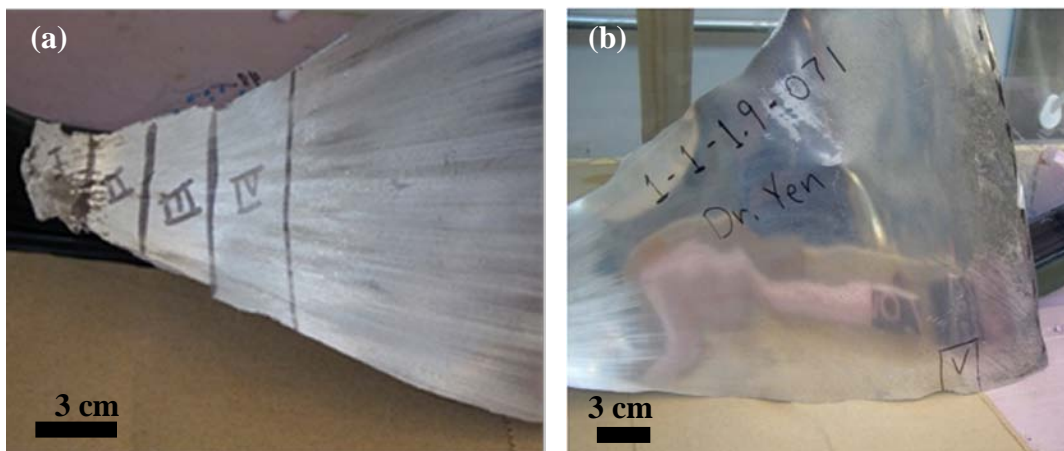
Figure 1. Sample areas (a) I through IV, and in (b), V from the ruptured panel.

From the ruptured panel, five sample pieces were obtained. The pieces were labeled I, II, III, IV and V respectively. Sample I is at the center of the explosion, while sample V was chosen at an area of the panel not affected by the explosion. The samples from this ruptured panel before getting cut into individual pieces for the analyses, are shown in Figure 1. For the not-ruptured panel, a triangular sample was removed from the center of the panel, similar in location to samples I through III of the ruptured panel (see Fig. 2). SEM and EDS analyses were conducted by using the FEI Nova NanoSEM600 microscope and EDAX Genesis, respectively. XRD analysis was conducted by using a Rigaku MiniFlex II Desktop X-ray Diffractometer. The x-ray was a CuK α 1 radiation of wavelength $\lambda=0.15406$ nm, at 2.0 degrees/min scan speed and 0.02 degrees sampling width. The hardness of the alloy was measured by using a Wilson Rockwell, Wilson Instruments, hardness tester.

The effect of the blast on the microstructure of ruptured AA 2024 T3 panels was studied by x-ray diffraction (XRD) as a function of the distance away from the center of the explosion according to Figure 1. A summary of the XRD results is shown in Figure 5. Since sample Area V of the panel at roughly 40 cm from the center of the explosion was not deformed (Fig. 1) by

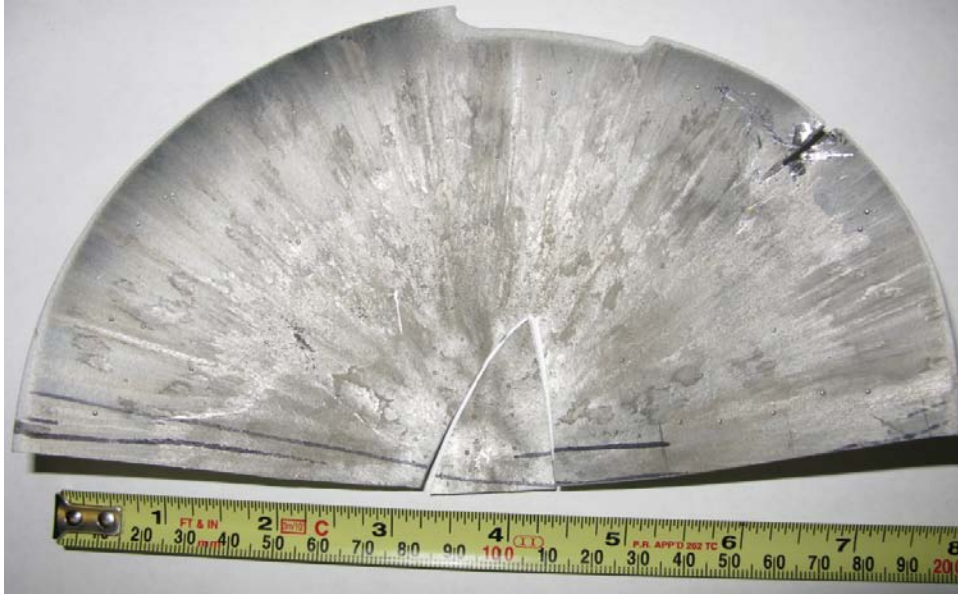
Figure 2. Triangular sample examined from the not- ruptured panel, in relation to the blast area

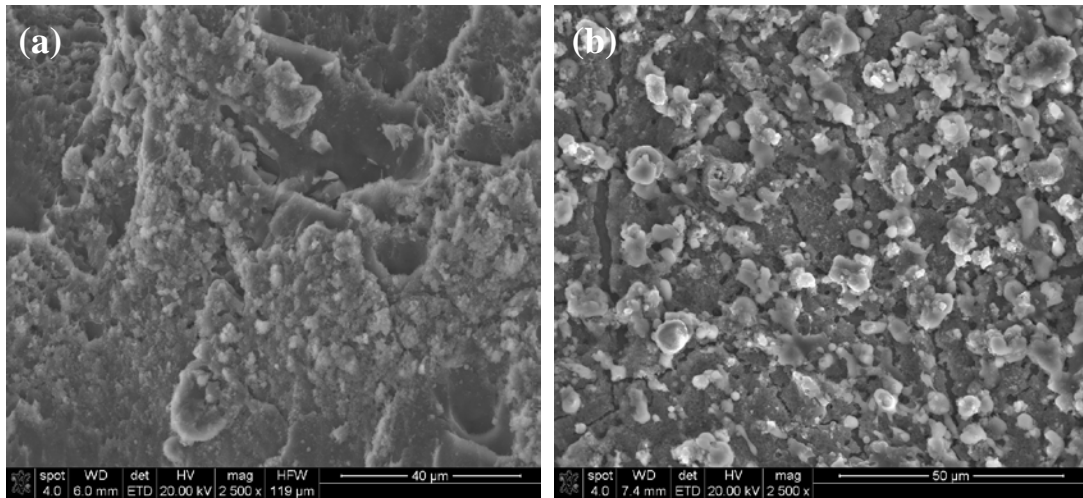
Figure 3. Damaged surfaces from (a) sample I by the blast center from the ruptured panel, (b) area by the blast center from the not-ruptured panel. Both images were captured at the same SEM conditions and magnifications.

Evaluation of the sample surfaces by the SEM of samples I through IV of the ruptured panel indicated a gradual change in surface deformation. Figure 3 (a) shows the heavily damaged region in sample I of the ruptured panel. The damage in sample I shows examples of ductile failure by void coalescence. The damage in sample II through IV shows voids, but none of the higher energy failures that were observed closer to the blast. Fracture by cracking has been observed in sample I through sample IV areas, but not in sample V.

For the not-ruptured panel, similar gradual change in surface deformation was observed away from the explosion. However void coalescence was not observed on surfaces close to the blast center (see Fig. 3 (b)). As with the ruptured panel, cracks were observed throughout the sample.

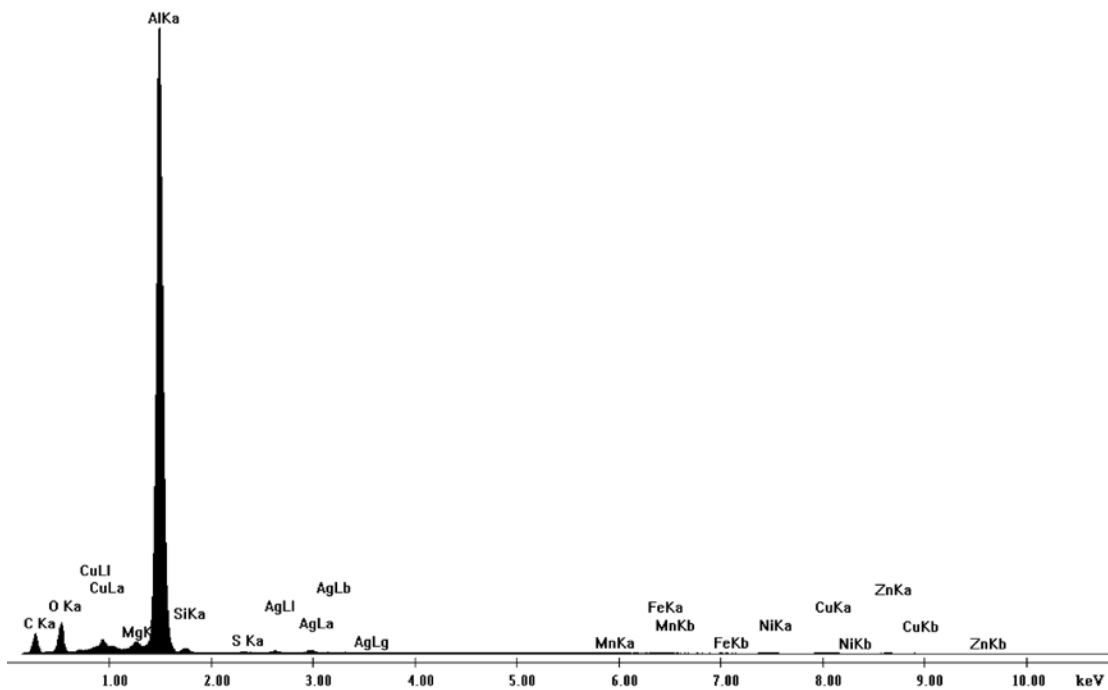
Figure 4. An example EDS spectra

EDS analysis of surfaces from all samples from the ruptured panel and not-ruptured panel were conducted. No significant difference was observed between the two panels. The observed sample chemistries, though not always consistently, were Al, Cu, Mg, Zn, Mn, Si, Fe, Ti, and Cr, as shown in Figure 4. This is in agreement with the typical AA 2024 composition [1]. But the current analysis also showed traces of S, Na, K, N, O, Ag, and C on the surface. It is very possible that these are residual elements that became situated on the sample surfaces from the blast.

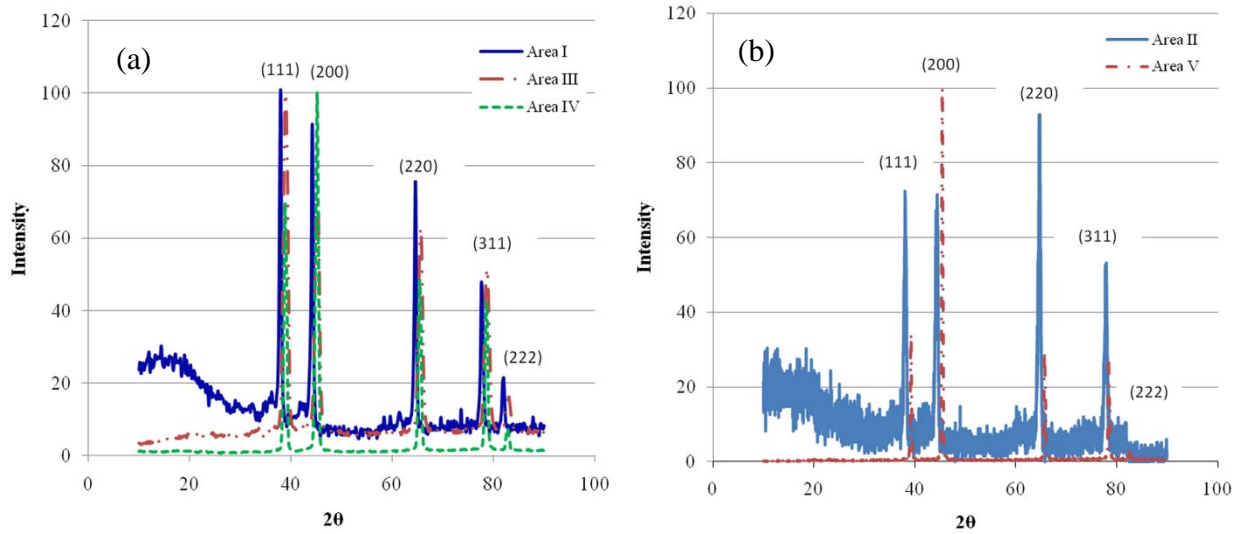
Figure 5. (a) XRD spectrum from Area I, Area III and Area IV and (b) XRD spectrum from Area II and Area V from the ruptured panel

the explosion, we consider its XRD spectrum as the reference for the analysis. The XRD spectra displayed the typical spectrum of aluminum and showed that the explosion did not create any new phases. The first five diffraction peaks of the reference XRD spectrum appear on all the

other XRD spectra (Figure 5 (a) and (b)). However, depending on the distance of the sample from the center of explosion, a shift of all the XRD peaks with respect to the reference XRD peak is observed, an indication of local deformation. Table T1 and T2 show the variation of the interplanar spacing and lattice parameter across the panel as a function of the diffraction peak and distance away from the center of explosion. The strain across the panel was computed as follows:

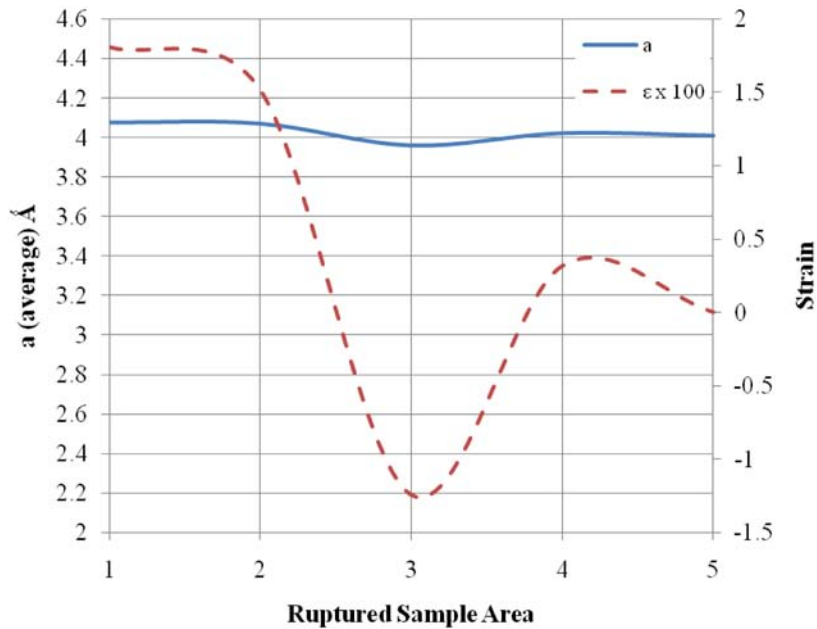
Figure 6. Lattice parameter, a , and strain variation from the explosion center

Figure 6 shows that at the distance of 7.6 cm from the center of the explosion (at Area III) the strain changed from tensile to compressive and it changed to tensile strain again at distances larger than 7.6 cm. Relative videos of the panel response to the explosion showed that the rupture of the panel initiated at about 7 cm from the center of the blast, in agreement with the measured strain.

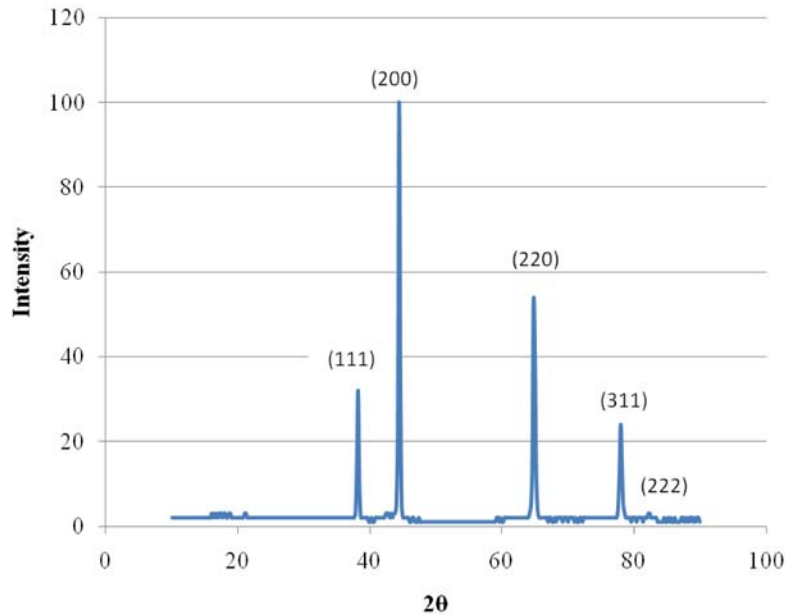
Figure 7. XRD spectrum around the impact area of not-ruptured Al 2024 T3 panel

Figure 7 shows the XRD spectrum of the not-ruptured Al 2024 T3 panel. The XRD spectrum was similar to the XRD spectrum on the ruptured panel. There was also no indication of new phase formation due to the explosion. The average lattice parameter was 4.04 \AA . The strain around the impact area was 0.79%, which was computed using Equation 1 with respect to the reference XRD interplanar spacing. The strain of the second, not-ruptured panel was 130% smaller than the corresponding strain of 1.81% at Area I of the first ruptured panel. This indicates that smaller stresses were experienced in the not-ruptured panel.

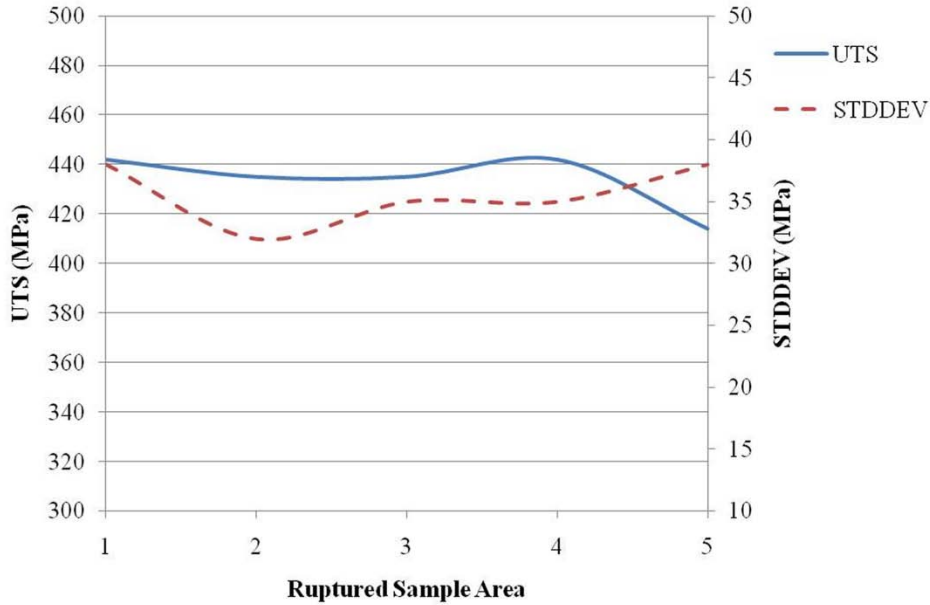
Figure 8. Average UTS across the ruptured Al 2024 T3 panel

The UTS of both ruptured and not-ruptured AA 2024 T3 panels was determined by converting the measured Rockwell Hardness B values across the panels into strength. A summary of the average UTS across the ruptured panel is shown on Figure 8. The average UTS of the non deformed part of both panels varied from 415 (not deformed) to 440 (deformed) MPa. These values agree well with the published values of the AA 2024 T3 alloy [2]. The average 6% UTS increase of the deformed part of both panels, compared to the non affected part of it, is attributed to the strain hardening of the alloy due to the explosion.
