## **Microstructural Characteristics of High Rate Plastic Deformation in Elektron™ WE43 Magnesium Alloy**

ARL-RP-363

*A reprint from the Proceedings of the TMS 141st Annual Meeting and Exhibition, Orlando, FL,  
pp. 433–438, 11 March 2012.*

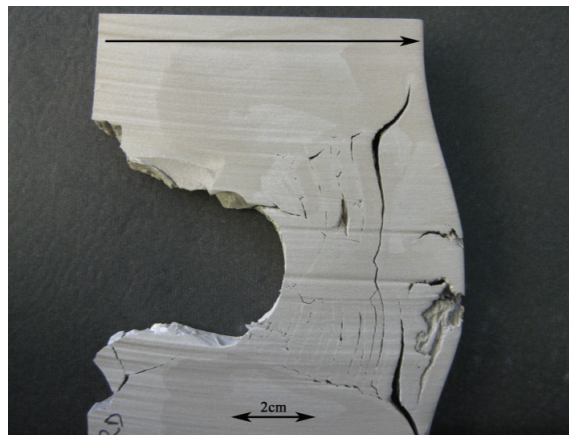
Figure 1. C-Partial sample, after cross sectioning, arrow indicates direction of impact.

A post-mortem analysis was performed on six 80mm thick WE43 samples (3.7-4.3% Yttrium, 2.4-4.4% Rare Earths, 0.4% Zirconium, balance Magnesium), that were produced in the T5 condition, thermally quenched after high-temperature rolling, and then artificially aged. The samples were then subjected to high velocity impacts that resulted in varying levels of severe plastic deformation (SPD). The samples were assigned the nomenclature of A, B, and C based on increasing level of damage. The samples were also labeled as Full, or Partial damaged samples based on the extent of SPD. Examples of the cross sectioned regions are shown in Figures 1 and 2.
