October 2011

# Explosives Dissolved from Unexploded Ordnance

U.S. Army Environmental Command  
Fort Sam Houston, TX 78234-7664

U.S. Army Corps of Engineers, Engineer Research and Development Center  
Cold Regions Research and Engineering Laboratory  
Hanover, NH 03755

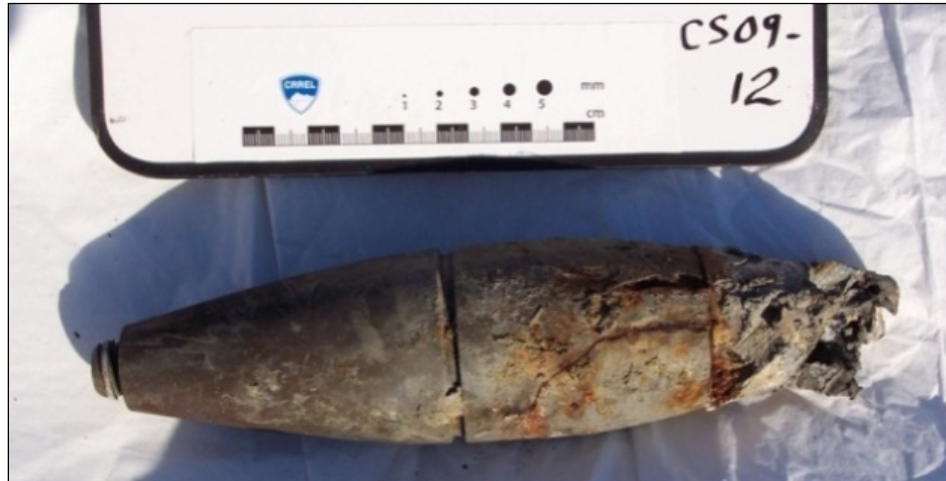
Figure 16. Image of CS09-12, a 60-mm UXO with a large longitudinal crack (upper), and high explosive compounds and breakdown products in soil samples lateral to and beneath the round.

A soil core taken beneath the cracked round contained the compounds TNT, RDX and HMX and degradation products in the top 5 cm of soil (Figure 16). We think this round was filled with Comp B and that the low concentrations of TNT result from degradation while the concentrations of RDX (10 mg kg<sup>-1</sup>) and HMX remain. Multi-increment samples taken horizontally away from the round contain only small amounts of HMX. Ongoing dissolution of Comp B from this round, coupled with the degradation of the TNT, would produce the sub-surface profile we see. The surface concentration of HMX could result from Comp B that dissolved some time ago leaving only its HMX.

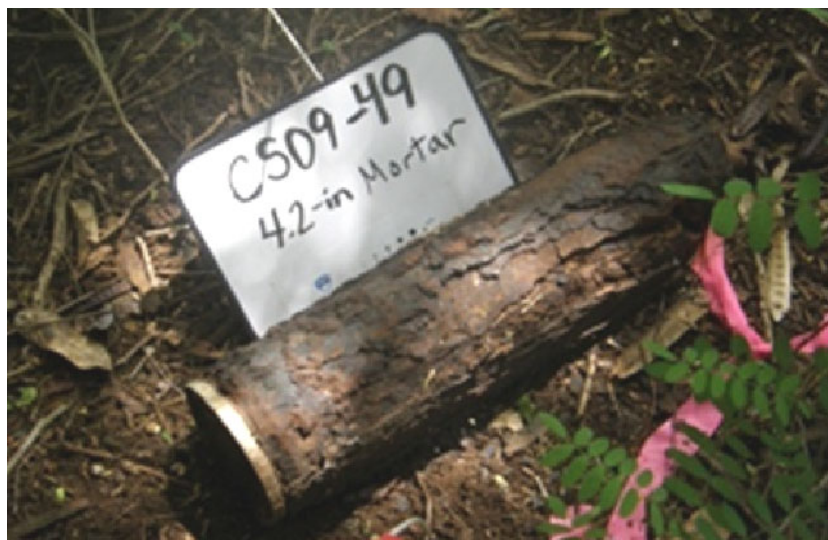
Figure 21. Image of the 4.2-in mortar CS09-49 (upper) and HE compounds and breakdown products in soil samples taken lateral to and in one core beneath the round.

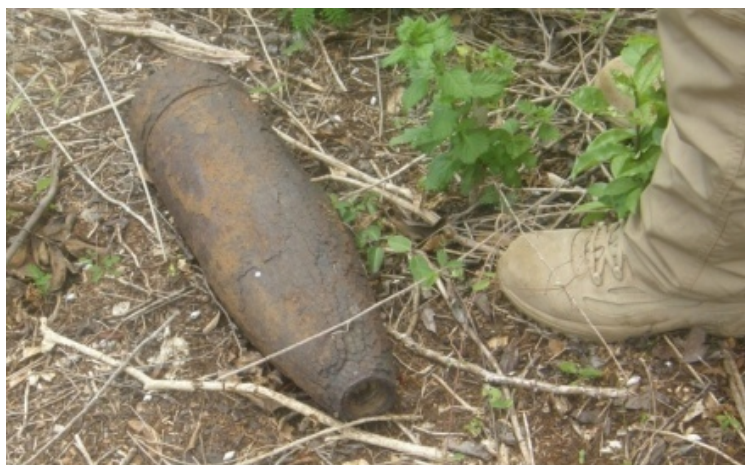
Figure 23. Image of the 155-mm mortar CS10-11 (upper) and HE compounds in soil samples taken laterally from and beneath the round.

The lateral samples contained primarily TNT at concentrations from  $<0.5$  to  $2 \text{ mg kg}^{-1}$ , along with trace amounts of 2,4-DNT ( $< 0.05 \text{ mg kg}^{-1}$ ). The highest concentration was found 10–15 cm from the tail. The upper two core samples also had mainly TNT, at concentrations less than  $0.5 \text{ mg kg}^{-1}$ , along with trace amounts of RDX (in the surface sample) and 2,4-DNT. No compounds were present in the deepest core sample (10–15 cm).

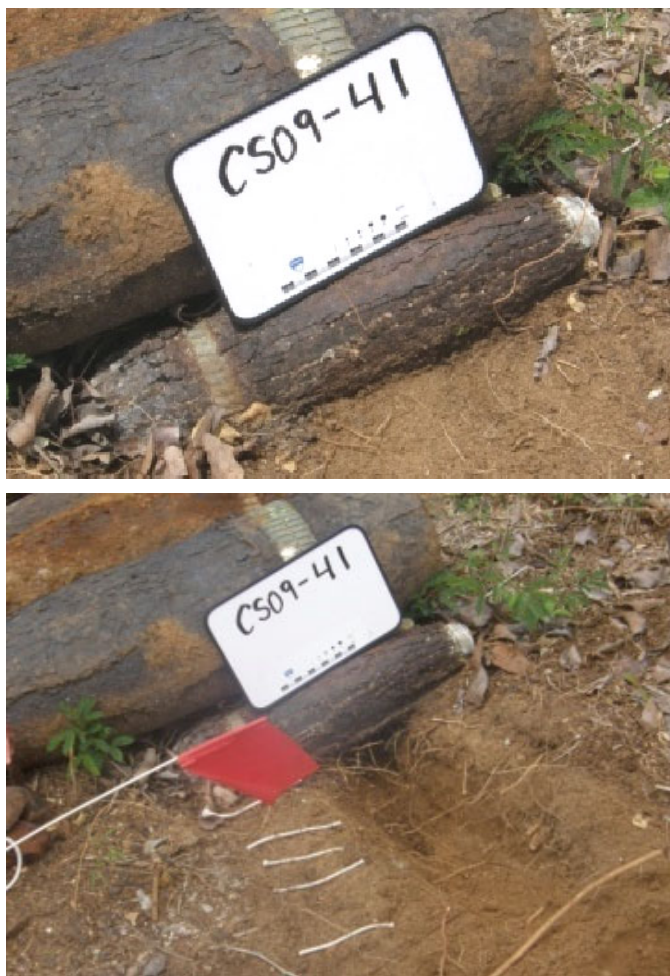
**Figure 28.** Image of 105-mm round found near the northern shoreline at Vieques (below sign in upper photo) and another showing the trench created by removing the lateral samples collected adjacent to this round.

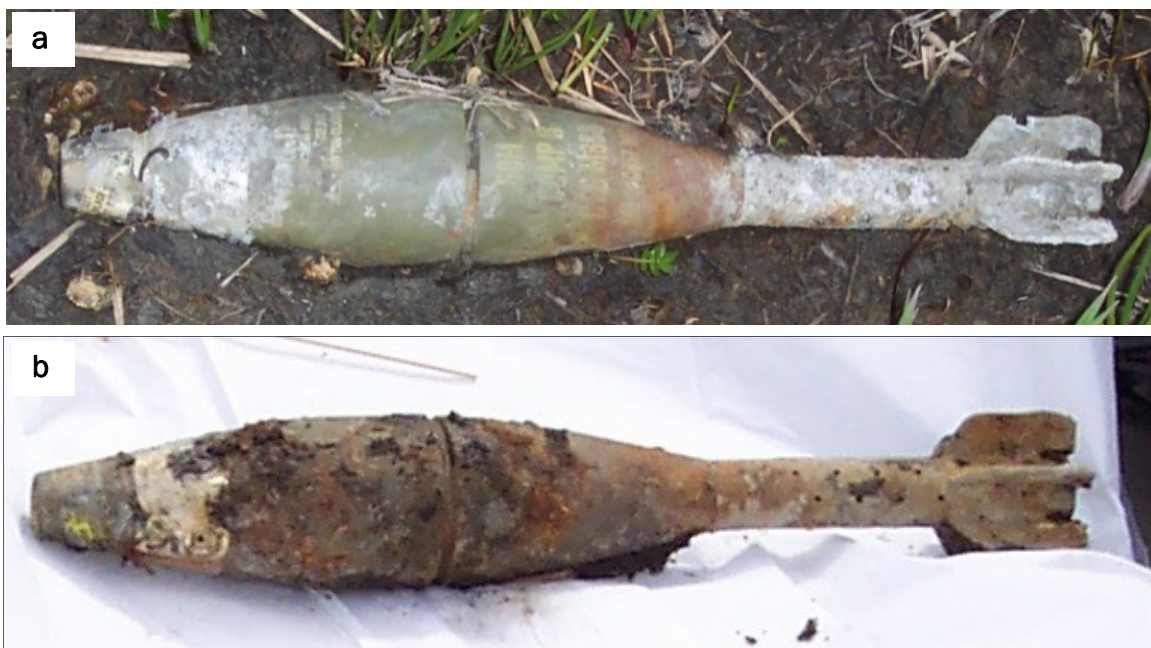
Figure 33. A 60-mm mortar (CS-09-8) found at ERF in 2009 and thought to have been fired during a 2006 training exercise showing the (a) visible side and (b) side in contact with the soil.

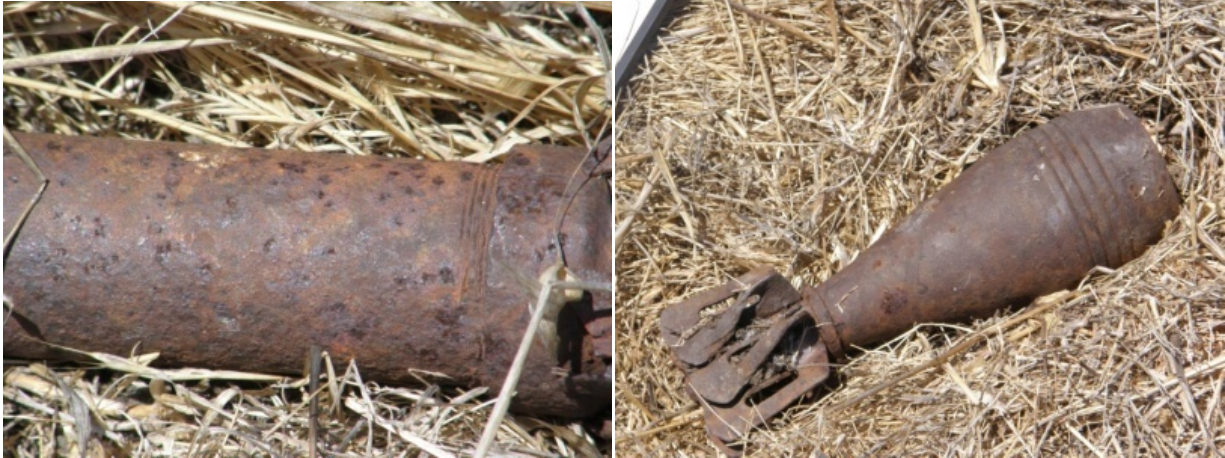
Figure 34. Examples of 60-mm mortar rounds found on the surface at San Luis Obispo.

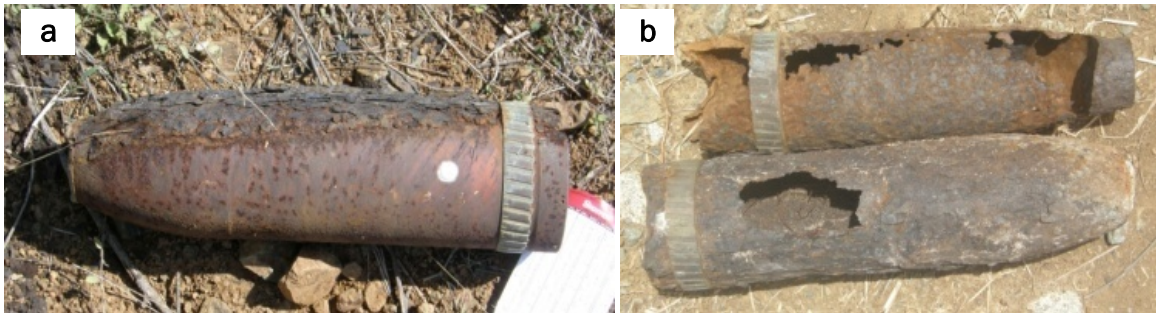
Figure 36. Examples of large-diameter UXO found at Vieques that were partially buried. (a) The surface of the UXO exposed to air was pitted and oxidized while the surface in contact with soil was highly corroded; (b) UXO carcasses showing large holes resulting from corrosion. What happened to the HE once in these rounds is not known.

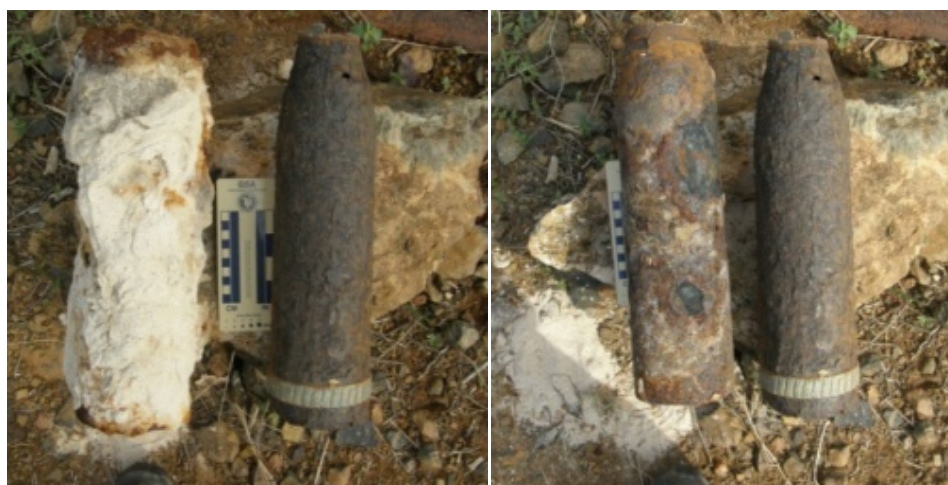
Figure 40. A 155-mm round that was pulled from the ocean in Vieques (left side of each image) along with one that had been on the island (a, left) before and (b, right) after scraping off the white crust layer.

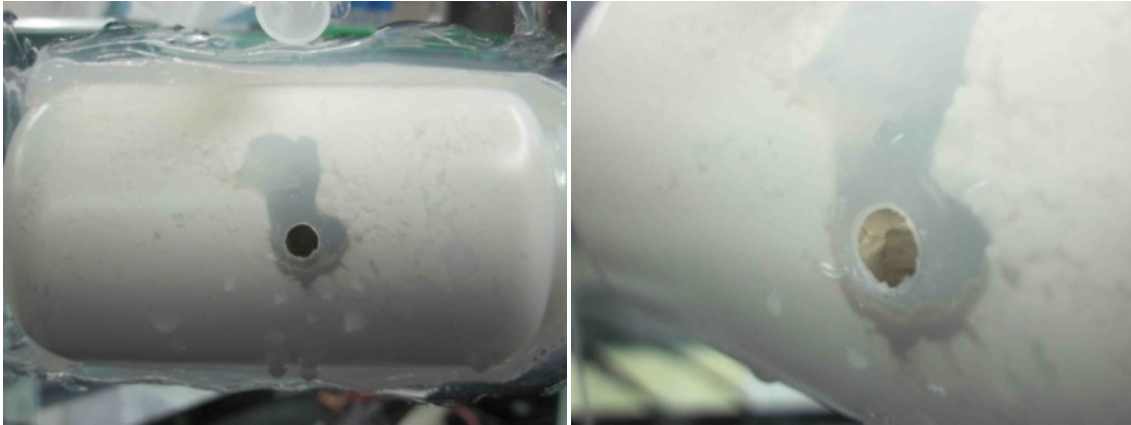
Figure 45. Pictures of the cavity formed in NG BIG. The depth of the cavity measured approximately 2.4 cm.

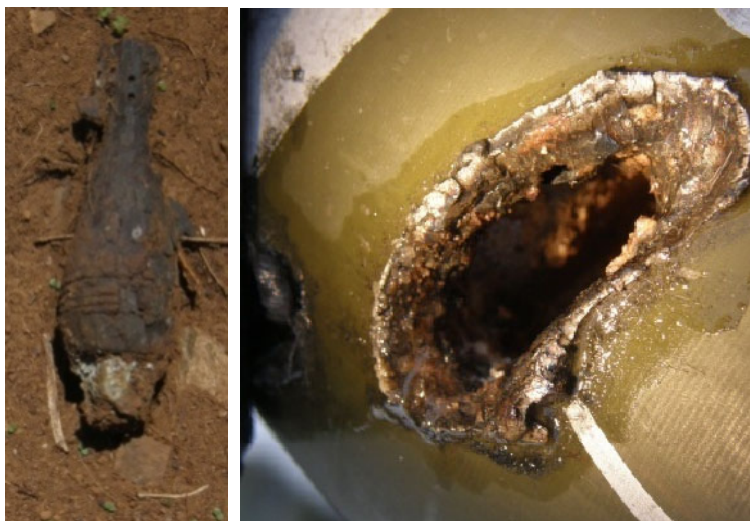
Figure 47. (a, upper) Very corroded 81mm round not leaking explosives and (b, lower) hole in a 81-mm mortar caused by a fragment from a nearby high-order detonation.
