# **Microbial Influenced Corrosion (MIC) Study**

**National Defense Industry Association  
Environment, Energy Security, &  
Sustainability Conference**

**May 23, 2012**

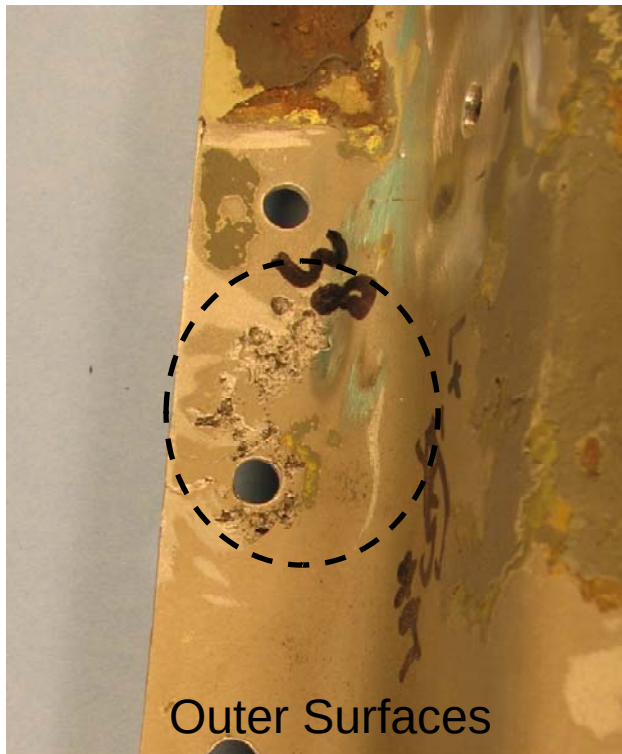
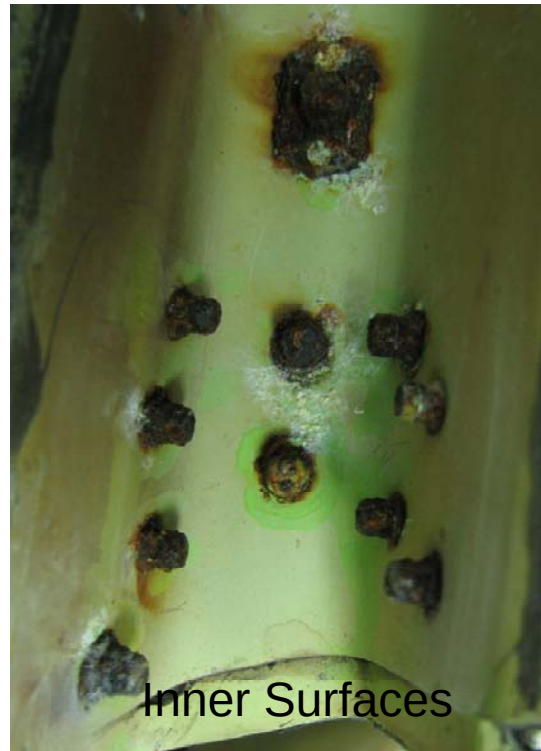
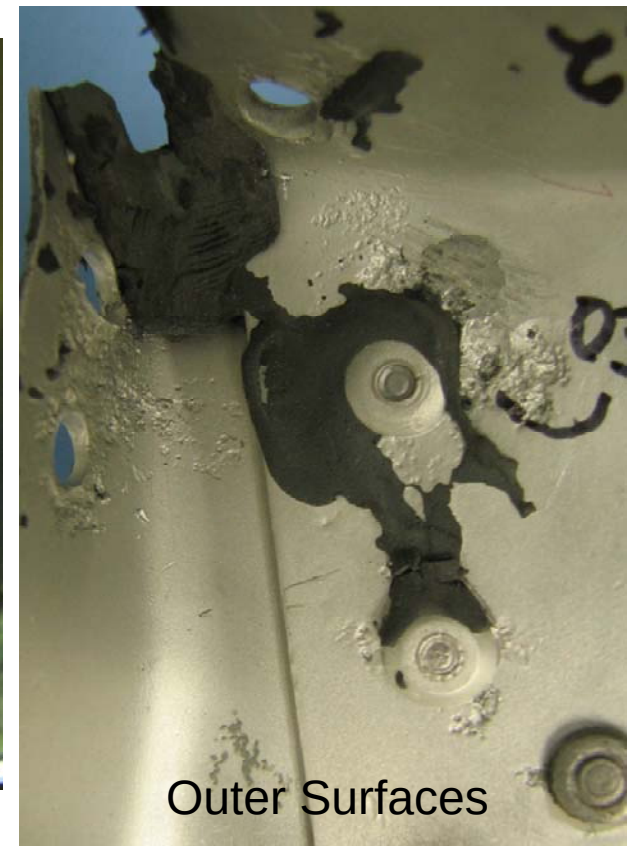
- Most damage confined to pitting corrosion of primary and secondary support structures
- Pitting corrosion morphology (i.e., tunneling suggests MIC)

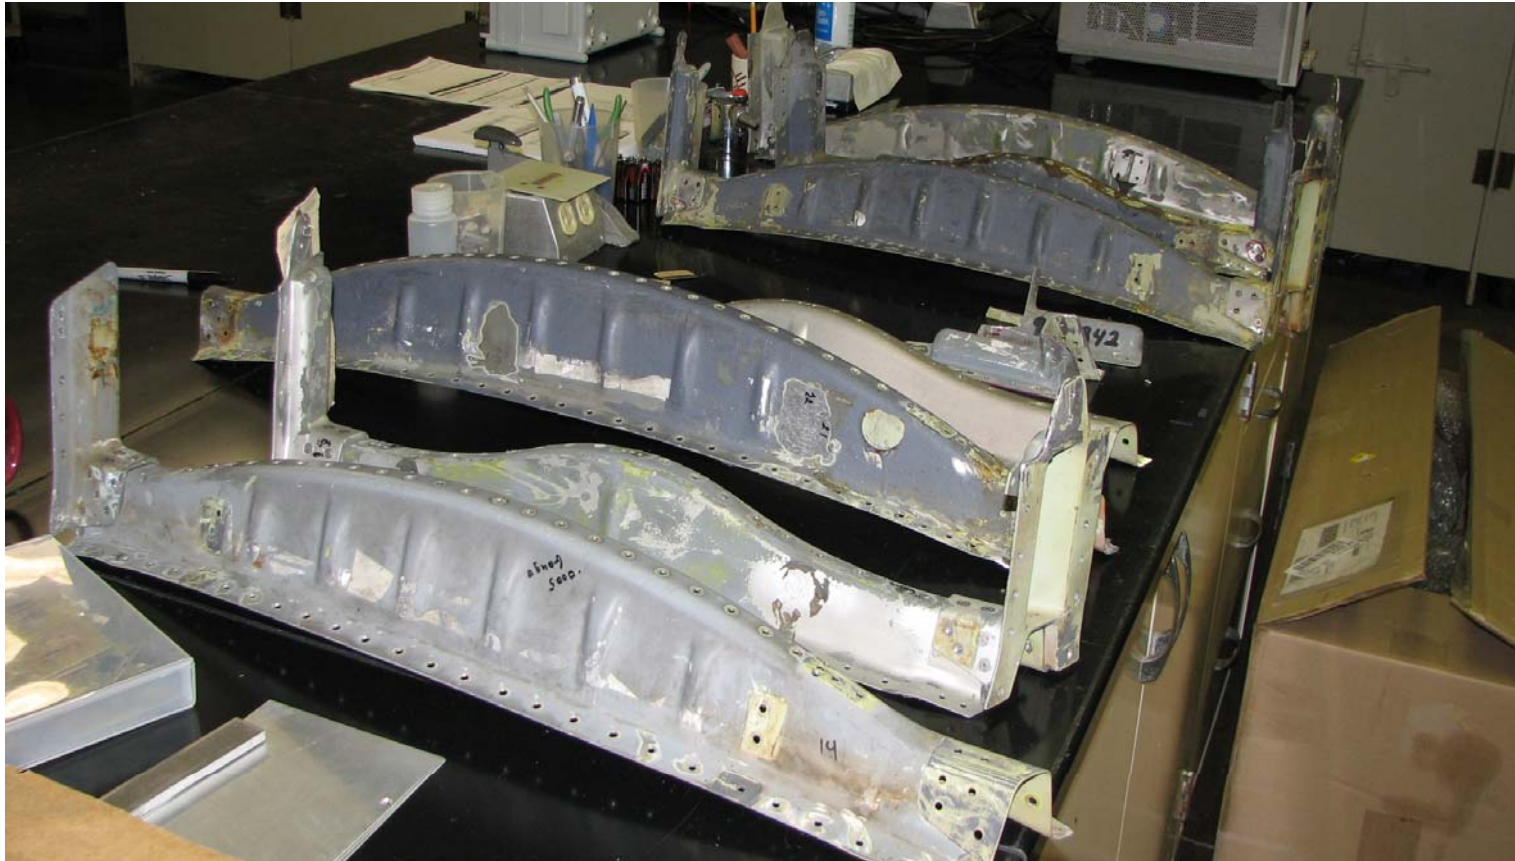
## Condemned Aircraft Component Parts

- Sixty-three samples collected from similar parts and OML locations (control samples) on six aircraft at Hill Air Force Base

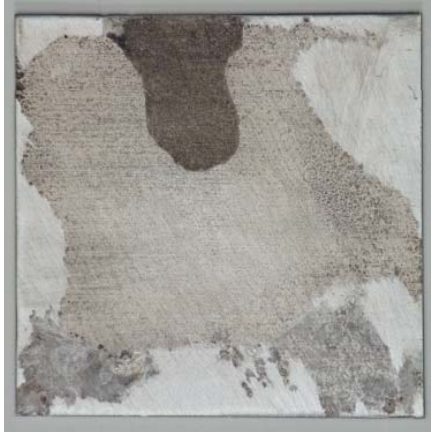
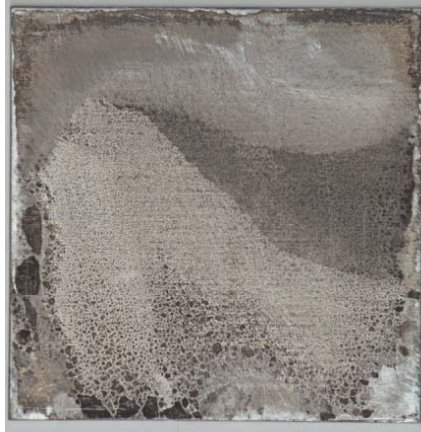
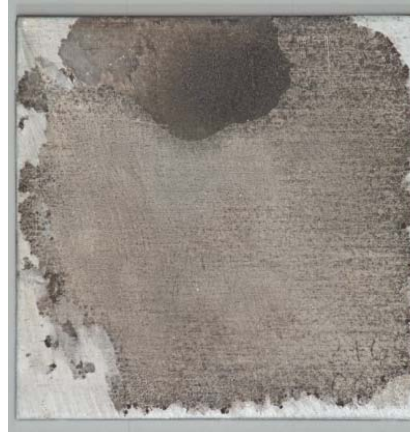
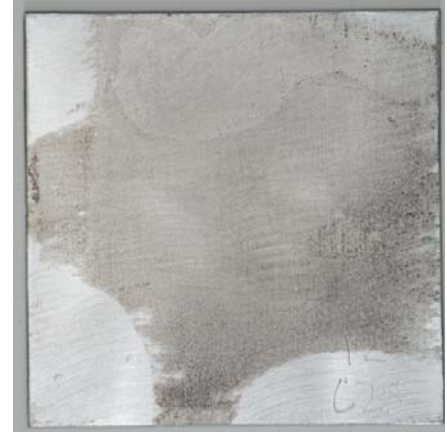
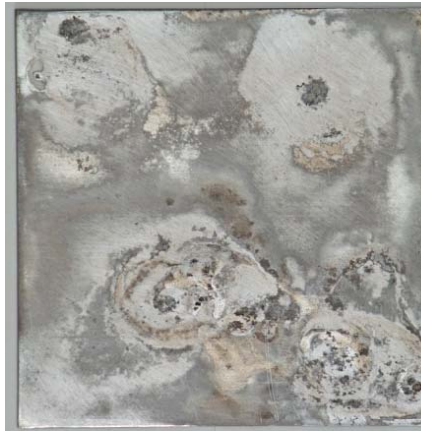
# Aluminum Coupon Results: 2-month Exposure, Descaled

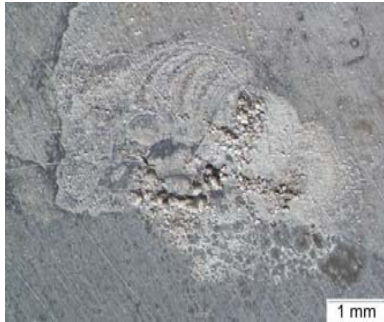
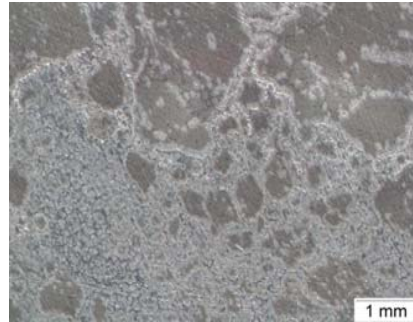
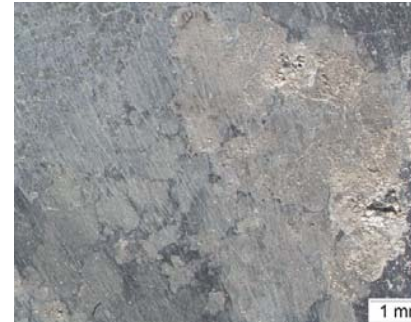
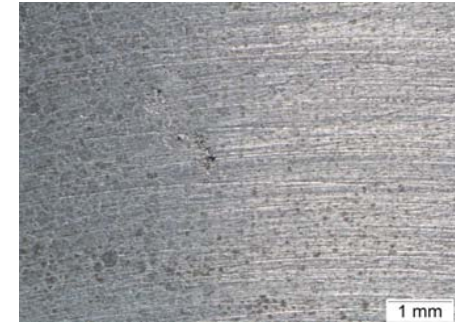
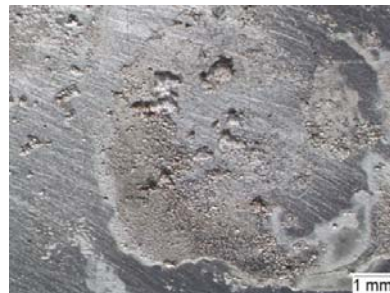
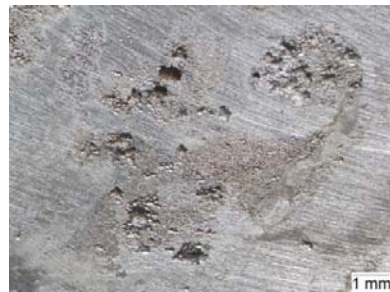
# Al Coupon Results: 3 Month Exposure, Descaled - Optical Micrographs

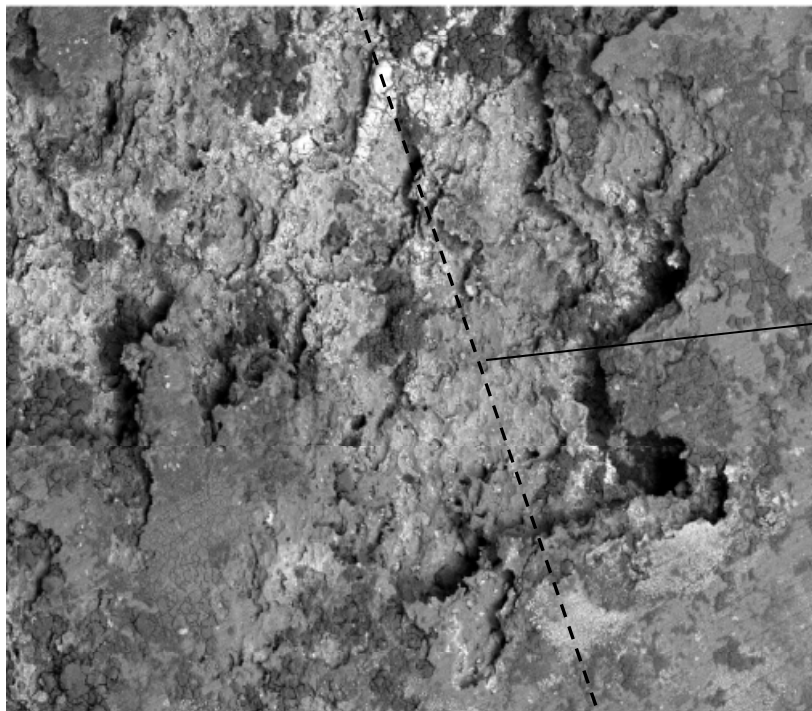
Coupon ID 305 Fungi Consortia

305 Bottom Cleaned 75x bse

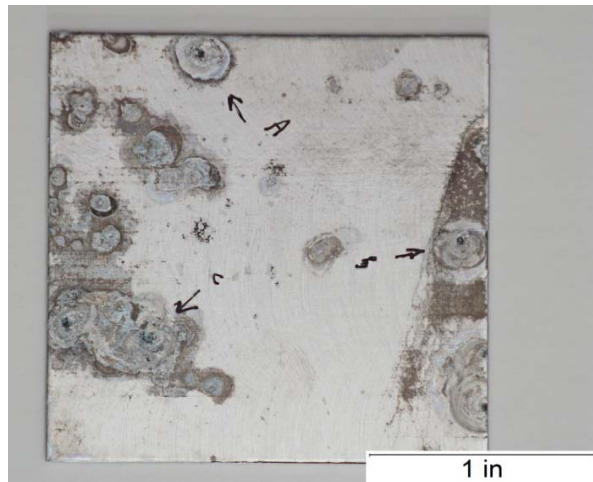
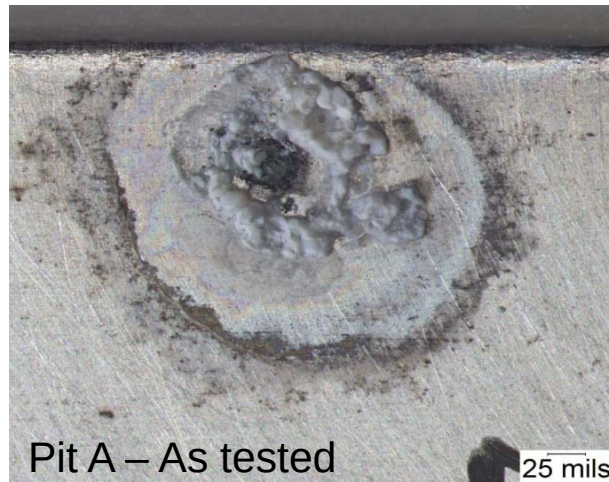
*Coupon ID No. 722 (Aircraft Consortia)*

| Coupon ID | Test Solution | pH | Discoloration<br>Top Bottom | Pitting, max<br>(mils) | Comments |
|---|---|---|---|---|---|
| 722 | Aircraft Consortia | 7.5 | 22L-2P G-NP | ~15 T | Edge corrosion pits – T deepest |

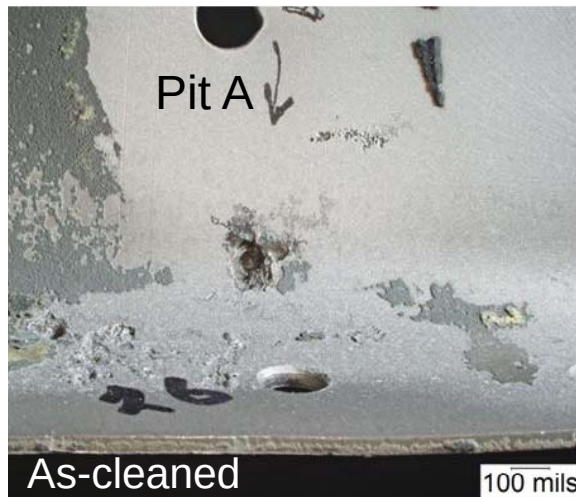
## *Aircraft Beam*

# Aluminum Parts Results: In-Service Exposure (Representative Sample)

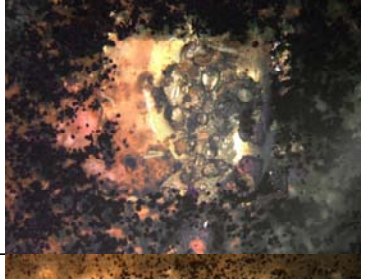
| SYSTEM I: Treated – aPDA + fungal consortium (coupon laying on fungi treated agar media) | | | |
|---|---|---|---|
| <b>Uncoated</b><br>Coupon Type: D<br><br><i>Bare Al2024-T3</i><br><i>(Negative Control)</i> | | | |

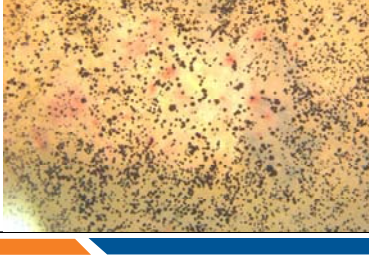
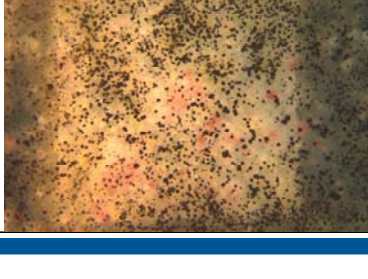
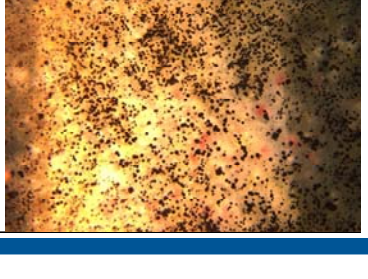
| SYSTEM I: Treated – aPDA + fungal consortium (coupon laying on fungi treated agar media) | | | |
|---|---|---|---|
| <b>Whatman Paper</b><br><i>(Positive Control)</i> | | | |

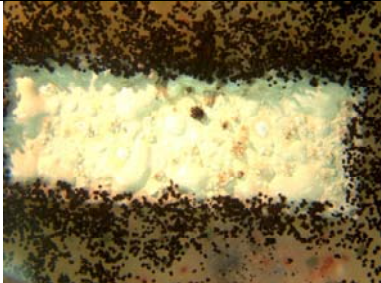
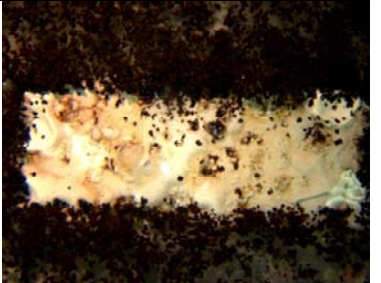
| Coupon Type | SYSTEM I: Treated – aPDA + fungal consortium (coupon laying on fungi treated agar media) | | |
|---|---|---|---|
| <b>Bunge Silver Coating</b><br>Coupon Type: H<br><br><i>Proprietary Coating w/ Silver Inhibitor</i> | | | |
