NDIA E2S2 Symposium

A Sustainability Approach to Upgrading Corroded, Inoperable or Difficult to Open Fire Hydrants via an Off-the-Shelf Stainless Steel Retrofit Kit

Engineer Research and Development Center/
Construction Engineering Research Lab
Champaign, IL.

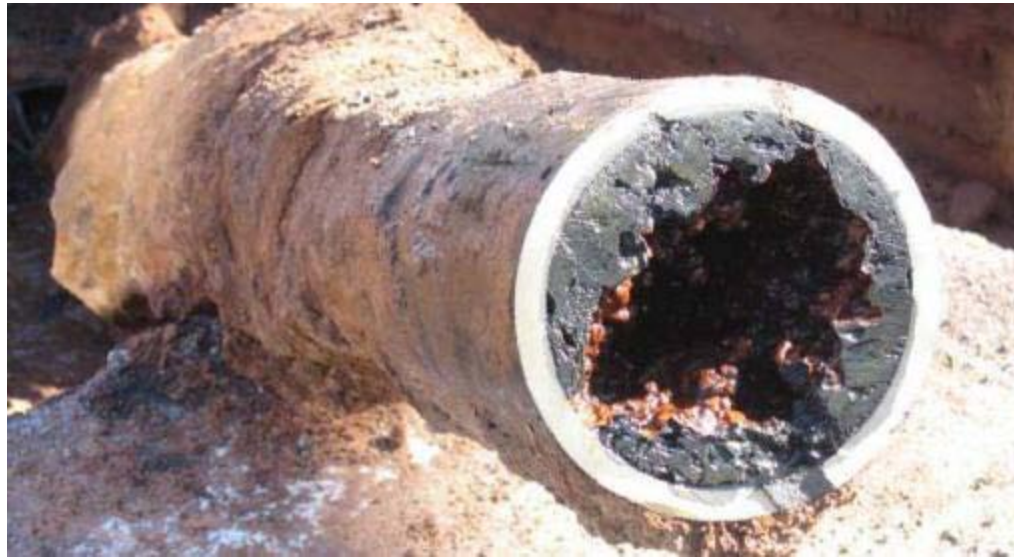
Tuberculation in 6-inch Unlined Water Main

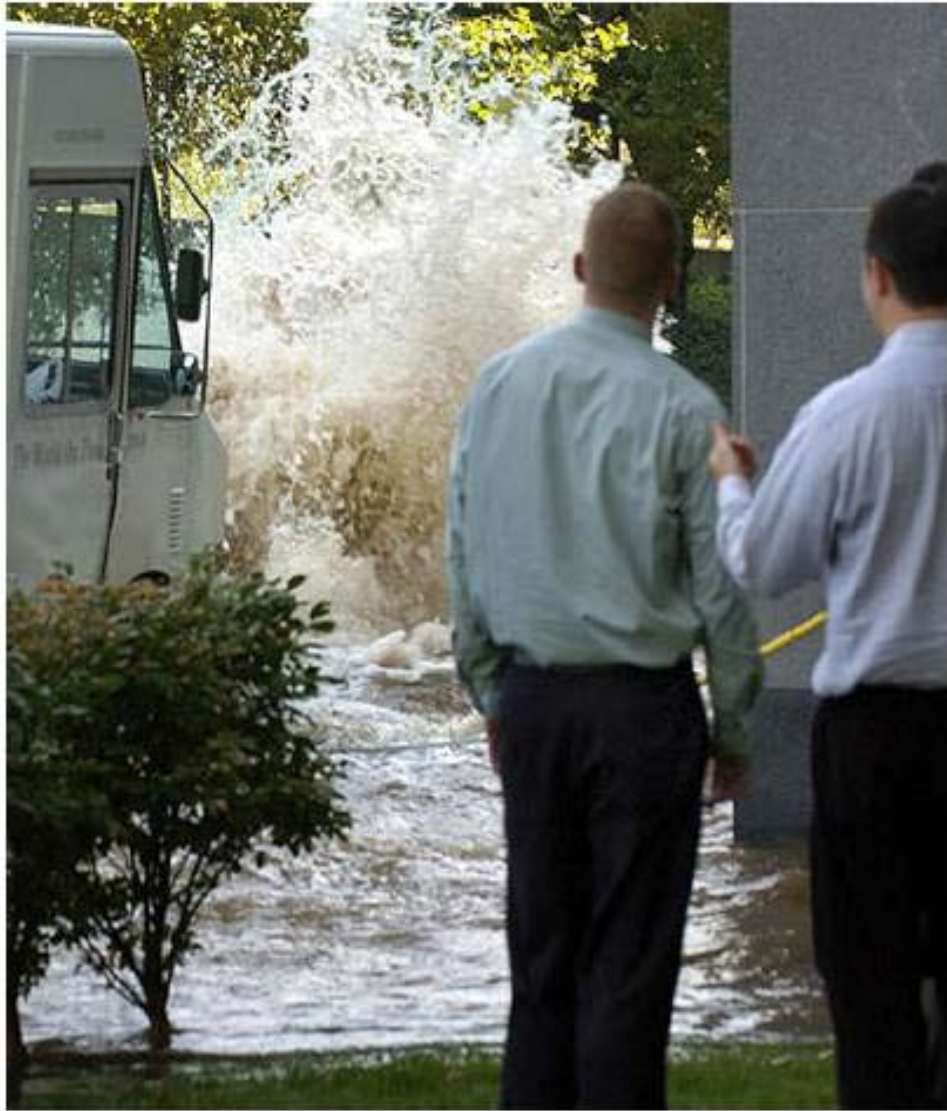
36 Inch Main Break

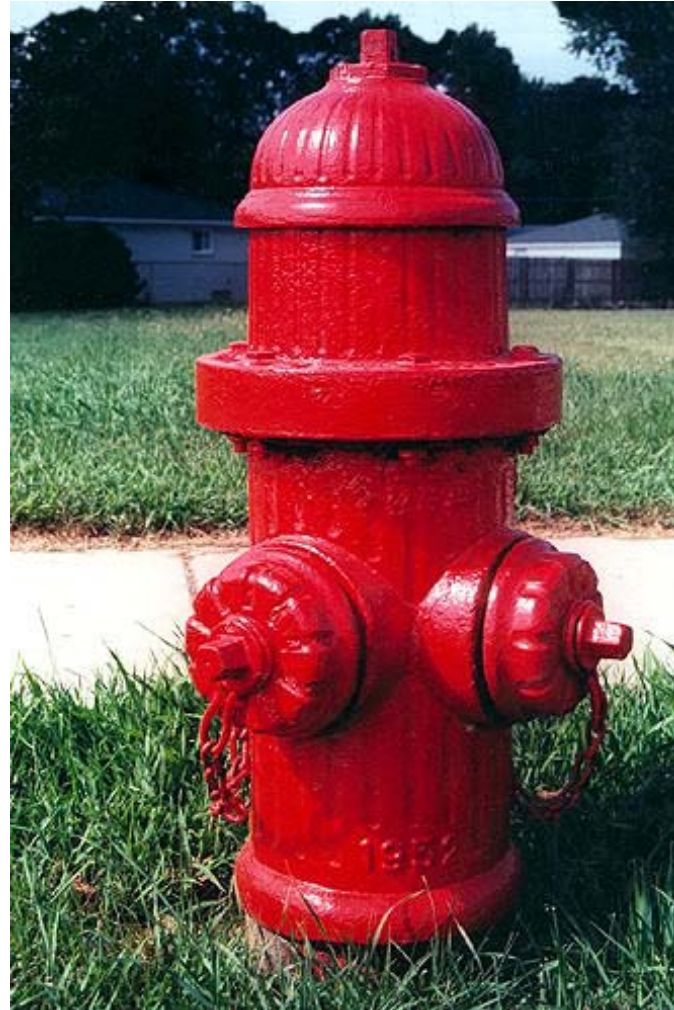
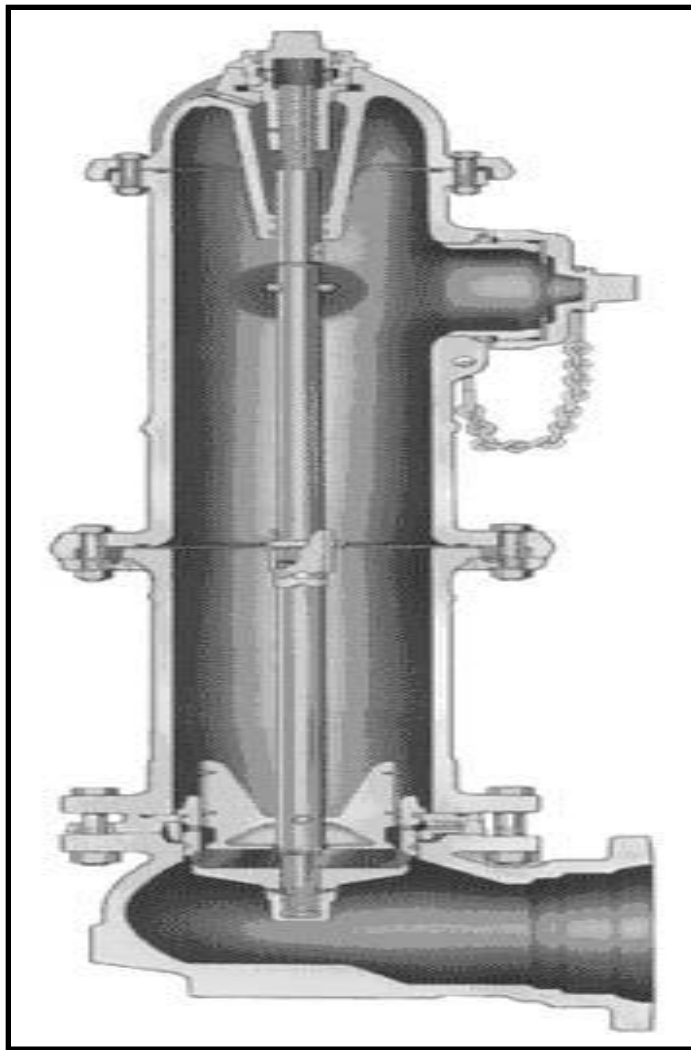
Standard Dry Barrel Fire Hydrants Have Cold-Rolled Steel Stems Which Can Corrode

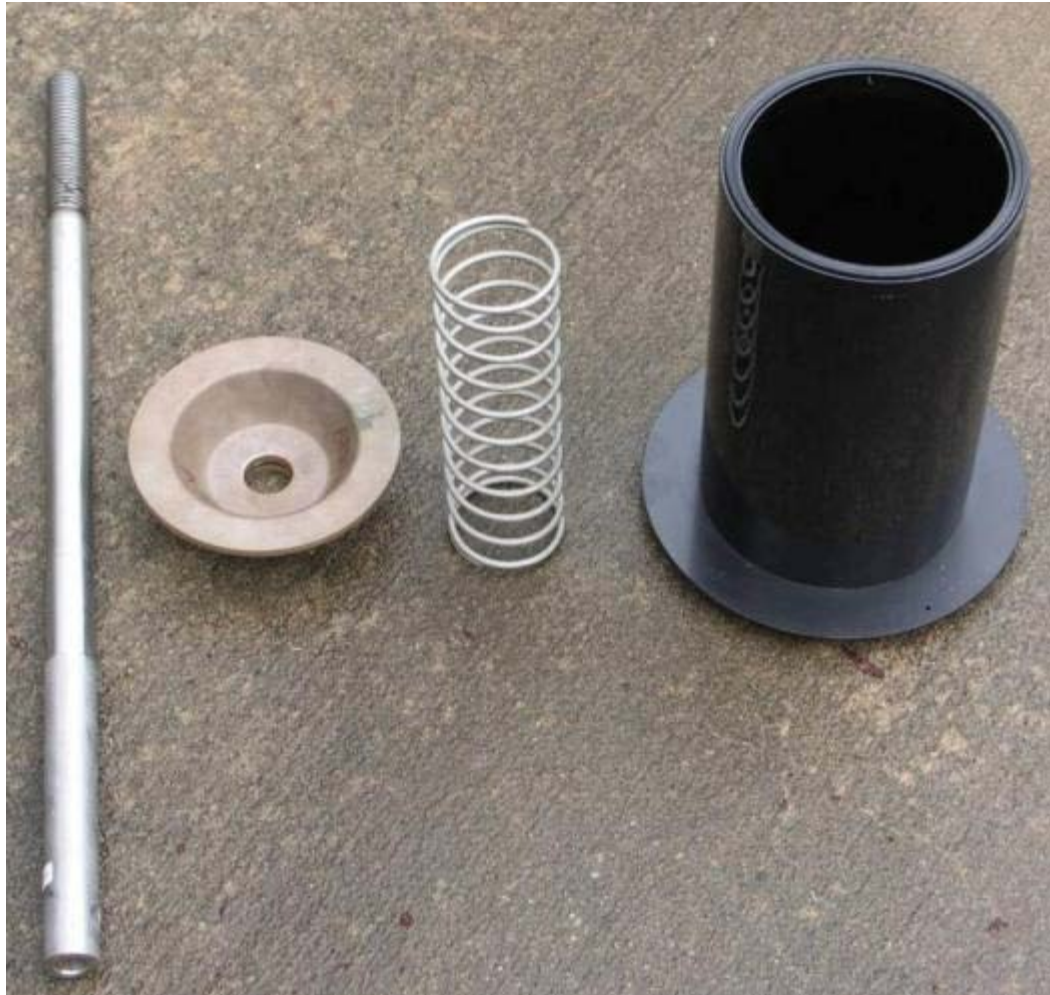
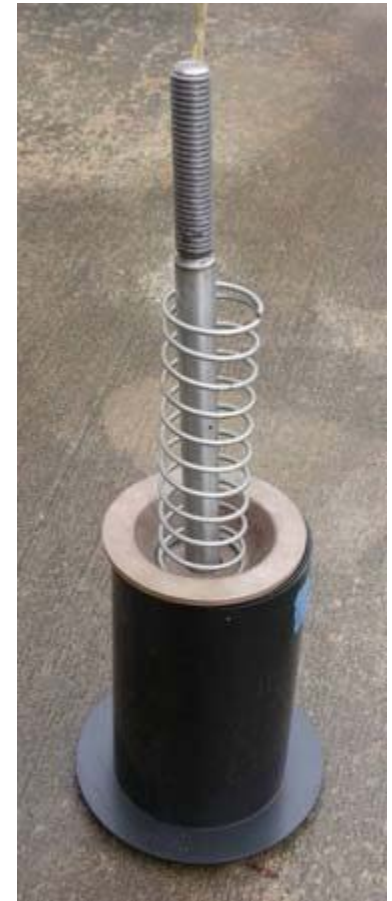
Components of the Proprietary Corrosion-resistant and Anti-Terrorism Valve

- Meets AWWA C502 Specs
- Offers continuous protection
- Easily retrofitted into new or existing hydrants
- Stealth design
- Fire Fighters operate hydrant as usual
- Ten year warranty
- Extremely durable materials for long life
- Qualifies for funding from several sources

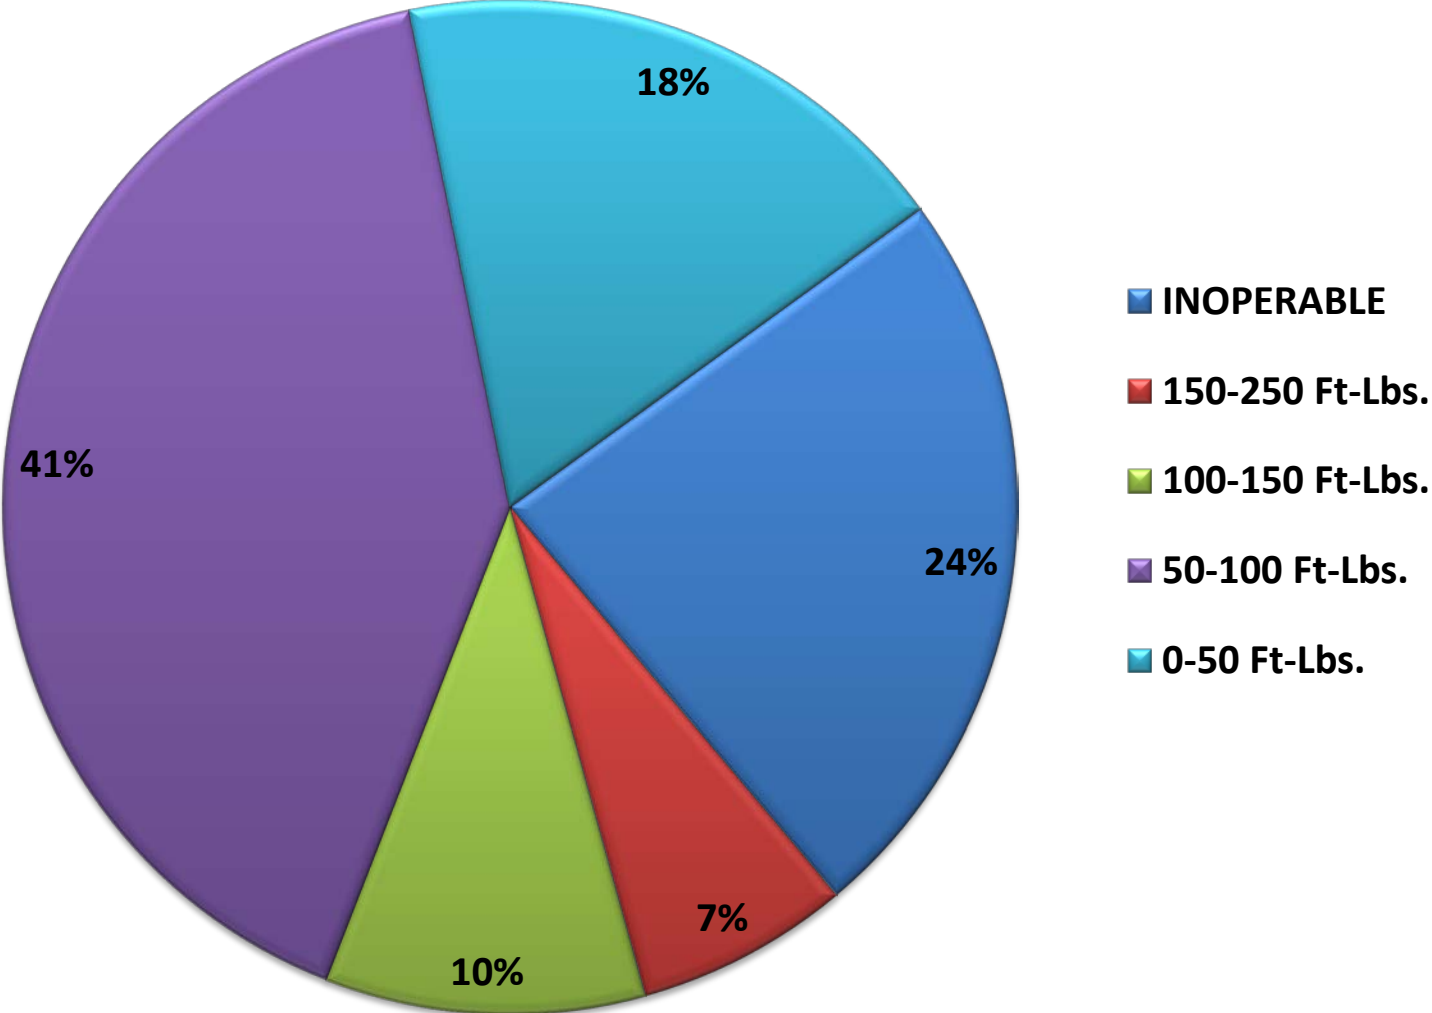
Torque Required To Open A Hydrant Before Servicing

- Each retrofitted hydrant was catalogued, cross referenced by GPS, street location, serial number of both old hydrant and upgrade kit.
- A record and photograph recording of the condition of each set of parts being replaced was documented.
- A video and HD digital camera record documented the steps necessary to retrofit the older units.
- The torque necessary to operate the hydrant was measured by a torque wrench before and after upgrade.

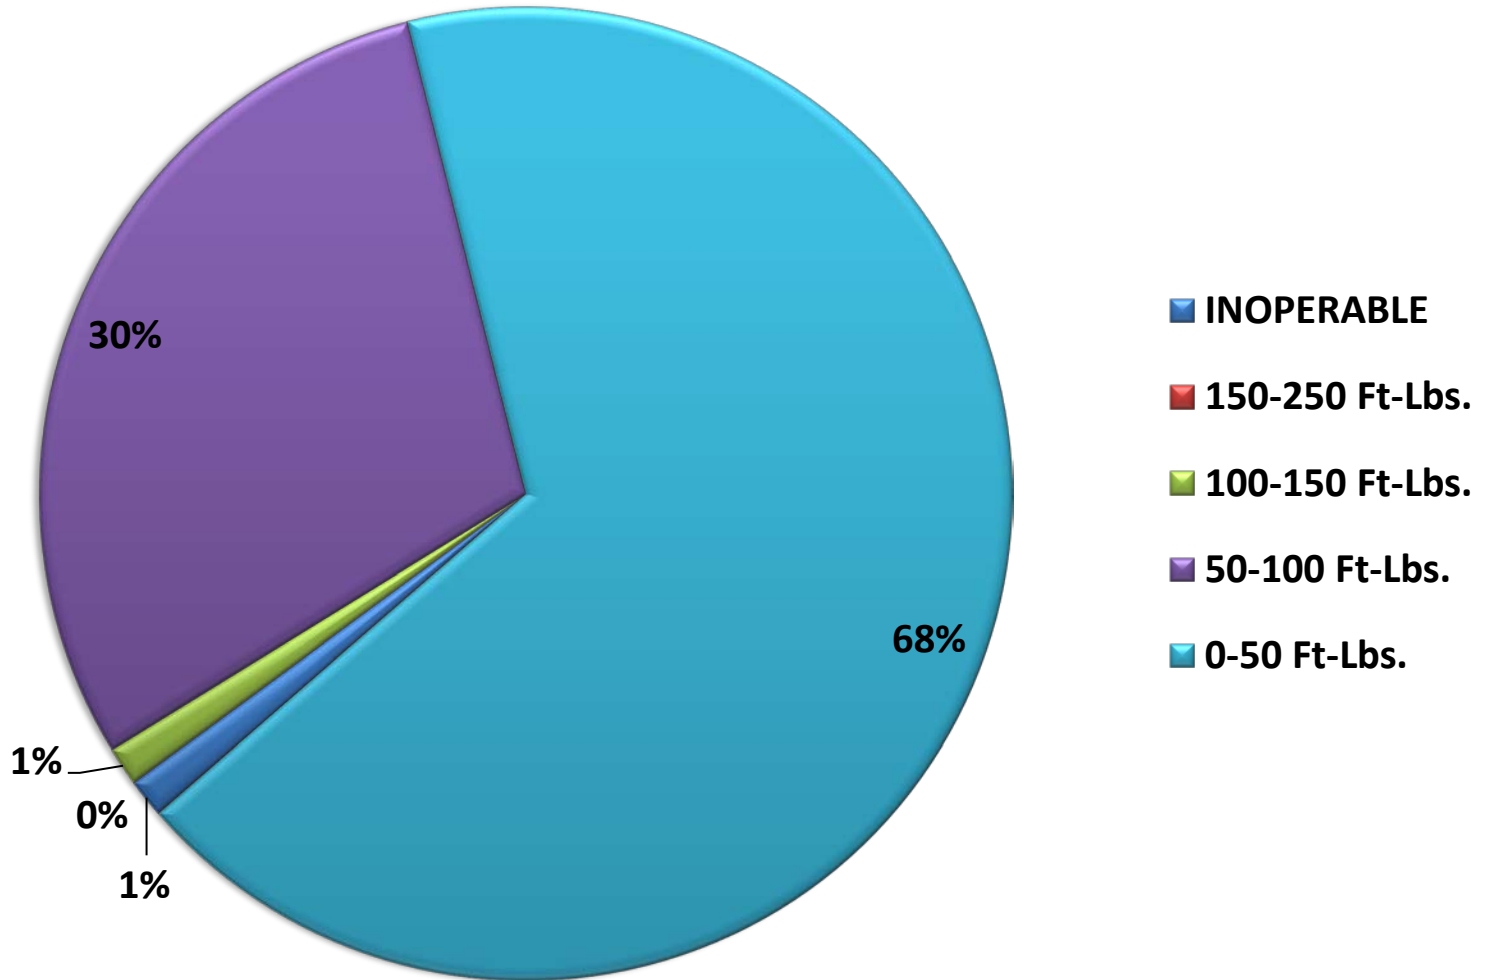
Torque Required To Open A Hydrant After Servicing

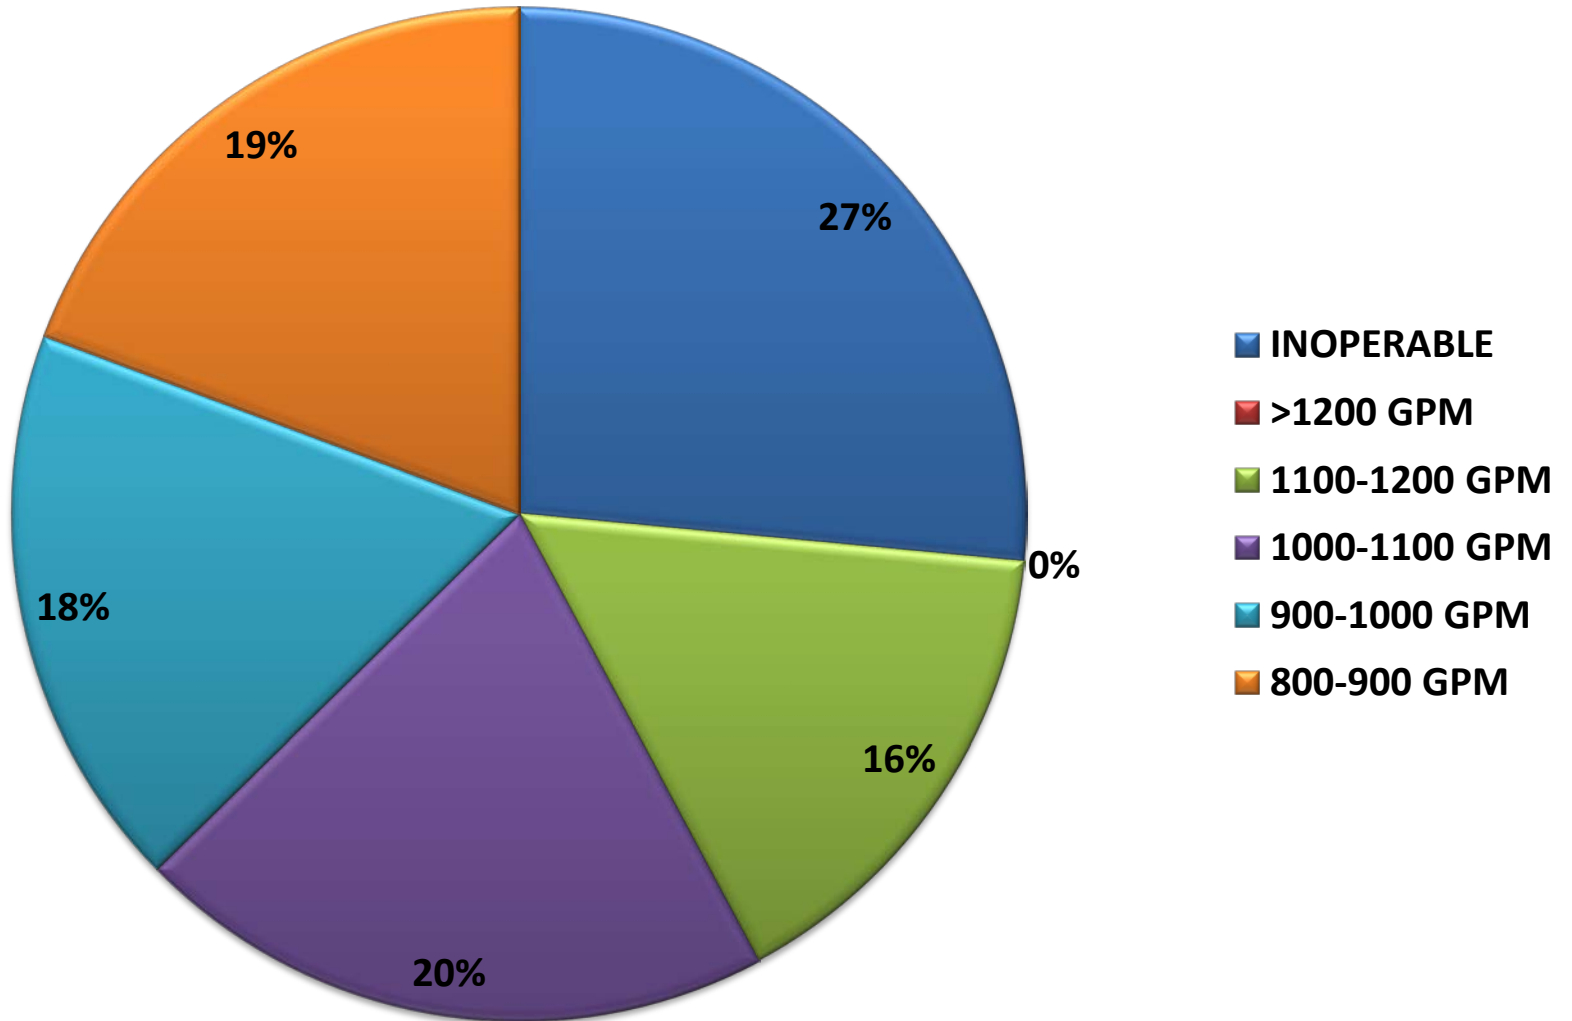
Flow Rate Of A Hydrant Before Servicing

- Full flow tests were made on all 90 hydrants and the experimental controls using a flow meter and experienced technician both immediately before and immediately after installation of the new inner workings. Static pressure was measured.
- The objective of this battery of testing is to compare performance of the new retrofit system to the old system.

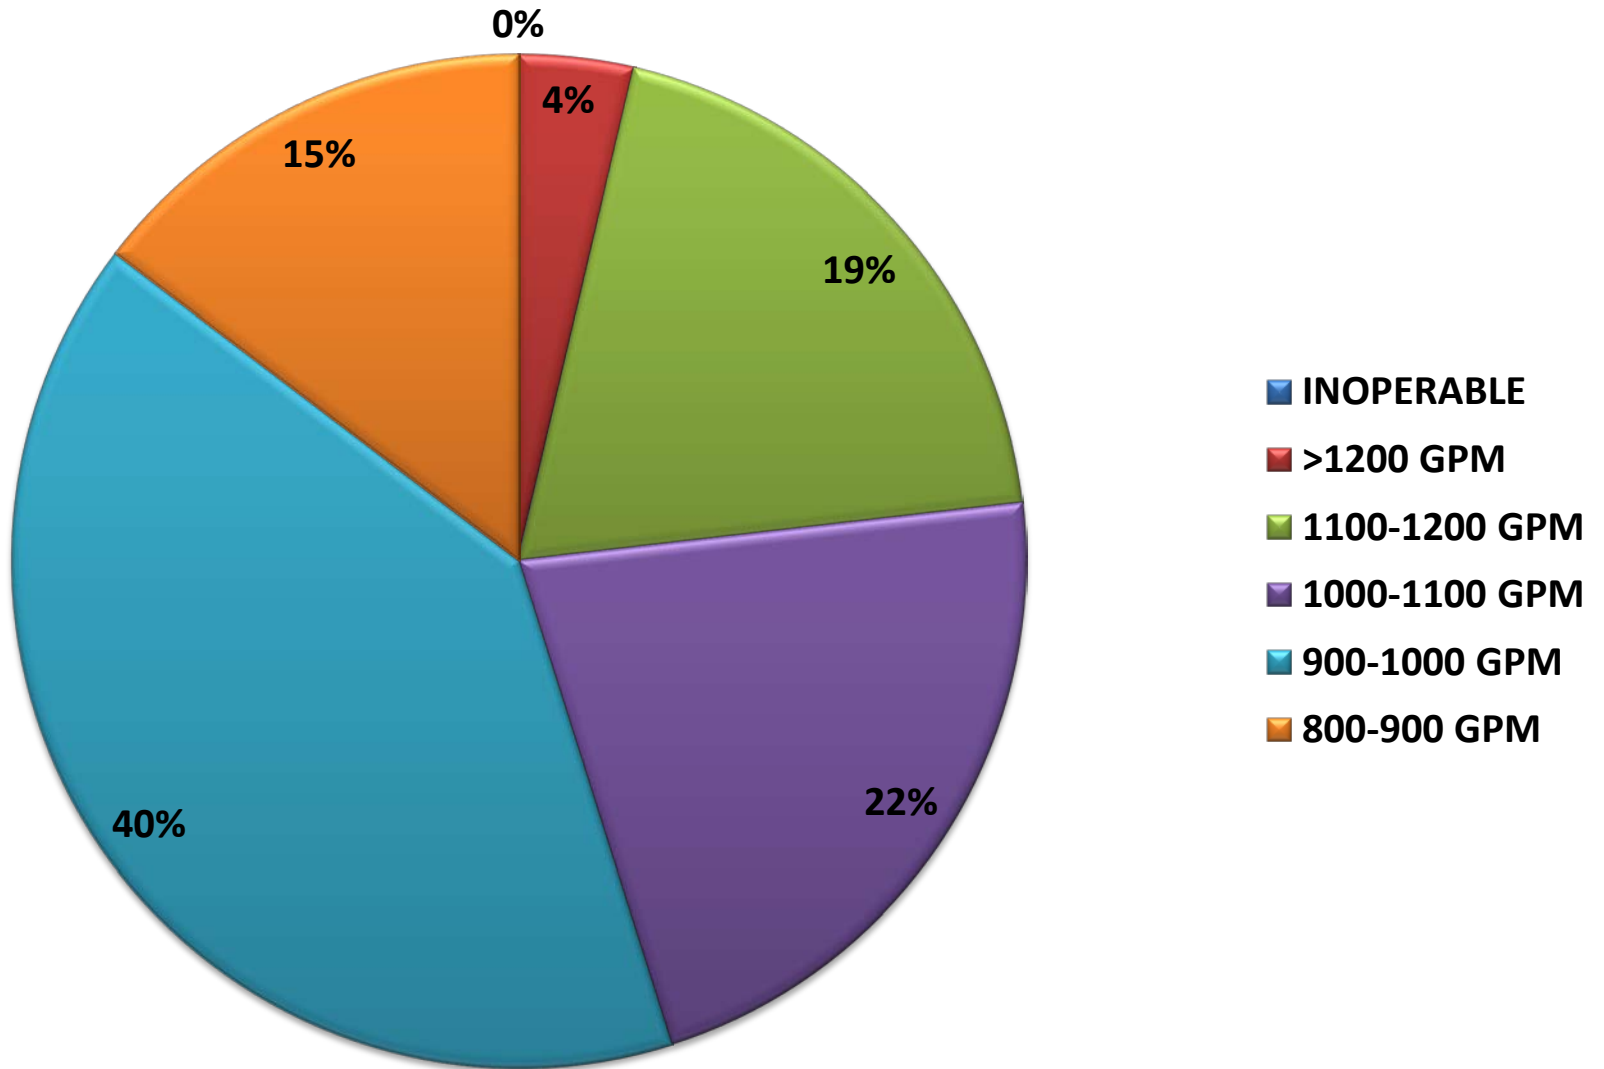
Flow Rate Of A Hydrant After Servicing

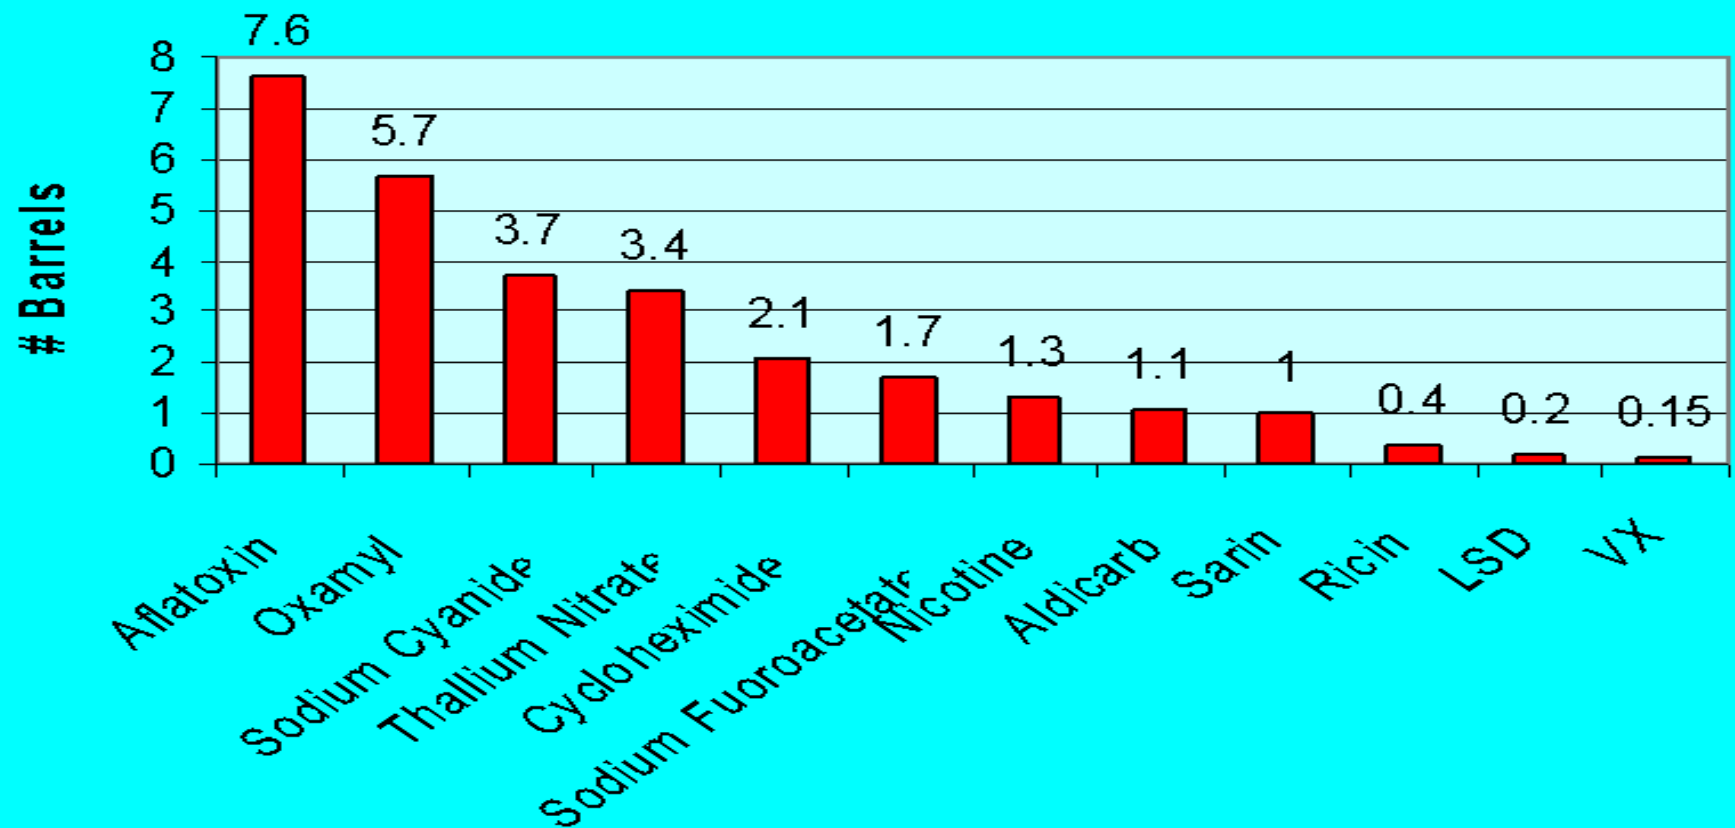
Number of 55 Gallon Barrels of Material Required to Poison 1 Million Gallons of Water for Some of the Most Dangerous Compounds

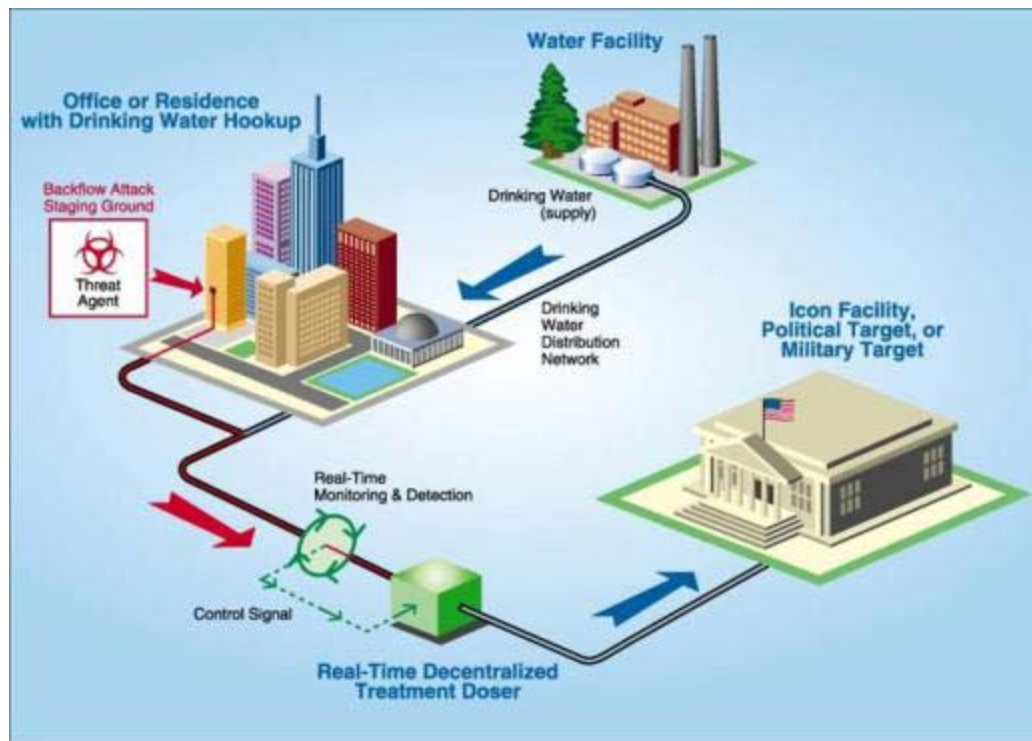
ERDC Designed Control System
Command Center
