**Multi-Impact Durability and Processing of Thick-Section  
Carbon-Glass/Epoxy Hybrid Composites Toughened  
With Thermoplastic Polyurethane Inter-Layer Films**

**ARL-TN-0501**

**September 2012**

**Steven E. Boyd and James P. Wolbert**  
**Weapons and Materials Research Directorate, ARL**

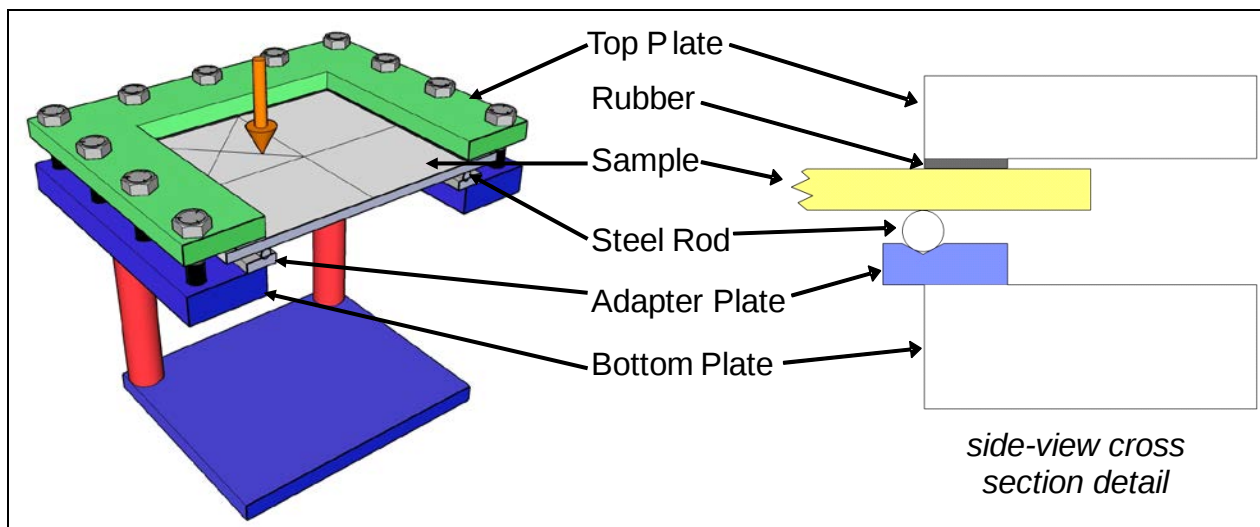
Figure 1. Exploded view illustration of the impact table, with detail showing a side-view cross-section of one side of the simple support.

The impact table fixture used in the impact testing is shown in figure 1. The all-steel fixture consists of a 3.8-cm thick, 50.8-cm square table, bolted to a 2.5-cm thick base plate with four 5.1-cm diameter, 30.5-cm long legs. The top plate is 2.5-cm thick held in place with sixteen 2.2-cm diameter high-strength steel bolts. Figure 1 illustrates the simply supported condition with the addition of the adapter plate (designed to snugly fit into the inner opening of the square table), four 1.3-cm steel rod supports that rest in machined “v”-grooves in the adapter plate, and a 0.3-cm thick 2.5-cm wide strip of soft rubber resting between the sample and top steel plate. The entire assembly is secured with sixteen hand tightened bolts to minimize rigid-body motion of the sample after impact and rebound.

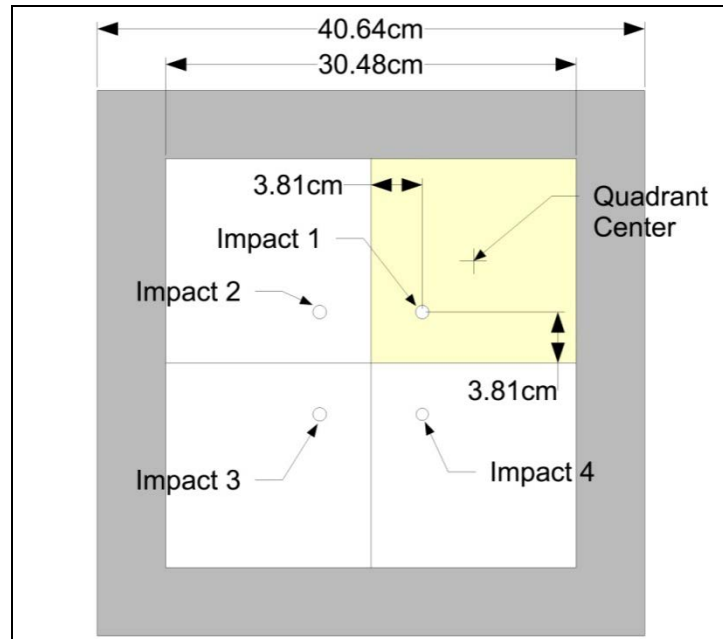
Figure 2. Illustration of the sample and impact location.

Figure 2 illustrates the locations of impact for all samples in this investigation. Impacts were conducted one-at-a-time to permit non-destructive evaluation of each panel after each impact. Mass and height of the impactor were 227.4 kg and 96 cm, respectively, yielding an impact energy of 2141 J and velocity of 4.34 m/s.

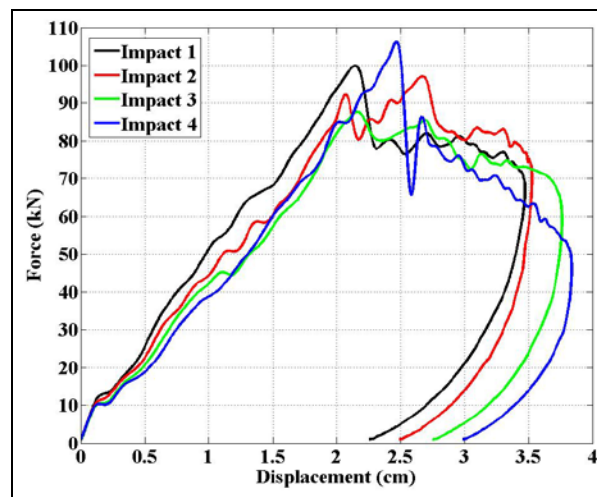
Figure 3. Force vs. displacement for Hybrid no. 1.

Force-deflection curves are given for all hybrid samples in figures 3–7. The curves are generally separated into three regions: (1) the impact portion, (2) a transient phase involving damage formation and energy absorption up to the maximum sample deflection, and (3) the rebound with a “recovery” to a permanent sample deflection. The baseline Hybrid no. 3 (no TPU) shows the highest loss in stiffness per impact and maximum deflection (see figure 5) of any hybrid. These two results are due to the lack of a TPU film toughening inter-layer, which would improve the samples damage tolerance. One interesting trend displayed by these force-deflection curves is the extensive damage and impact energy absorption that occurs. Each hybrid displays a significant sample deflection between 2 and 3.5 cm. This is unique to the hybrids of this investigation and is not observed in similar areal density reinforced samples tested in prior studies (3–5). Two possible causes of this extensive damage include the mechanical properties of the E-glass used in the core and the disparate properties in the carbon and glass pre-forms. The impact energy of 2.1 kJ was originally selected for S2-glass composites (3). E-glass fiber composites have lower strength and stiffness than corresponding S2-glass composites and therefore experience more damage and deflection subject to the same impact energy. Also, the carbon pre-form is much stiffer than the E-glass core and produces large interfacial shearing stresses under impact, which cause TPU film inter-layer failure (see figures 15–19 in section 4.3). In summary, the hybrids with TPU film inter-layers perform slightly better than the baseline having slightly higher peak loads, less damage, and less deflection after four impacts.

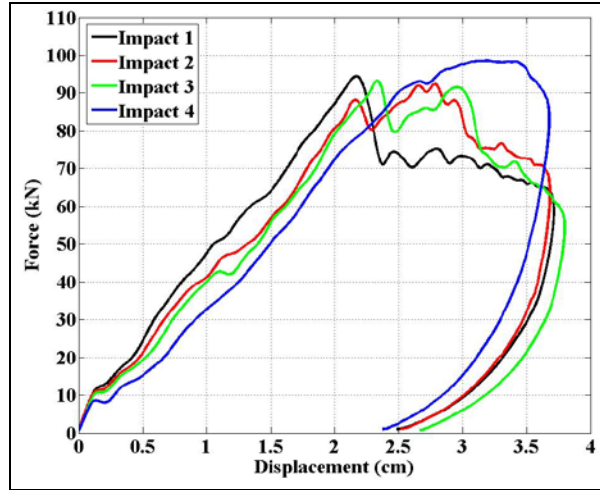
Figure 4. Force vs. displacement for Hybrid no. 2  
("pre-pressed").

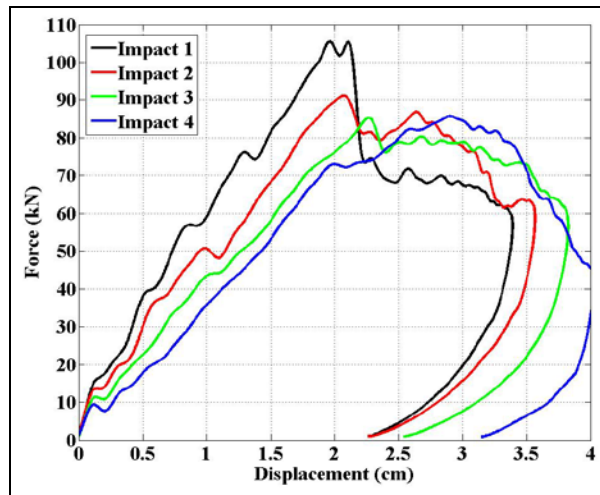
Figure 5. Force vs. displacement for Hybrid no. 3  
(baseline).

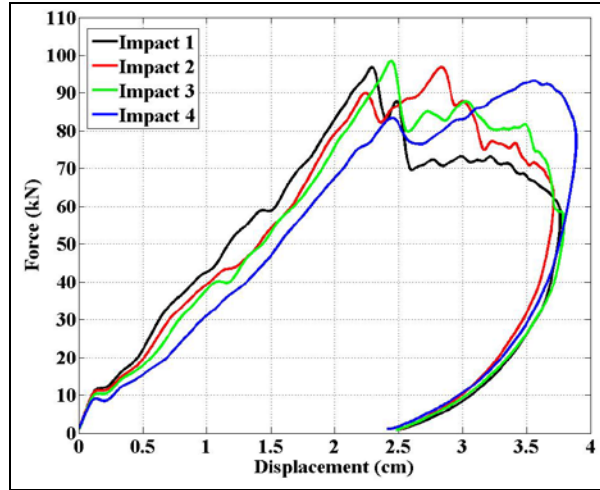
Figure 6. Force vs. displacement for Hybrid no. 4 (PA-VARTM).

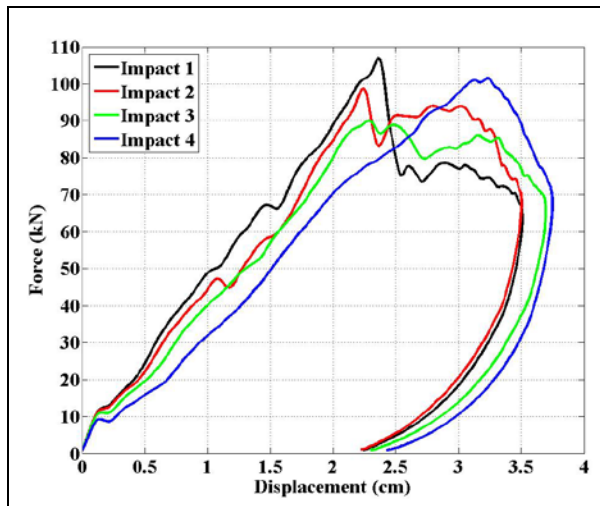
Figure 7. Force vs. displacement for Hybrid no. 5.

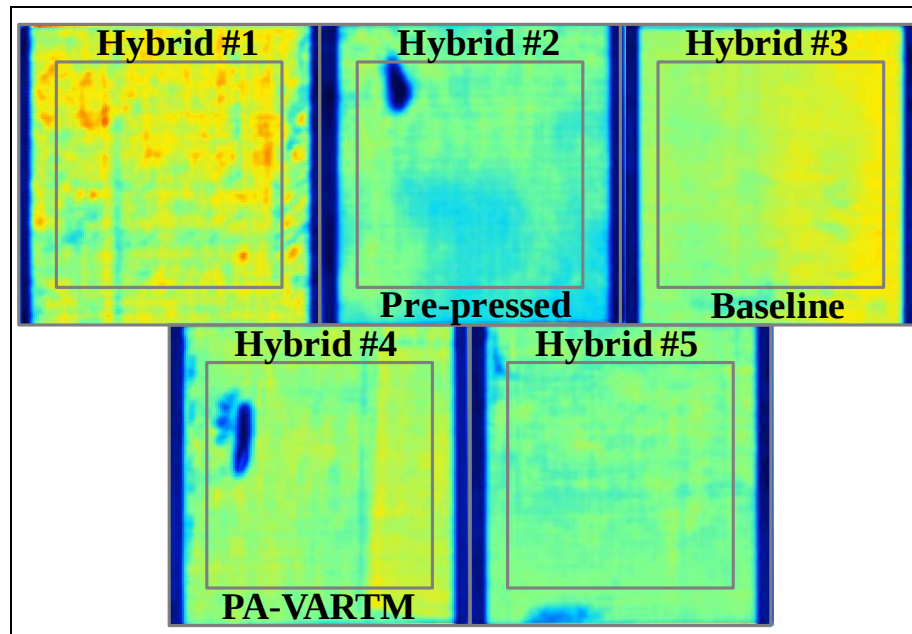
Figure 8. C-scan images showing initial undamaged state for all hybrids as labeled.

Figure 8 gives ultrasonic c-scan images for all hybrids prior to impact testing. Pre-impact scans are performed for all samples tested and are critically important for revealing any processing issues that may compromise impact performance. Before discussing the results, it is important to understand that through-transmission scans identify inclusions and their extent but not their through-thickness location. As expected the baseline hybrid with no TPU film inter-layers had no initial defects and was processed successfully. Samples with TPU film had defects related to the impermeability of the TPU film layers, mostly dry fiber areas caused by “race-tracking” during infusion. Hybrid nos. 1 and 5, processed using standard VARTM, had some defects, but since the defects were located near the edges, the samples were judged to be successfully processed. The two hybrids that included a heat and pressure component in the processing phase had two significant inclusions. Although the inclusions can be located anywhere in the thickness, they are most likely at the interface between the pre-forms and TPU films. In both Hybrid nos. 2 and 4, the processing under heat and pressure of the stacked layers probably pressed the TPU film into surrounding fibers saturating them and inhibiting resin infusion. Regardless of the presence of the inclusions, the samples were tested for impact properties.

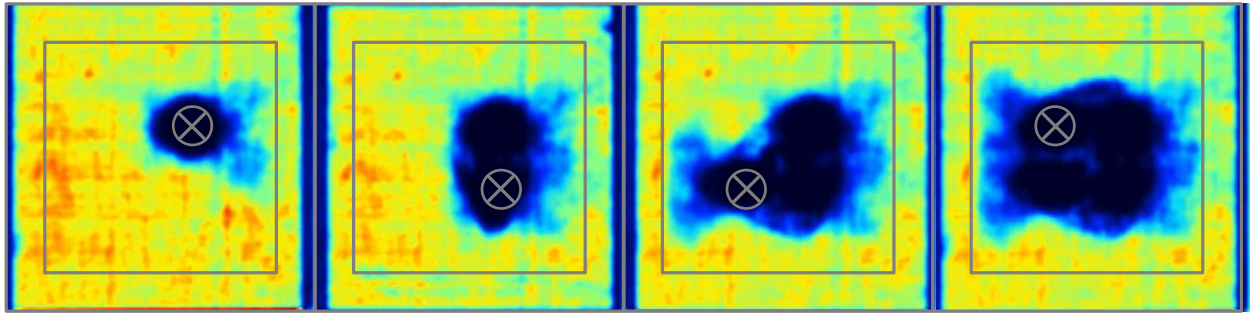
Figure 9. C-scan image showing progression of delamination in Hybrid no. 1.

Figures 9–13 show ultrasonic c-scan images of damage progression for all hybrid materials. The best performer was Hybrid no. 1 (figure 9) with the lowest damage area progression per impact and damage contained largely in the vicinity of the hemispherical impactor. The baseline Hybrid no. 3 (figure 11) had the most damage area progression of any of the hybrids due to its lack of TPU toughening inter-layers. The two pressed hybrids, Hybrid nos. 2 and 4, had the most “fringe” damage showing up as lighter damage areas surrounding the main point of impact.

These “fringe” areas are most likely delaminations of the interfaces, perhaps failure in the TPU film inter-layers. It is interesting to note that during successive impacts, the inclusions of Hybrid nos.2 and 4 do not appear to affect the impact damage or damage progression in the sample. The damage formation and progression of Hybrid no. 5 is similarly unaffected by edge defects; however, Hybrid no. 5 performs slightly worse than identically processed Hybrid no. 1.

Delamination area and progression in all hybrid samples is given in figure 14. The damage is presented as a percentage of aperture—area of the sample not constrained by the simply-supported boundary conditions (see figures 2 and 3). The key result here is that TPU film interlayers significantly reduce and arrest the progression of impact damage. Without TPU interlayers, there is a significant increase in damage after each impact. Hybrid nos. 1 and 2 performed best under impact as can be seen from the ultrasonic c-scans (see figures 9 and 10).

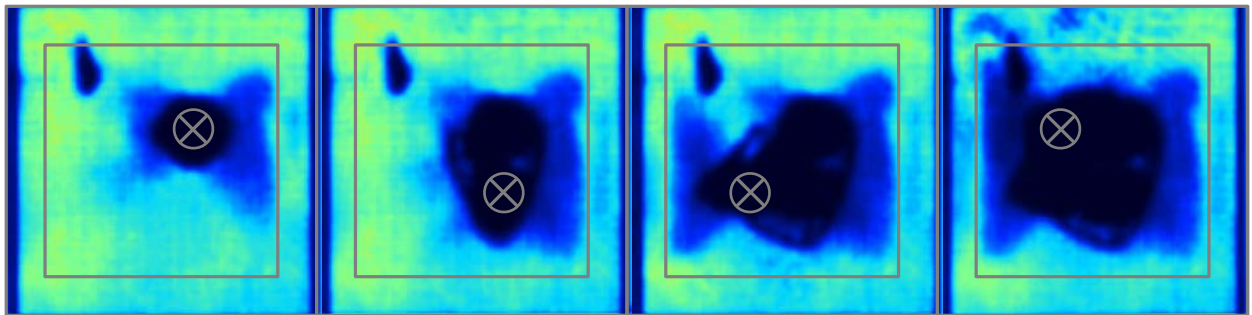
Figure 10. C-scan image showing progression of delamination in Hybrid no. 2 (“pre-pressed”).

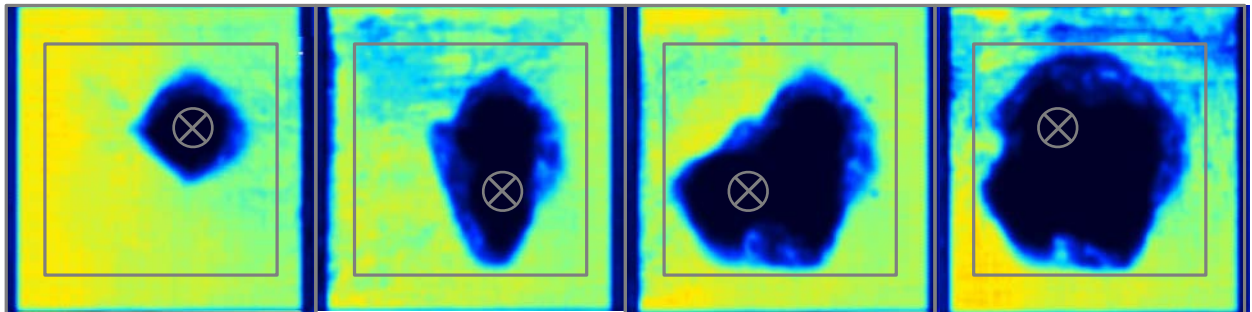
Figure 11. C-scan image showing progression of delamination in Hybrid no. 3 (baseline).

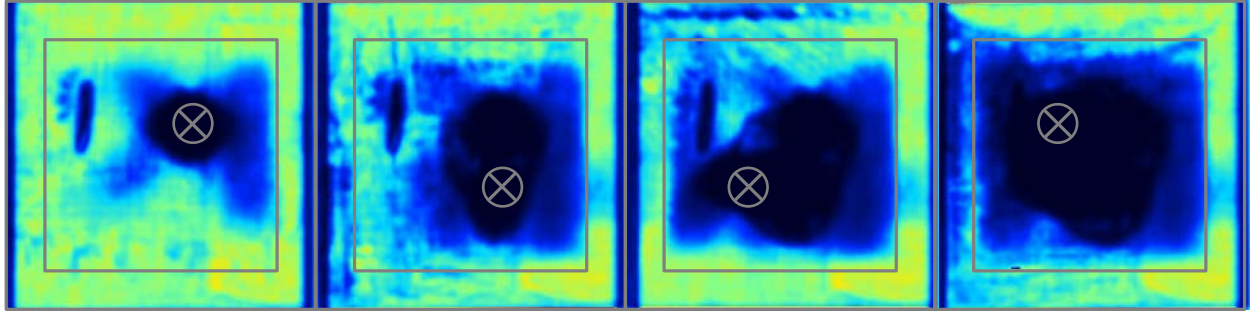
Figure 12. C-scan image showing progression of delamination in Hybrid no. 4 (PA-VARTM).

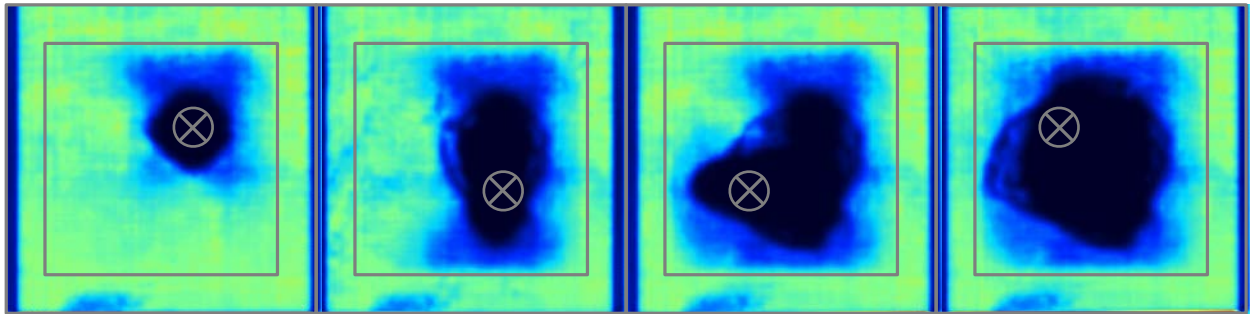
Figure 13. C-scan image showing progression of delamination in Hybrid no. 5.

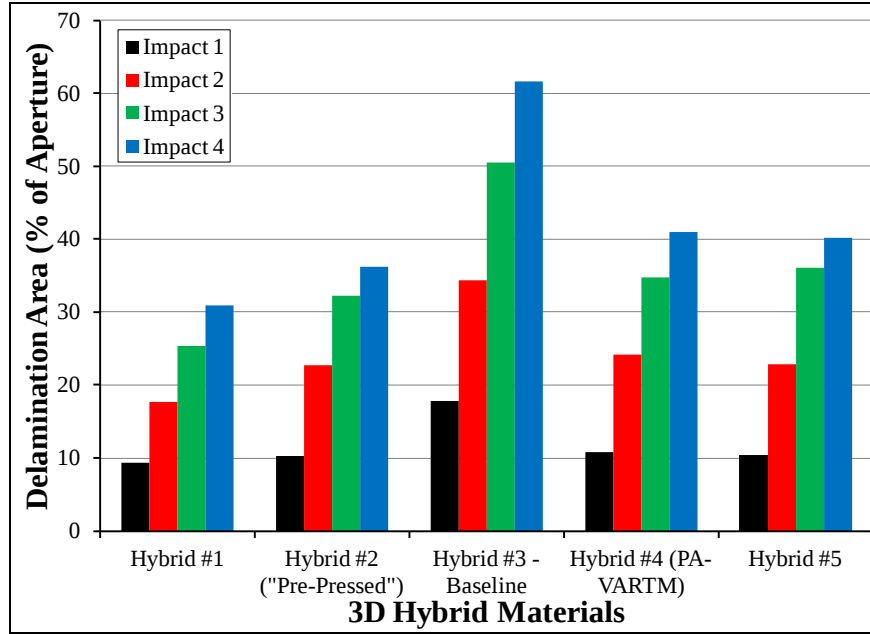
Figure 14. Delamination areas as a percentage of impact table aperture for each material.

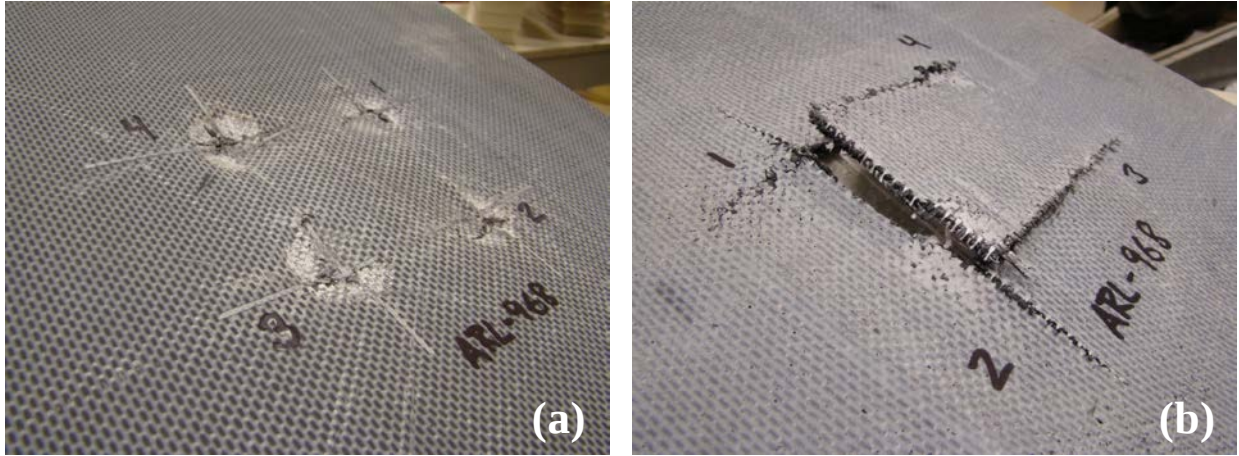
Figure 15. Front face (a) and back face (b) impact damage for Hybrid no. 1.

Images of front and back face impact damage for each sample are shown in figures 15–19. From the force-deflection curves of each sample (see figures 3–7); a significant amount of damage and energy absorption was indicated during impact. The images of figures 15–19 demonstrate that each sample experienced much localized impact damage directly under the hemispherical impactor and back face perforation resulting in a rectangular tab of the outer carbon pre-form separating from the hybrid assembly. The breakage is most severe in the area of the first and second impact indicating that the first couple of impacts caused more localized damage and punching shear perforation through the sample. After successive impacts, the failure transitions from localized shear to wide spread delamination as the damaged samples become more compliant to impact. From figure 17 for the baseline Hybrid no. 3, the damage is more severe revealing significant punching on the front face and perforation on the back face. From this visual evidence, the TPU film inter-layers provide a much improved damage tolerance and durability to the hybrid samples. However, severe damage observed on the back face images of figures 15–19 (b) suggested that a mismatch in carbon and glass properties may be causing a failure in the TPU inter-layers in the vicinity of the impact.

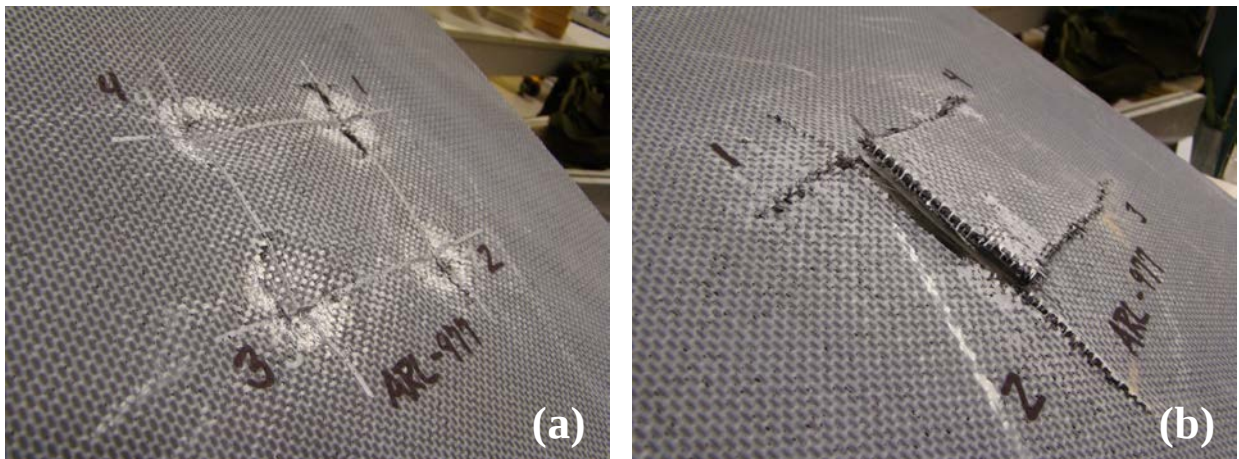
Figure 16. Front face (a) and back face (b) impact damage for Hybrid no. 2 ("pre-pressed").

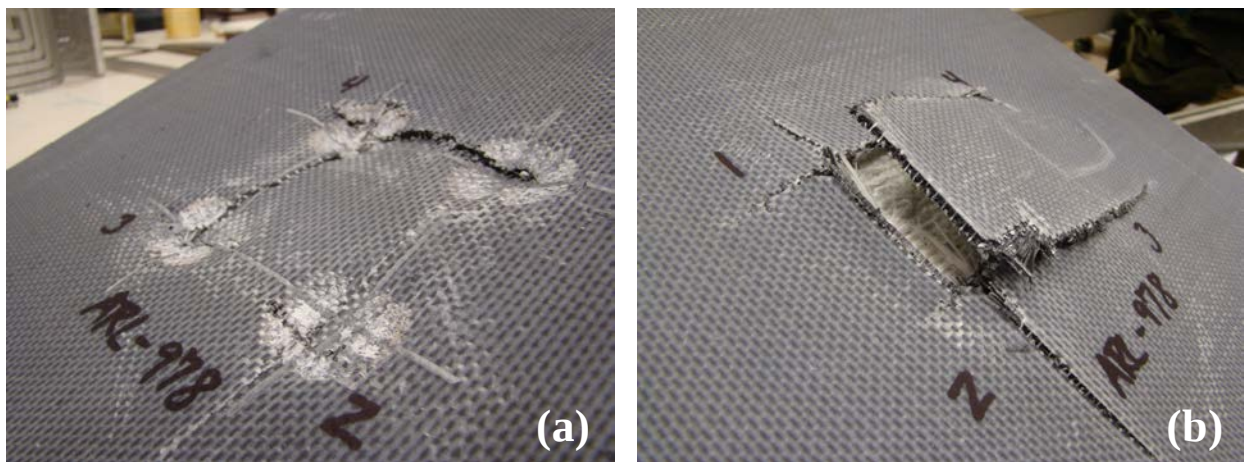
Figure 17. Front face (a) and back face (b) impact damage for Hybrid no. 3 (baseline).

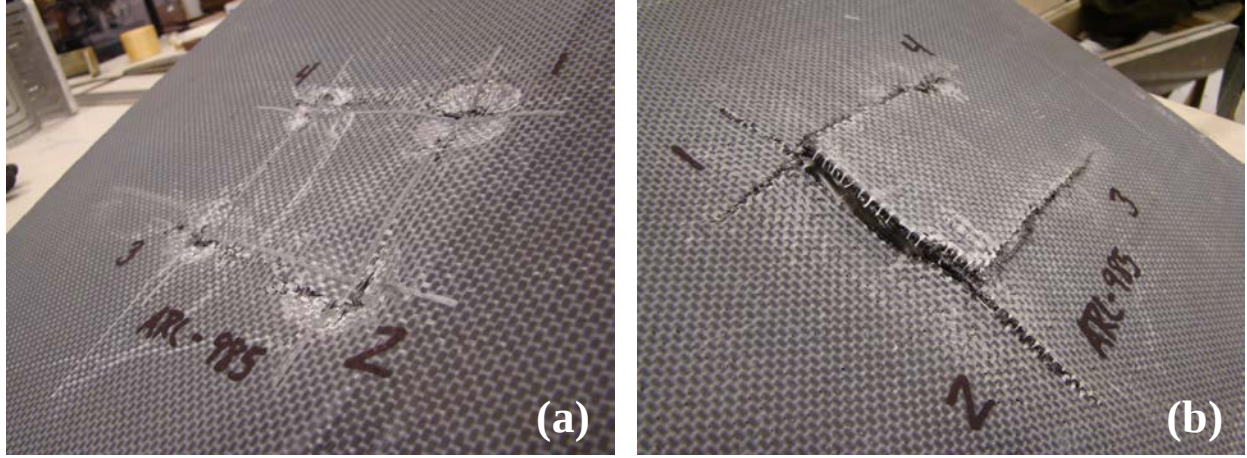
Figure 18. Front face (a) and back face (b) impact damage for Hybrid no. 4 (PA-VARTM).

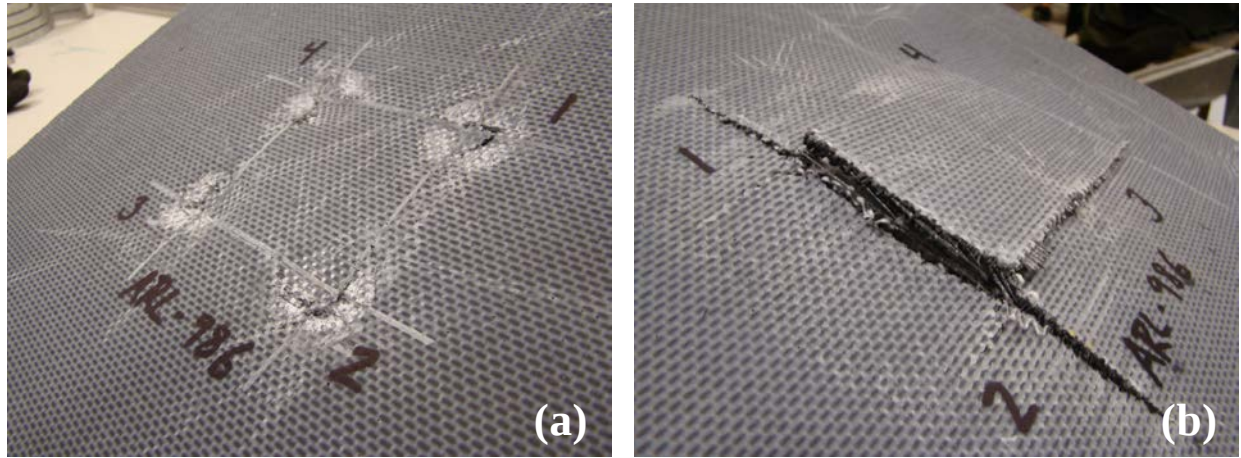
Figure 19. Front face (a) and back face (b) impact damage for Hybrid no. 5.

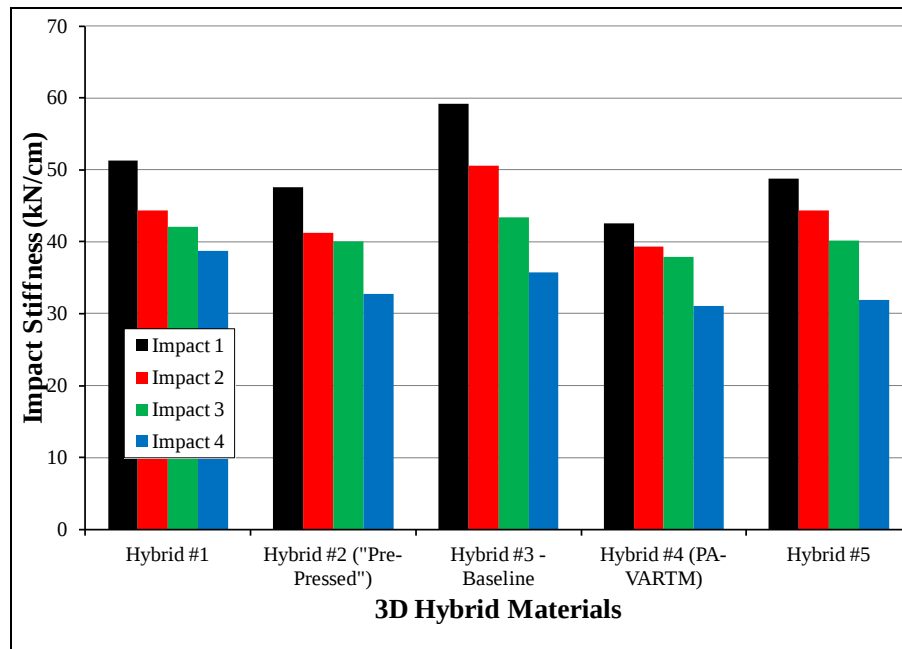
Figure 20. Initial impact stiffness for all hybrid materials.

The impact stiffness for all hybrid materials is listed in figure 20. The stiffest sample is the baseline Hybrid no. 3 without TPU film inter-layers. This result is surprising considering that Hybrid no. 3 had the most damage progression (see figure 14) and sustained the highest localized damage and energy absorption (see both figures 5 and 17). Considering that TPU films may be modeled as materials with hyper-elastic constitutive properties (16), the addition of 0.015-in

TPU film inter-layers may have reduced the flexural stiffness of the other hybrid samples versus the baseline sample. The observed decrease in sample stiffness from the baseline (Hybrid no. 3) to other identically processed hybrids (Hybrid nos. 1 and 5) containing TPU was not demonstrated in similar research involving S2-glass composites (17). However, as seen in both figure 20 and table 2, the baseline hybrid still had the greatest degradation rate per impact. This indicates that even though Hybrid no. 3 is a stiff sample, after two impacts, its stiffness reduction matches or exceeds that of the other TPU toughened hybrids.
