| <b>1. REPORT DATE (DD-MM-YYYY)</b><br>6 Dec 2012 | | <b>2. REPORT TYPE</b><br>Consultative Letter | | <b>3. DATES COVERED (From – To)</b><br>July 2012 – November 2012 | |
| <b>4. TITLE AND SUBTITLE</b><br><br>Stewart Air National Guard Base, NY, C-5M Painting Refurbishment Assessment | | | | <b>5a. CONTRACT NUMBER</b> | |

SUBJECT: Consultative Letter AFRL-SA-WP-CL-2012-0068, Stewart Air National Guard  
Base, NY, C-5M Painting Refurbishment Assessment

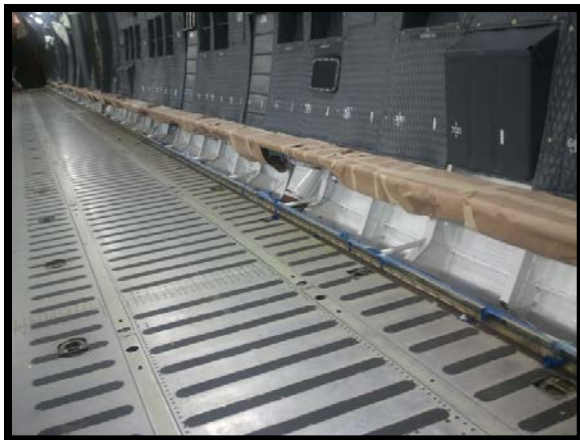
2. SURVEY PROCEDURES/DISCUSSION: The team from USAFSAM/OEC accomplished air sampling from 25-26 July and 30-31 July for chine coves (Figure 1) and flight deck (Figure 2) refurbishment processes, respectively. The two processes were unique from each other in that the chine coves are in a naturally ventilated open cargo area yet use isocyanate paints, while the flight deck area has restricted air flow yet uses water-based polyurethane paints.

**Figure 1: Chine coves, pictured here in white**

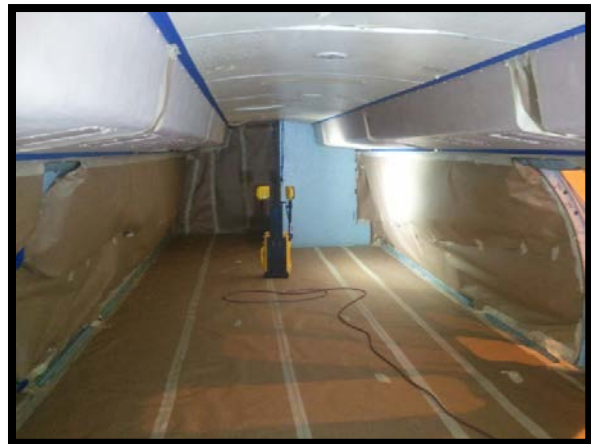
**Figure 2: Flight deck**

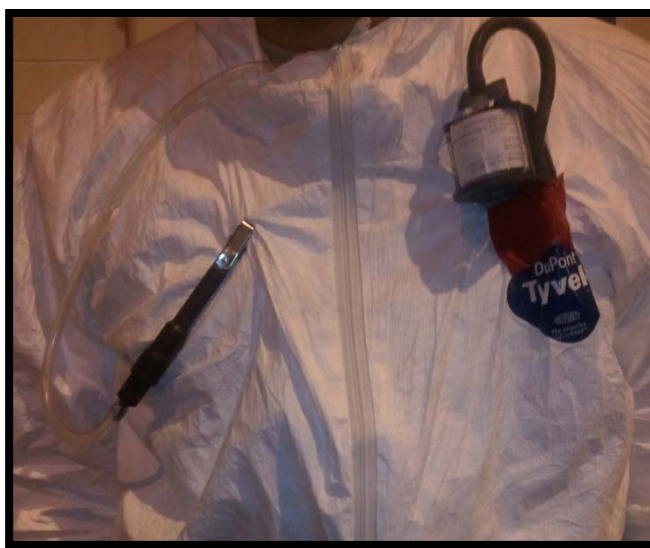
a. Air samples were collected using two methods simultaneously. During chine cove painting, the Iso-Chek™ sampler and the passive sampler were used. During flight deck painting, the Iso-Chek™ sampler and the charcoal tube sampler were used. The two sampling techniques were selected to quantify both the principal hazard of the isocyanates as well as the secondary concern with various volatile organic constituents of the painting processes. The Iso-Chek™ method is the USAFSAM-recommended sample method for quantifying both the monomer as well as the oligomer species of the hexamethylene diisocyanate (HDI)<sup>2</sup>. The volatile organics were assessed using the passive sampler for chine cove painting and the charcoal tube sampler for the flight deck painting.

b. Due to a limited number of Iso-Chek™ samplers, only one representative painter was assessed using the Iso-Chek™ method per work shift. Additional Iso-Chek™ sampling by the local Bioenvironmental Engineering Flight could add statistical confidence to the hazard characterization. The Iso-Chek™ sampler was clipped to the shoulder of the painter within the breathing zone, while either a passive sampler or a charcoal tube sampler was clipped to the opposite shoulder of all four painters. The cassettes were held in place with a cassette holder, while the charcoal tube samplers were held in place with a tube holder in line with a low flow reducer (Figure 3). The flow rate for the Iso-Chek™ sampler was set at 1 liter per minute (Lpm). The flow rate for the charcoal tube sampler was set at 0.2 Lpm.

**Figure 3: Iso-Chek™ and charcoal tube samplers**

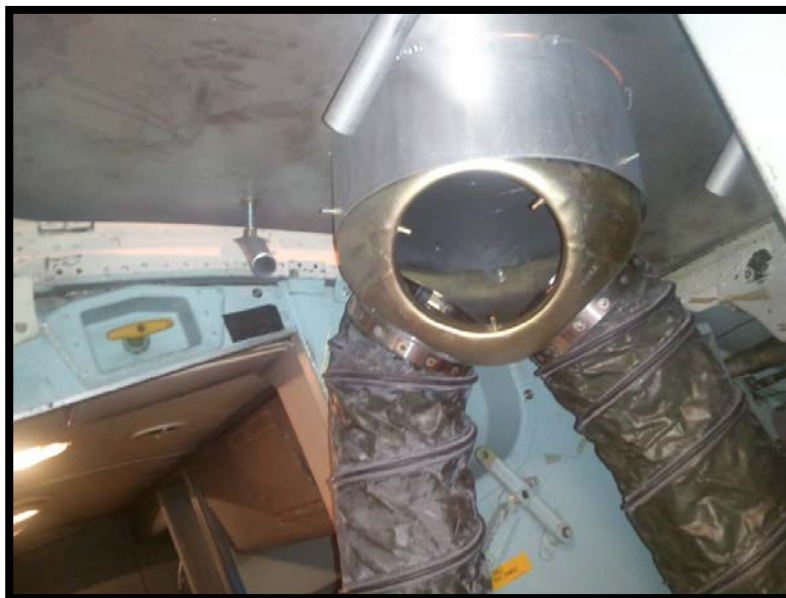
d. During the time of the chine cove survey, ample natural ventilation was provided by having both the forward and aft loading bay doors of the C-5 open and parallel to the open front and back hangar doors. These conditions provided variable cross-ventilation through the cargo compartment of the C-5. The outside hangar doors are kept closed during winter months. During flight deck sampling, an exhaust ventilation system was employed (Figure 4). However, only two of the three ducts were used, thereby significantly limiting the efficacy of the local exhaust due to the massive loss at the point of connection.

**Figure 4: Local exhaust for flight deck painting operations**

f. When painting in the flight deck, attach the third local exhaust duct for a third painter or cap the opening of the unused duct so that the flow of ventilation is maximized at the two painters' positions. A box fan could be placed near the access door to increase air movement if stagnant zones are a concern.
