# THE ROYAL INSTITUTION OF NAVAL ARCHITECTS

## Design, Verification, and Forensic Correlation of Composite Yacht Structures

P H Miller, United States Naval Academy, USA

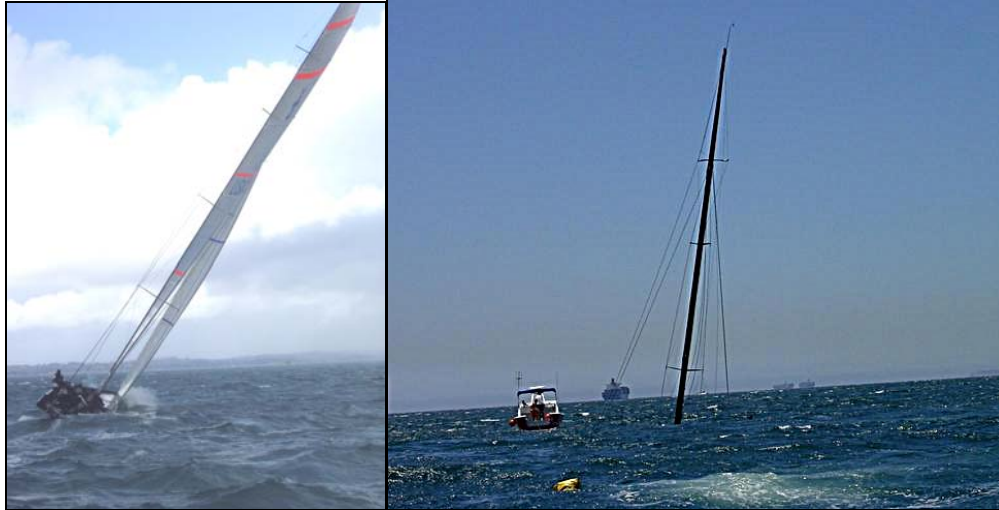
Figure 1: “Stars and Stripes” IACC USA-77

TDC's program included the design and construction of two (~25 m) vessels, five (~35 m) rigs and numerous keels, rudders, bulbs and winglets (see Figure 1). Working for about 16 months, TDC employed three part-time engineers to complement the principal naval architects, Reichel/Pugh Yacht Design (Harry Dunning - full time, Jim Pugh and John Reichel - part time) in the structural design of the hull, deck, internals, and appendages. Additionally the team developed the rigs and supported New England Boatworks, the builders.

Just prior to shipping the boats to New Zealand from Long Beach, California, USA 77 sank during practice (see Figure 1). Luckily it was in relatively shallow water and she was recovered in remarkably short time. While the cause was quickly determined, the bigger question was the extent of damage and the required scope of repairs.

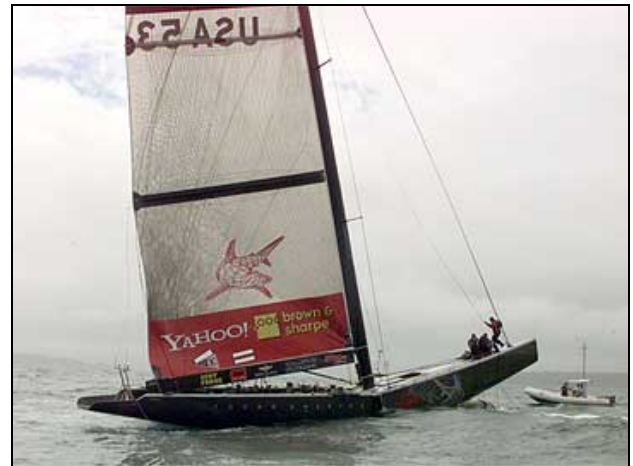
Figure 2: “Young America” suffering deck failure during the 2000 America’s Cup

IACC yachts are in many ways like a longbow that is being pulled back for firing. The arrow is the mast, the fore and back stays the bowstring, and the hull the longbow. Due to the large tension in the stays the mast experiences large compressive forces and the deck is in compression as the bow and stern bend upwards. The near loss of the IACC yacht “Young America” identified the sidedeck (Figure 2) as one of the critical components.

No published report identified the failure mode, however due to the compressive forces the failure was likely either compressive material yield or buckling, with delamination a possible contributing factor. In this area the partial side decks transition to a full-width foredeck near the area of maximum global bending moment. The IACC rules require the minimum thicknesses as: upper deck skin - 1.2 mm, lower deck skin - 0.9 mm, core - 14 mm. Additional uni plies are often added longitudinally to stiffen the hull. These can be added on either skin with the trade-off that adding them to the upper skin beneficially places them farther from the vessel’s neutral axis while negatively unbalancing the laminate.

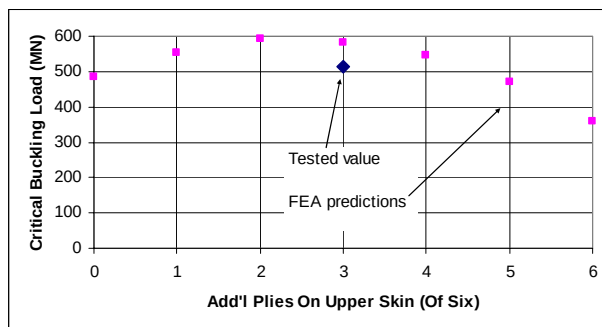
Figure 4: Ply distribution on buckling load

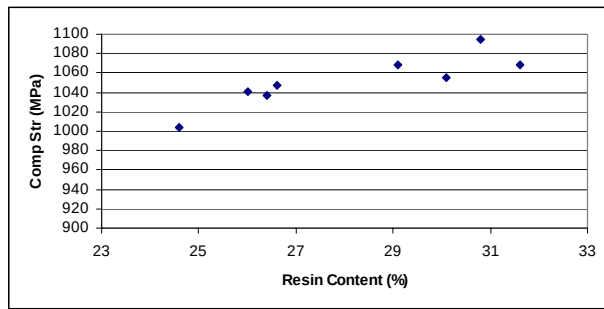
Figure 5: Compressive strength versus resin content

TDC and Southern Spars worked closely with the prepreg supplier, Newport Composites of Irvine, California to develop a product with the minimum resin content for mast construction while retaining toughness. Initial consideration looked at three resins, but preliminary tests showed one resin, while exhibiting slightly lower modulus, had higher compressive strength and toughness values. Figure 5 shows the resulting compressive strength versus resin content. Newport was comfortable with a 4% manufacturing variation, and the drop off near 28% led to a resin content specification of 30+/-2%. As the outer plies were more susceptible to resin bleed and abrasion, on later masts those plies were specified with 33% resin content.

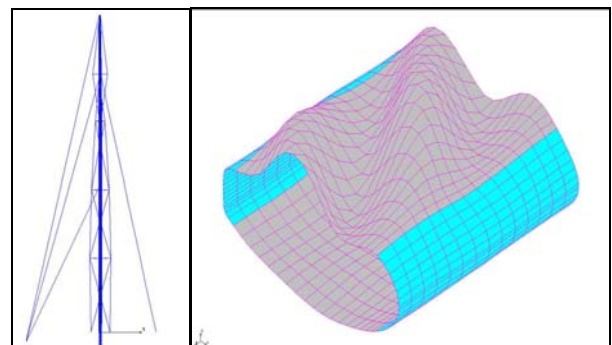
Figure 6 shows the global and a section of the local FEA mast models. The local model has two noticeable asymmetries in its results. These reflect the final calibration of the model to the test pieces and jig and the nature of the laminate. In addition to gravity, the boundary conditions were not exactly square, and the travel of the piston was not perfectly axial. The laminate was not perfectly symmetric and balanced due to an odd number of off-axis ply pairs.

Figure 6: Global rig and local mast models
