**THE SEVERE DUTY VEGETATION SHREDDER
TECHNICAL TESTING OF CAPABILITY
MAY 2002**

Severe Duty Vegetation Shredder Technical Test

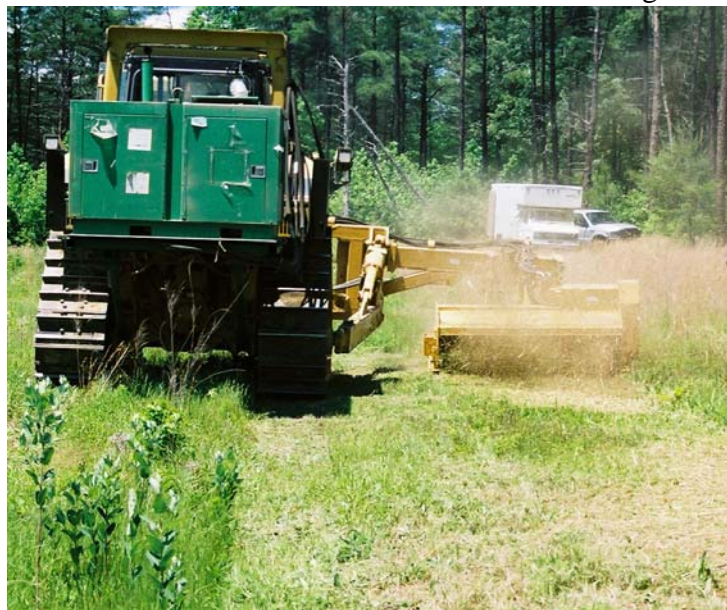
The system can be operated from a previously cleared lane in order to reduce/eliminate the vegetation from adjacent uncleared areas (see figure 1). It cuts a swath just under 2 meters wide and can be stowed in front of the vehicle blade for cross country travel purposes. The interface between the shredder and tractor is designed to allow freedom of movement between the tractor and the shredding implement to permit contour tracking over uneven ground.

Figure 1 Reaching in to suspect area

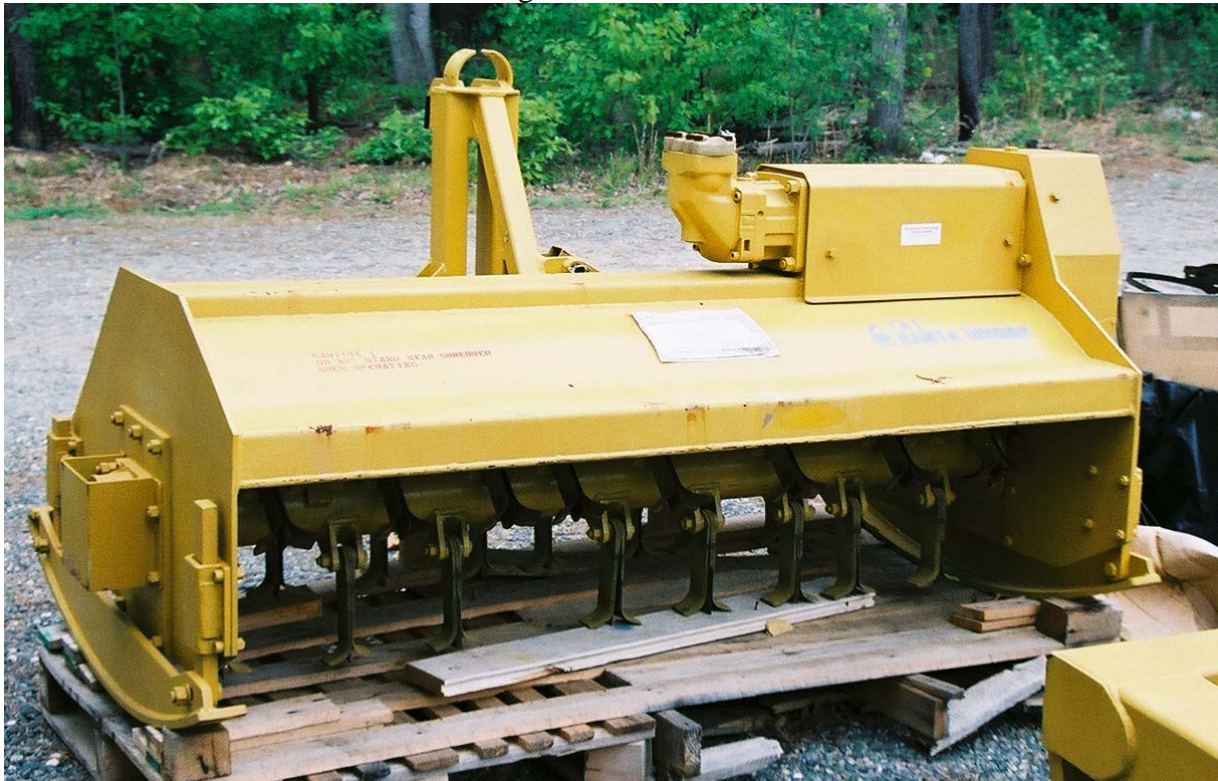
The shredding implement is a modified commercially available component (see figure 2). The shredding implement is hydraulically driven and has a horizontally rotating shaft with hardened cutting knives pinned to its surface. The drum rotates at 1800 RPM. The knives are commercially available “wear items” and can be replaced in about half an hour. The direction of rotation provides for an upward stroke of the knives on the leading edge of the system. Skids at the edges of the shredder provide a bearing surface for the shredder to ride on if the operator maneuvers the shredder too close to the ground surface.

Figure 2 Shredding Implement

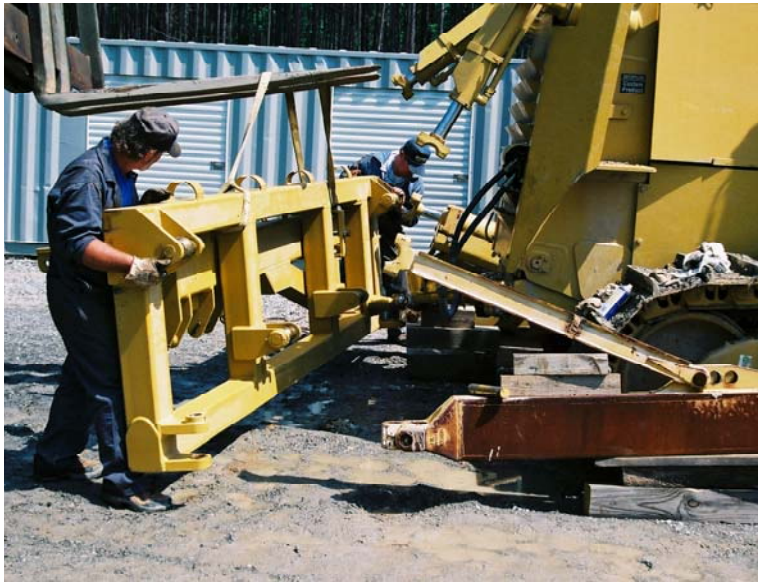
The mainframe ties in with the lift and lower features of the tractor and allows the cutter to operate from 1-2 feet below the surface of the tracks to 6 feet above the surface of the tracks (see figure 3). The tilt feature of the tractor/mainframe interface can contribute additional height and

Figure 3 Installation of Mainframe on tractor

The mainframe vehicle interface replaces the standard dozing blade on the crawler tractor. The mainframe provides for the three point hitch that allows the shredding implement to “float” along adjacent to the path the tractor is traveling. In addition the mainframe provides a plus or minus 30 degree “roll direction” rotation of the shredding implement to keep the cutter parallel with the ground when traveling over terrain with a transverse slope different from the path of the tractor such as when cutting a drainage ditch or road shoulder.

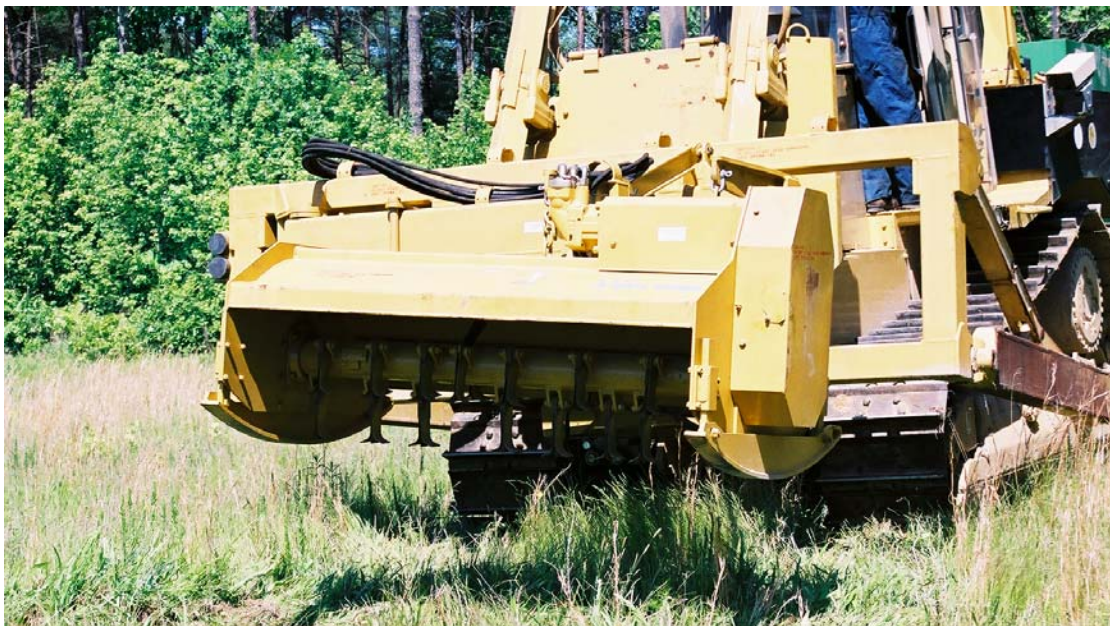
rotation of the shredding implement beyond the lift lower function and shredding implement rotation function. The “float” of the 3 point hitch allows the shredder a couple of degrees of rotation freedom and several inches of elevation freedom so the operator is not required to precisely control the terrain tracking of the shredder. In addition, the mainframe provides for the shredder to be folded around to the front of the tractor into a travel position (see figure 4).

Figure 4 Travel Position

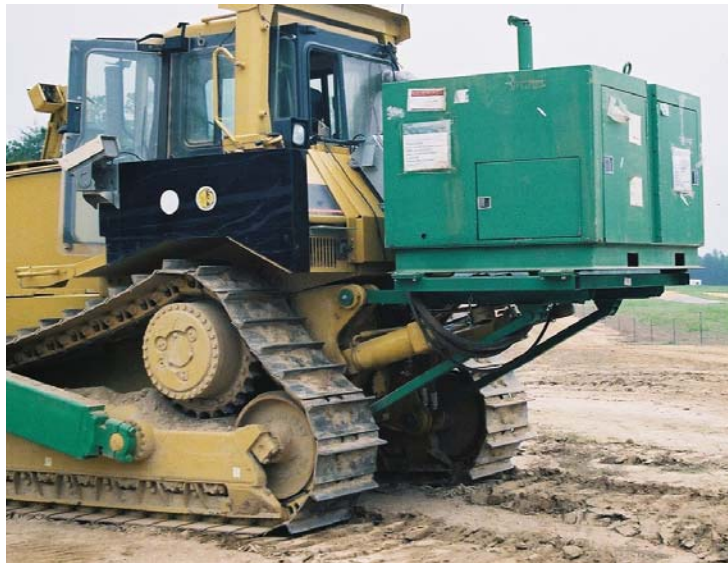
The hydraulic power pack supplies up to 80 kw of hydraulic power to turn the cutting rotor. The pack weighs approximately 1000 kg and is designed to mount on the rear of the tractor using the

attachment pins for the standard ripper (see figure 5). The pack features a load sensing system designed to efficiently match flow conditions with working demand. Hydraulic hoses are routed along the left side of the tractor to power the shredder. Rotor speed is infinitely variable from 0 to 1800 rpm with the power pack operating at full speed. The hydraulic power pack is driven from an air cooled diesel engine and houses an 80 gallon hydraulic oil reservoir and 20 gallon fuel tank. It is capable of operating 6-8 hours depending upon conditions.

Figure 5 Rear Mounted Hydraulic Power Pack

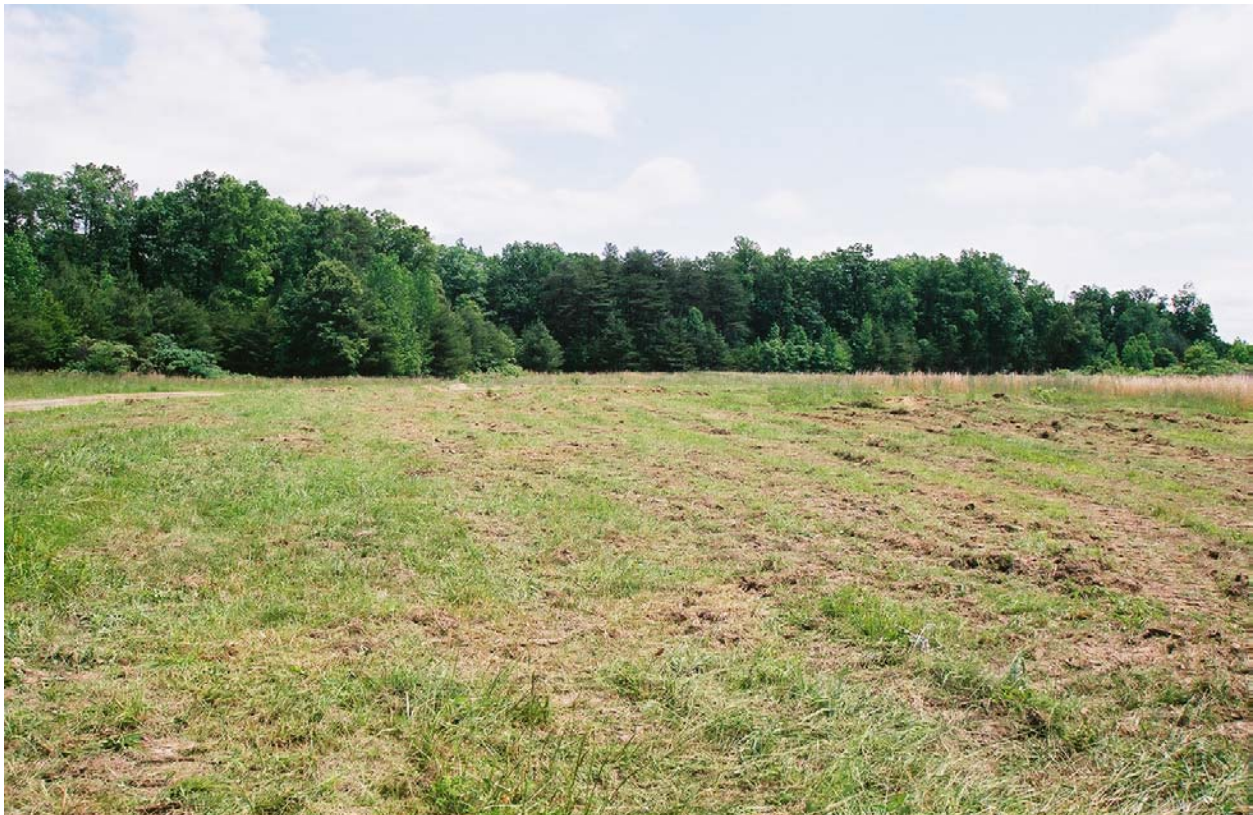
The performance of the SDVS was measured through a series of timed tests cutting increasingly difficult vegetation and terrain features. The first tests were performed in 1 meter high grass. The portion of the field shown in figure 6 was cleared in 1 hour with no difficulty. Operation in

this area did highlight the need for a minimum level of operator training. It is possible for the right lower corner of the mainframe to plow soil while the operator concentrates on the left side and the shredder. Once the test operator was familiar with this possibility, no further problems of this kind were encountered. The uniformity of cut while not as good as a grass mower, was adequate. In total 1404 sq meters were cut giving a rate for an inexperienced operator of .35 acres/hour. The area was sufficiently cleared to give access to all sites for hand held detector sweeping and mine excavation.

Figure 6 Category 1, Grassy Test Area (After Shredding)

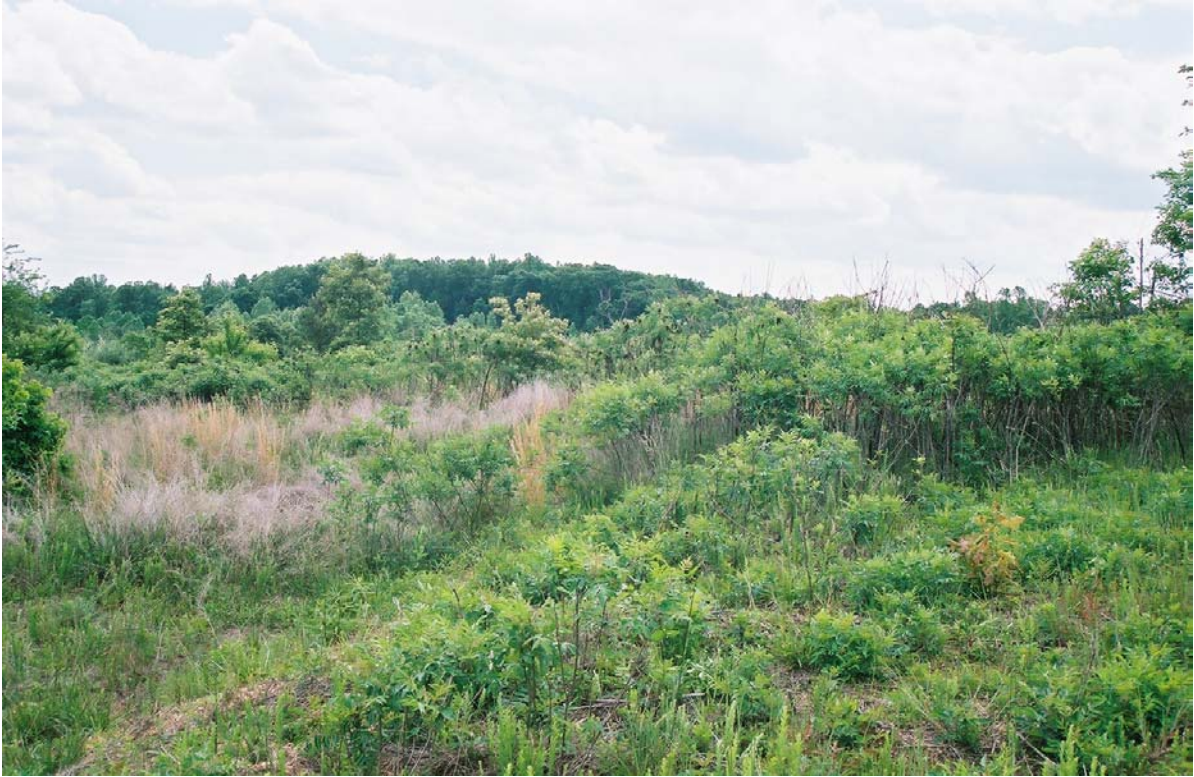
The second test area in which the Severe Duty Vegetation Shredder performed consisted mainly of 1 to 2 meter high, dense scrub brush with occasional large bushes and saplings in the range of 10-15 centimeter diameter stalks on a gently sloping hillside. The shredder operated in this area for 3.4 hours and cleared 2615 sq. meters of land giving a clearance rate of .18 acres/hr. Again, no problems were encountered in this field and the clearance was performed in a continuous operation. Some stubs in the 3-5 centimeter range were left, and in places the mulch was thick enough to require clearing by hand to expose the ground surface. Figure 7 and 8 show the area before and after the shredding operation from approximately the same vantage point. Some inadvertent plowing with the mainframe occurred but this tendency was significantly reduced by the end of the test.

Figure 7 Category 3 Vegetation Before Shredding

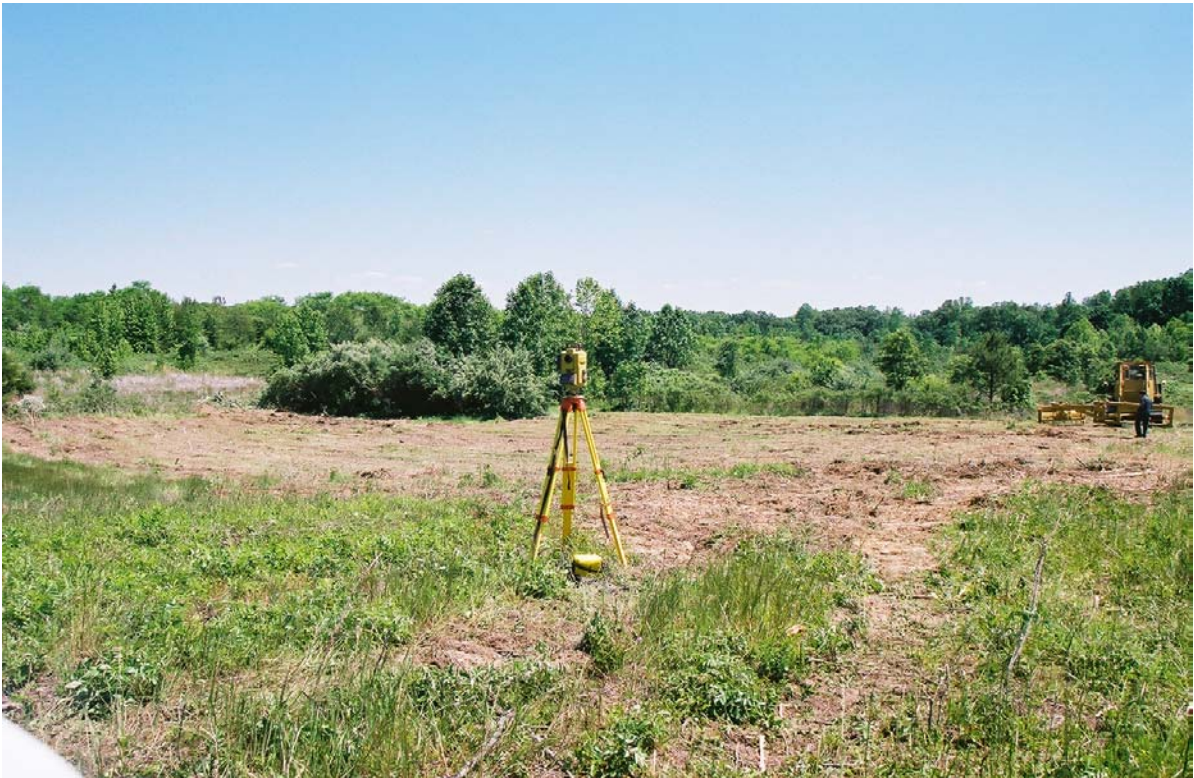
Figure 8 Category 3 Vegetation After Shredding

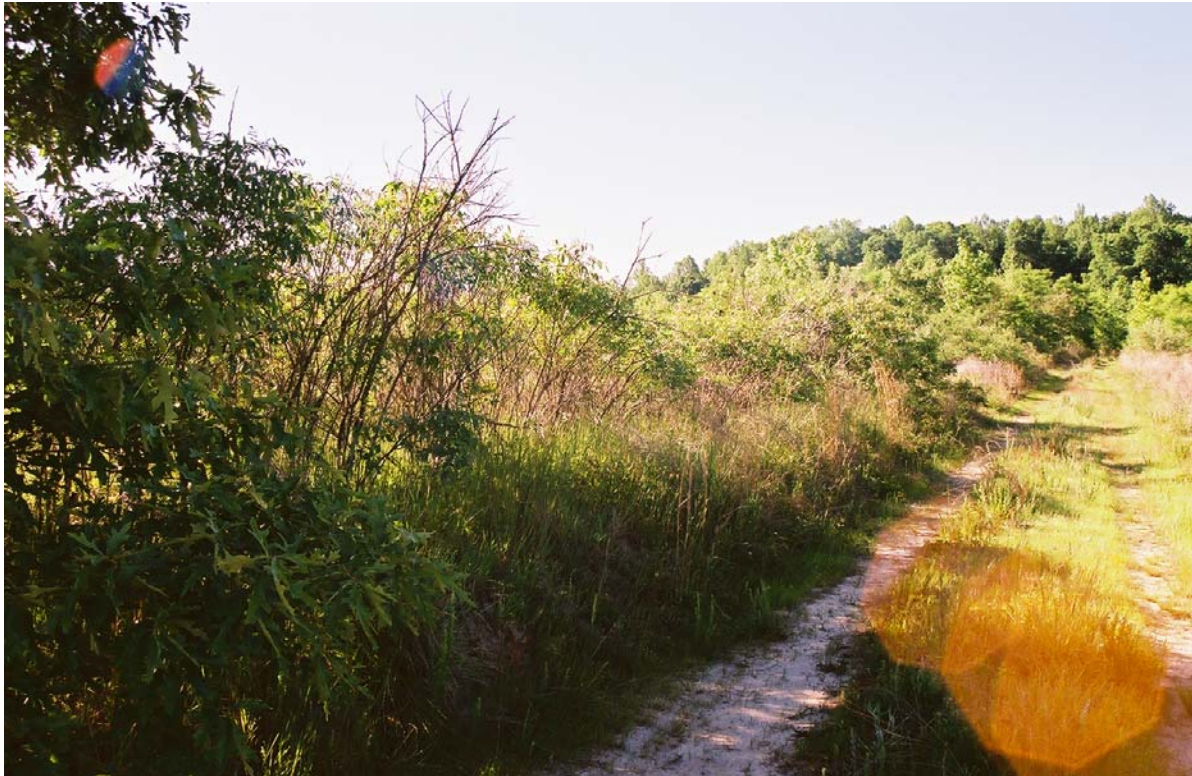
The final vegetation category in which the shredder was operated consisted of a mix of dense brush with trees ranging in diameter from 10 – 25 centimeters and up to 10 meters high. Figure 9 shows the test area before the shredding took place. Most of the dense tree growth in the figure is near the far end of the test area.

Figure 9 Category 4 Vegetation Before Shredding

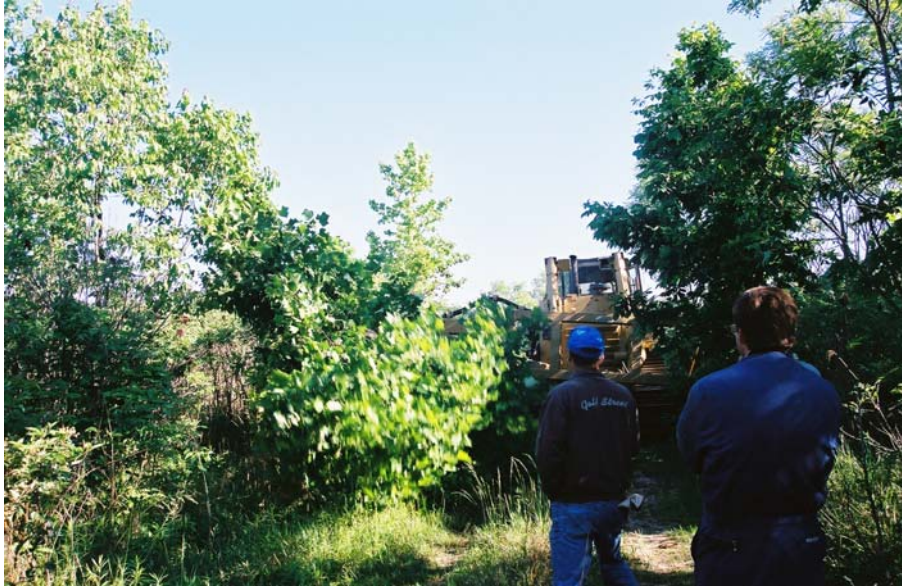
Trees up to 12 centimeters in diameter could be mowed down with the shredder in pretty much continuous fashion. Trees in range of 12-20 centimeters could be efficiently felled by raising the shredder high and pushing the tree over and then bringing the shredder down on top of the bent stalk (see figure 10).

Figure 10 Bringing Down 10 m Tree

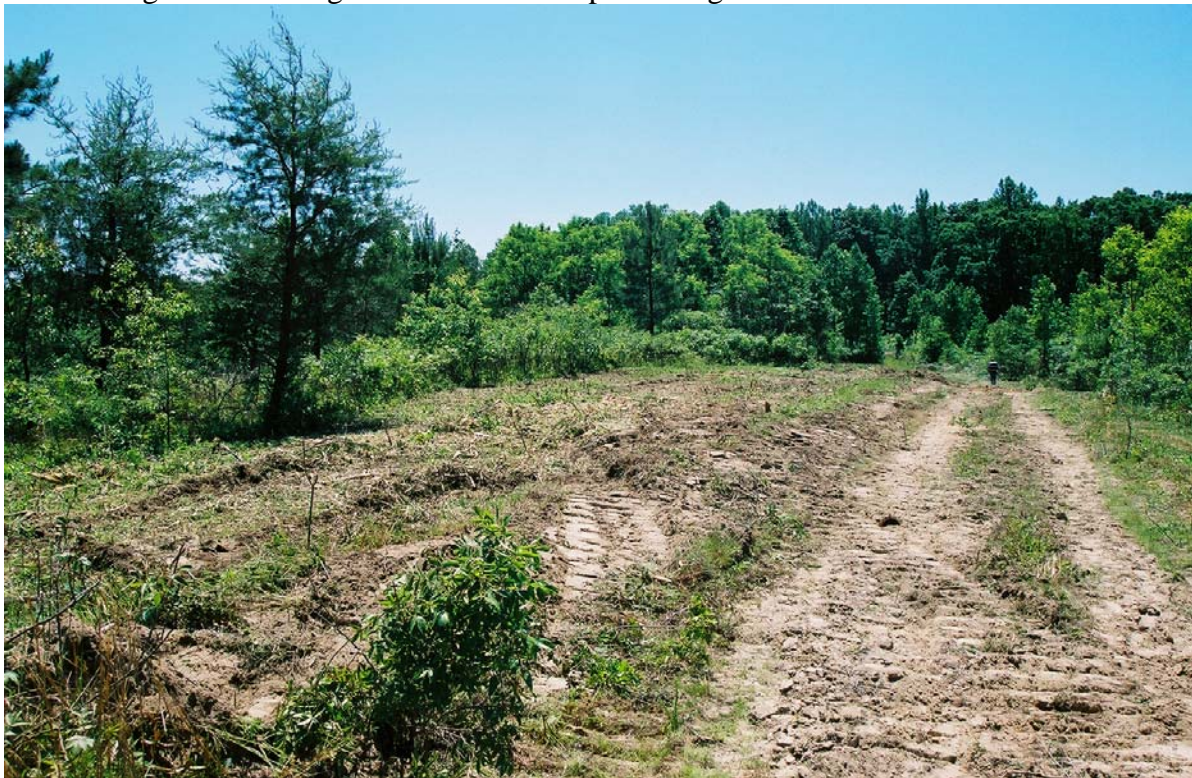
Trees in the range of 20-25 centimeters could also be brought down, but the strain on the system was heavy and large residue is likely. After two hours of operation in this category 3 and 4 vegetation, the shredder knives were examined. Two were heavily bent but still in place and contributing to the shredding action. All knives showed evidence of minimal wear. At one point in the testing a barbed wire coil became tangled in the shredder. The after action photo is shown in figure 11. Half way down the cleared land on the left is a protrusion of uncleared bush surrounding the remaining barbed wire fence protruding into the now cleared area.

Figure 11 Category 4 After Shredder

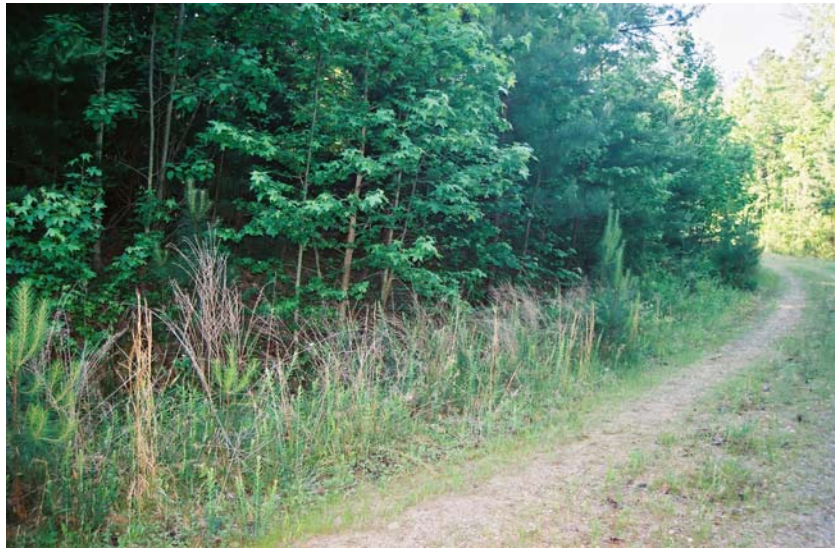
Two final areas were cut in which a significant discontinuity in the elevation and slope of the terrain was present between the path of travel of the tractor and the path of the cutter. The first area was an uphill embankment along a roadway approximately 70 meters in length. The strip contained mainly category 2 vegetation consisting of weeds and saplings up to 10 centimeters in diameter. The highest point reached on the embankment was 1.4 meters above the road surface on which the tractor traveled. The slope of the embankment relative to the road surface varied between 25 and 32 degrees. The before and after photographs of the area are shown in figures 12 and 13.

Figure 12 Uphill Embankment

In all 342 sq. meters were cleared along this embankment. The only problem encountered was a bottoming out of the cutter in the soil as the operator tried to reach the highest points from the roadway. This did stall the cutter drum, but resulted in no damage to the machine. The time spent clearing the strip was 40 minutes, giving a clearance rate on the uphill, category 2 vegetation of .13 acres/hour.

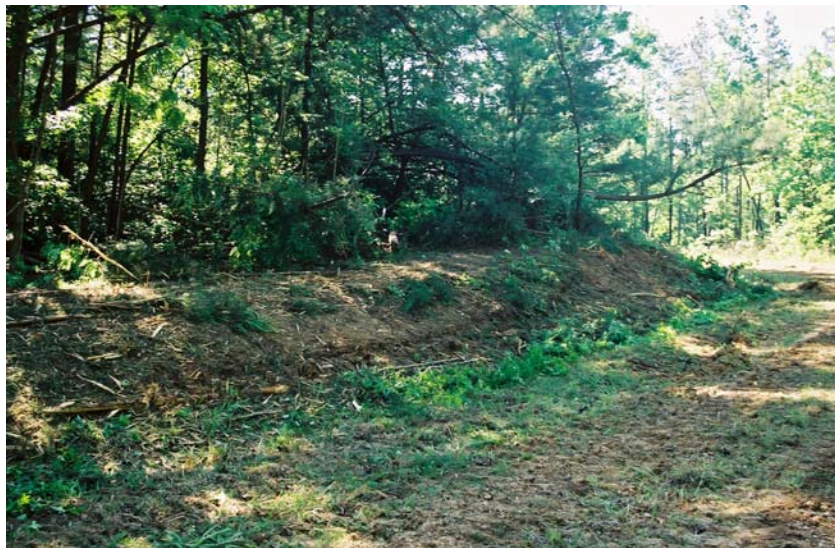
Figure 13 Uphill Embankment, After Shredding

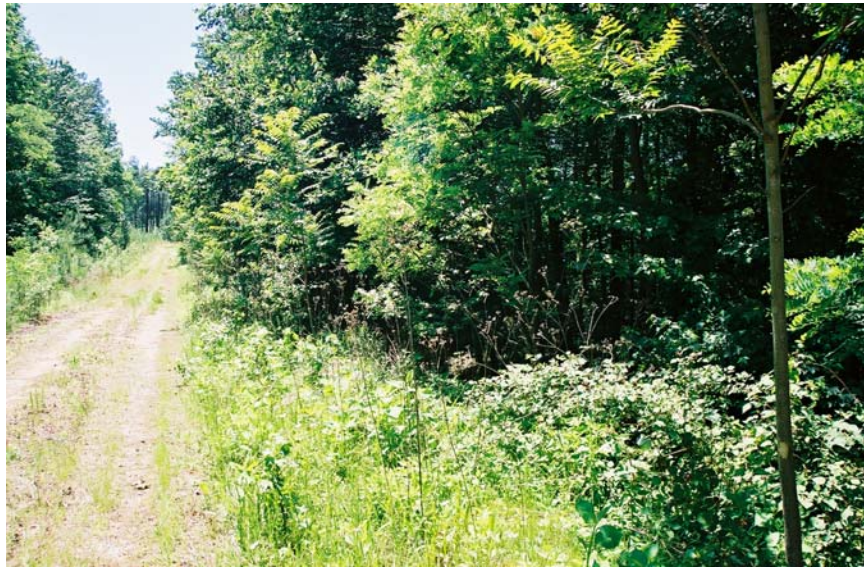
The downhill embankment, like the uphill trial contained weeds and category 2 saplings. The slope and elevation differences were not measured, but are roughly comparable to the uphill

case. The cleared areas were along the sides of a stretch of roadway 230 meters in length. Clearing proved much easier in cutting banks sloping downhill from the side of the tractor than uphill from the side of the tractor. Both sides of the roadway were cleared in 65 minutes with no problems. See figures 14 and 15. The total area cleared was 1542 sq. meters for an effective clearance rate of .38 meters/hour.

Figure 14 Downhill Embankment, Before Shredding

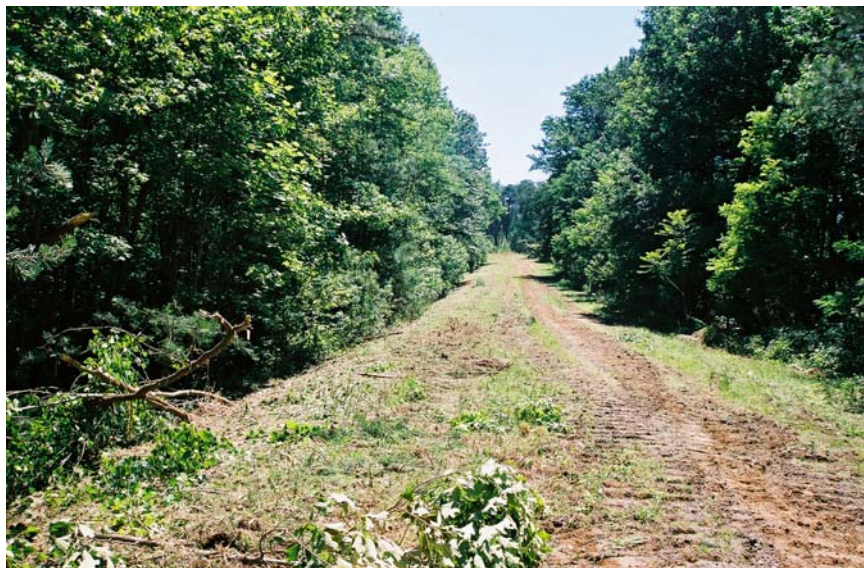
Figure 15 Downhill Embankment, After Shredding

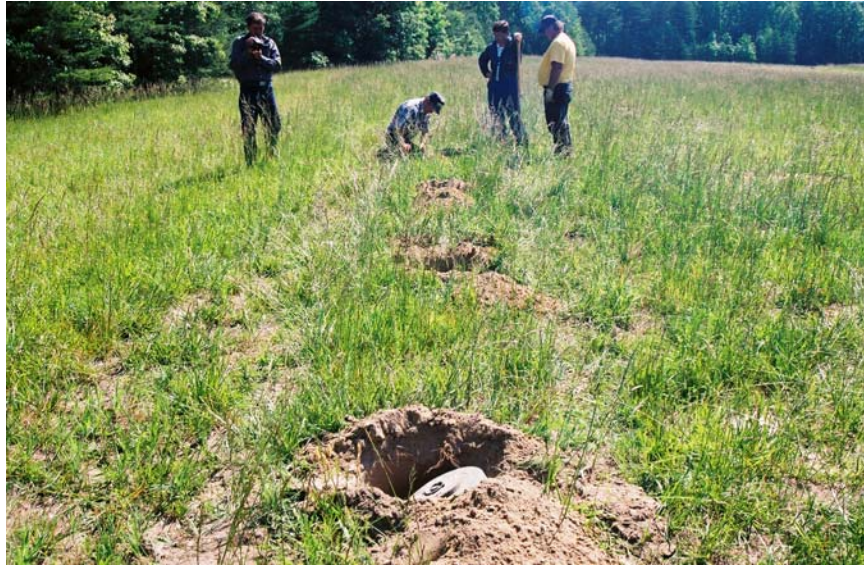
A simple and quick test of the tendency of the shredder to cause unwanted detonations of landmines during operations was performed. Four M15 landmines containing functional smoke generating fuzes were buried under 1 inch of soil cover. The shredder was maneuvered such that the weight bearing skids would pass over each of the mines. The first pass of the tractor was

made with the skids appearing to just make contact with the ground surface. The height of the upper pins on the three point hitch were measure at 68.5 centimeters above the ground, and each subsequent pass was made with the pins 2.5 centimeters lower in order to gradually increase the ground pressure applied to the mines. The first pass caused one of the mines to detonate, and each of the 3 successive passes caused one of the remaining mines to detonate. Clearly the risk to the shredder and vehicle is high if the operator allows the shredder to ride on the skids in areas

Figure 16 Mine Burial for Sensitivity Test

containing antitank landmines since the lightest pressure we were able to apply cause mine detonation. Operators could be trained to avoid making ground contact with the shredder but additional evaluation would need to be performed to assess whether this would be effective in reducing the risk from mines sufficiently in an operational situation.

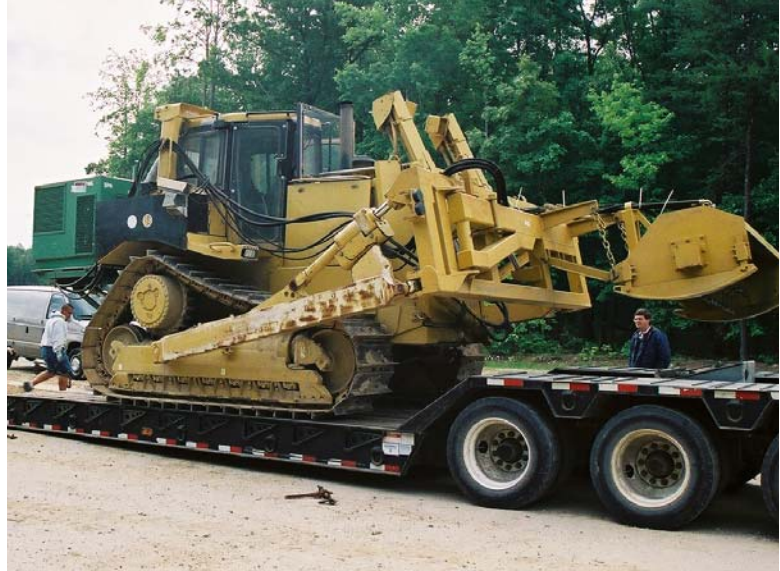
The system (less the tractor) was shipped from Israel to the US by sea vessel, then by commercial truck to the test site. The system and all components were placed on shipping pallets for transportation but could have fit within one 20' ISO Container. The system is transportable by truck, rail, vessel, and C-130 aircraft or other larger aircraft. In its unassembled state, the system and all components other than the tractor can be containerized for shipment. Once on site the system was assembled and installed on the D7R crawler tractor. The installed system was transported between sites at the test range on a flat bed trailer (see figure 17).

Figure 17 Shredder System and Tractor on Trailer

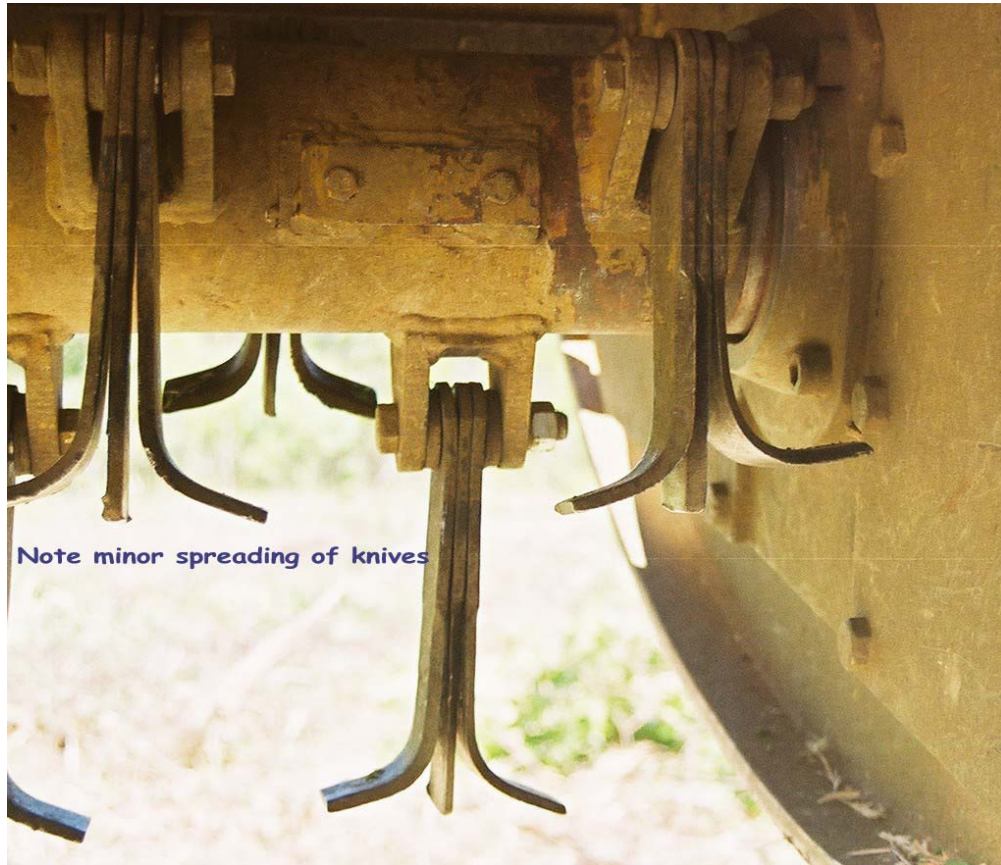
The D7 is supportable worldwide. The shredder and hydraulic portions of the system are constructed of standard components and are supportable. Most items unique to the shredder are field repairable. Daily maintenance on the SDVS required less than 30 minutes to accomplish. During the conduct of the test, two repairs were required on the D7 tractor, 1 repair on the hydraulic power supply, and none on the shredding implement and mainframe. The tractor repairs were unrelated to the SDVS system. The hydraulic power supply hydraulic thermostat did fail and was bypassed for the duration of the test. The only operational problem occurred when the shredding implement encountered and tangled a wire fence. Approximately 45 minutes and heavy wire cutters were required to unwrap the cutting drum. Wear from category 1, 2, and 3 vegetation is expected to be slow and knives may be expected to last hundreds of hours. Wear in the areas containing thick hard wooded trees was heavy and knives may need replacement every 1 or 2 days. Minor spreading and bending of some of the knives required them to be

replaced at the test conclusion, see figure 18. The manufacturer provided an Operation and Maintenance Manual which is comprehensive and well written.

Figure 18 Knives Wear at Test Conclusion
