# A Nondestructive Inspection System for the Inspection of Wear Surfaces in Tank Track Shoes

Valery F. Godínez-Azcuaga, Richard D. Finlayson  
Physical Acoustics Corporation

Basavaraju B. Raju  
U.S. Army Tank and Armaments Command

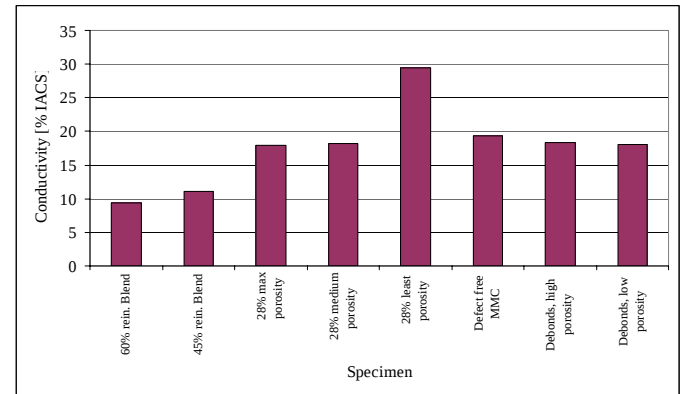
Point measurements were performed of the eight controlled-defect MMC specimens, and the results indicate the EC sensitivity to property variations as reinforcement and porosity content. Figure 1 shows the average conductivity of the specimens taken over 9 measurements on each specimen. Table 2 summarizes the results of the point EC measurements, and shows average conductivity and standard deviation, both in % IACS.

Figure 1. Conductivity measurements (point by point) on control defect specimens.

The results shown in Figure 1 and Table 2 indicate that increasing the porosity decreases the average conductivity. The porosity changes from 29.45% IACS for the specimen with lowest porosity (specimen 5) to 17.92% IACS for the specimen with highest porosity (specimen 3). The medium porosity specimen (number 4) has a conductivity of 18.3% IACS.

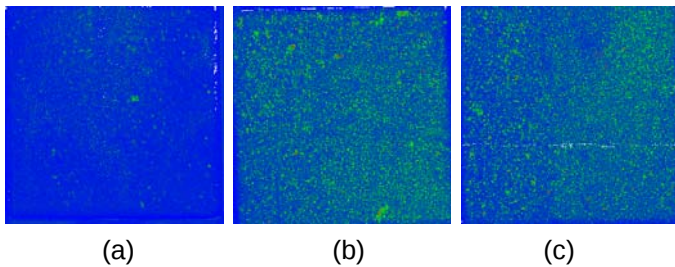
Figure 2 shows C-Scan images of specimen number 5 with minimum porosity, specimen number 4 with medium porosity, and sample 3 with high porosity. The images shown represent data taken from the region between the front and back walls of the samples, and so represent the distribution of porosity in the specimen. As can be seen in Figure 2(a) (specimen # 5) there are no prominent defects seen (shades of color other than blue, especially green and red) in the specimen with low porosity. This indicates that there were no features in the interior of the specimen that gave reflections between the front and back wall, which is expected from low porosity in the volume of the specimen.

Figure 2. Ultrasonic C-scan images of controlled-defect specimens bulk reflections: (a) Specimen 5 (low porosity), (b) Specimen 4 (medium porosity), (c) Specimen 3 (high porosity).

As can be seen from Figure 2(b) (specimen #4), there is a rather uniform distribution of damage throughout the specimen with medium porosity. It is important to note that the damage here is representative of the entire volume of the insert, and the different damage spots correspond to varying depths. There is a clear distinction from Figure 2(a) (specimen # 5), which produced a very clean image.

Figure 2(c) (specimen #3) shows an ultrasonic C-scan image of the specimen with the maximum amount of porosity. Again, there is a relatively large amount of damage visible in this picture. As mentioned before, it is important to keep in mind that this damage is representative of the entire volume of the specimen.

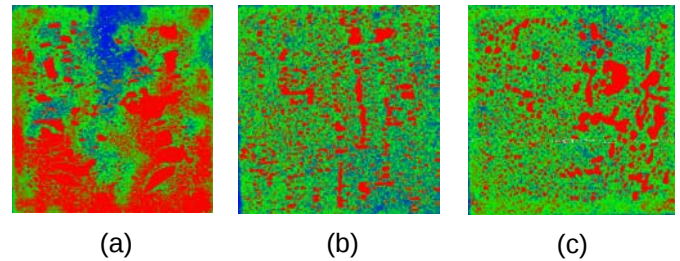
Figure 3 shows the images obtained by mapping the amplitude of the back wall echo from specimens 5, 4 and 3.

Figure 3. Ultrasonic C-scan images of controlled-defect specimens back-wall reflection: (a) Specimen 5 (low porosity), (b) Specimen 4 (medium porosity), (c) Specimen 3 (high porosity).

The red areas are the regions where the system detects a large reflection from the interface between the MMC and the aluminum substrate, indicating that there exists a region of high acoustic impedance mismatch, or in other words, debonds. Under good bonding conditions, the MMC-AI interface produces a relatively small reflection since the acoustic impedances of MMC and AI have very similar values. On the other hand, the presence of air in this interface results in a larger reflection. As can be seen, all three specimens have some debonds in the interface region, and specimen 5 in particular displays a large number of debonds. Again, specimen 5 showed the largest conductivity measurement (29% IACS), indicating the insensitivity of eddy current measurements to debonds.

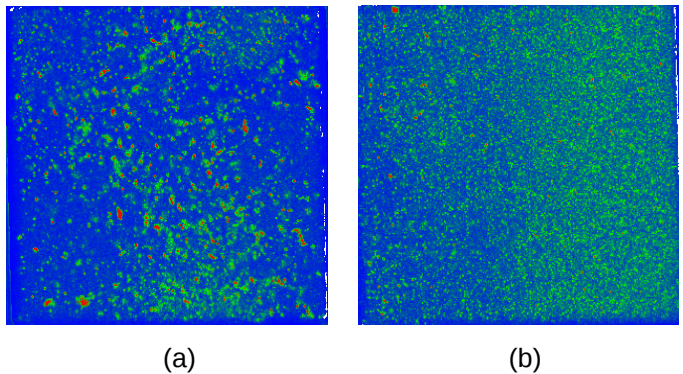
Figure 4 shows the ultrasonic C-scan images taken of specimens 7 and 8, the specimens with debonds, but containing different amounts of porosity. These images are from the interior of the specimen, and thus represent porosity damage. As can be seen from the images, the two specimens contain essentially the same amount of porosity, and there is little distinction between the 'high porosity' and 'low porosity' specimens. The main difference is that the high porosity specimen has larger spots of porous regions, distributed over a smaller area, whereas the low porosity specimen has smaller spots of

Figure 4. C-scan images of specimens with debonds, bulk reflections: (a) Specimen 7 with high porosity, (b) Specimen 8 with low porosity.

porosity, but distributed over the right hand side volume of the specimen. This almost identical amount of porosity indicated by the ultrasonic measurements explains why the EC measurements gave almost identical conductivity values for the two specimens, further corroborating those results. As in the case of specimens 3 and 4, a quantitative analysis of the UT C-scan images is necessary to establish a precise correlation with the EC measurements.

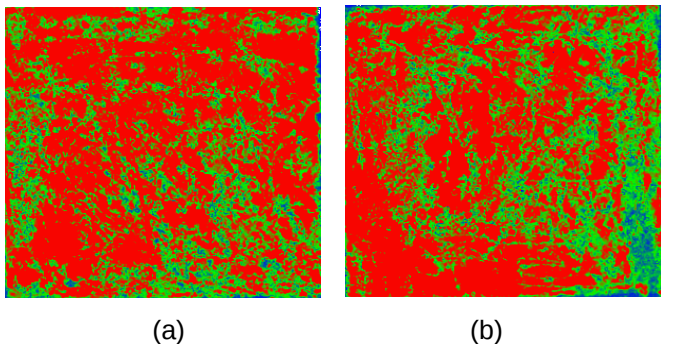
Figure 5 shows the ultrasonic C-scan images taken of the back wall echo of the MMC, showing the presence of

Figure 5. C-scan images of specimens with debonds, back wall reflection: (a) Specimen 7 with high porosity, (b) Specimen 8 with low porosity.

numerous debonds. There is clearly much more damage in this interface region compared to specimens 3, 4 and 5. Again, The presence of debonds does not affect the eddy current measurement, as eddy currents are inherently insensitive to their presence.

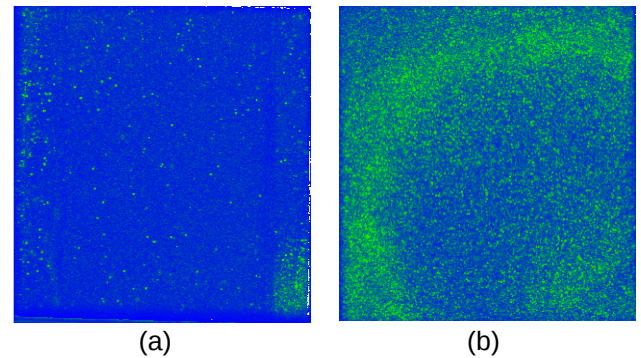
Specimens 1 and 2 were engineered to contain a higher percentage of reinforcement in the MMC insert. Figure 6 shows the ultrasonic images taken of the interior of the specimens. As can be seen from these images, specimen 2 has a high degree of porosity in the interior, whereas specimen 1 is relatively porosity free.

Figure 6. Ultrasonic C-scan of interior of specimens with different reinforcement volume fraction: (a) Specimen 1, with 60% reinforcement, (b) Specimen 2, with 45% reinforcement.

6, and there was some doubt as to the actual origin of this drop in conductivity. This can now be resolved by analyzing the results of the ultrasonic scans. The higher degree of porosity in specimen 2, coupled with a higher degree of reinforcement most likely gave the low value of conductivity in the eddy current measurement. Specimen 1, on the other hand, contains very little porosity, and the low conductivity value obtained arises solely due to the increased reinforcement content. Thus, the tandem inspection technique utilizing both EC and UT makes a comprehensive analysis of the specimen possible. A low value of conductivity measured with EC need not necessarily indicate porosity induced damage, but could mean a different reinforcement concentration and distribution. This can be verified by performing an ultrasonic C-scan, and correlating the damage found with the two techniques.
