| 4. TITLE AND SUBTITLE<br>Collaborative University Research on Corrosion OSD Education Initiative | | | | | 5a. CONTRACT NUMBER<br>W9132T-09-2-0020 | |

## **CORROSION PILOT PROGRAM**

### **Collaborative University Research on Corrosion OSD Education Initiative**

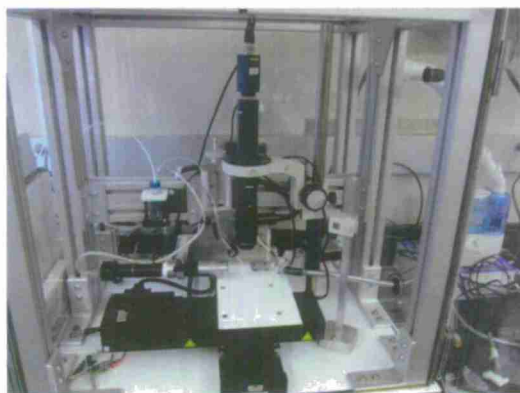
Figure 11. (a) Photograph of ink jet system, including programmable xy-stage and cabinet for controlled humidity.

In order to quantitatively assess the role of salt loading density, salt type, and RH on the atmospheric corrosion of steel, it is important to be able to closely control the environment on the metal surface. To accomplish this objective, an ink jet printer (JetLab) was modified in order to provide computer control of the salt pattern as shown in Figure 11. The system is able to produce drops as small as  $35\text{ }\mu\text{m}$  in diameter (representing a volume of 3 pL) with spacing as close as  $< 10\text{ }\mu\text{m}$ , if desired. With the computer-controlled stage, substrates as large as  $230 \times 280 \times 250\text{ mm}$  thick can be printed upon. A custom-made chamber allows the humidity in the chamber to be controlled between  $<1$  to 100 % RH through an external water vapor source. Different salt solutions were deposited and tested for wetting/drying behavior: NaCl,  $\text{NaNO}_3$ , NaCl +  $\text{NaNO}_3$ ,  $\text{MgCl}_2$ , and  $\text{MgSO}_4$ .

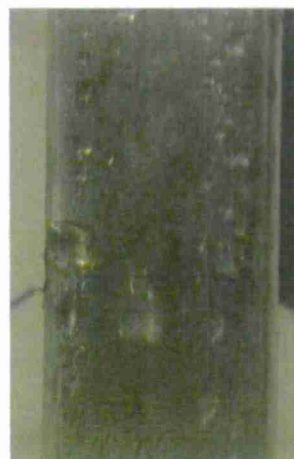
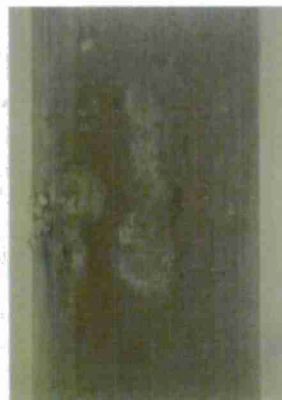
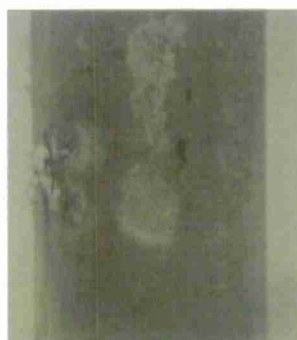
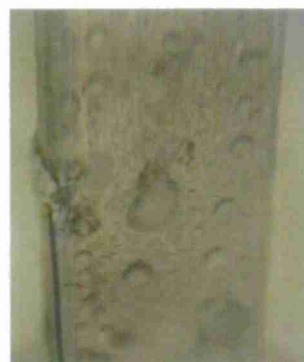
no applied current  
T = 24.6°C

8A  
T = 31.5°C

6A  
T = 29.4°C

5A  
T = 27.6°C

Figure 46. Photographs of salt deposited surfaces of SEN specimens with different applied DCPD currents. The temperature of the specimen at which the picture was taken and applied current are listed under each image.

Constant  $\Delta K$  - varying  $f$  experiments with pure NaCl-coated SEN specimens show that atmospheric conditions producing heterogeneous and homogenous NaCl droplets on a C47A-T86 surface promote EFCP and hinder alloy-induced inhibition at low  $f$ , but do not drastically increase (or decrease) high- $f$  EFCP rates where alloy-induced inhibition does not occur. For loading at 30 Hz, Figure 48 shows that  $da/dN$  values are essentially equal for all environments including: full immersion in pure NaCl ( $\bullet$ ) and NaCl +  $\text{Na}_2\text{MoO}_4$  ( $\circ$ ), atmospheric exposure with pure NaCl ( $\Delta$  &  $\blacktriangle$ ), and salt-free high humidity air ( $x$ ). In contrast loading at 0.2 Hz, where alloy-induced inhibition is established for C47A-T86<sup>32, 47</sup>,  $da/dN$  is accelerated by the presence of NaCl droplets as compared to full immersion in pure chloride solution, but does not exceed  $da/dN$  measured for a salt free surface stressed in high humidity air ( $x$ ). Notably, the EFCP response is similar for the heterogeneous and homogeneous NaCl droplets produced by atmospheric deliquescence, at each loading frequency examined.

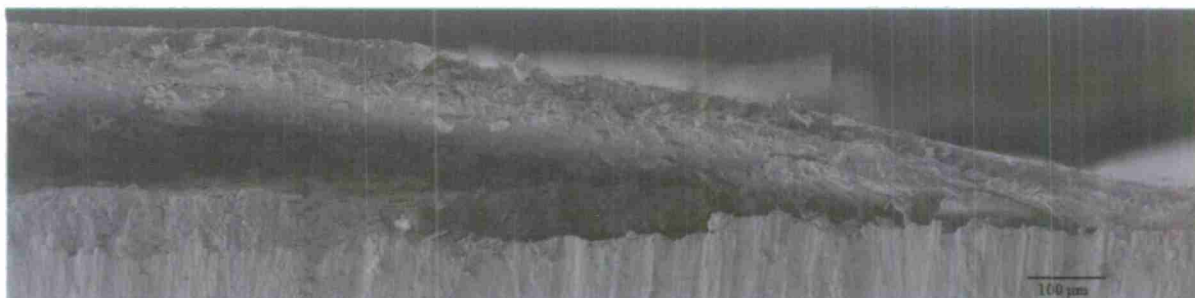
Figure 60. Montage of SEM cross-sections of blisters on AA2024-T351 coated with Akzo Nobel MgRP (PVC = 0%) and Aerodur 5000 Topcoat after environmental exposure at Dayton Beach, FL for 1 yr. Sample ID: unknown

Blistered areas along the scribes from each sample visible in Figure 59 were cross sectioned and examined in a field emission SEM with EDS capabilities (Figure 60 and Figure 61). EDS area scans were taken in three areas of each cross sectioned blister: 1) the substrate, 2) the corrosion product, and 3) the coating system and are indicated by the numbered boxes (1-3) in each micrograph in Figure 61. Figure 61d summarizes the results of the EDS measurements. There were striking similarities found between the blisters sectioned on each sample. They could be characterized by large areas of organic coating delamination over top of thick, relatively uniform layers of fractured corrosion product associated with shallow penetration. It was found that the corrosion product layer in each blister was located underneath both the primer and topcoat layers of the coating system, was approximately 50-80  $\mu\text{m}$  thick, and was relatively uniform. Each corrosion product layer appeared to follow the Al substrate morphology perfectly, suggesting that they grew from the substrate and that they have a Pilling-Bedworth ratio of approximately 1<sup>49</sup>. Furthermore, EDS analysis showed that the corrosion product layer in each blister consisted solely of Al and O. EDS analysis of the coating systems over top of each blister were also very similar, each exhibiting strong C, O, Al, Cl and Si peaks. Elemental Mg only appeared in the EDS area scans of the coating system which contained Mg pigment in the primer.

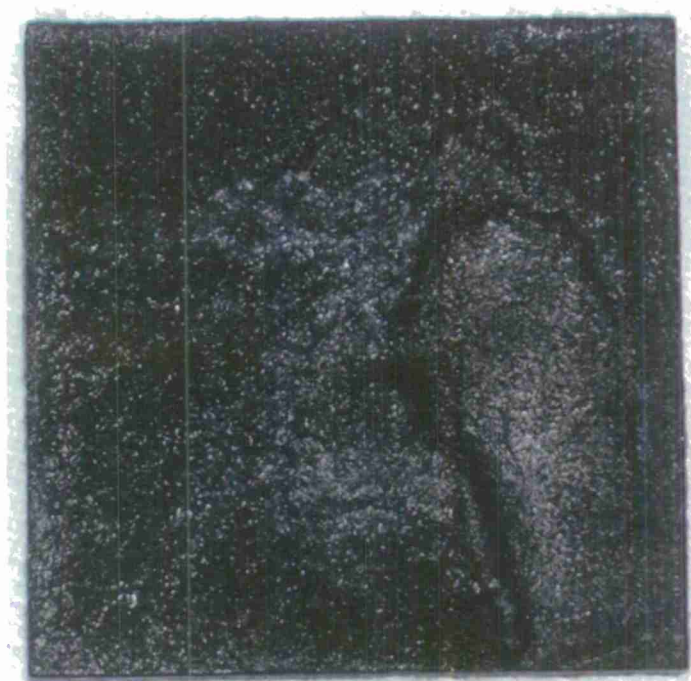
Figure 64. Optical images of AA2024-T351 after 1 week immersion in 50 mM NaCl with ambient aeration and Mg shavings.

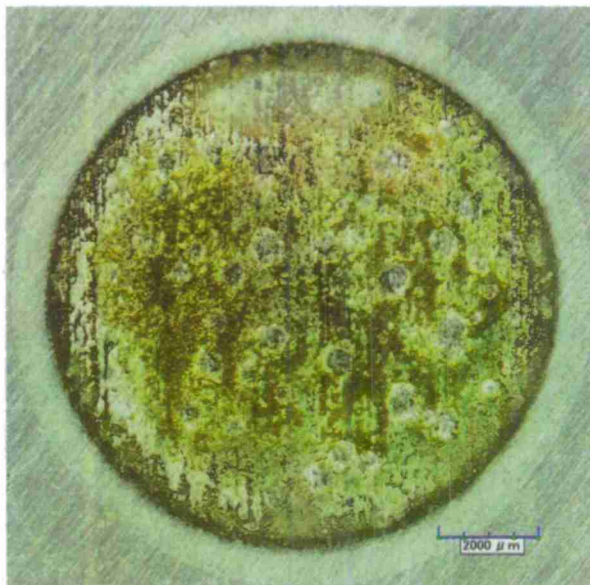
Figure 66. Optical images of AA2024-T351 after (a) 1 hour potentiostatic hold at  $-1.5\text{ V vs. SCE}$  in  $50\text{ mM NaCl}$  with ambient aeration. (b) 1 hour galvanic couple with Mg in  $50\text{ mM NaCl}$  solution with ambient aeration

To investigate whether cathodic corrosion of AA2024-T351 is possible at potentials relevant to the Mg/Al galvanic couple system, a sample of bare AA2024-T351 polished to 1200 grit paper was potentiostatically held at -1.5 V vs. SCE for 1 hour in full immersion in 300 mL of aerated 50 mM NaCl. After exposure the sample showed significant corrosion (Figure 66a). Similarly a sample of bare AA2024-T351 was galvanically coupled to bare Mg in 300 mL of aerated 50 mM NaCl for 1 hour. The galvanic couple potential was measured to be fairly stable at -1.5 V vs SCE for the entirety of the test. This sample also showed significant AA2024-T351 corrosion after the exposure (Figure 66b).

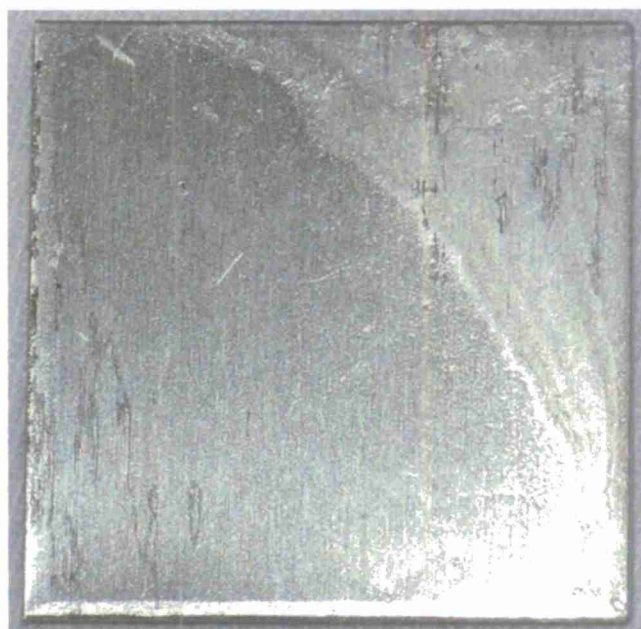
Figure 74. Optical images of AA2024-T351 after 1 week immersion in 50 mM NaCl with Mg shavings and bubbled CO<sub>2</sub>.

evidenced by cathodic polarization and galvanic couple experiments reported earlier (Figure 74, Figure 75, Figure 76).

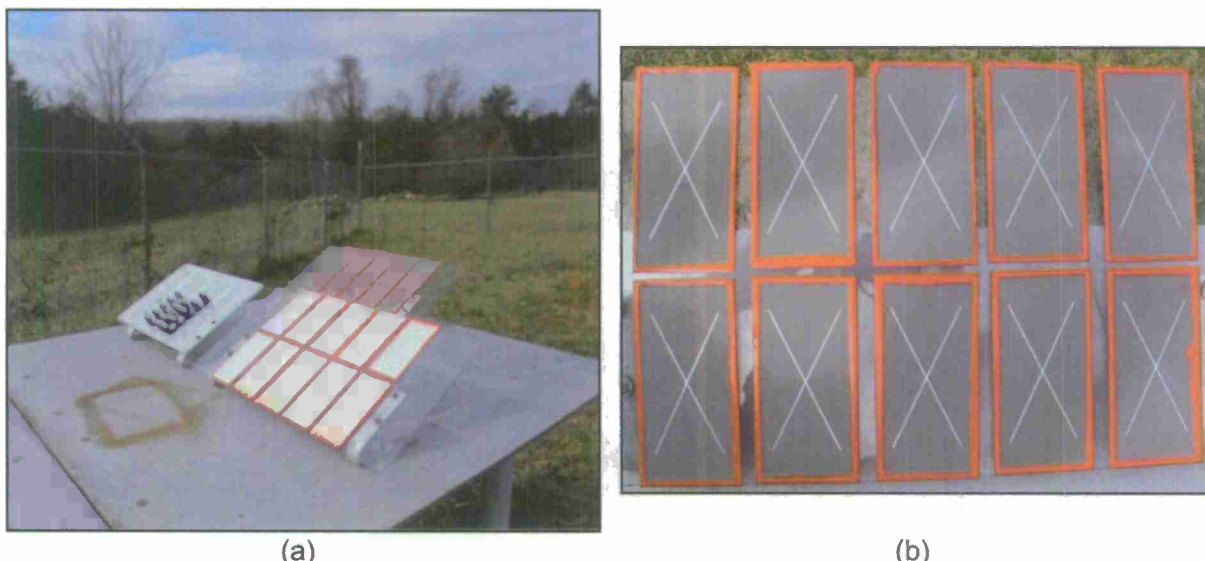
(a) (b)  
Figure 90. Picture of (a) test rack and (b) MgRP-coated AA2024-T351 samples on exposure at Birdwood GC in Charlottesville, VA at  $t = 0$  hrs. (38.0402°N, 78.54.27°W, elevation = 172 m)

Natural weathering exposures of Mg-rich primer-coated AA2024-T351 panels were conducted at Birdwood Golf Course in Charlottesville, VA (38.0402°N, 78.54.27°W, elevation = 172 m) which is an atmospheric exposure site maintained by the UVA Department of Environmental Sciences. This is an inland, rural atmospheric testing site located in Central Virginia's Albemarle County. During exposure, panels were mounted on atmospheric test racks (shown in Figure 90) with full exposure to natural elements according to ASTM G4 and G50.<sup>61, 62</sup> Panels were removed at a front-weighted removal schedule for imaging, XRD analysis, electrochemical interrogation and post-mortem characterization initially in two week intervals and, after 2 weeks of exposure, in 4 week intervals. Pertinent environmental parameters for Birdwood Golf Course in Charlottesville, VA such as mean temperature, mean relative humidity, mean dew point, mean precipitation rate, precipitation pH and chloride deposition rate are shown in Table 7.

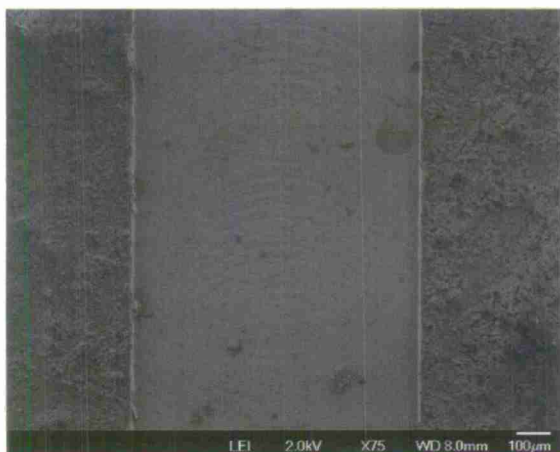
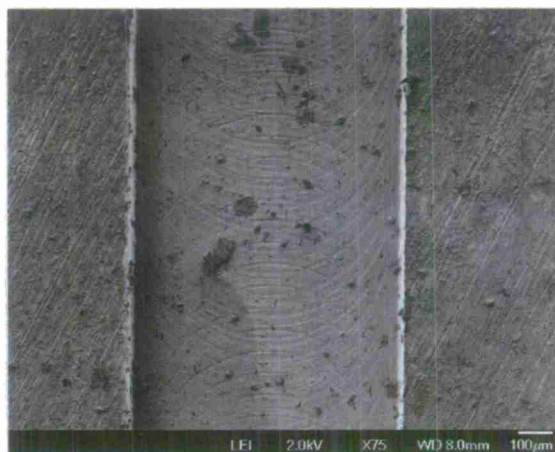
Figure 109. Scanning electron micrograph of AA2024-T351 pretreated with Prekote and coated with MgRP (initial MgPVC = 45%) after environmental exposure in the field at Charlottesville, VA for (a) 12 weeks and (b) 24 weeks.

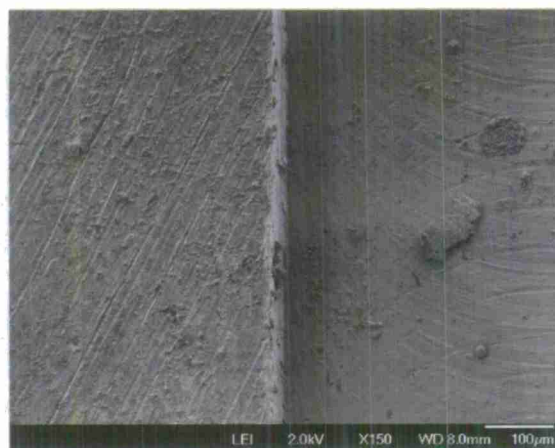
Figure 110. Scanning electron micrograph of AA2024-T351 pretreated with Prekote and coated with MgRP (initial MgPVC = 45%) after environmental exposure in the field at Charlottesville, VA for (a) 12 weeks and (b) 24 weeks.

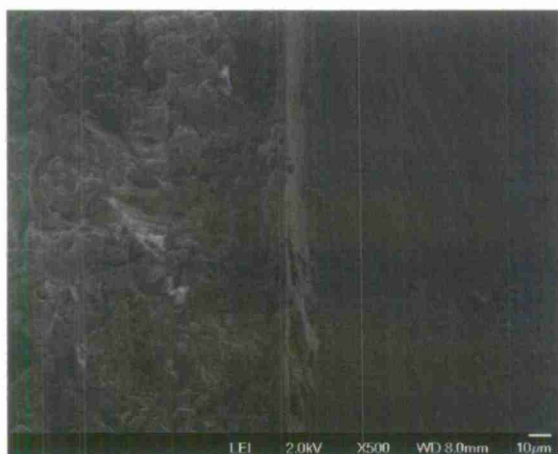
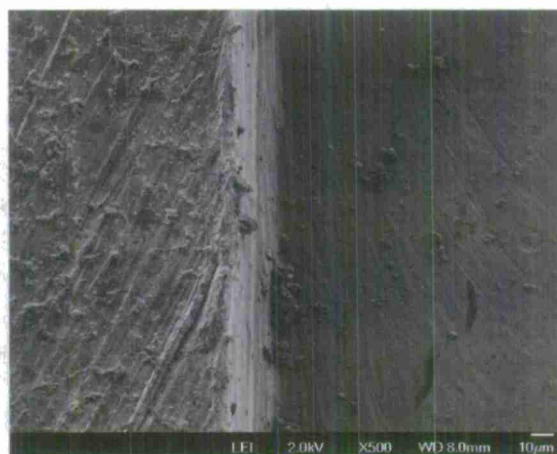
Figure 111. Higher magnification scanning electron micrograph (planar view) of scribed AA2024-T351 pretreated with Prekote and coated with MgRP (initial MgPVC = 45%) after field exposure at Charlottesville, VA for (a) 12 weeks and (b) 24 weeks.

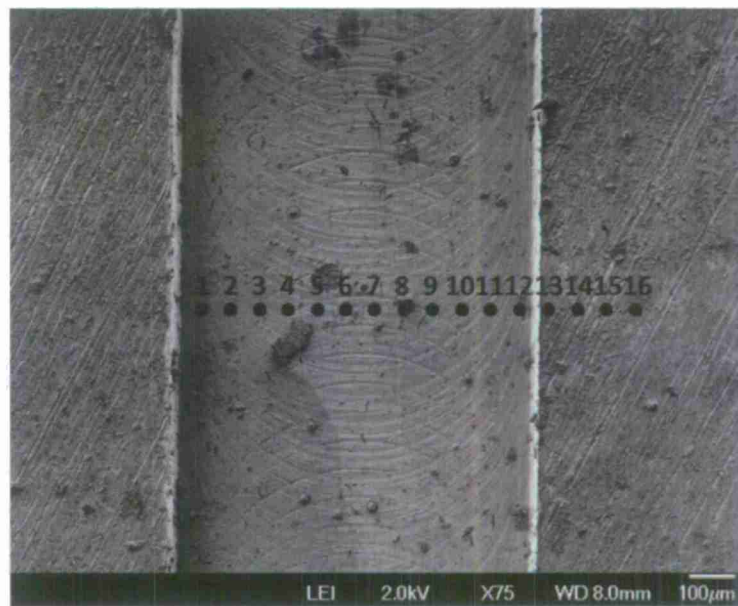
(a)

Figure 112. SEM micrograph (planar view) of scribed AA2024-T351 pretreated with Prekote and coated with MgRP (initial MgPVC = 45%) after field exposure at Charlottesville, VA for 24 weeks. Spot markers indicate approximate location of EDS analysis shown in (b).

Variations in MgRP polymer degradation were also observed between laboratory salt fog and field exposure environments. In the field, the polymer exhibited severe damage and dissolution as evidenced by EDS (Figure 101 and Figure 112) and SEM cross-section (Figure 102 and Figure 113). In the lab, a significant amount of the MgRP polymer was observed to remain after prolonged exposures in ASTM B-117 with 5% NaCl (Figure 122 and Figure 123) and with ASTM artificial sea water (Figure 132 and Figure 133). This variation in performance in the field is presumed to be due to UV degradation. The mean hourly solar radiation at Kennedy Space Center, FL over the dates of exposure is shown in Figure 145 and is known to be a severe site of UV exposure.<sup>60</sup> UV radiation is known to severely degrade epoxy organic polymers that are used in the Mg-rich primer.<sup>18, 20, 21, 40</sup> The degradation process is very common and is referred to "chalking" due to the continuous breakdown of the polymeric backbone and subsequent formation of a chalky mixture of polymer and pigment fragments on the coating's surface. The chalky mixture is then easily removed by wind and precipitation. This chalking behavior was observed on MgRP-coated AA2024-T351 panels exposed in the field at Kennedy Space Center, FL (Figure 96 and Figure 97) and at Birdwood Golf Course in Charlottesville, VA (Figure 107 and Figure 108) but not in laboratory ASTM B-117 exposures where UV exposure is extremely low. Polyurethane organic polymers undergo far less degradation as a result of UV exposure. For this reason Polyurethane polymers with UV absorbing pigments, like the one used in the Aerodur 5000 Topcoat, are primarily used as topcoat polymers.<sup>18, 21</sup> It is recognized that primer only systems may not be deployed in service. However, this is an initial step necessary to understand performance in this system.

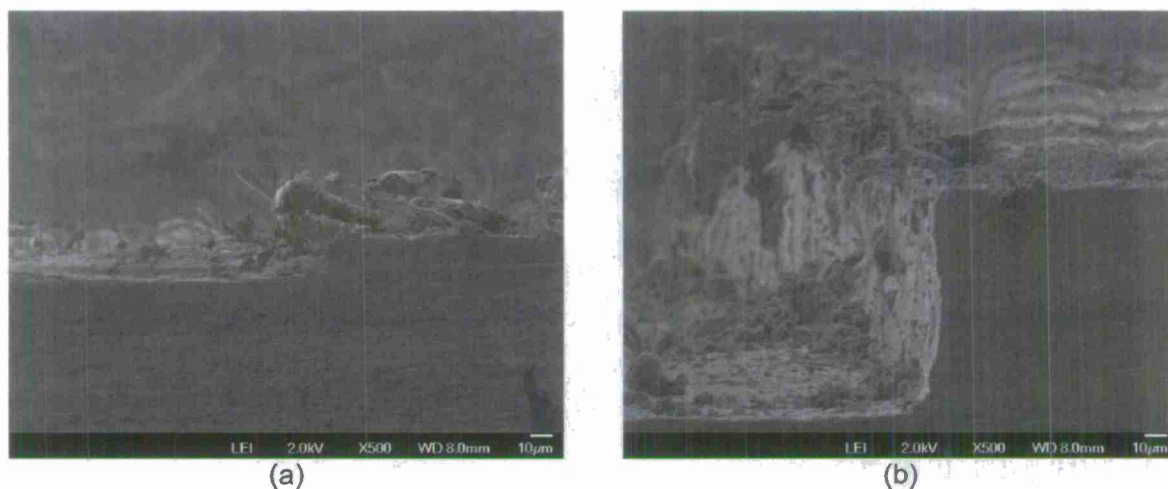
Figure 114. Scanning electron micrograph of cross sectioned AA2024-T351 pretreated with Prekote and coated with MgRP (initial MgPVC = 45%) after environmental exposure in the field at Charlottesville, VA for (a) 12 weeks and (b) 24 weeks.

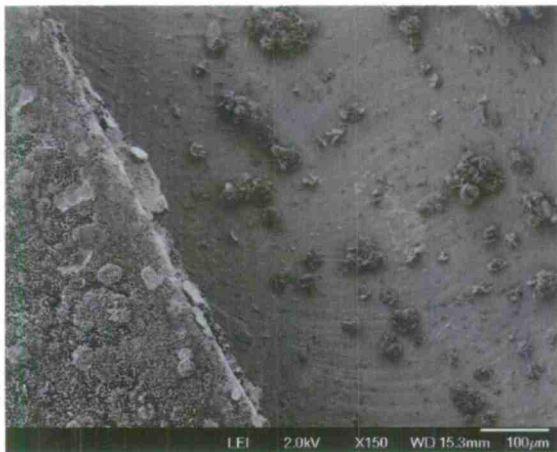
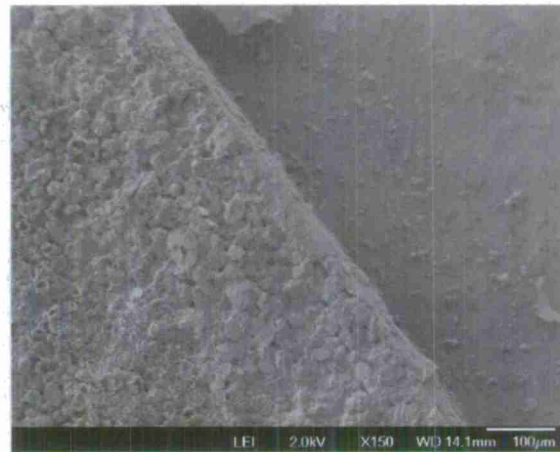
Figure 120. Scanning electron micrograph (planar view) of scribed AA2024-T351 pretreated with Prekote and coated with MgRP (initial MgPVC = 45%) after lab accelerated life testing in ASTM B117 for (a) 384 hrs and (b) 984 hrs.

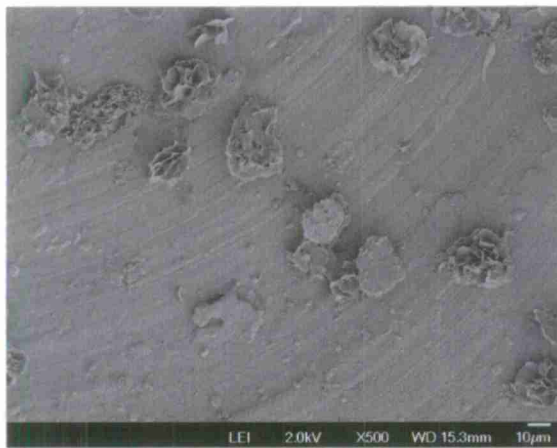
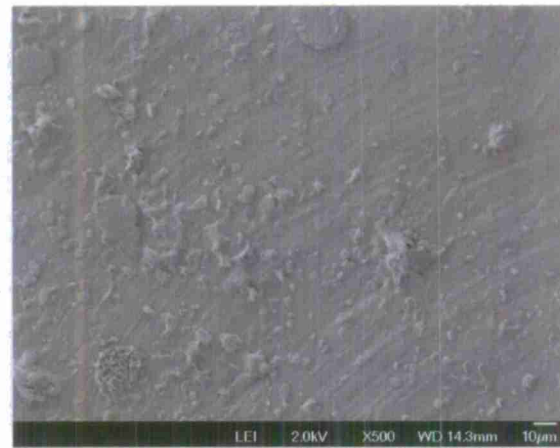
Figure 121. Scanning electron micrograph (planar view) of scribed AA2024-T351 pretreated with Prekote and coated with MgRP (initial MgPVC = 45%) after lab accelerated life testing in ASTM B117 for (a) 384 hrs and (b) 984 hrs.

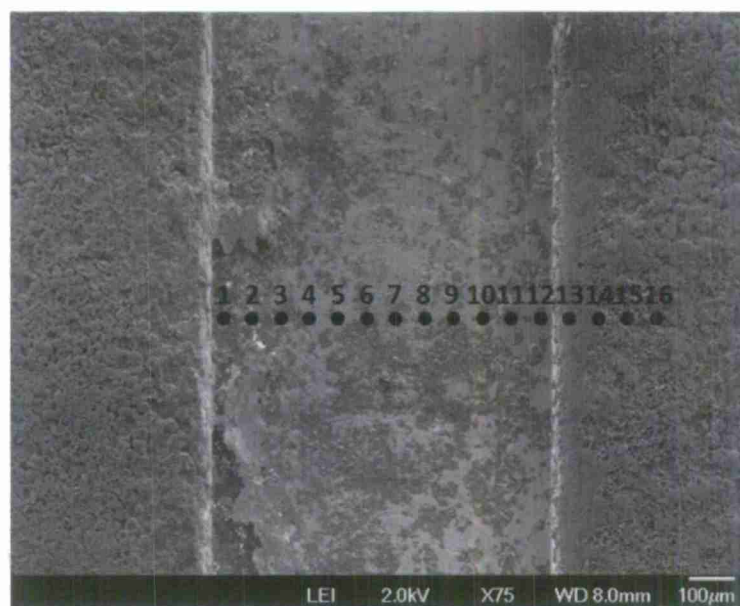
(a)

Figure 122. SEM micrograph (planar view) of scribed AA2024-T351 pretreated with Prekote and coated with MgRP (initial MgPVC = 45%) after lab accelerated life testing in ASTM B117 for 984 hrs. Spot markers indicate approximate location of EDS analysis shown in (b).

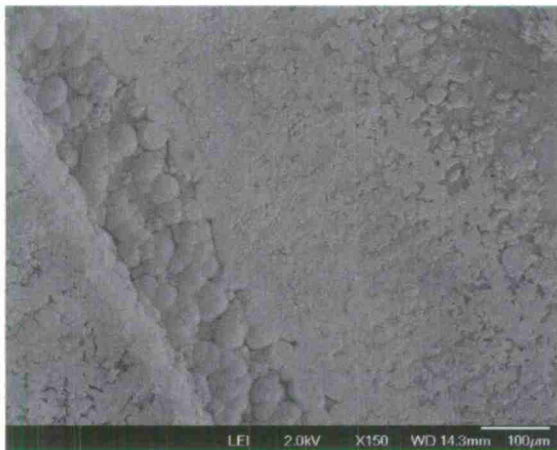
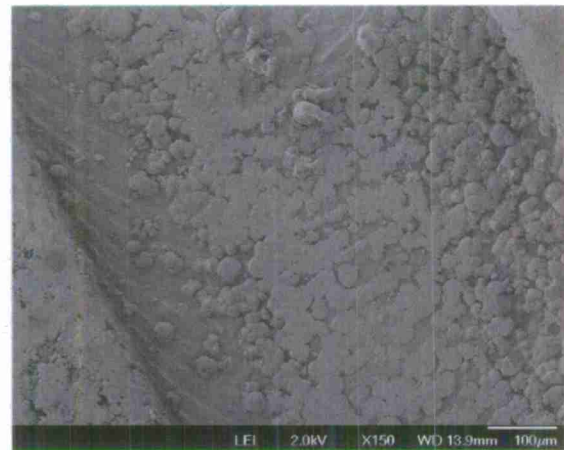
Figure 130. Scanning electron micrograph (planar view) of scribed AA2024-T351 pretreated with Prekote and coated with MgRP (initial MgPVC = 45%) after lab accelerated life testing in ASTM B117 modified with artificial sea water for (a) 408 hrs and (b) 1000 hrs.

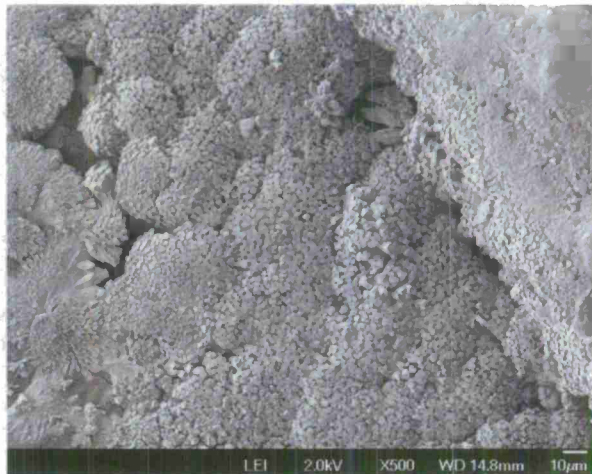
Figure 131. Higher magnification scanning electron micrograph (planar view) of scribed AA2024-T351 pretreated with Prekote and coated with MgRP (initial MgPVC = 45%) after lab accelerated life testing in ASTM B117 modified with artificial sea water for (a) 408 hrs and (b) 1000 hrs.

Optical micrographs of MgRP coated AA2024-T351 panels that have been exposed in ASTM B-117 modified with ASTM artificial sea water solution for 0, 408, and 1000 hours are shown in Figure 127 and Figure 128. In general, with increased exposure time, the coating developed a dense, ivory colored film covering the whole sample. The film is presumably due to the conversion of Mg to a corrosion product or the deposition of a salt present in the ASTM artificial sea water which has limited solubility in solutions of  $\text{pH} \geq 8$ . After 1000 hours of exposure in the ASTM B-117 environment modified with ASTM artificial sea water the scribe appears, at low magnification, to be full of corrosion product or deposit. It is important to note that no blistering or similar macroscopic coating failure phenomena are observed in the MgRP or along the scribe lines after exposure for 1000 hours in the ASTM B-117 environment modified with ASTM artificial sea. Upon closer investigation with the SEM (Figure 129, Figure 130, and Figure 131), after 408 hours of exposure the scribe and MgRP-coated region appear to be very rough in texture and covered in spherical groupings of needle-like precipitates. The precipitates can be easily seen in Figure 131.

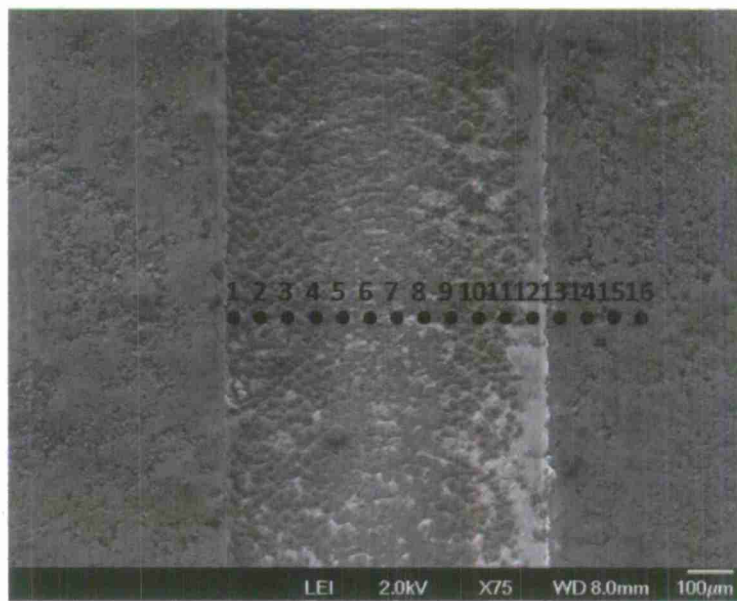
(a)

Figure 132. SEM micrograph (planar view) of scribed AA2024-T351 pretreated with Prekote and coated with MgRP (initial MgPVC = 45%) after after lab accelerated life testing in ASTM B117 modified with artificial sea water for 1000 hrs. Spot markers indicate approximate location of EDS analysis shown in (b).

To further investigate the composition of the deposits on the coating and in the scribe 16 consecutive EDS spot scans were obtained across the width of the scribe and coating interface (labeled 1-16 in Figure 132). The spacing between scans was approximately 65  $\mu\text{m}$ . Two basic EDS spectra, one consisting solely of Ca, and a second consisting of both Mg and Al, were observed across the scribe and coating interface. The EDS spot scans throughout almost the entire width of the scribe (positions labeled 1 – 11) as well as over the MgRP coating (positions labeled 14, 15, and 16) solely show significant amounts of Ca species present. Calcareous deposits primarily consist of  $\text{CaCO}_3$  and are indicative of regions of cathodic protection afforded to the AA2024-T351 by the MgRP.<sup>71-78</sup> The deposition of Ca species throughout most of the

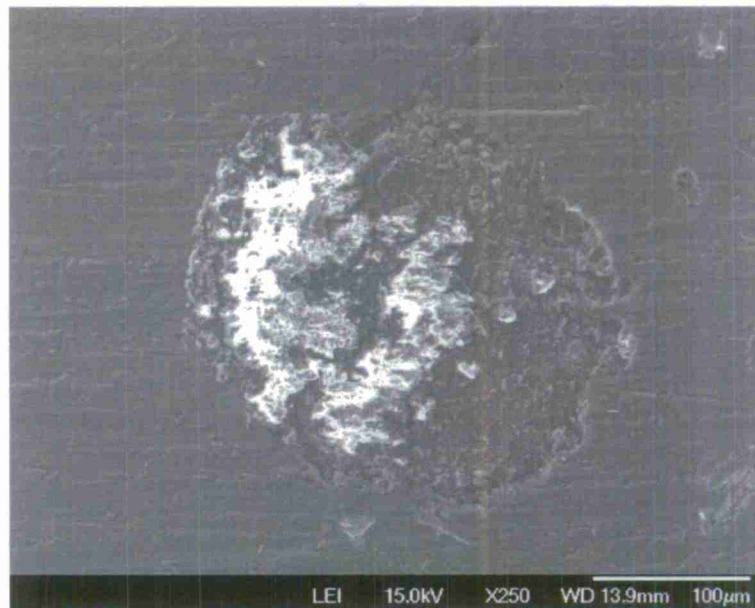
Figure 174. SEM image of pit that is filled with oxide. Sample exposed in CC+O<sub>3</sub> (10-25 ppm) for 5 days. Sample was rinsed with DI water before imaging.
