SIGAR Inspection 13-5

## IMAM SAHIB BORDER POLICE COMPANY HEADQUARTERS IN KUNDUZ PROVINCE: \$7.3 MILLION FACILITY SITS LARGELY UNUSED

JANUARY  
2013

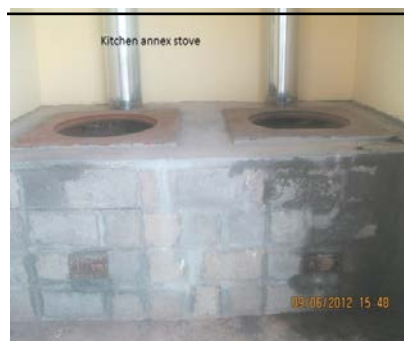
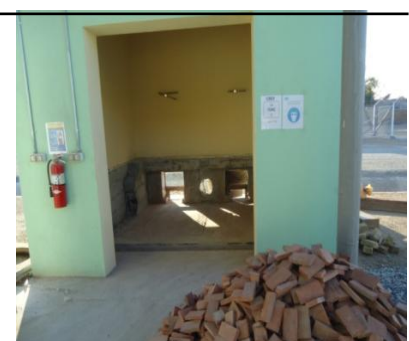
Wood burning stoves installed on September 6, 2012 (left photo), but dismantled (right) by the time of the SIGAR visit on November 19, 2012.

Furthermore, some equipment installed during construction had been dismantled at the time of our site visit. Specifically, two wood-burning stoves had been constructed in a small annex adjacent to a covered walkway that connected the annex with the site's dining facility (see figure 7). At the time of our November 2012 visit, however, the two stoves had been dismantled (see figure 8).

According to the Afghan Border Police commander present during our site visit, the stoves had been dismantled to make minor repairs. In contrast, three other Afghan personnel present on-site told us that the stoves had been removed from the annex so that the building could be used instead for storage. We were unable to resolve the discrepancy between these explanations during our visit. In particular, it is unclear from our observations whether the stoves had ever been used, raising questions as to how it was known that repairs were needed.

NTM-A/CSTC-A concurred with Recommendation 4 and took corrective action. An NTM-A/CSTC-A investigation disclosed that the Afghan Border Police had dismantled the wood-burning stoves because the pots they were using were larger than the available cooking area on the stoves provided. The Afghans have built a new larger stove and are currently using it. NTM-A/CSTC-A will incorporate this lesson learned into future construction standards.

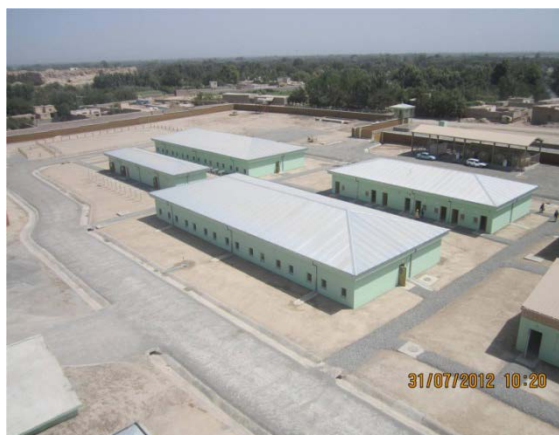
**Figure 1 - Northern Portion of Imam Sahib Border Police Company Headquarters**

See figures 1 and 2 for aerial views of the site that were taken by USACE-TAN in July 2012. Appendix III summarizes the scope of the contract.

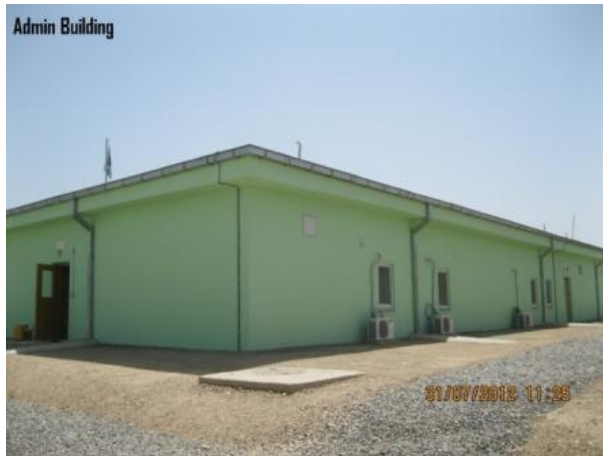
**Figure 3 - Exterior of the Administration Building**

We were able to obtain access to the site's administration building (see figures 3 and 4) and combination latrine/ablution(bathing)/laundry building (see figures 5), as well as to a small building attached to the site's dining facility that was designed to house two wood-burning stoves. This latter facility was connected to the dining facility by a covered walkway and wood storage area. The site, as a whole, was clean and appeared to be well-maintained. Structural construction of the facilities we were able to visit generally appeared to meet contract and design specifications. For example, we found no construction defects in the administration

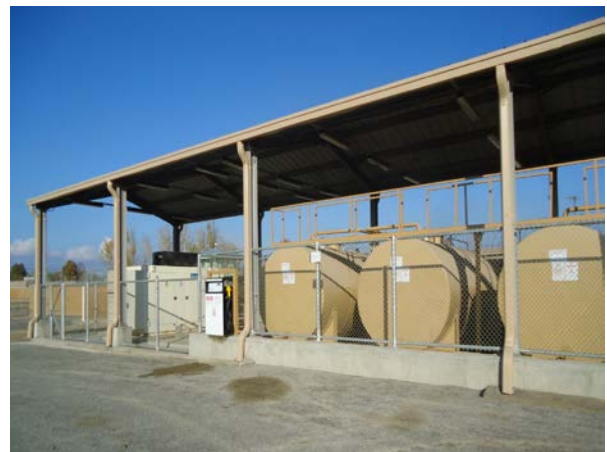
**Figure 6 - Combined Fueling Point for Afghan Border Police Vehicles and Site Generator**

building or the latrine. In addition, the fueling point for Afghan Border Police vehicles and the on-site electrical generator was observed to be running during our visit (see figure 6). Although we could not access the well house or water tank, the potable water system was functional as evidenced by the availability of water to the toilets and showers.

Our inspection found other use and sustainability issues. For example, the site has no backup generator or connection to the municipal power grid. As a result, electrical power will be unavailable during periods that the on-site generator is undergoing maintenance or repair, when fuel is unavailable, and during periods of unexpected outages. In addition, there is neither an operation and maintenance contract for on-site facilities and equipment nor are there plans to provide training for local Afghan personnel to keep these systems in good working order. The site is fairly new, largely unoccupied, and, to date, has had little need for operation and maintenance support. Nevertheless, sustaining site support facilities—including the electrical generator; fueling station; water treatment system, and the heating, ventilating, and air conditioning systems—will require operation and maintenance skills, especially given the site’s remote location. We recently reported similar findings in our inspection of the Kunduz ANP headquarters facility.<sup>12</sup>

- 2. Rather than relying solely on a single generator, determine the feasibility of installing a backup generator or connecting the site electrical system to the local power grid to prevent loss of electricity across the site when the primary generator is out of service for repair or maintenance or from unintended power outages, including lack of fuel.**

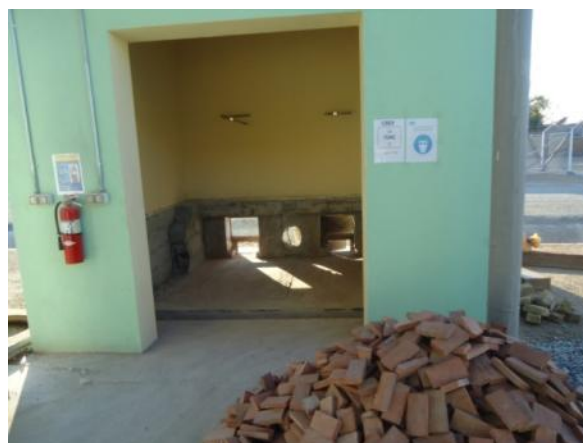
**Figure 8 - November 19, 2012, Photograph of Dismantled Stoves**

Furthermore, if repairs were indeed necessary, the stoves would have still been under warranty and so any minor repairs should have been referred by Afghan officials to USACE-TAN. Specifically, the Federal Acquisition

Regulation clause incorporated into the construction contract states that “the warranty shall continue for a period of one year from the final acceptance of the work [and] the Contractor shall remedy at the Contractor’s expense any failure to conform, or any defect...the Contracting Officer shall notify the Contractor...of any failure, defect, or damage.”<sup>11</sup>

- 4. Determine why the Afghan Border Police dismantled the wood-burning stoves at the Imam Sahib Border Police Company Headquarters and assess the need to provide wood-burning stoves at other facilities currently under construction or planned for the future.**

- b. NTM-A/CSTA-A acknowledges the SIGAR’s recommendation. NTM-A investigated this issue with the Afghan Border Police (ABP) 5<sup>th</sup> zone and found that the ABP had dismantled the stove to increase the size of the cooking area. The size of the pots they were using was larger than the available cooking area. The Afghans have already built a new larger stove and are currently using it. NTM-A will incorporate this lesson learned into future build standards.
