# Analysis of Packery Channel Public Access Boat Ramp Shoreline Failure

Christopher W. Reed<sup>†</sup> and Lihwa Lin<sup>‡</sup>

**ADDITIONAL INDEX WORDS:** *Coastal hydrodynamics, flow modeling, wave modeling, Packery Channel.*

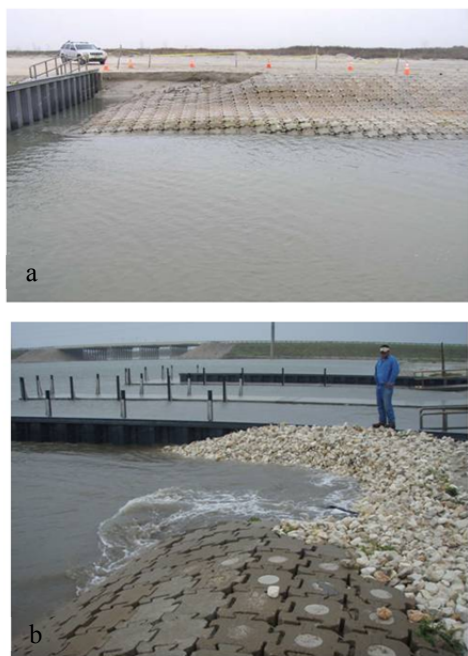
The shoreline stabilization adjacent to the public access boat ramp in the Packery Channel basin has been damaged in two separate events. In August, 2006 the articulated mats on the east side of the eastern bulkhead failed and slumped into the channel. A view of the damaged articulated mats are shown in Figure 1a. The damage was likely associated with tropical storm Erin. The damage to the articulated mats was sufficiently severe and the repositioning of the mats was not feasible. Therefore, an interim shoreline re-stabilization measure consisting of filling in the damaged area with cobble size rock was implemented. This approach was intended to temporarily protect the damaged area until a complete analysis and design could be developed. The construction of the complete solution was to be implemented simultaneously with the construction of the parking area and related infrastructure adjacent to the boat ramp. However, on a second incident, in September, 2007, prior to completion of the design and construction of the final remedy the rock fill failed and slumped into the channel. A view of the damaged fill is shown in Figure 1b. The damage was likely associated with hurricane Ike. An investigation of the potential causes of the damage was undertaken after the second failure.

Figure 1. a) Damage to original articulated mat during tropical storm Erin. b) Damage to interim rock fill during Hurricane Ike.

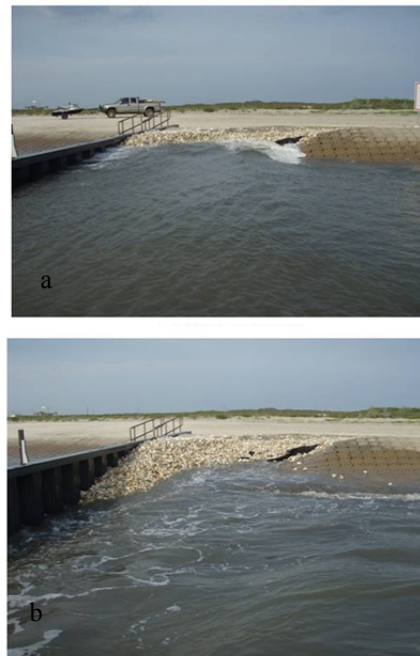
Figure 2. a) Wave propagating into the bulkhead and shoreline. b) Wave surge receding from the bulkhead and shoreline.

Photographic evidence of the presence of low-frequency low-amplitude waves as well as movies providing quantification of the periods associated with the waves supports the hypothesis that these waves are the primary source of damage at the boat ramp bulkhead. Figures 2a and 2b show the water surface height in the vicinity of the bulkhead as the wave propagates through the basin. The wave propagates into and away from the corner formed by the bulkhead and shoreline with a period on the order of 45 seconds. There is no wave breaking apparent, but the long-period wave acts as small surge during each passing. It appears the corner area is subject to heightened surge level from the wave, likely due to the deflection of the surge by the bulkhead.
