# Identification of and Remedial Approaches to Hot Spots

*by Donald K. Stauble and Mark B. Gravens*

**PURPOSE:** This Coastal and Hydraulics Engineering Technical Note (CHETN) provides information about the suspected causes and remedial approaches that have been applied to erosion hot spots on several recent beach nourishment projects. These diverse examples form the basis for general identification and steps that can be taken to mitigate for and anticipate the development of hot spots on beach nourishment shore protection and environmental restoration projects.

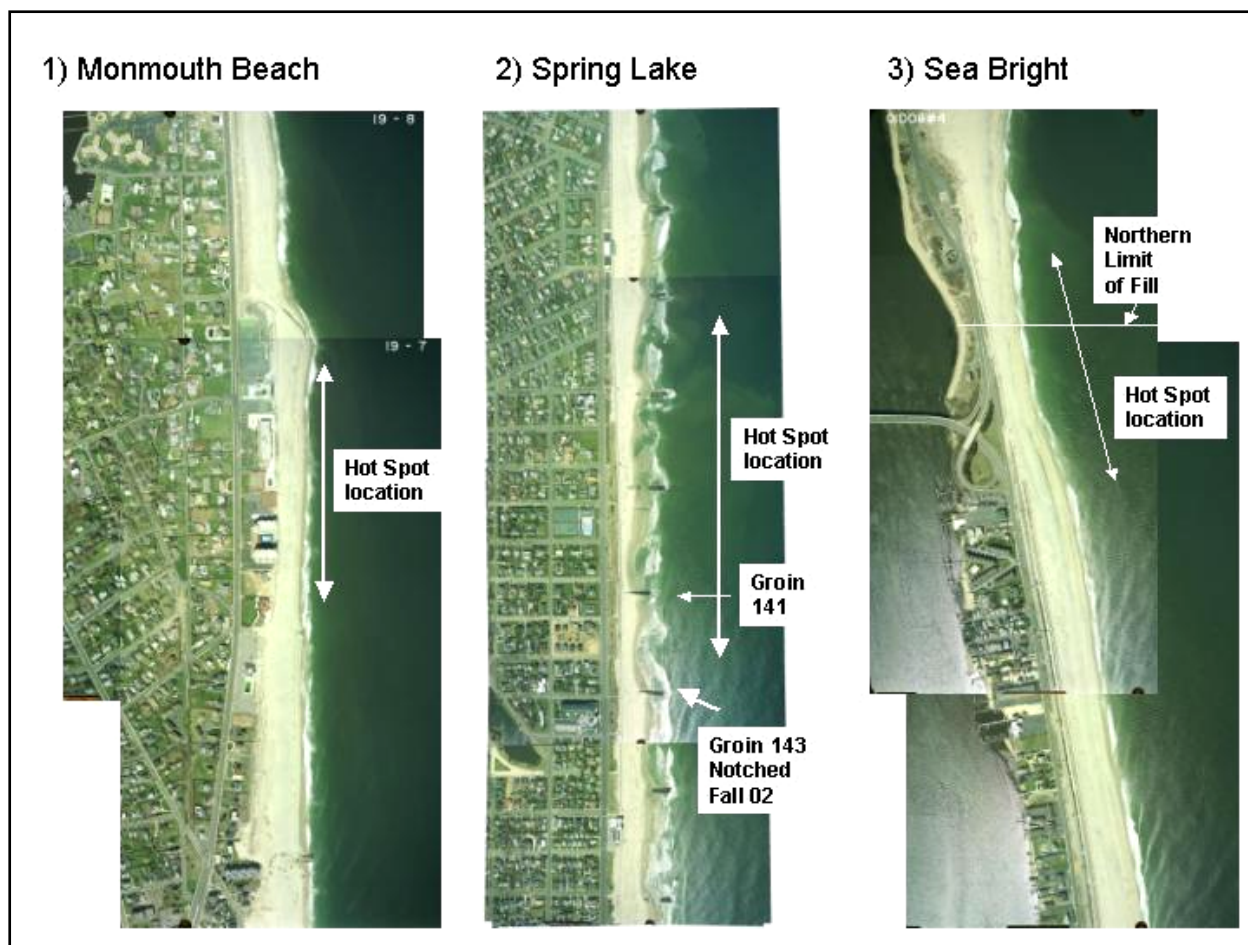
Figure 5. Hot spot locations of Sea Bright to Manasquan Inlet Project (courtesy of Lynn Bocamazo, New York District)

Hot spot 1 at Monmouth Beach was located at the southern boundary of the first contract reach and covered a 793-m (2,600-ft) section of contract area. The initial fill was placed in November 1994 with 396,827 cu m (519,000 cu yd) placed. To mitigate for the erosion experienced at this hot spot, a second placement occurred in November 1995 with 175,858 cu m (230,000 cu yd) placed. A third placement was needed in May 1998 with 431,234 cu m (564,000 cu yd) of fill placed. Through monitoring and analysis it was determined that the cause was seaward perturbation of the beach due to encroachment of the upland structures onto the beach and the design requirement of a uniform

30-m (100-ft) berm width (Figure 5). This area was also at the southern end of Reach 1A and end losses were suspected as a contributor to loss of fill material. This hot spot was resolved with the addition of fill to the south with placement in the next Reach 2 making the beach planform more uniform along the entire reach and the new fill provided an updrift source of sand for the hot spot (net drift is north along this part of the New Jersey coast). The hot spot area was again renourished in September and October 2002 as planned and will continue to be monitored to assess the behavior of this hot spot.

The second hot spot at Spring Lake was located within a groin compartment along a stretch of beach with a groin field. Initial fill was placed between April and October 1997. A visible difference in erosion rates was noticed by the following spring, 610 m (2,000 ft) north of groin 143. To investigate the hot spot, beach profiles and sediment monitoring were increased in this area, and numerical modeling of surf zone hydrodynamics conducted. Construction details were reviewed and a change from one borrow area to another was noted during construction in this area. The wave climate and storm history was also examined for the period after fill placement. The groin length/spacing ratio was examined and groin notching was considered as an alternative to enhance longshore transport and restore the flow of sediments between groin compartments. A determination of causes indicated that the cross-shore adjustment started immediately after fill placement. The average grain size in the erosive hot spot area was smaller than in groin compartments to the south due to the change in borrow areas. Groin 143 should have been notched, because it was trapping too much material.

Groin 141 was determined to be too short and was not retaining enough material. There was also an anomaly in the bathymetric contours offshore of the eroding area, which lead to higher energy dissipation in the center of the eroding groin cell hot spot area. To remedy the hot spot, several alternatives were proposed, but the State of New Jersey wanted the least effort alternative. This consisted of placing 174,329 cu m (228,000 cu yd) of coarser fill material in the hot spot area north of groin 143 in July 2002 and notching the groin in the fall of 2002 (Figure 5). No conclusions have been reached yet on how well notching and larger grain size material is working to remedy the hot spot.

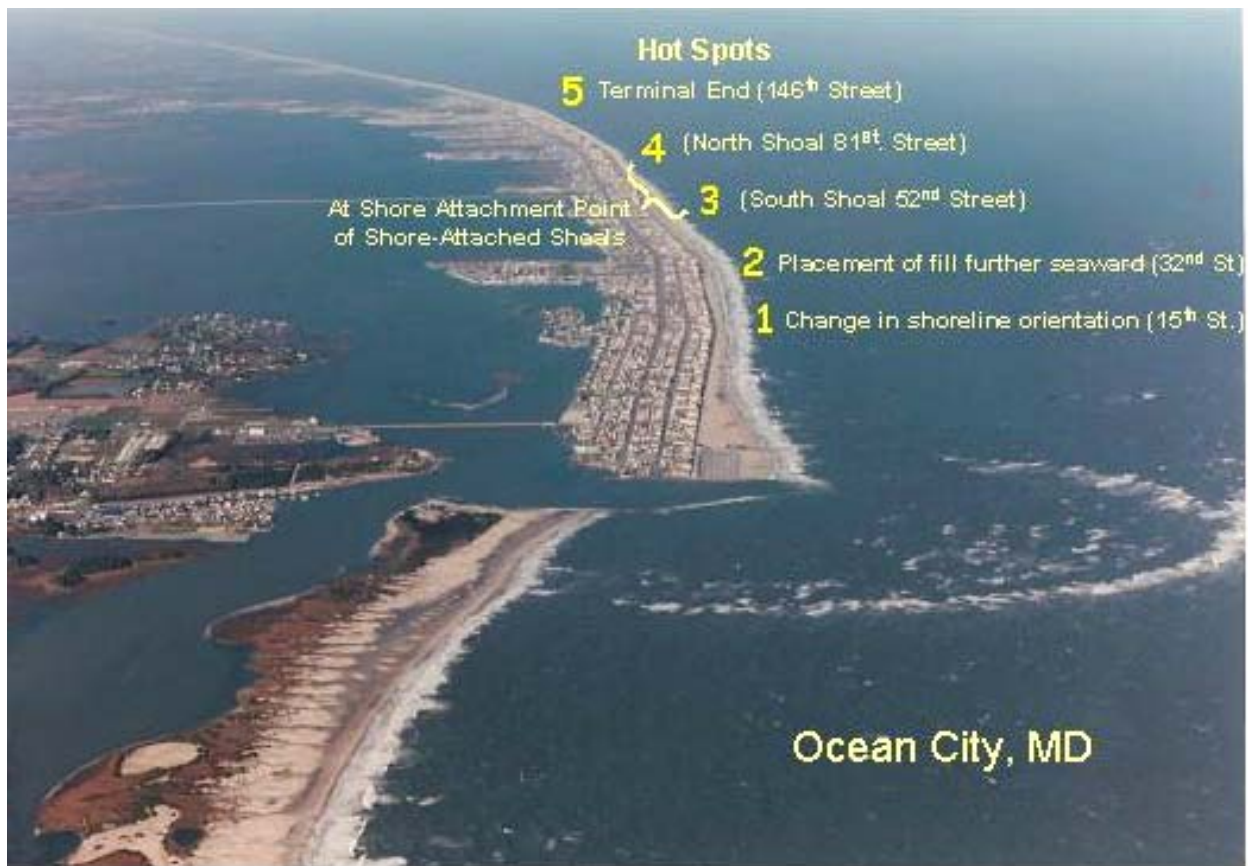
Figure 8. Location of the five hot spots along Atlantic coast of Maryland (Ocean City) Shoreline Protection project (Stauble and Bass 1999)

The project developed five unanticipated hot spots at 15th, 32nd, 52nd, 81st, and 146th Streets (Figure 8). These hot spots were identified by analysis of beach profile data using shoreline position and fill volume change and percent of fill remaining analysis (Stauble and Kraus 1993; Stauble 1994; Stauble and Bass 1999) and wave refraction studies (Smith and Ebersole 1997). The 15th Street hot spot is identified as an orientation change in the shoreline from northwest to a more northward facing shoreline. Extra fill was placed during renourishment and as more sand was placed

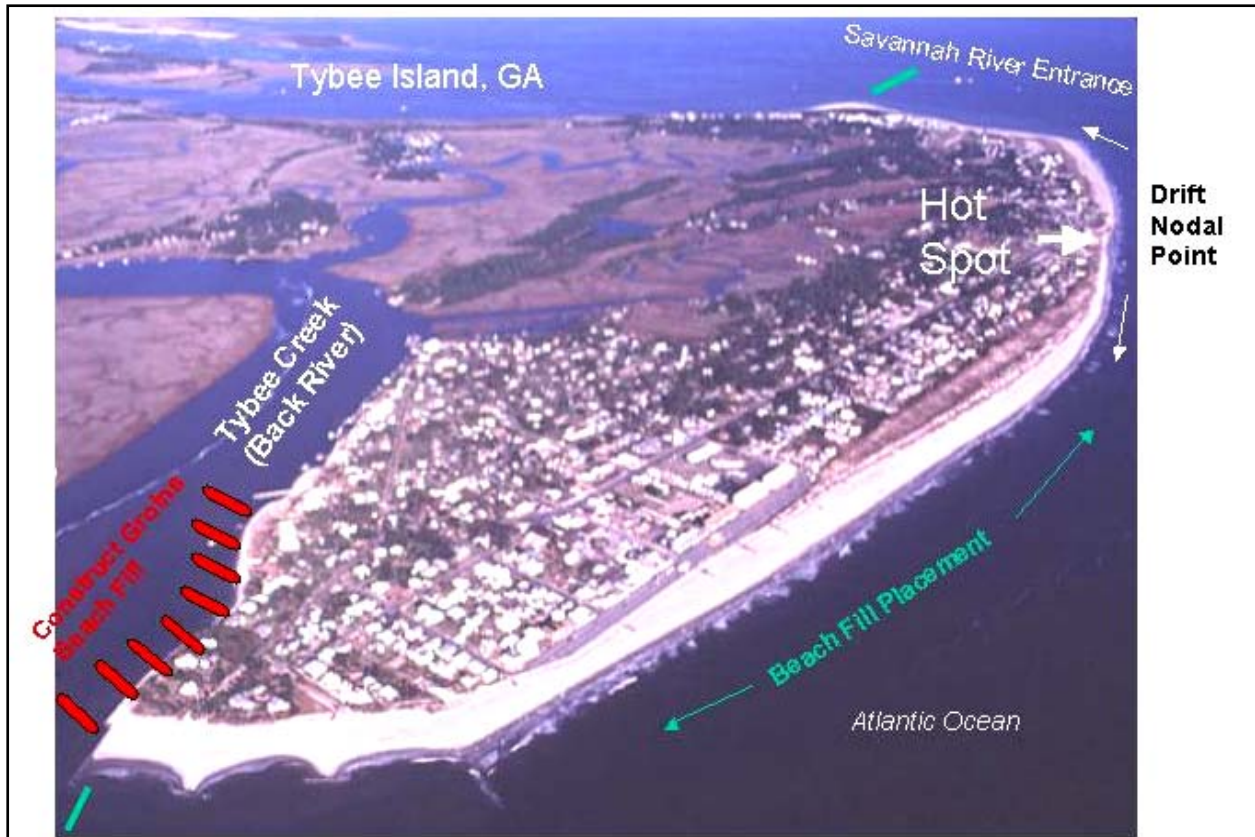
Figure 16. Hot spot location and nodal point at Tybee Island, GA, fill project (courtesy of Carol Abercrombie, Savannah District)

One hot spot has formed on the ocean beach in the middle of the island (Figure 16). The suspected cause of this hot spot is a change in shoreline orientation, which is also a nodal point for sediment transport north into the Savannah River entrance and south to Tybee Creek (Back River) inlet. The hot spot has become a sediment source for transport in both directions away from the placement area. Methods taken to addressing the hot spot include the construction of groins at the hot spot area to interfere with the longshore transport, lengthening and sand tightening of the north end groin to trap sand from loss into the Savannah River entrance, increasing the beach's berm width and increasing the frequency of renourishment to provide a sand supply to this nodal point.

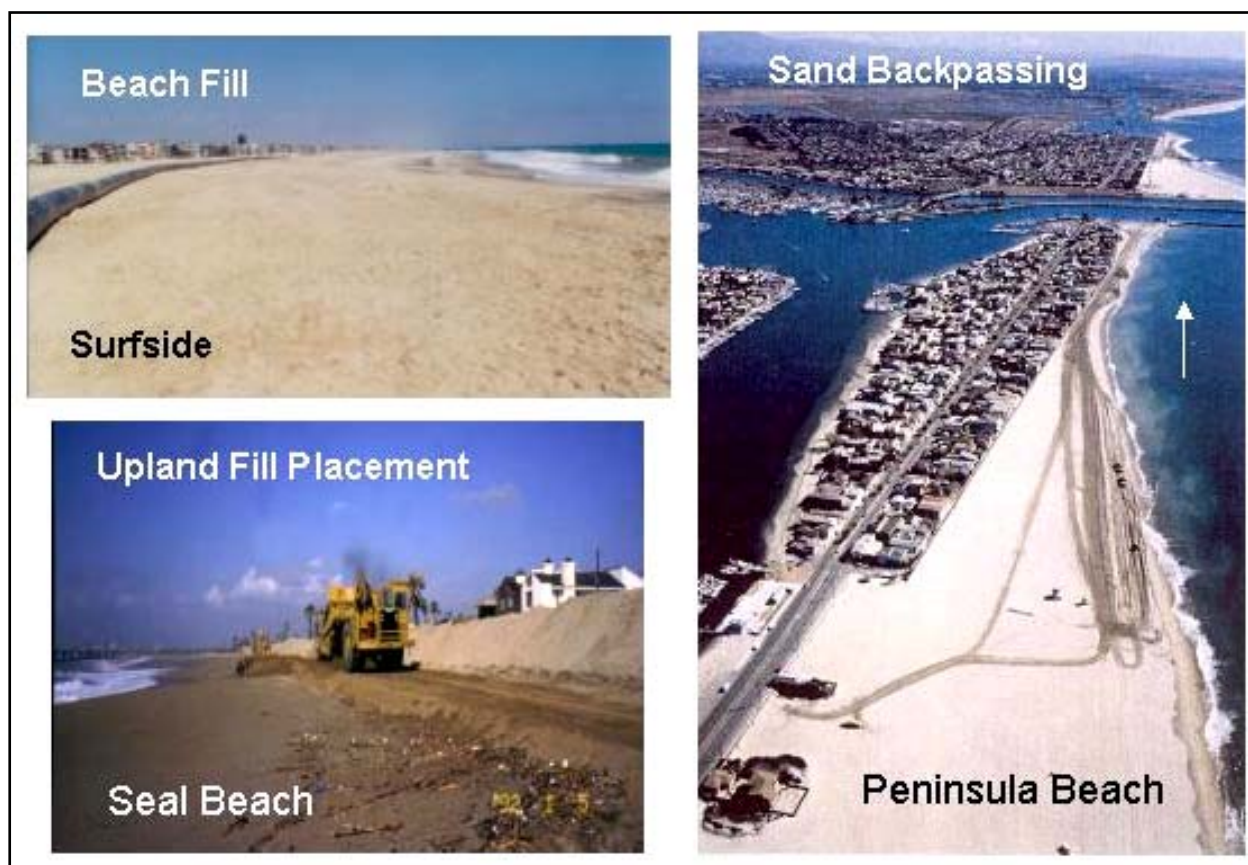
Figure 22. Photographs of mitigation for the three hot spots along southern California coast showing pipeline fill renourishment from offshore borrow area at surfside, upland fill placement at Seal Beach and truck haul backpassing at Peninsula Beach (courtesy of Chuck Mesa, Los Angeles District)

Mitigation for the hot spots include periodic beach nourishment using a nearshore borrow area for Surfside (Figure 22). The first fill was placed using an upland source in 1964. The project has been filled 11 times since then on a roughly 6-year renourishment cycle, with the last one in May 2002. The dredging of the channel into the Naval Weapons Station was used as a source of fill on two occasions, but most of the fill has been from nearshore borrow areas. The hot spot at Seal Beach was nourished with an upland fill source that was moved by rail to the coast and truck hauled onto the beach by local interests. Local interests filled the Peninsula Beach hot spot with sand back-passed by truck from the wide beach to the west back to the beach adjacent to the jetty.
