AFRL-RX-TY-TR-2012-0077

## **EVALUATION OF LIQUID DETERGENTS AND METHODS USED FOR AIRFIELD RUBBER REMOVAL**

**AIR FORCE RESEARCH LABORATORY  
MATERIALS AND MANUFACTURING DIRECTORATE**

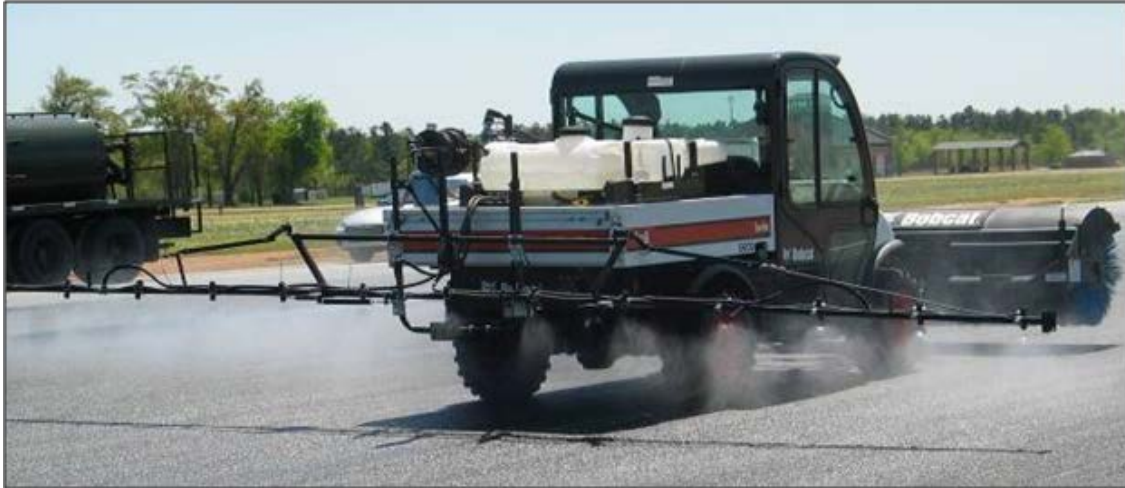
**Figure 3. Toolcat<sup>®</sup> Applying Detergents with 21-ft Spray Bar**

The detergent application system has two main components: a pumping mechanism and a spray bar attachment. During the experiment, two different pumping mechanisms were used: a gasoline-powered pump and a hydraulically-driven system powered by the Toolcat<sup>®</sup> vehicle. The hydraulically-driven system malfunctioned and was replaced throughout testing by the gasoline-powered pump. Each system delivered the chosen detergent from an on-board holding tank to a 21-ft collapsible spray bar attachment as shown below in Figure 3.

The spray bar consisted of 13 nozzles spaced evenly across with maximum operating pressures of 50 psi each. The flow rate exiting the nozzles remained consistent and applied coverage is determined by the forward speed of the Toolcat<sup>®</sup>. Because coverage requirements differed by detergent, the forward speed of the Toolcat<sup>®</sup> was adjusted to compensate. Detergent application will be discussed in greater detail later in this report.

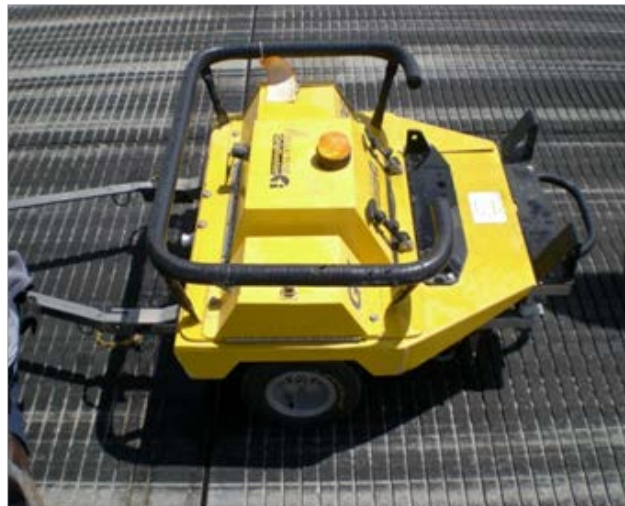
**Figure 5. Findley-Irvine GripTester Device**

The friction data is collected and compiled using a Findley-Irvine GripTester CFME device provided by the Air Force Civil Engineering Support Agency (AFCESA) as shown in Figure 5. The device can be towed behind any ½-ton (or larger) vehicle with adequate storage capacity for a metered water delivery system and equipped with a receiver hitch. The GripTester unit records real-time friction coefficients of the airfield pavement surface.

This CFME device is a lightweight, three-wheeled trailer which weighs 183 lb (83 kg) and is operated using a single, smooth tread tire that is mechanically forced to slip at 14.5 percent of the relative trailer forward speed. The differential slip is controlled by a calibrated, chain-driven transmission directly linking the skid tire and the main wheel axle.

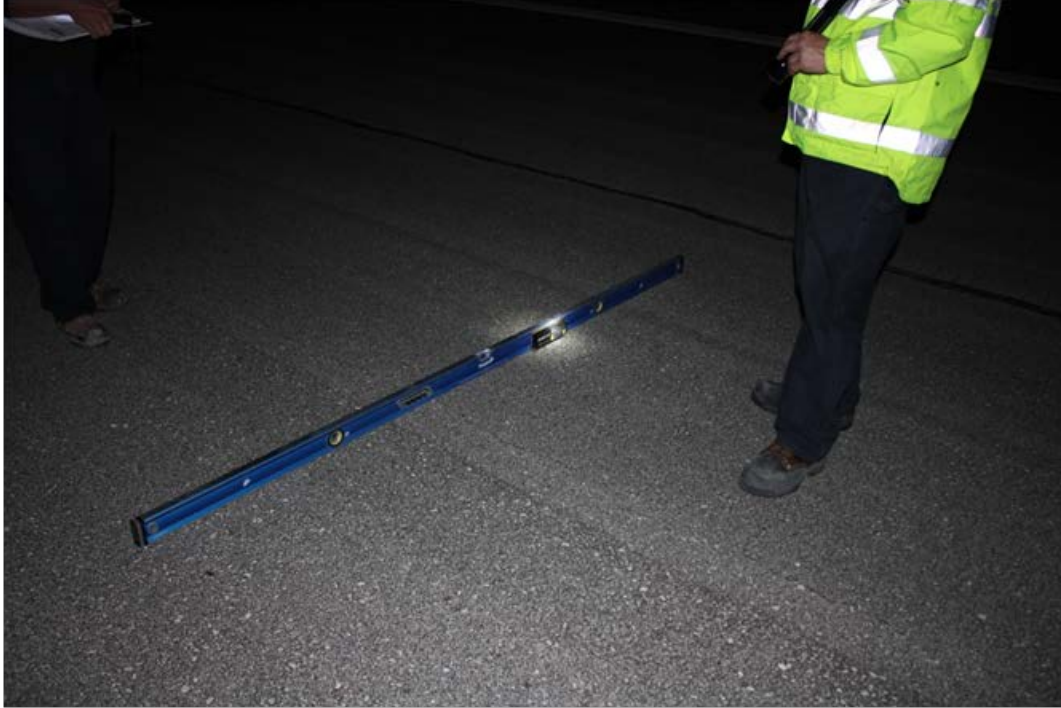
**Figure 10. Slope Measurement**

Runway slopes were measured prior to friction analysis and rubber removal. These measurements were taken to identify ponding issues that could adversely affect friction. Two different slope measurements were recorded at each location; longitudinal and transverse. The longitudinal slope was measured along the runway centerline and the transverse slope was measured perpendicular to the centerline [5]. Figure 10 and Figure 11 show the slope measurement being measured in the field. The slope measurement field notes are located in Appendix A.

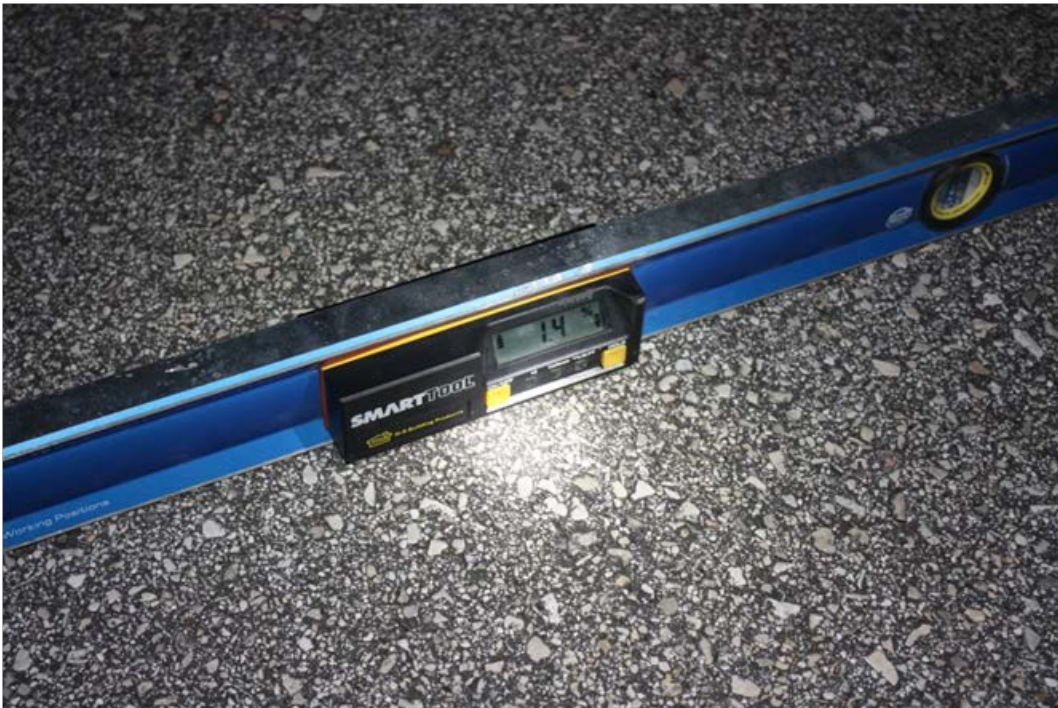
**Figure 11. Slope Measurement Reading**

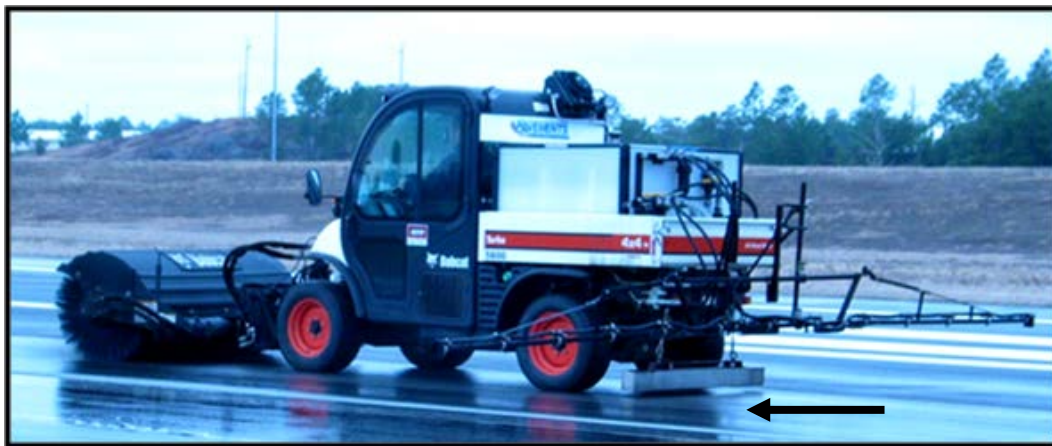
**Figure 16. Magnetic Bar Orientation on Toolcat<sup>®</sup>**

A magnetic bar was mounted via wired rope cables at the rear of the vehicle and oriented such that the magnet hung approximately one half inch above the airfield surface. Its purpose was to remove metallic FOD and broken wire broom bristles from the airfield during agitation. The magnetic bar is shown in Figure 16.

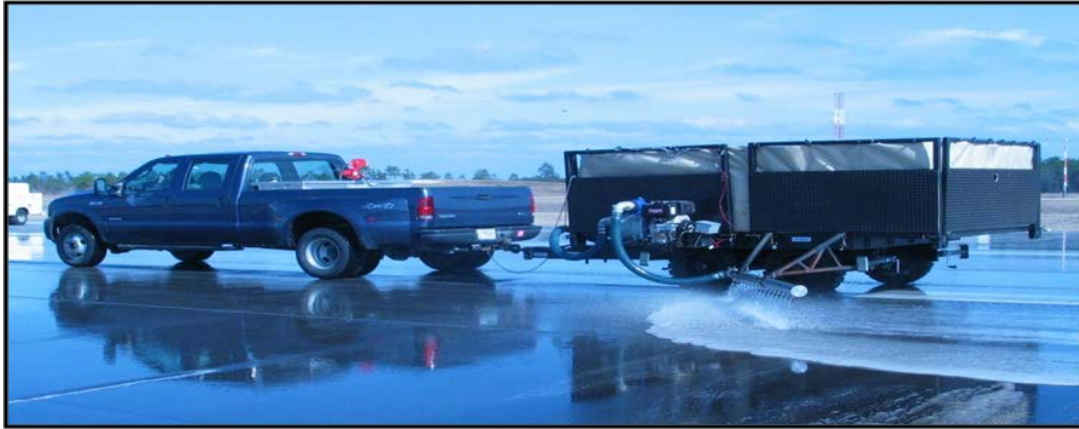
**Figure 19. Detergent Rinsing Technique**

The entire test area was thoroughly rinsed to remove the loosened rubber material immediately following the agitation effort; Figure 19 illustrates this process. The rinsing process also neutralized the detergent agents. The amount of water needed for this task was detergent dependent. Re-filling of the water trailer was required multiple times over the course of rinsing each test section.

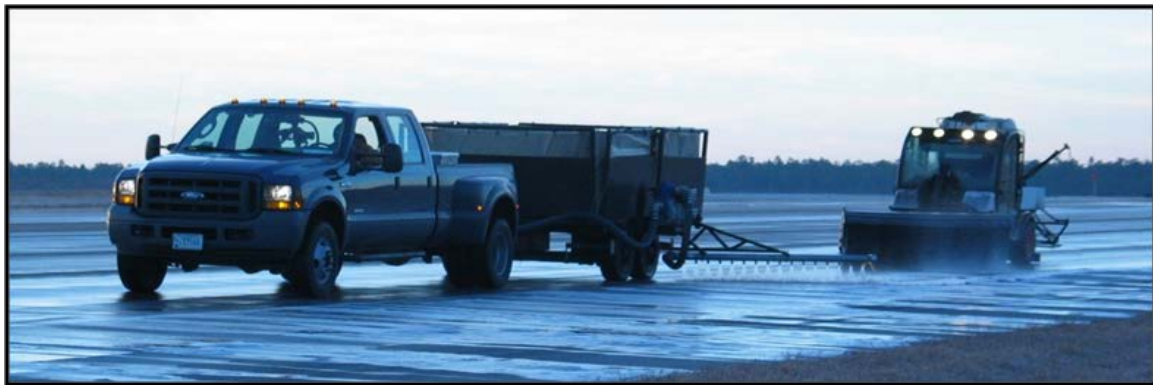
**Figure 20. Toolcat<sup>®</sup> Applying Detergents to Dampened Test Area**

The rinse procedure began at the centerline (or crown) of the airfield and worked outward in a growing pattern until all detergent and excess water had been pushed from the runway and onto the adjacent grassed area. The Toolcat<sup>®</sup> with broom attachment followed the rinse trailer to ensure removal of any foreign debris and standing water as shown in Figure 20.
