**Missouri River Flood 2011  
Vulnerabilities Assessment Report  
Volume II-Technical Report**

**Northwestern Division  
US Army Corps of Engineers**

**October 2012**

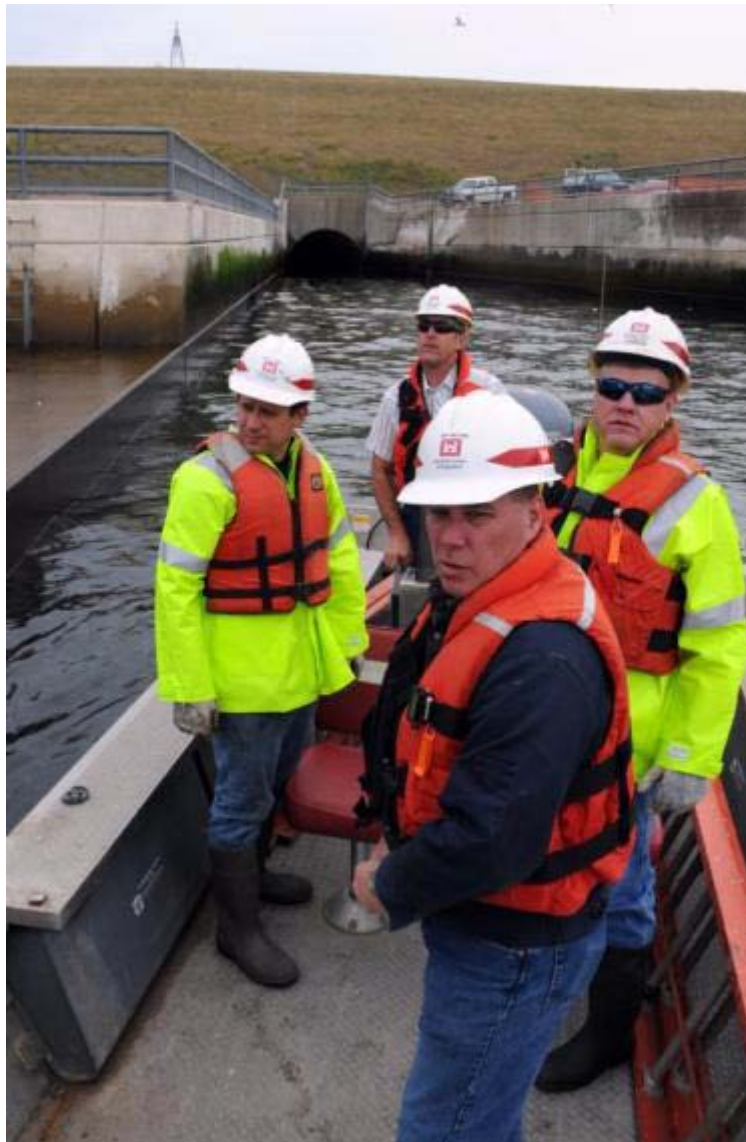
**Figure 20. Oahe personnel prepare to enter one of the Oahe Dam stilling basin outlet tunnels August 29, 2011. They drove boats one half mile into the tunnels to visually inspect tunnel walls for cracks, spalls or distress in the concrete.**

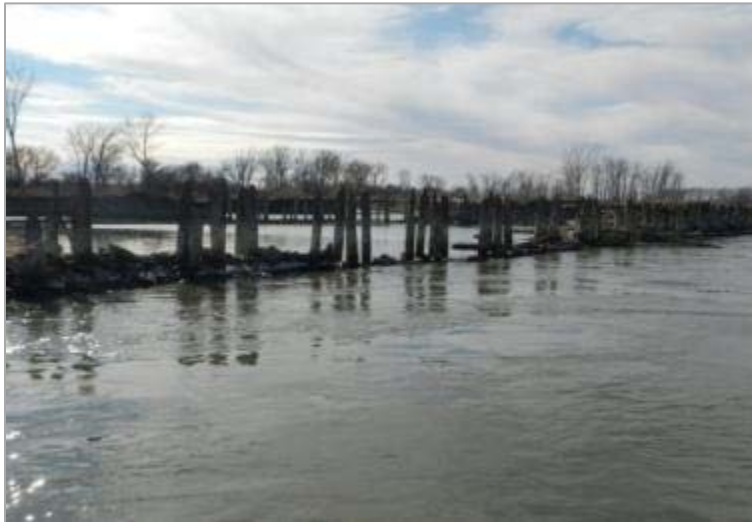
**Figure 30. Revetment Near River Mile 679.8**

Repair Dimensions: Approximately 100 ft long and 7 ft high.

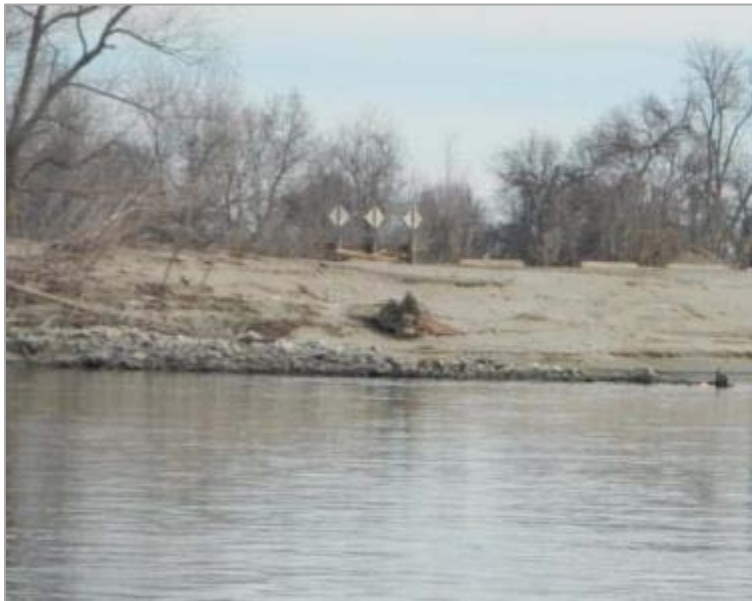
**Figure 31. Dike Near River Mile 640.2**

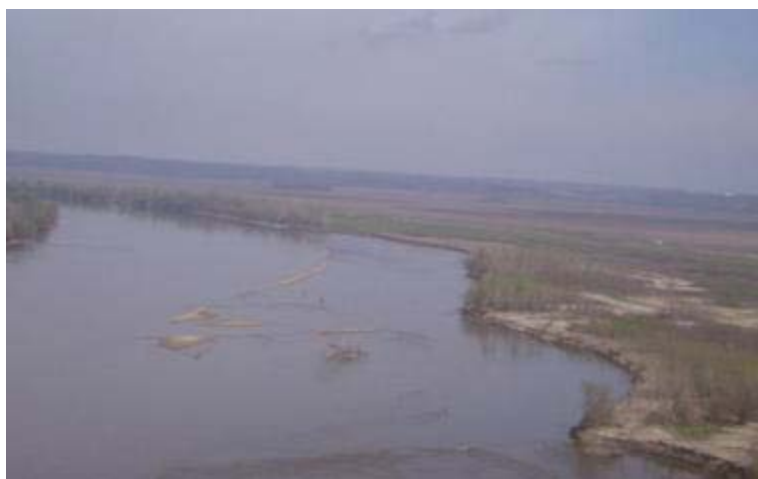
**Figure 32. Wolf Creek Bend Revetment Chute Erosion**

Damage: Chute Erosion

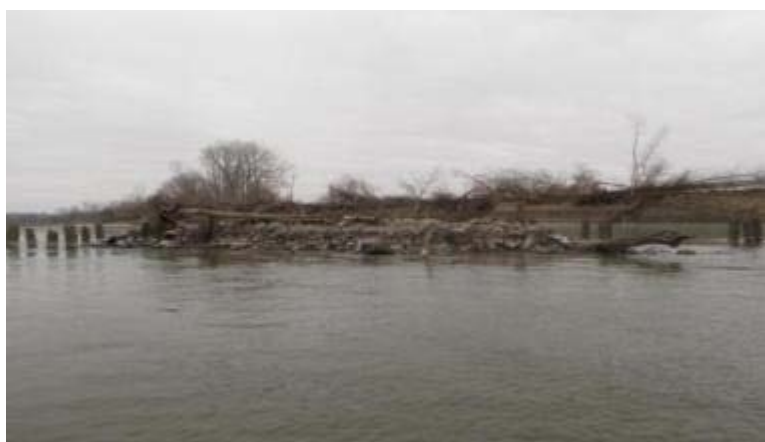
**Figure 33. Flanked Dike at River Mile 322.4 on Right Bank.**

Damage: Flanked Dike

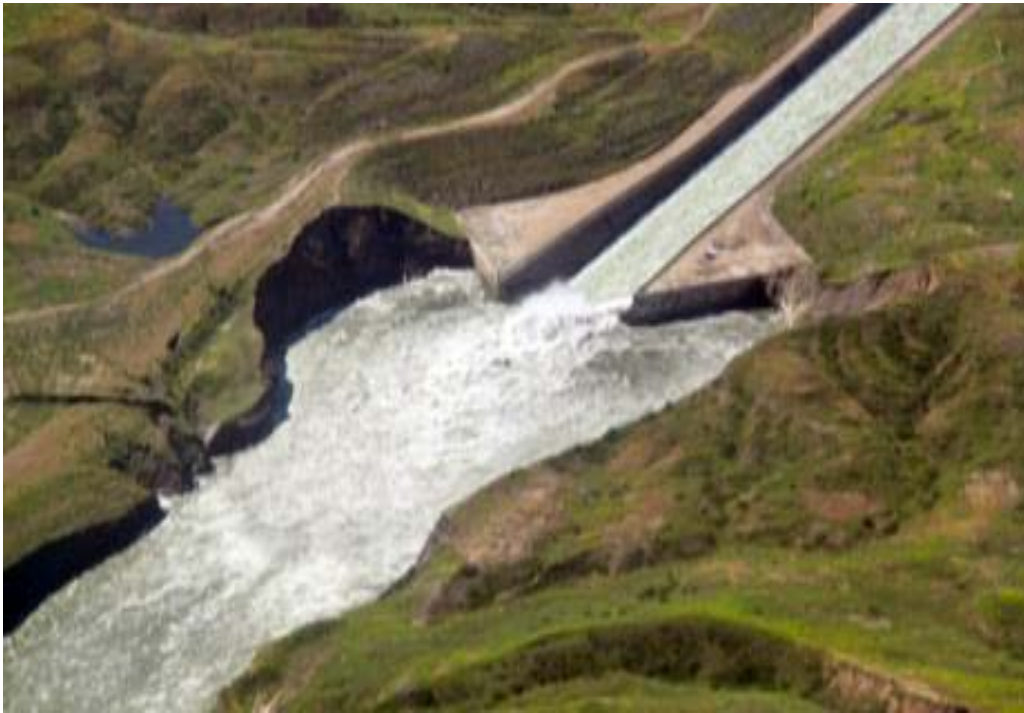
**Figure 65. Dams damage/erosion: Fort Peck - Erosion along the spillway plunge pool extending from Fort Peck's spillway in Fort Peck, Montana**

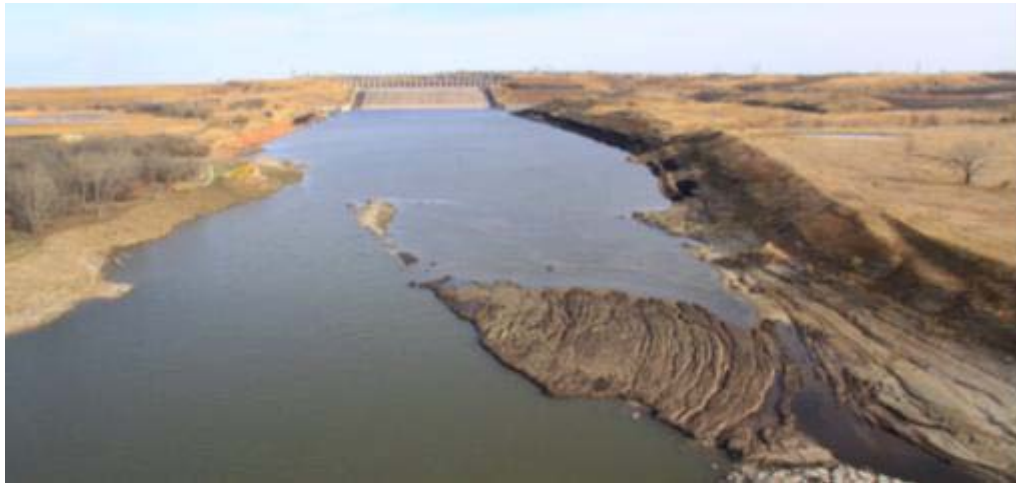
**Figure 70. Dams damage/erosion: Garrison - Erosion along the earthen walls extending from Garrison Dam's spillway apron in North Dakota**

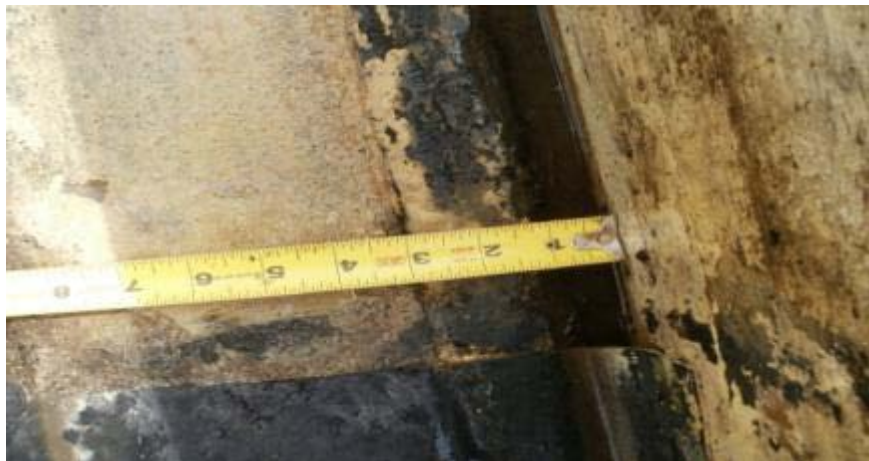
**Figure 73. Dams damage/erosion: Garrison - Joint separation and seal repairs required at Garrison Dam in North Dakota**

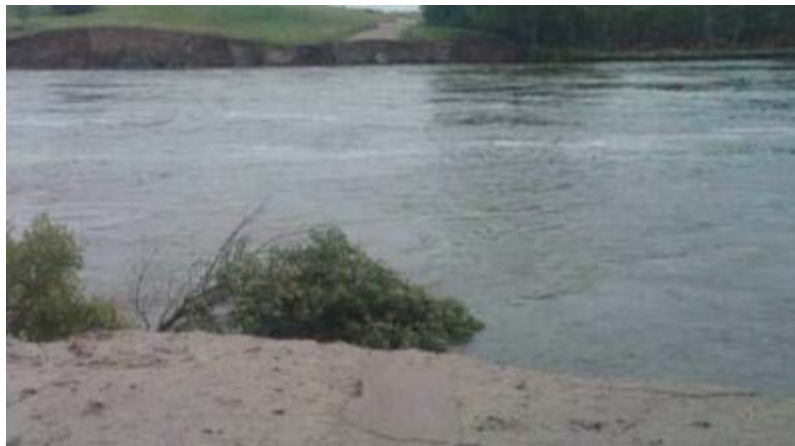
**Figure 74. Dams damage/erosion: Garrison - Erosion along the earthen walls extending from Garrison Dam's spillway apron in North Dakota**

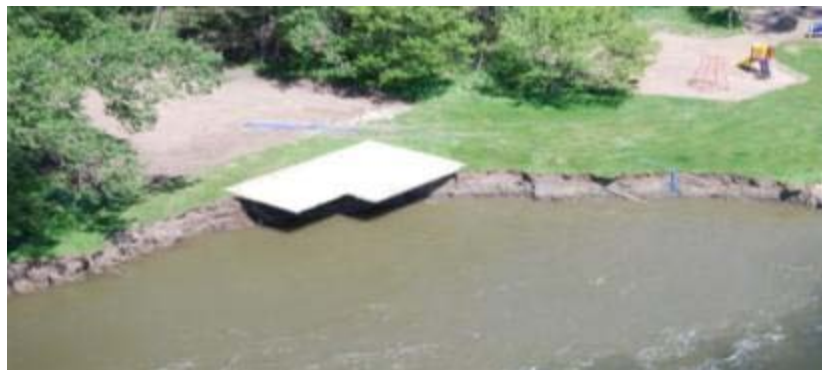
**Figure 75. Dams damage/erosion: Garrison - Downstream camp erosion at Garrison Dam in North Dakota**

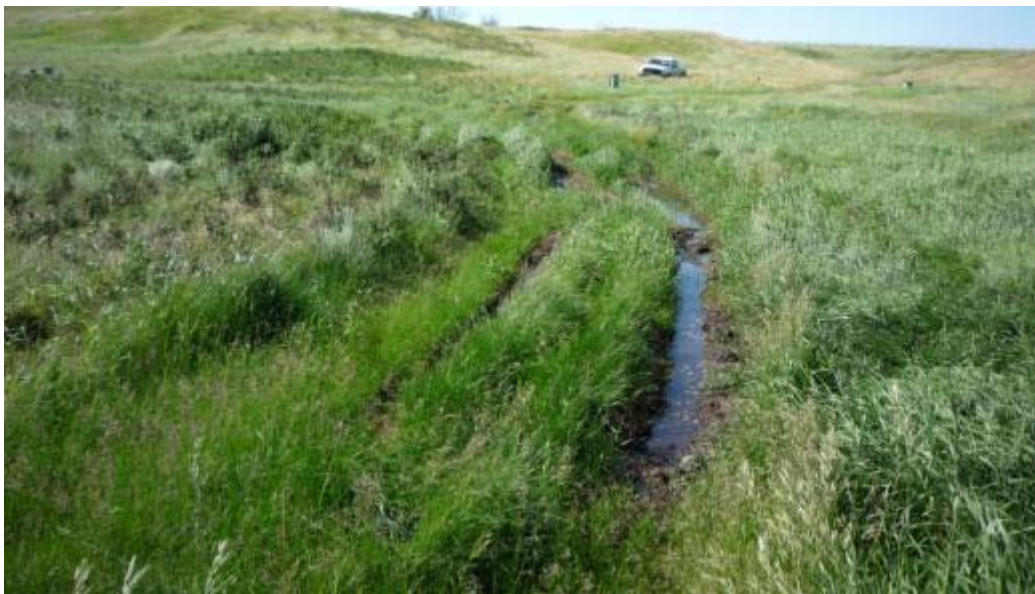
**Figure 77. Dams damage/erosion: Pipestem Dam - Downstream right abutment seepage area at Pipestem Dam in South Dakota**

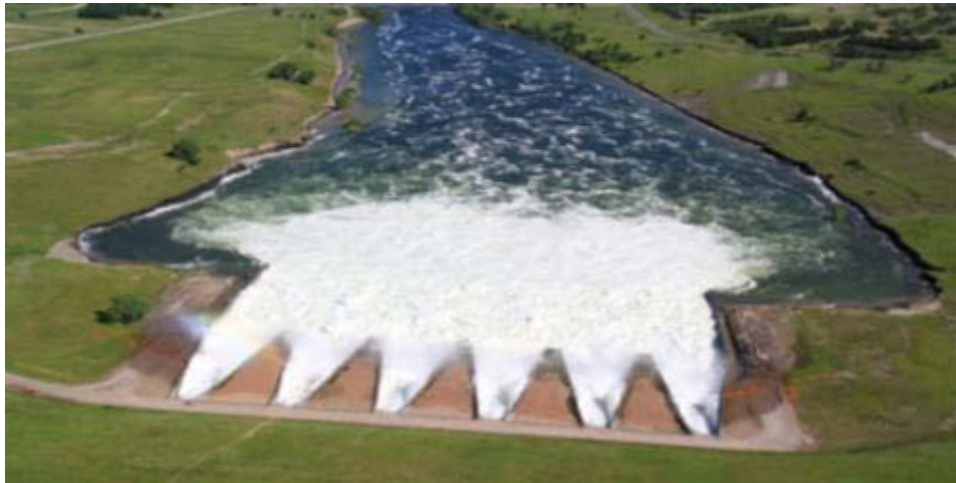
**Figure 80. Dams damage/erosion: Oahe - Erosion along the earthen walls extending from Oahe's stilling basin outside Fort Pierre, South Dakota**

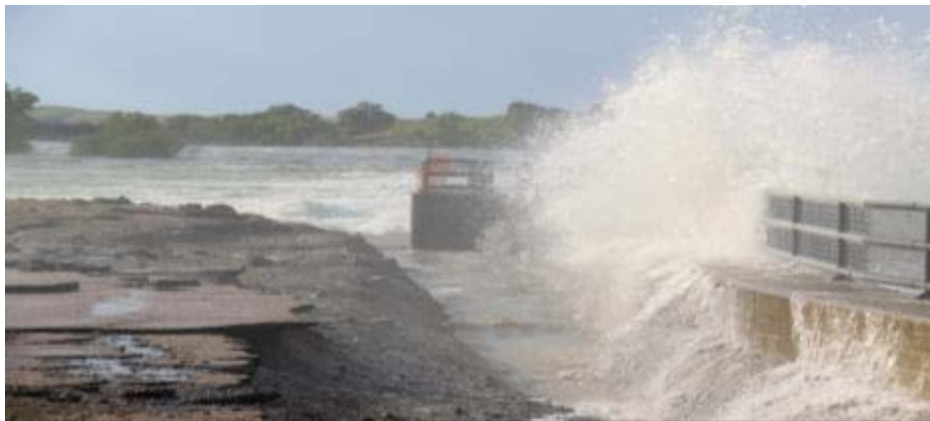
**Figure 81. Dams damage/erosion: Oahe**

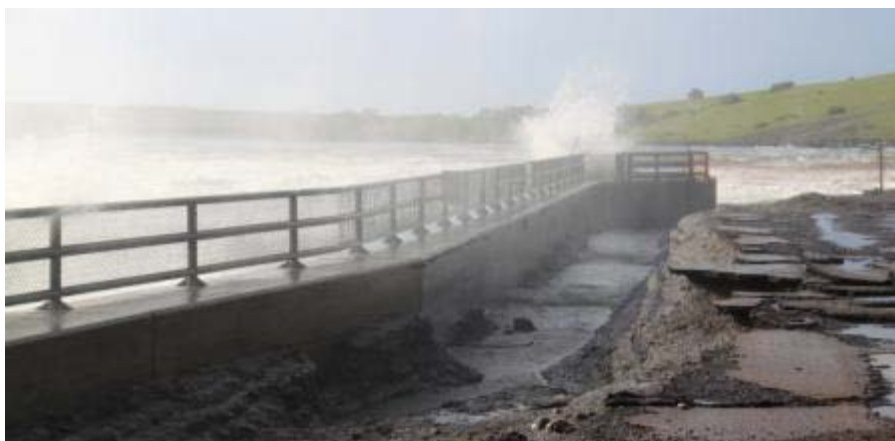
**Figure 82. Dams damage/erosion: Oahe - Erosion at flood tunnel outlet for Oahe outside Fort Pierre, South Dakota (under repair)**

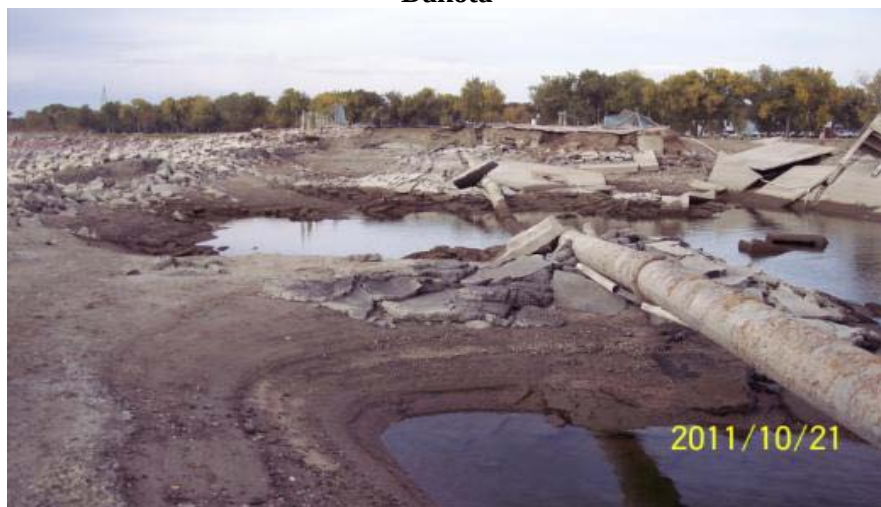
**Figure 85. Damage/erosion: LaFramboise Island Causeway - City of Pierre waterlines damaged at LaFramboise Island Causeway (Corps) in Pierre, South Dakota**

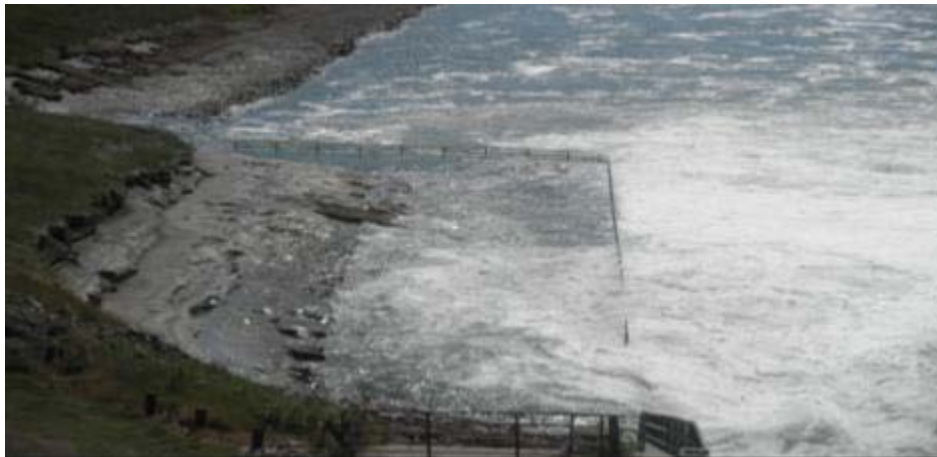
**Figure 87. Dams damage/erosion: Big Bend Erosion on earthen walls of the project's spillway in South Dakota**

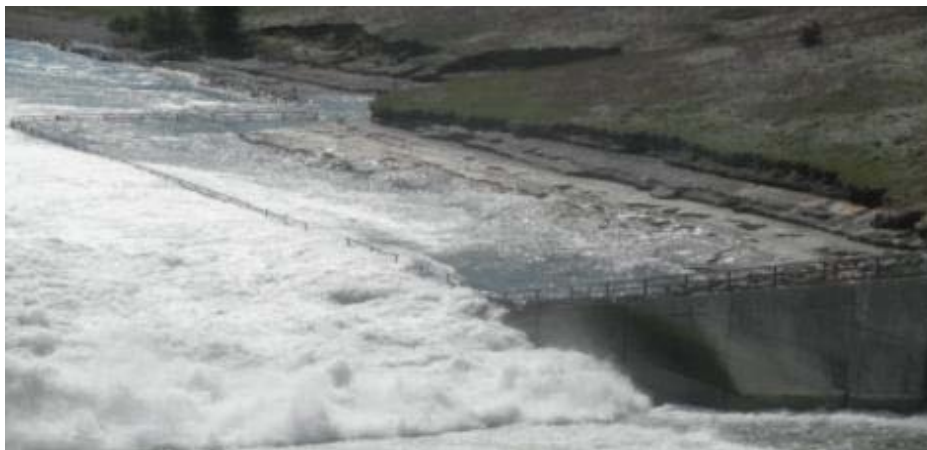
**Figure 88. Dams damage/erosion: Big Bend Erosion on earthen walls of the project's spillway in South Dakota**

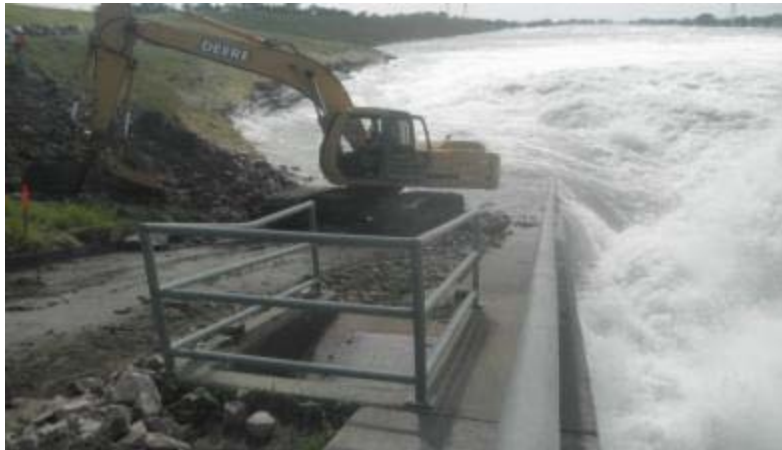
**Figure 89. Dams damage/erosion: Big Bend - Project's spillway in South Dakota being overtopped during flood**

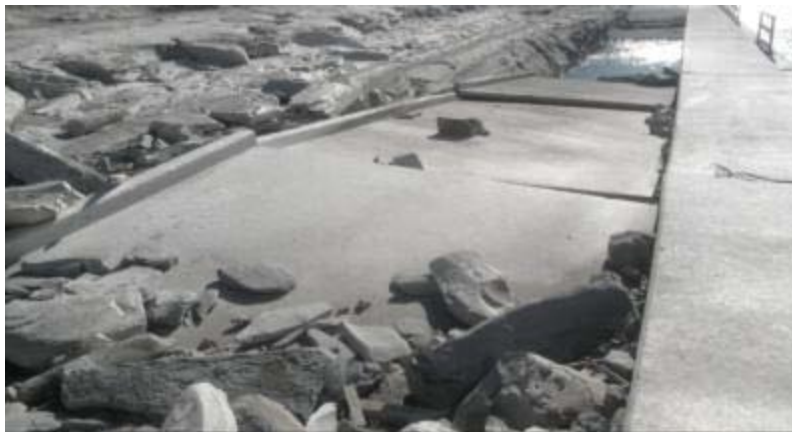
**Figure 90. Dams damage/erosion: Big Bend – Project's spillway overtopping damage in South Dakota currently under repair**

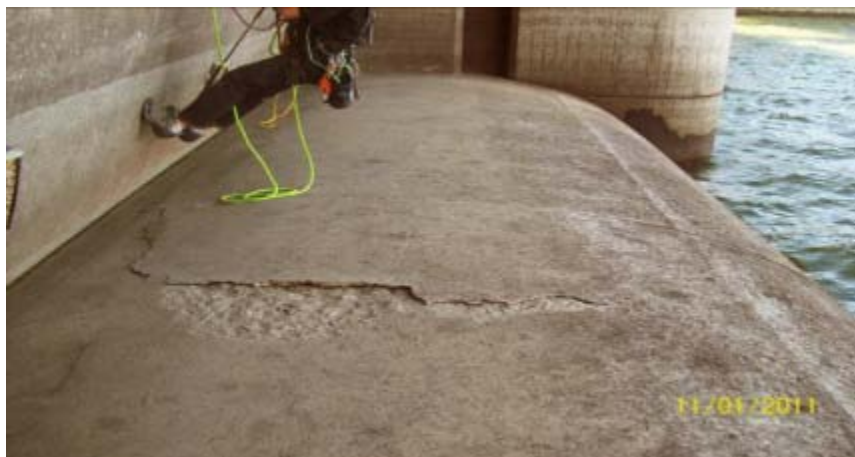
**Figure 93. Dams damage/erosions: Fort Randall - Spillway weir spalling**

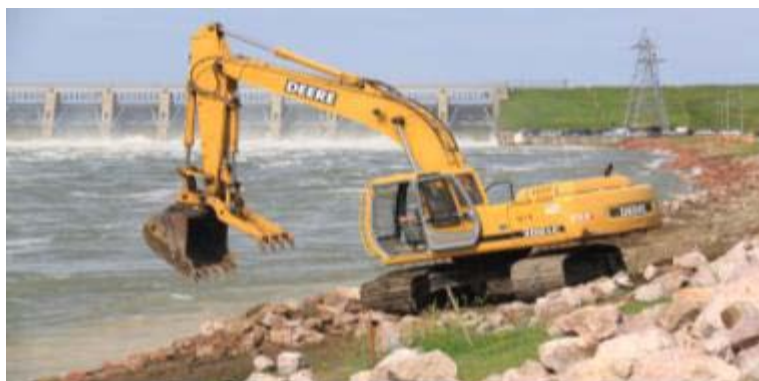
**Figure 99. Dams damage/erosion: Gavins Point - Erosion on earthen walls of the project's spillway in South Dakota (under repair)**

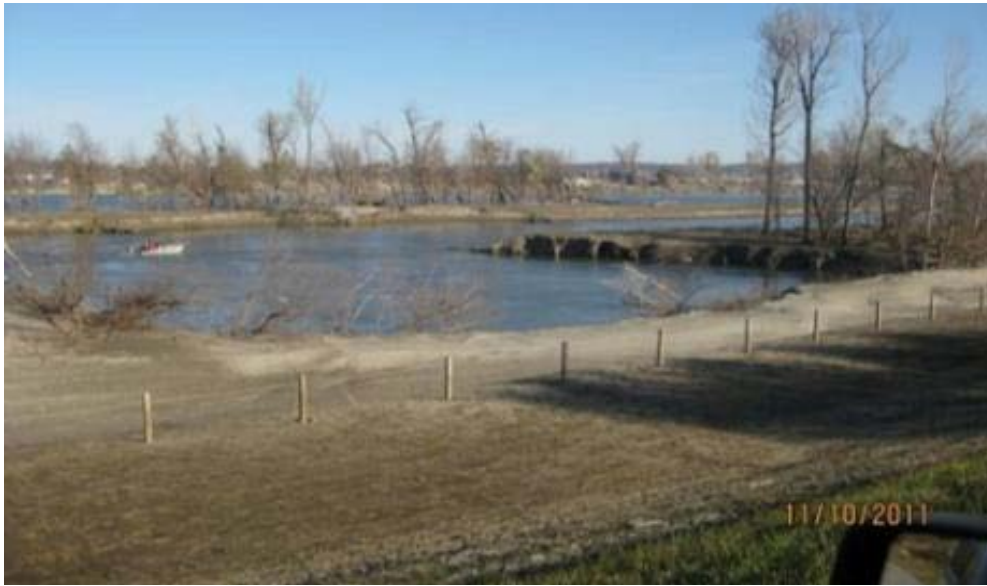
**Figure 100. Levee scouring/erosion: Scour hole between Council Bend chute and MR Levee L624-627 toe in Council Bluffs, Iowa**

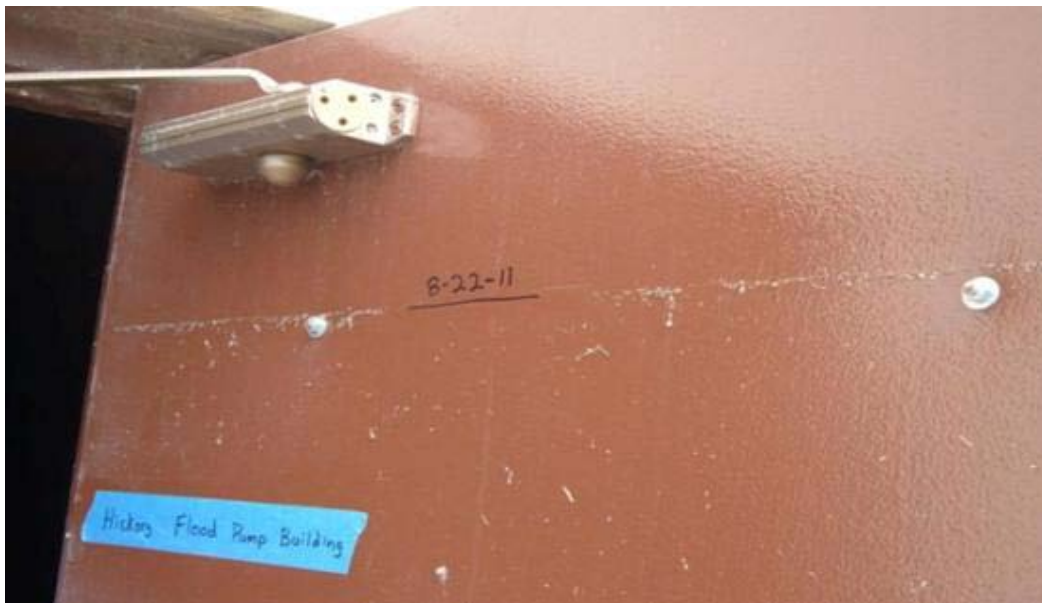
**Figure 101. Flood protection project damage: Hickory Street Pump Station - High water mark on interior side of an exterior door at a flood protection project in Omaha, Nebraska**

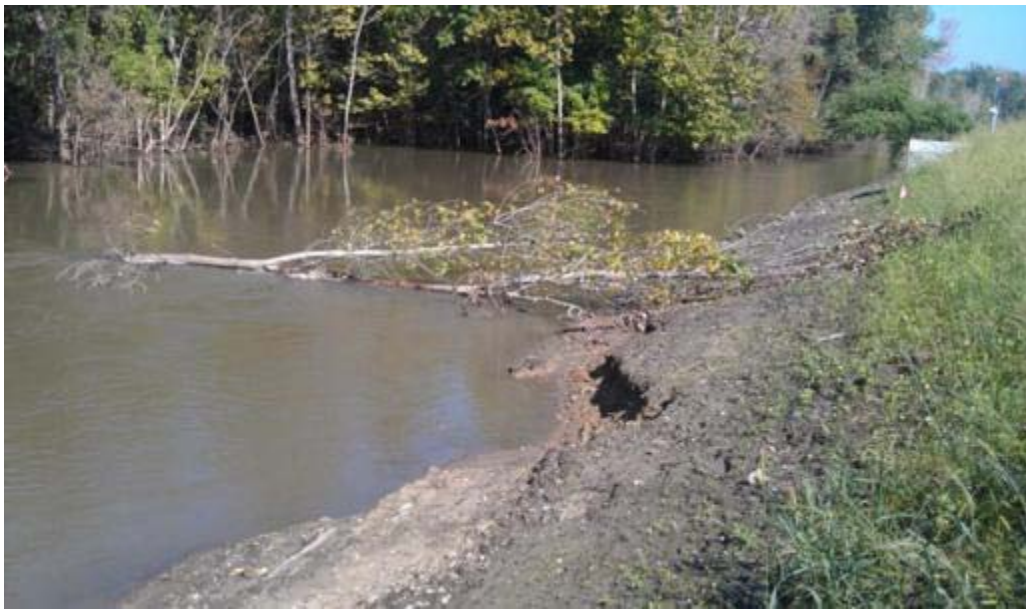
**Figure 102. Levee scouring/erosion: Typical riverside erosion and vegetation loss at L611-614 near Council Bluffs, Iowa**

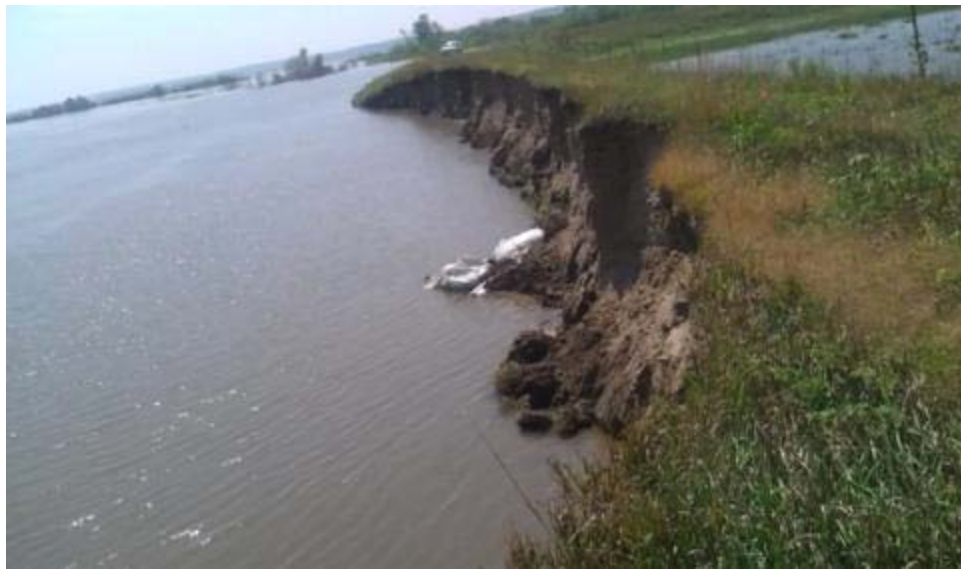
**Figure 113. Levee scouring/erosion: L536 - Levee erosion – more than 50 percent of the embankment is missing – at MR Levee L536**
