**Low-Velocity, Multi-Impact Durability Performance of  
Thick-Section 3WEAVE S2-Glass/SC-15 Composites  
Toughened With Thermoplastic Polyurethane  
Inter-Layer Films**

**ARL-TR-6547**

**August 2013**

# **Army Research Laboratory**

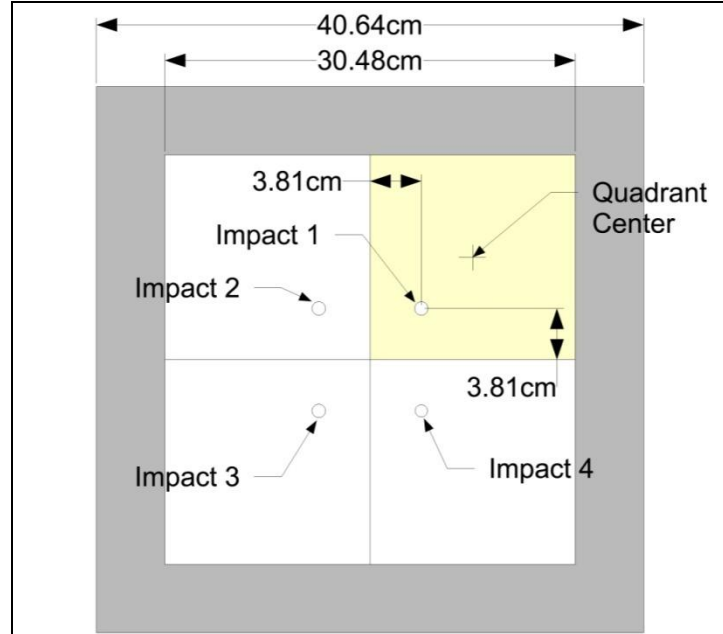
Figure 1. Illustration of clamped area of panel and impact location.

Impact testing was performed on a rigid stand with a thick steel frame that clamped around the perimeter of the sample. The entire stand-frame assembly was secured with 16 bolts that were tightened with a pneumatic wrench to minimize rigid-body motion of the sample after impact and rebound. Figure 1 illustrates the overall panel dimensions and the area of the outside perimeter that was under a clamped constraint.

Figure 1 also shows the locations of impact for all samples in this investigation. Impacts were conducted one-at-a-time to permit non-destructive evaluation of each panel after each impact. Mass and height of the impactor were 227.4 kg and 96 cm, respectively, yielding an impact energy of 2141 J and velocity of 4.34 m/s.

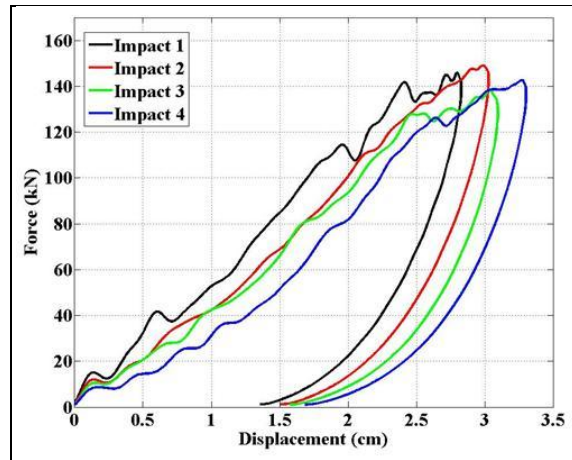
Figure 2. Force versus displacement for 2-D S2/SC-15.

Force-deflection curves are given for all samples in figures 2–5. The force-deflection curves of figure 2 are representative of the set of four samples tested for quasi-isotropic 2-D S2-glass composites. The quasi-isotropic lay-up represents the baseline material system as it is the most characterized and will serve as the point of comparison for the key impact metrics discussed in this report. The force-deflection curves per impact shown in figure 2 illustrate a quantifiable degradation in material stiffness as shown by the decreasing slopes of the impact event portion of the curve. The peak loads on each impact are similar indicating that no one particular impact caused excessive damage (localized crushing under the impactor and shear deformation) to the sample. The rebound portions of the curves also show increasing deflections and permanent out-of-plane deformations with successive impacts. In summary, this material system displays significant quantifiable damage after four impacts and yields useful data for calculating a stiffness of the sample during impact and a progressive reduction in stiffness (herein referred to as the “degradation rate”) between impacts.

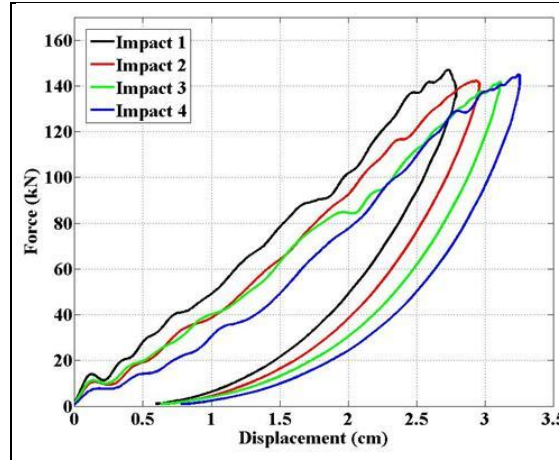
Figure 3. Force versus displacement for 3WEAVE S2/SC-15 (no TPU).

The 3WEAVE\* S2/SC-15 composite response in figure 3 displays force deflection behavior that is very similar to the 2-D S2/SC-15 material. One difference in behavior is that the 3-D material sustains a lower permanent deflection of 0.5 cm to 1 cm. It is interesting that the peak deflections are approximately equal given the different fiber architectures present in the 2-D woven roving (undulating) and the 3-D pre-form (unidirectional with z-direction warp weaver). The difference in fiber architectures may explain the difference in permanent deformation between the materials. Another important observation is that reducing the number of plies (and, hence, delamination sites) alone does not improve the degradation rate of the material. The 22-ply 2-D S2/SC-15 material has 21 interfaces between fiber layers while the 3-D pre-form only has four interfaces.

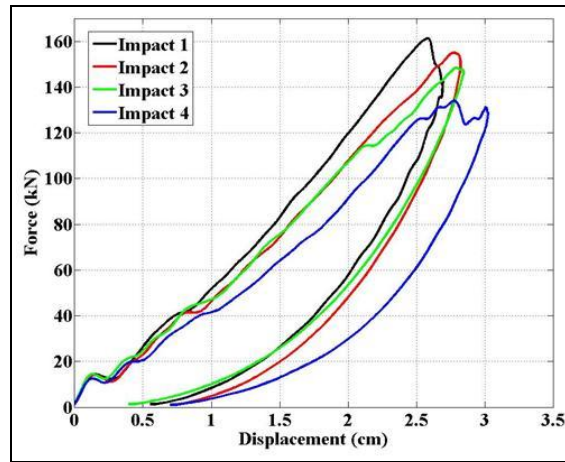
Figure 4. Force versus displacement for 3WEAVE S2/SC-15 + 5 mil TPU.

The force-deflection curves for materials incorporating TPU film inter-layers are given in figures 4–5. The material of figure 4 incorporates 5-mil TPU inter-layers and exhibits a lower degradation rate compared to the 3WEAVE S2/SC-15 material shown in figure 5. Peak loads for impacts 1–3 are higher with less impact energy absorbed by the material. The fourth impact causes more damage as evidenced by a lower peak load and increased sample deflection; however, the inclusion of 5-mil TPU inter-layers did reduce overall panel deflections from 3 to 2.5 cm compared with the 3WEAVE S2/SC-15 baseline.

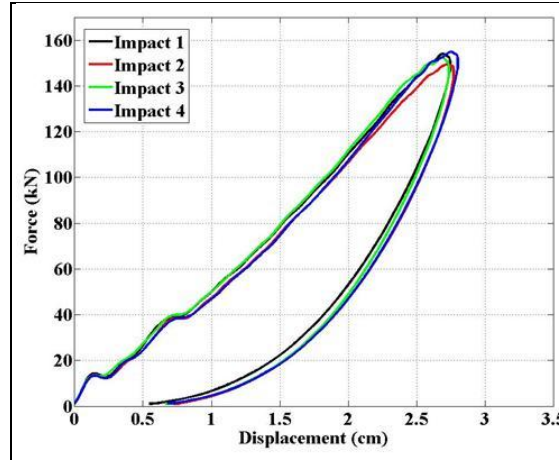
Figure 5. Force versus displacement for 3WEAVE S2/SC-15 + 10 mil TPU.

Figure 5 shows that the 3-D S2 material with 10-mil TPU inter-layers exhibits the best damage resistance of the materials tested in this report. Specifically, no discernible degradation is observed between impacts and panel deflections are the lowest. This result indicates that the 10 mil interlayers are of sufficient thickness to elicit a significantly different mode of mechanical response compared to that of the other materials. This mode of response is one where delamination is essentially eliminated (discussed in section 3.2) and the panel deforms as a monolithic structure.

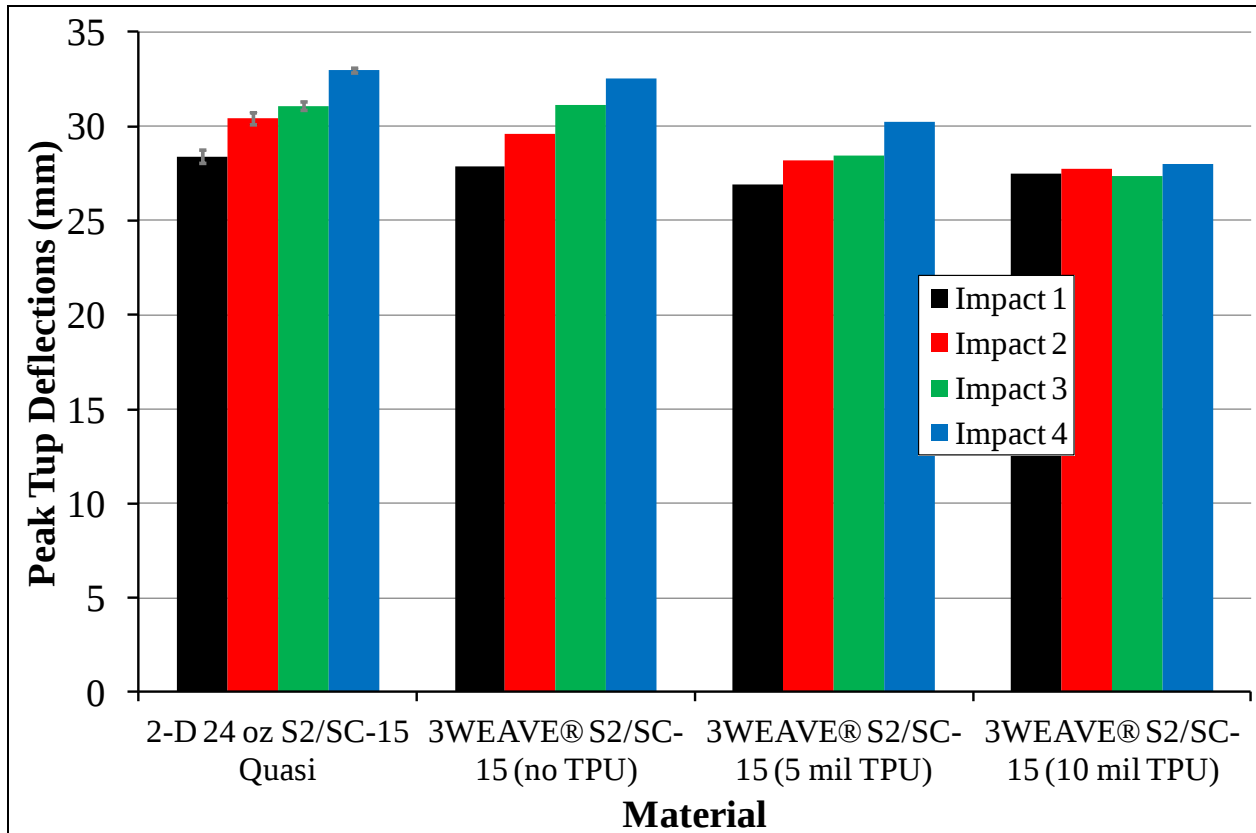
Figure 6. Peak tup deflections for each material. The 2-D material has averages plotted with standard deviation as error bars.

Figure 6 is a column chart comparing the peak tup deflections for all the materials. It is important to note, though, that these values are for comparison only since tup deflections do not account for localized crushing under the impactor and are therefore always greater than the actual back-face deflections that may be measured using optical techniques. Figure 6 shows that the 3WEAVE S2/SC-15 with 10-mil TPU exhibits the lowest deflections of all the materials tested.

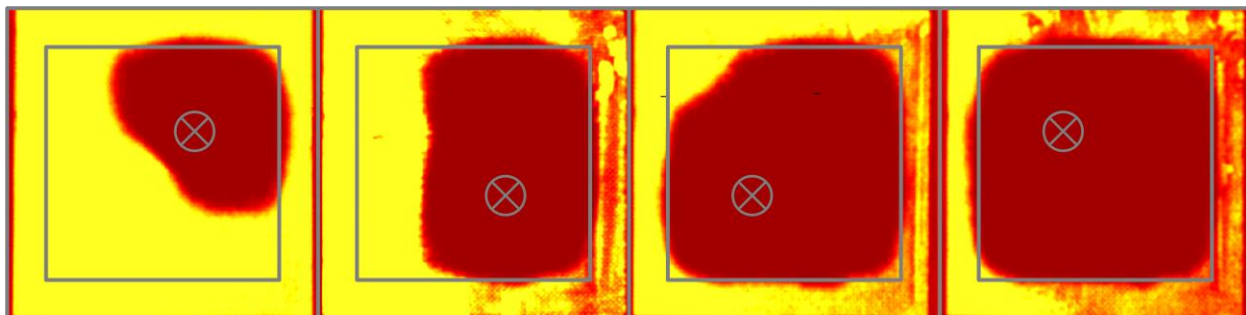
Figure 7. C-scan image showing progression of delamination in a 2-D S2/SC-15 quasi-isotropic sample.

Ultrasonic c-scan images for all the materials are presented in figures 7–10. Figures 7 and 8 show that the materials without interlayers sustain extensive delamination covering the entire aperture of the test fixture after the fourth impact. It is important to note from a comparison of figures 7 and 8 that the 3WEAVE S2/SC-15 material has a similar damage progression per impact to the baseline 2-D S2/SC-15 even though the 3-D material reinforcement only has four interlaminar regions.

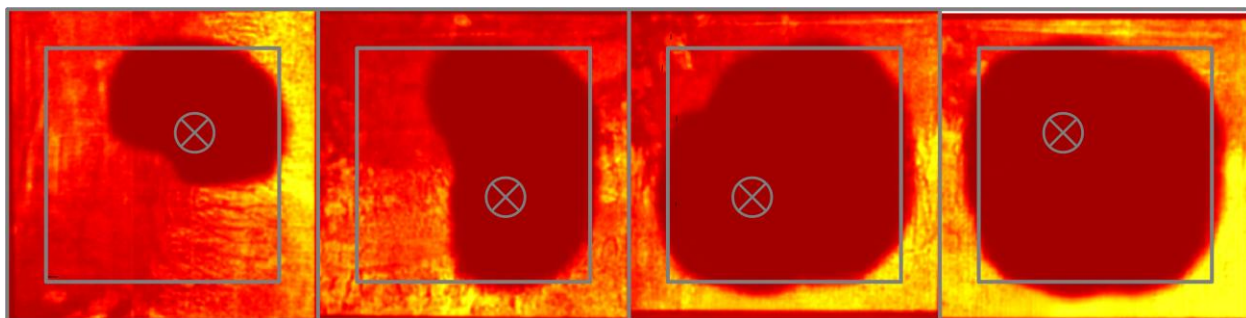
Figure 8. C-scan image showing progression of delamination in a 3WEAVE S2/SC-15 (no TPU) sample.

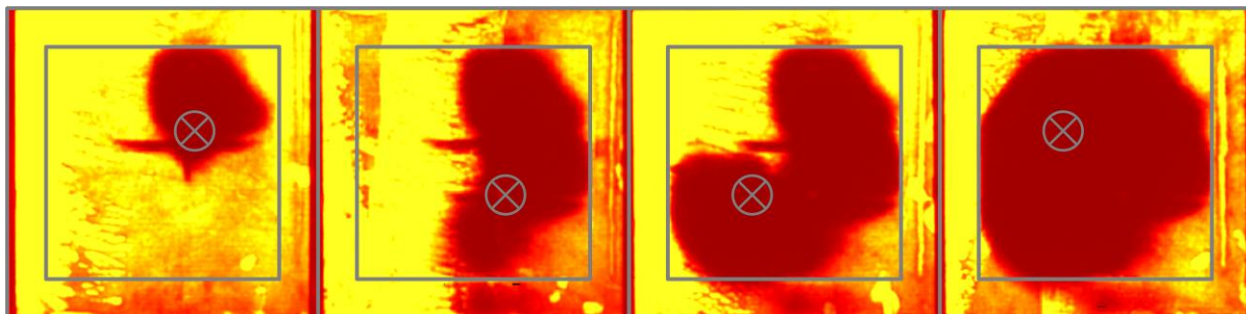
Figure 9. C-scan image showing progression of delamination in a 3WEAVE S2/SC-15 sample containing 5-mil TPU inter-layers.

Figures 9 and 10 show delamination progressions for the materials containing TPU film. The inclusion of 5-mil TPU (figure 9) only modestly improves the delamination response of the 3-D S2 panel. The delamination response of the panel with a 10-mil TPU film is given in figure 10, showing damage only in the immediate vicinity of the impact. After all four impacts, the damage is localized and the sample largely intact. The delamination areas for all materials are summarized in a column chart in figure 11.

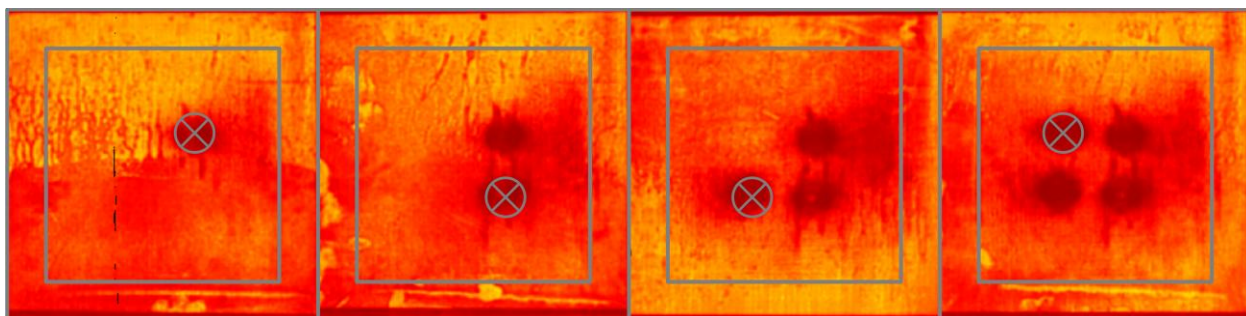
Figure 10. C-scan image showing progression of delamination in a 3WEAVE S2/SC-15 sample containing 10-mil TPU inter-layers.

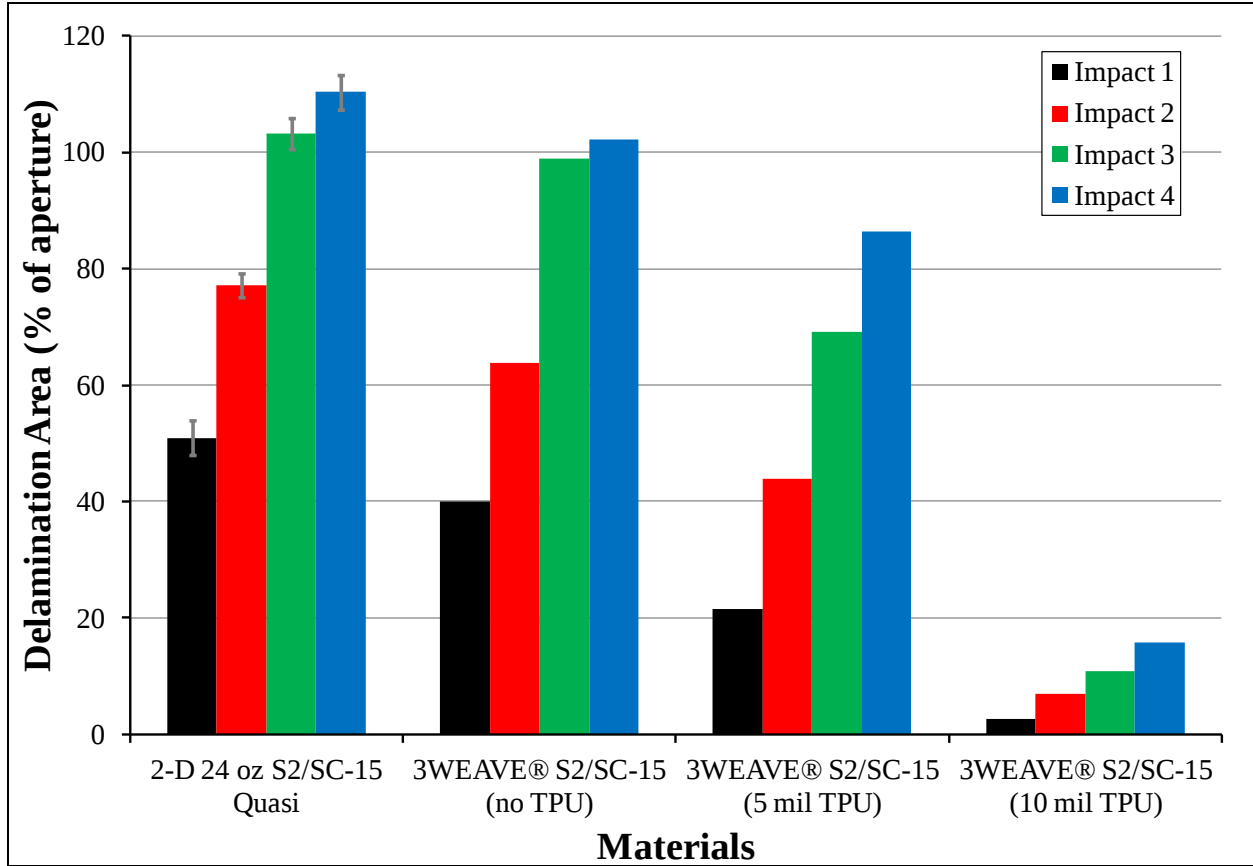
Figure 11. Delamination areas as a percentage of impact table aperture for each material. Averages are plotted for the 2-D S2/SC-15 material with standard deviations as error bars.

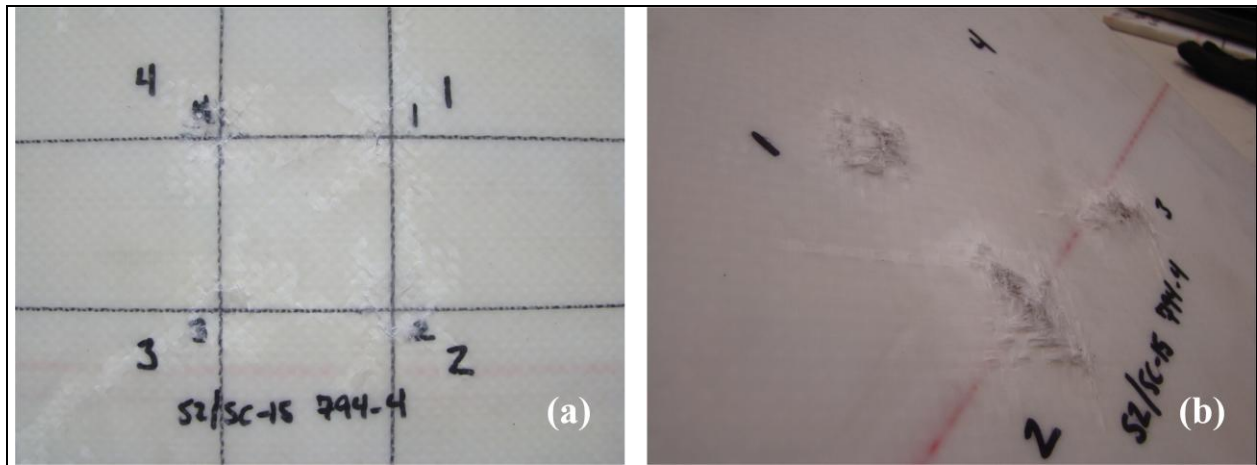
Figure 12. Front-face (a) and back-face (b) impact damage for a quasi-isotropic 2-D S2/SC-15 sample.

Representative images of front and back face impact damage are shown in figures 12–15. The quasi-isotropic 2-D S2/SC-15 material (see figure 12) has a characteristic pattern of damage consisting of front-face crushing immediately under the impactor, back-face perforation, and modest delamination in the vicinity of the impact. This type of damage is associated with localized punching or shear deformation. The damage progression eventually renders the sample more compliant and a transition in damage mechanisms is observed as excessive bending, out-of-plane deflection, and permanent sample deflection. After the second or third impact, the shift in the damage mechanism causes the back-face perforation to diminish or disappear (see figure 12b for the third and fourth impacts).

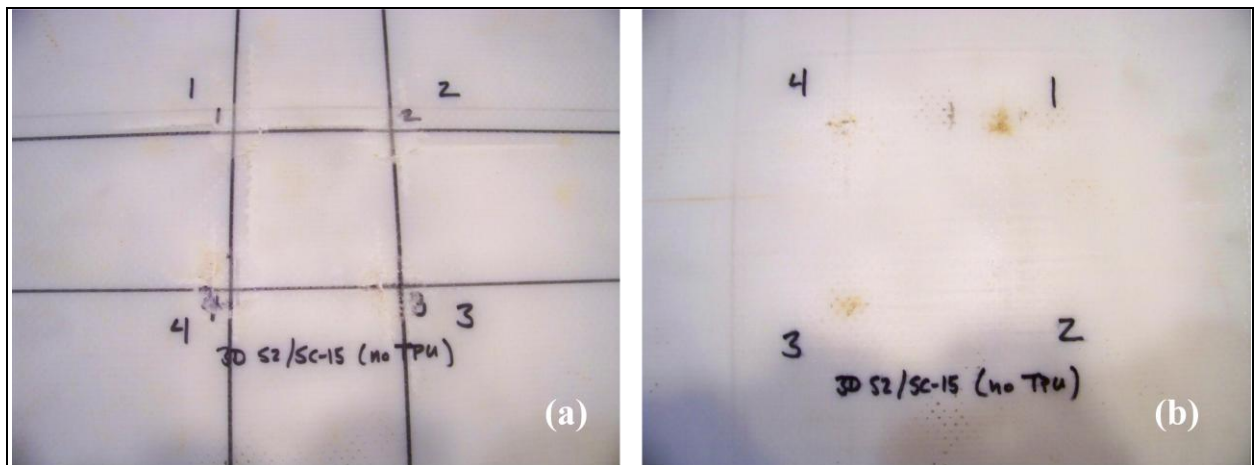
Figure 13. Front-face (a) and back-face (b) impact damage for a 3WEAVE S2/SC-15 baseline (no TPU).

The 3-D reinforced materials of figures 13–15 have a different reinforcing architecture (uni-directional, non-undulating warp and weft fibers) and thus different modes of damage. Visual inspection of figure 14a and figure 15a reveal lines of localized fiber micro-buckling due to the impact and localized crushing under the impactor. The crushing is reduced compared with the quasi-isotropic 2-D S2/SC-15 material as is the back-face perforation. Predominantly what is observed in the 3-D material samples is a front-face indent and raised back-face permanent

deflection with no or little fiber perforation. Combining information obtained from the visual images (figures 13–15) with the c-scan images (figures 8–10) for the 3-D S2-glass materials, the presumed mode of damage is localized delamination at the interfaces of the 3-D reinforcement pre-forms. The localized punching and back-face perforation so distinct in the 2-D S2/SC-15 materials is arrested by the through thickness (z-direction warp weaver) reinforcement in the pre-forms. The best performing material, the 10-mil TPU 3WEAVE S2/SC-15 (see figure 15), exhibits little external evidence that the sample was even impacted (reference c-scan images [figure 10]). The materials with TPU inter-layers then limit the delamination observed in the c-scan images to the vicinity of the impact by toughening the interfaces.

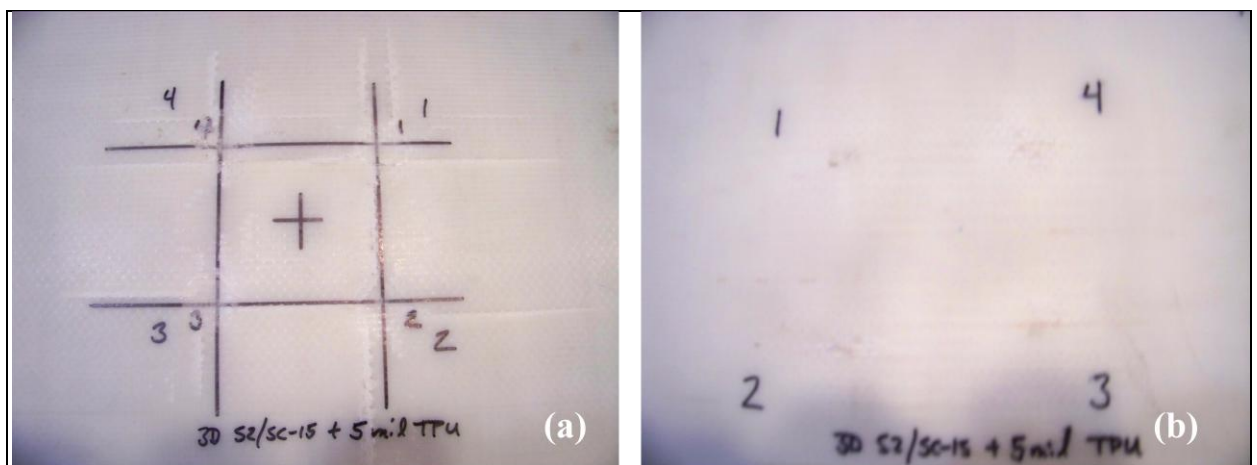
Figure 14. Front-face (a) and back-face (b) impact damage for a 3WEAVE S2/SC-15 + 5 mil TPU sample.

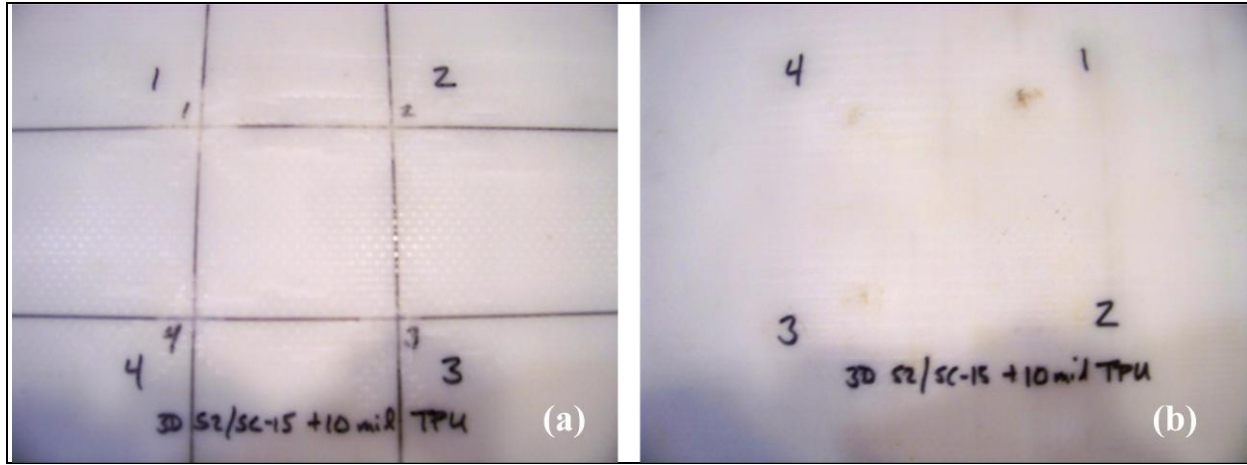
Figure 15. Front-face (a) and back-face (b) impact damage for a 3WEAVE S2/SC-15 + 10-mil TPU sample.

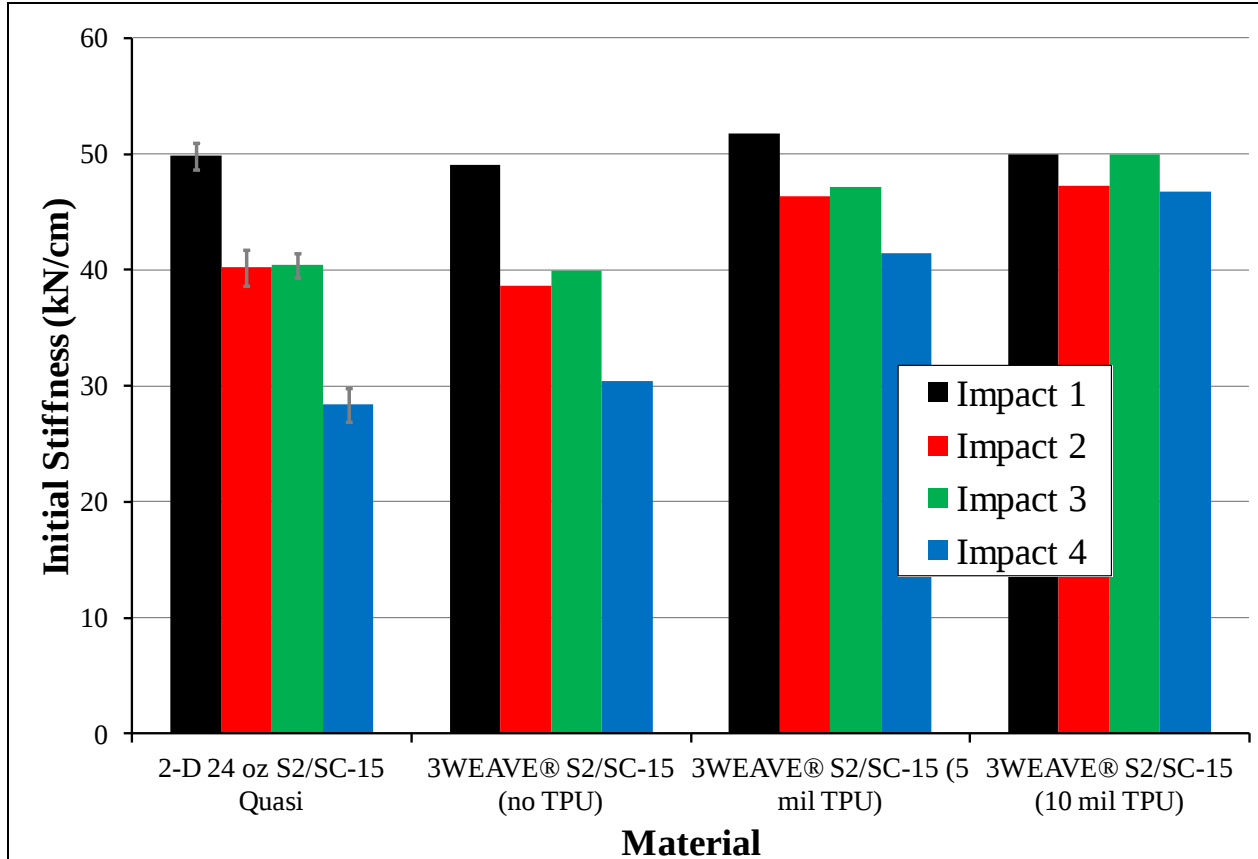
Figure 16. Initial impact stiffness values for all materials with mixed boundary conditions. Averages plotted for 2-D S2/SC-15 material with standard deviation as error bars.

Figure 16 shows a plot of the initial stiffness per impact for all materials. All materials tested that did not contain any TPU film inter-layers displayed a significant drop in sample stiffness (increased rate of degradation) per impact regardless of 2-D or 3-D reinforcements. The drop was most significant after the first and third impacts. It is interesting to note again that there is little difference between the degradations of the 2-D quasi-isotropic S2/SC-15 material and the 3WEAVE S2/SC-15 material even though the 3-D material has only four interfaces and a percentage of through-thickness reinforcement.

All materials with TPU film inter-layers had higher sample stiffness and stiffness retention after successive impacts. The 3WEAVE S2/SC-15 with the 10-mil TPU film inter-layers performed best with an almost immeasurable degradation for an impact energy of 2.1 kJ. It is evident that a

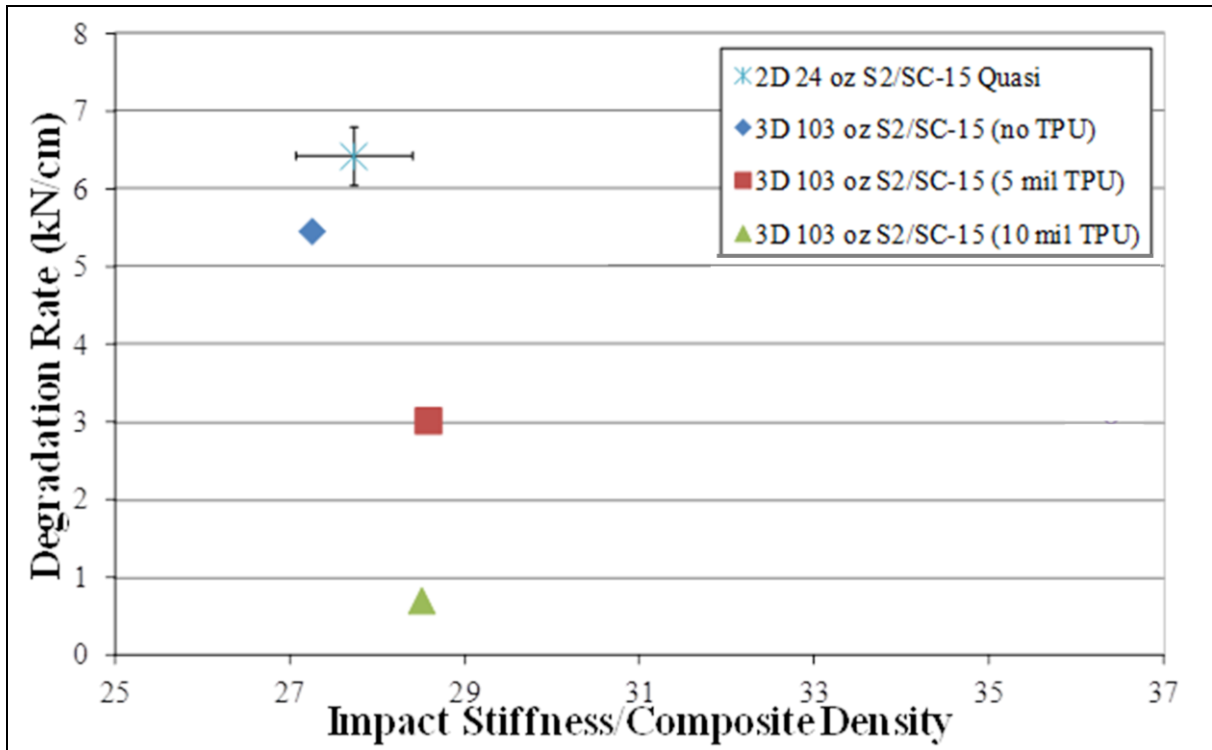
Figure 17. Ashby-type plot showing the relative durability of 2-D and 3-D S2/SC-15 composites with and without TPU film inter-layers.

Figure 17 displays the Ashby-type chart developed in (5) to more easily assess the multi-hit durability of composite materials. The plot contains all the materials tested in this study and provides a good means of comparison between 2-D and 3-D materials with and without TPU film inter-layers. The materials without any interface toughening TPU film inter-layers are less durable and clustered near the upper right of the plot with higher degradation rates. The best performing material has the lowest degradation rate, the 3WEAVE S2/SC-15 with 10-mil TPU.
