**FUEL LUBRICITY IMPACT ON SHIPBOARD ENGINE AND FUEL
SYSTEMS AND SENSITIVITY OF U.S. NAVY DIESEL ENGINES
TO LOW-SULFUR DIESEL FUEL**

**INTERIM REPORT
TFLRF No. 414**

**U.S. Army TARDEC Fuels and Lubricants Research Facility
Southwest Research Institute[®] (SwRI[®])
San Antonio, TX**

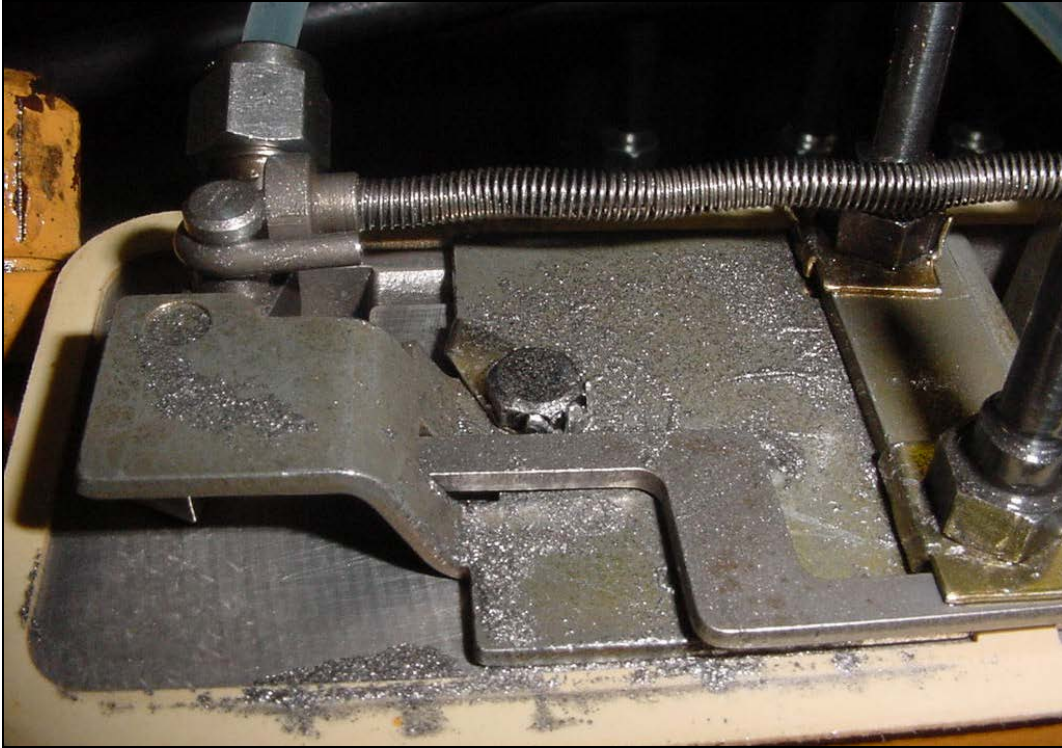
Figure 2. Delphi Pump Wear Debris with S-8 (F1000) Fuel

A used Delphi pump was operated on the test stand. The pump was inspected and built with serviceable components, then sent to a diesel fuel injection service facility to verify pump operation. The pump was installed on the test stand to validate the test stand drive coupling arrangement and alignment. The drive system was validated by operating the pump for several hours on diesel fuel and monitoring the pump performance. Since the pump was mounted on the stand it was decided to switch load the fuel from the diesel fuel to the Neat S-8 (F1000) fuel. The pump is used on the Cummins 3.9L “B” series engine that has the following military applications: USMC rough terrain crane, USN 4000 lb rough terrain forklift, and Army 7.5T wheeled crane. The pump stand was operated at rated speed on neat S-8 fuel, at 16.5 hours the pump had worn to the point where there was no fuel delivery. Inspection of the pump revealed extreme roller and cam wear. Figure 2 shows the wear debris in the pump. There were indications of severe fuel lubricity problems with using neat S-8 fuel in a fuel lubricated rotary injection pump.

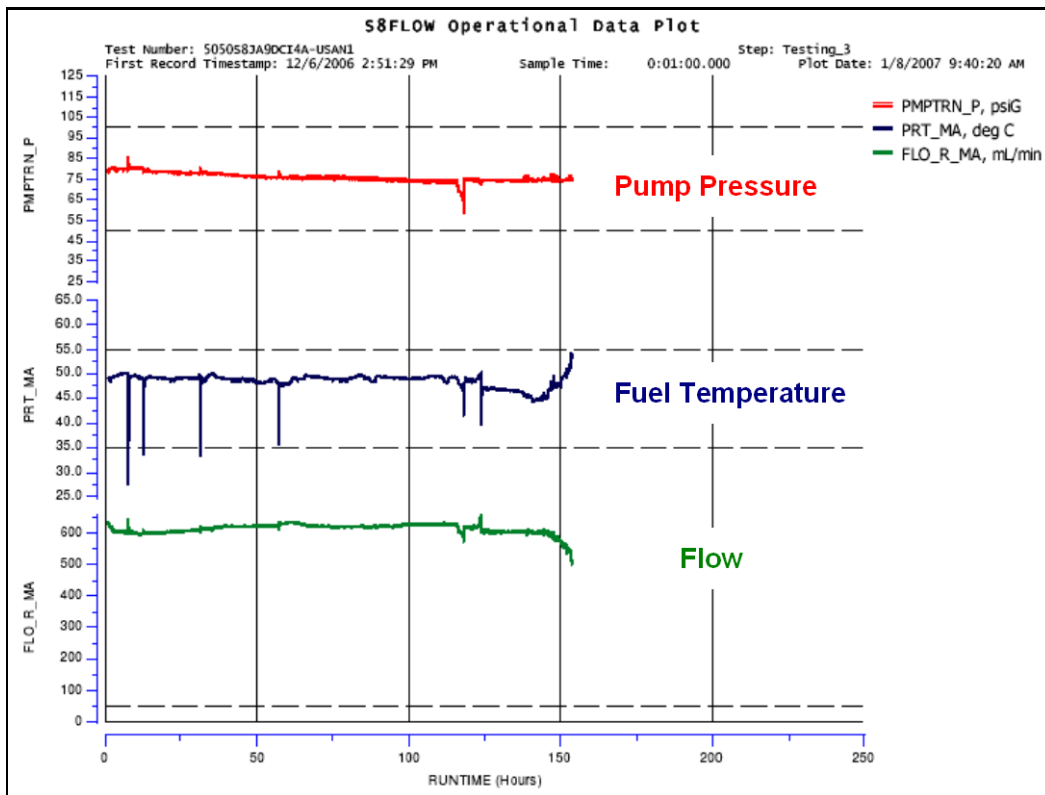
Figure 3. Operational Data Plot

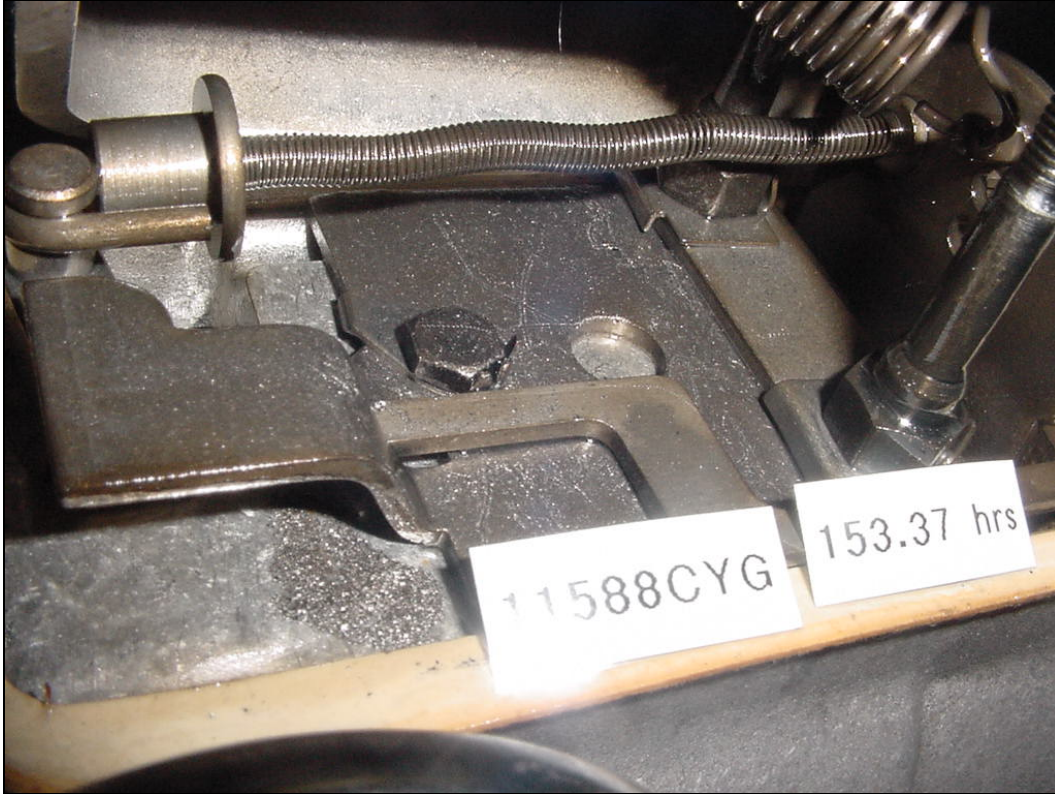
Figure 4. Metal Debris inside Pump at 153-hours for Test No. 4

A test of the 50/50 S-8/Jet A fuel with 9 ppm DCI-4A was evaluated for a Delphi rotary pump. The pump was run-in for 2 hours at the fuel injection service, however there was damage due to un-lubricated contact between the drive thrust washer and the aluminum housing. The service supplied a new housing and installed the internal components into the new housing, made adjustments, and performed a calibration check noted as New housing in Table 5. At 153 hours, the test was stopped because of apparent pump wear. As shown in Figure 3, fuel temperature was increasing (the middle plot), and pump flow was decreasing (bottom plot). The pump cover was removed and metal wear debris was present, Figure 4. The pump-metering valve felt as if there was debris in the bore.

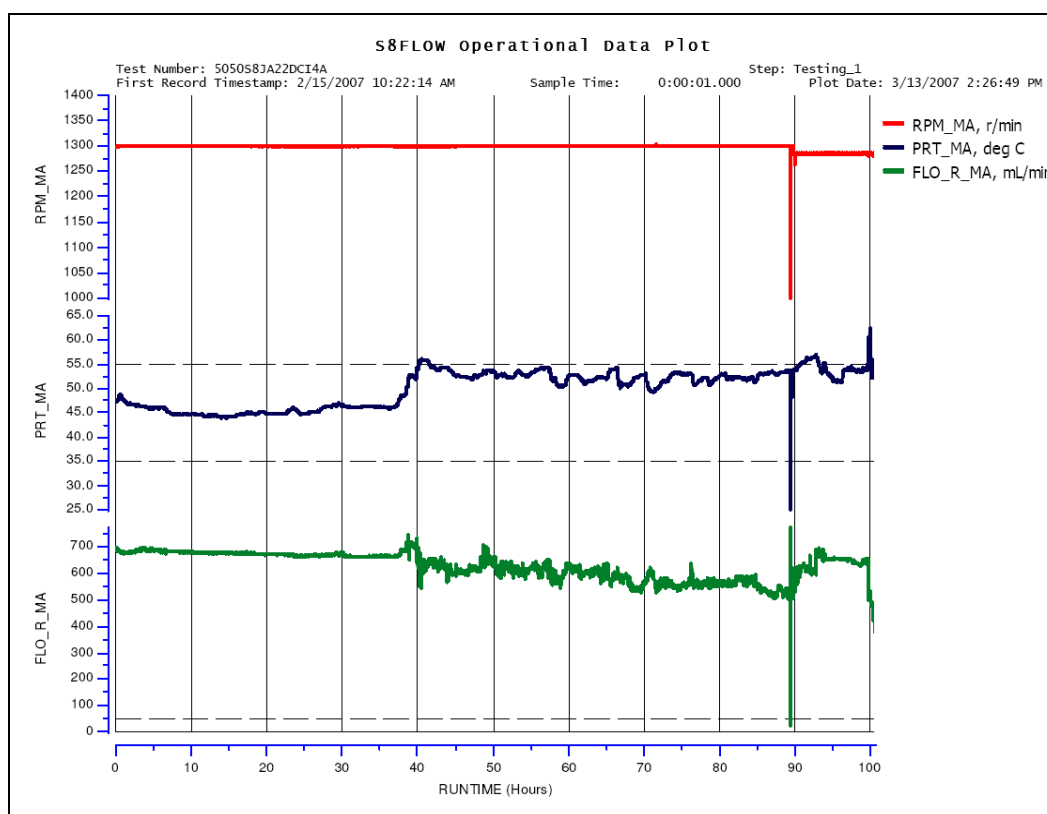
Figure 5. Delphi DPA Pump Performance Data with a 50/50 Blend of S-8/Jet A with 22.5 ppm DCI-4A Corrosion Inhibitor/Lubricity Improver (CI/LI) Additive

A test of the 50/50 S-8/Jet A fuel with 22.5 ppm DCI-4A was performed for a Delphi rotary pump. Noted in Figure 5 is a change in pump return temperature and delivery at around 39 hours of operation. The change in return temperature suggests a change in the wear rate of the components in the pump. Likewise the variability of the pump delivery suggests a change in the pump, however the pump was still delivering fuel above the flow limit at 39 hours.

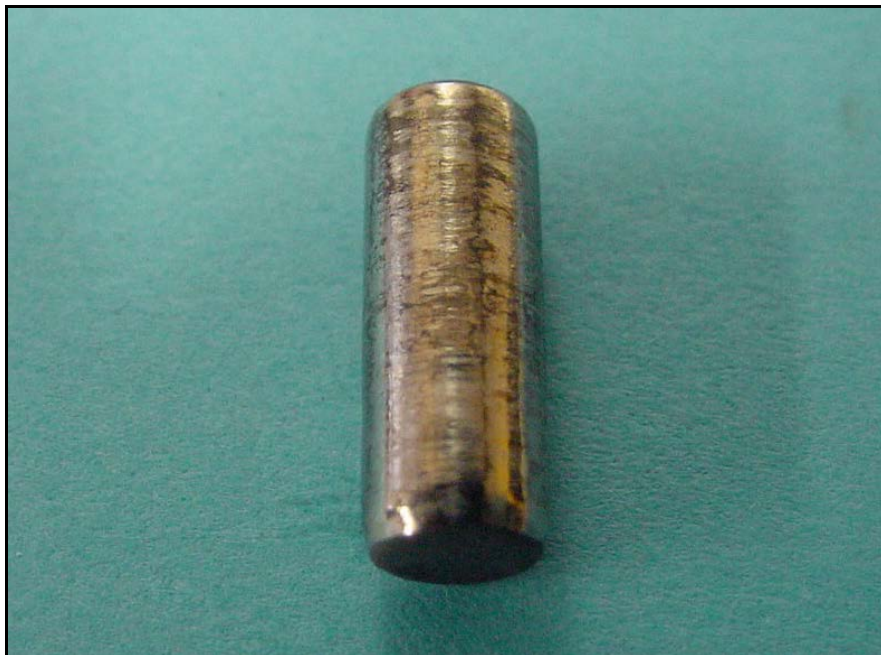
Figure 7. Delphi DPA Pump Cam Roller Wear with 50/50 S-8/Jet A Fuel with 22.5-ppm DCI-4A CI/LI Additive

The cam roller from the DPA pump is shown in Figure 7. The wear seen on the roller in Figure 7 is typical for all four rollers. Not evident from the photograph, the roller is slightly tapered due to wear. Once the roller becomes tapered, wear in the pump would have accelerated because the roller would no longer roll on an axis parallel to the driveshaft axis of rotation. Figure 8 shows one of the roller shoes, with severe wear that suggest the roller was shifting in the shoe, and not just rotating. The level of wear debris evident throughout the pump is shown on the governor weight in Figure 9.

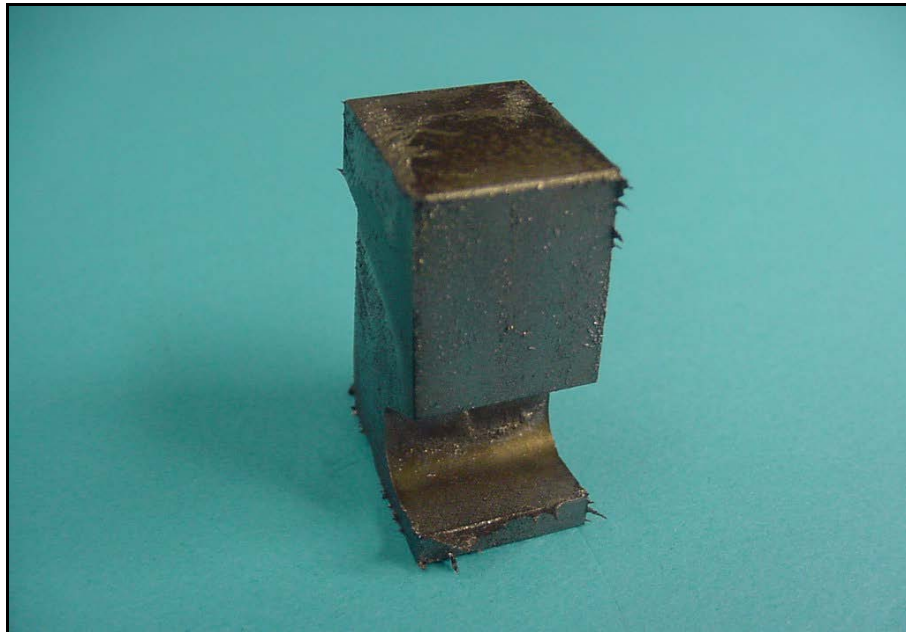
Figure 9. Delphi DPA Pump Governor Weight with 50/50 S-8/Jet A Fuel with 22.5-ppm DCI-4A CI/LI Additive

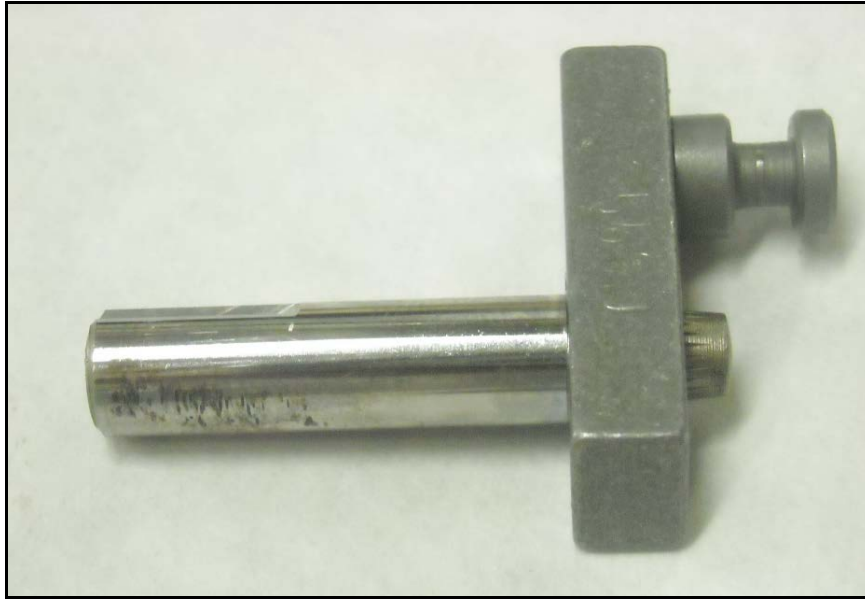
Figure 11. Delphi Rotary Fuel Injection Pump Metering Valve after 250 hours with S-8/Jet-A + 22.5-ppm DCI-4A Fuel

Figure 11 is the metering valve from the test pump revealing an unusual wear pattern. The governor thrust washer from the S-8/Jet A + 22.5 ppm DCI-4A test revealed the highly unusual wear pattern shown in Figure 12. The thrust washer appeared to stop rotating and distinct wear scars formed from the action of the governor weights. Figure 13 shows a thrust washer with a more typical wear pattern. Other components of the governor linkage also revealed larger than normal wear scars.

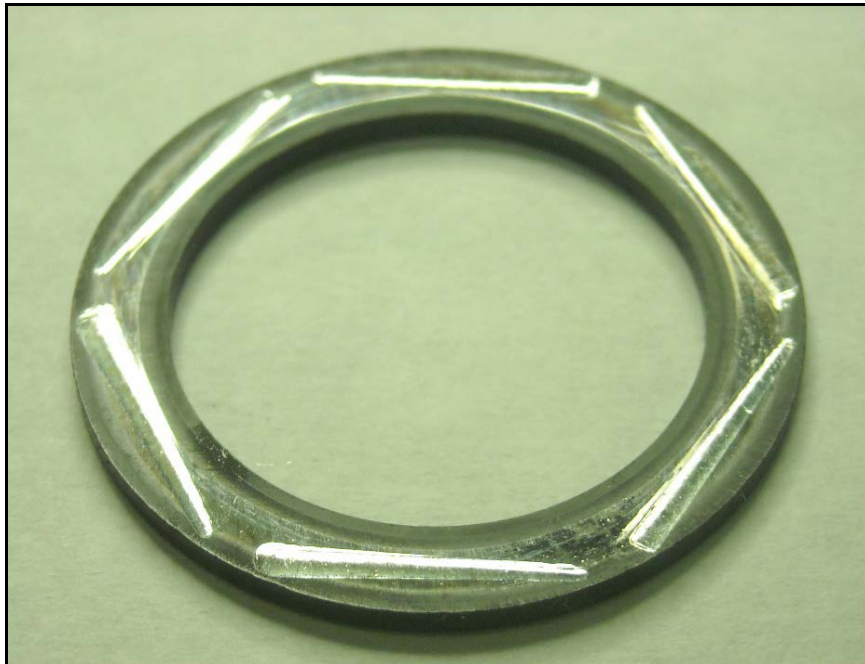
Figure 12. Wear Scars on Governor Thrust Washer from Governor Weights at 250 hours with S-8/Jet A + 22.5 ppm DCI-4A Fuel

THRUST. WASH.	Unusual wear pattern from the foot of the weights. There is four weights and there was six grooves worn into the washer. Normally the wear scar is consistent around the surface of the washer.
THRUST. SLEEVE.	Worn from fingers of governor arm.
GOV. WEIGHTS	Heavy wear on foot from washer contact. Wear on heel from weight cage contact.
LINK HOOK	Groove worn into linkage long spring retainer.
M-VALVE	Unusual chatter wear marks on valve.
DR. SHAFT SPLINE	Normal Wear.
DR. SHAFT SEAL AREA	Worn from seal contact. Some wear at bearing pilot contact.
ADV. PISTON	Normal Wear. One scratch.
HOUSING	Normal Wear.
R/R DIMENSION - A/E	1.9930" Before test. As rec. from factory. Diesel Injection adjusted on the stand starting point unknown. After test - 1.9870"
R/R DIMENSION - D/H	1.9930" Before test. As rec. from factory. Diesel Injection adjusted on the stand starting point unknown. After test - 1.9864"

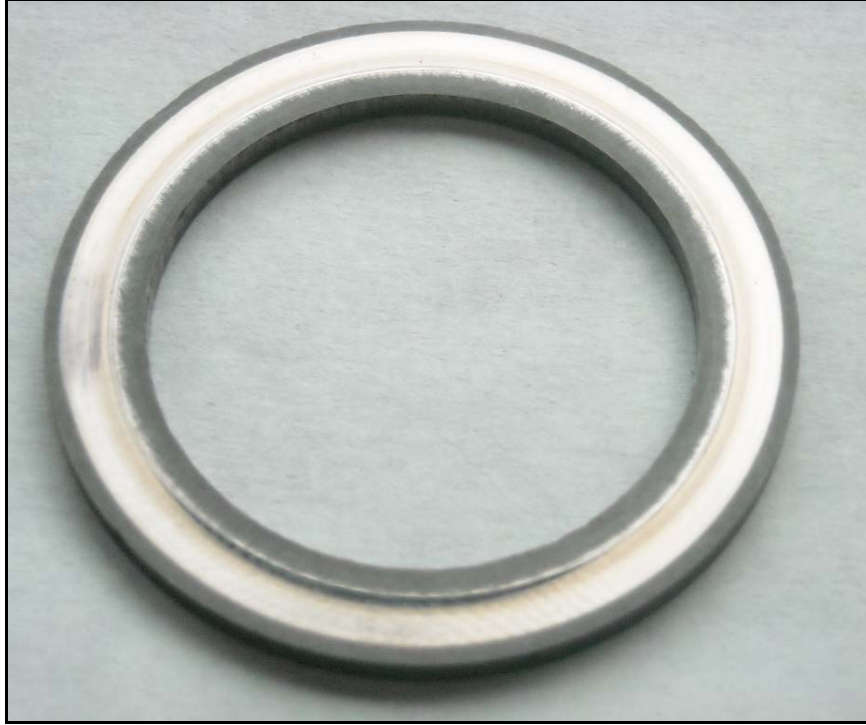
**Figure 13. Delphi Thrust Washer with Typical Wear Pattern
after 500 hours Jet A Fuel**

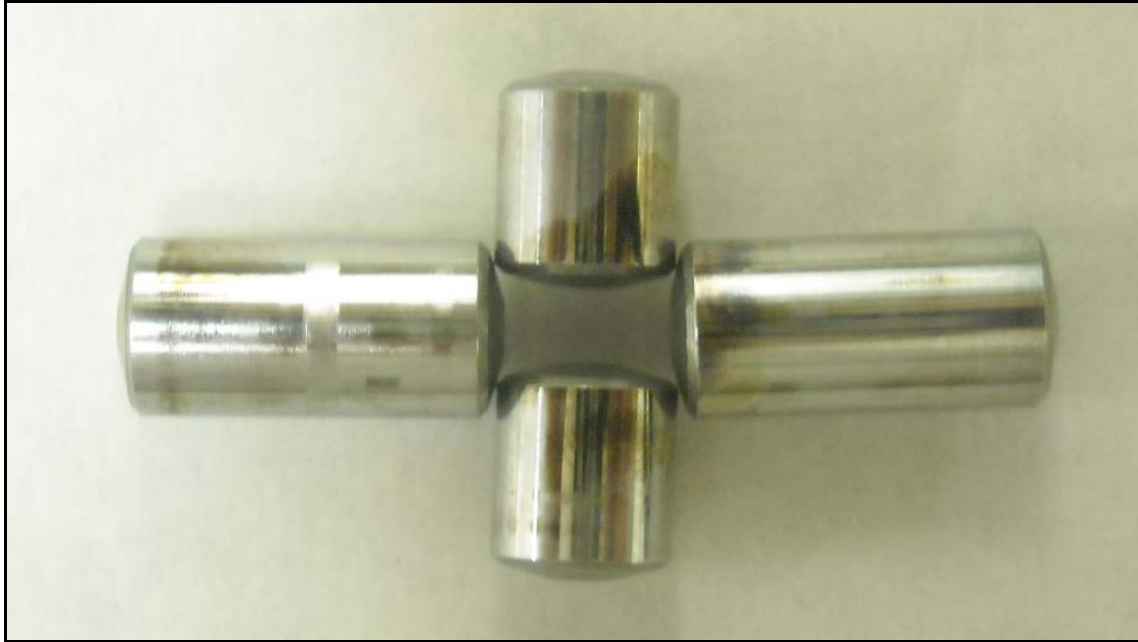
Figure 14. Delphi Pumping Plunger Wear Scars after Operation with S-8/Jet A + 22.5 ppm DCI-4A Fuel

The pumping plungers, Figure 14, from the S-8/Jet A + 22.5 ppm DCI-4A test revealed wear that caused them to cock in their bores when pressure was applied to measure the roller-to-roller dimension. The roller shoes in Figure 15 revealed substantial wear scars on the sides contacting the pumping plungers.

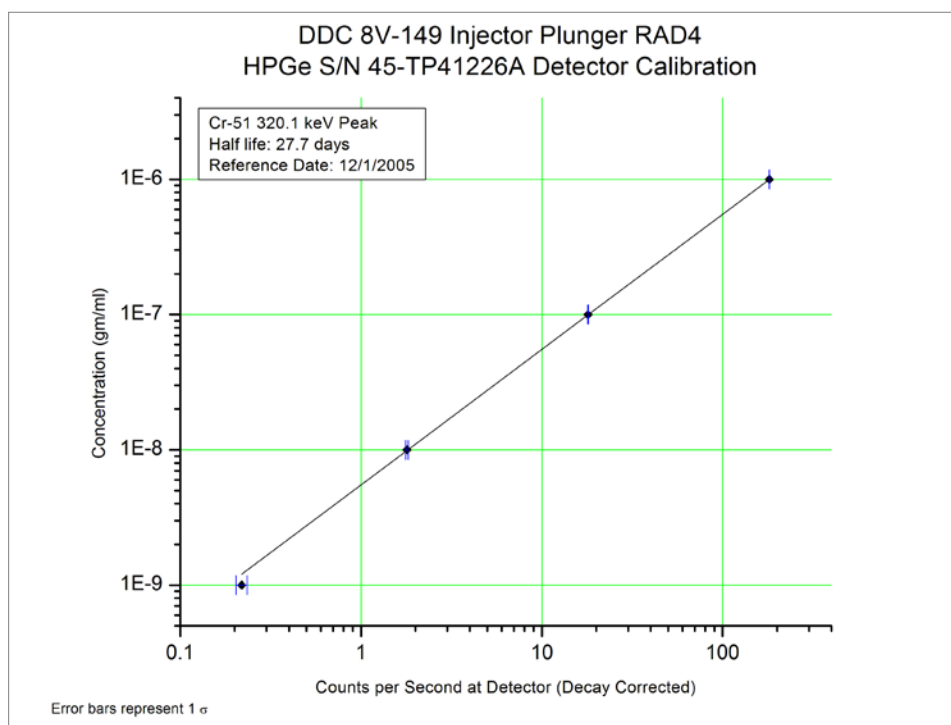
Figure B1. Radioactive Tracer Wear Calibration Curve

The irradiated parts appeared to be in as sent condition, with no visible changes to the surfaces. The two calibration pieces were carefully weighed and digested into a liquid solution containing a combination of hydrochloric and nitric acid. The solution was then diluted with DI water into a stock solution volume of 100 ml. A series of four calibrating solution concentrations were made from this stock solution. The calibrating solution concentrations were 1E-6, 1E-7, 1E-8, and 1E-9 gm/ml. These solutions were individually poured into a detector measurement vessel in order of increasing concentration. Each solution was counted on an Ortec High Purity Germanium (HPGe) detector (S/N 45-TP41226A, 80% relative efficiency) with a Canberra DSA-1000 multichannel acquisition system and analyzed with Canberra Genie-2000 gamma spectroscopy software. The measured counts at the 320.1 keV peak (Cr-51) were decay corrected to a reference date of 12/1/2005. Cr-51 has a half-life of 27.7 days. The decay corrected counts were then plotted against concentration and a least squares method was used to determine the slope of the resulting line. This slope is used as the calibration factor to convert decay corrected counts to the concentration of wear debris in the test fuel. The calibration curve is shown in Figure B1.

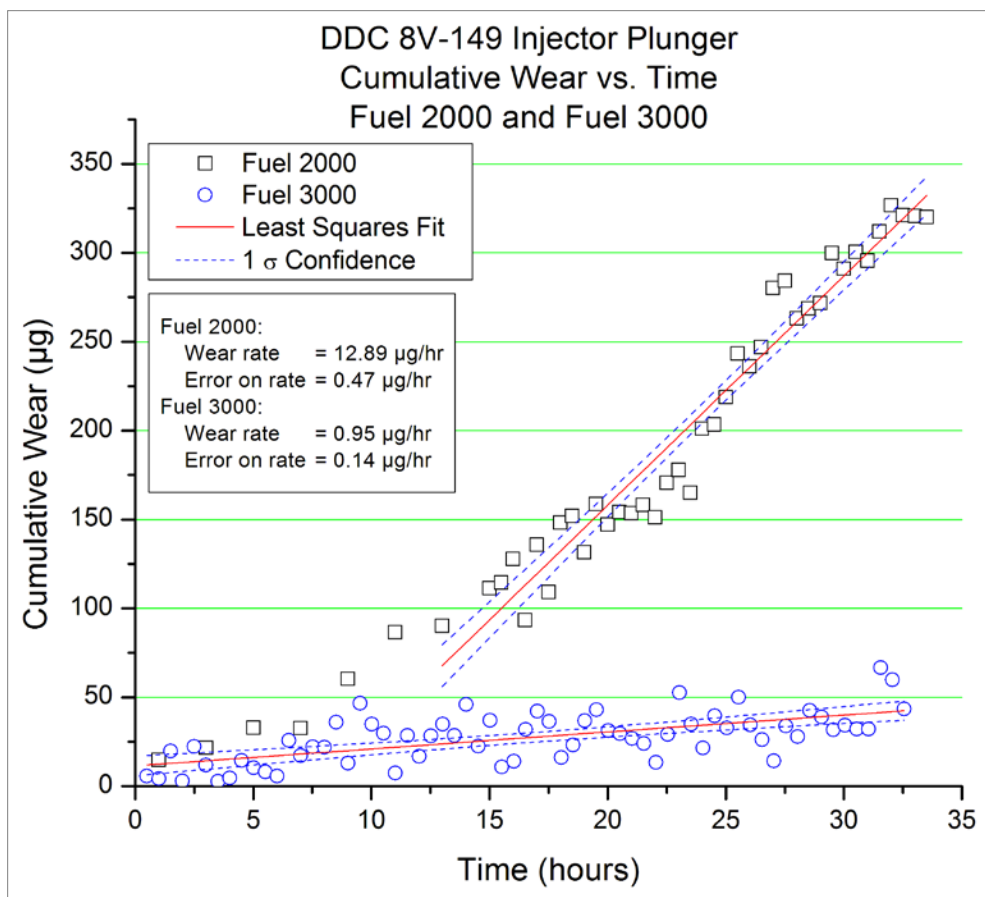
Figure B2. Wear Slopes between Fuels

Test fuel was circulated through a specially designed stainless steel vessel mounted on an Ortec HPGe detector (S/N 45-TP41226A). The vessel is designed to achieve a good counting efficiency. Fuel flow rate through the vessel was maintained at approximately 1 liter/minute. Sufficient counts were present to allow for a data measurement increment of 30 minutes, allowing for an increased time resolution. The Fuel 2000 was run for 33.5 hours and Fuel 3000 was run for 32.5 hours. Cumulative wear as a function of time is shown in Figure B2. It can be seen that Fuel 2000 had an initially lower wear rate that appeared to increase to a steady state rate starting at approximately 13 hours. Cumulative wear data for this steady state wear region between 13 and 33.5 hours were fitted to a line using the least squares method. This line is shown with 1 standard deviation confidence limits on the plot. The slope of this line represents the steady state wear rate. Fuel 3000 appeared to wear at a steady state rate from the beginning; therefore the entire data set was used to determine the steady state wear rate for Fuel 3000. Steady state wear rates for these two fuels are shown in Table B1.

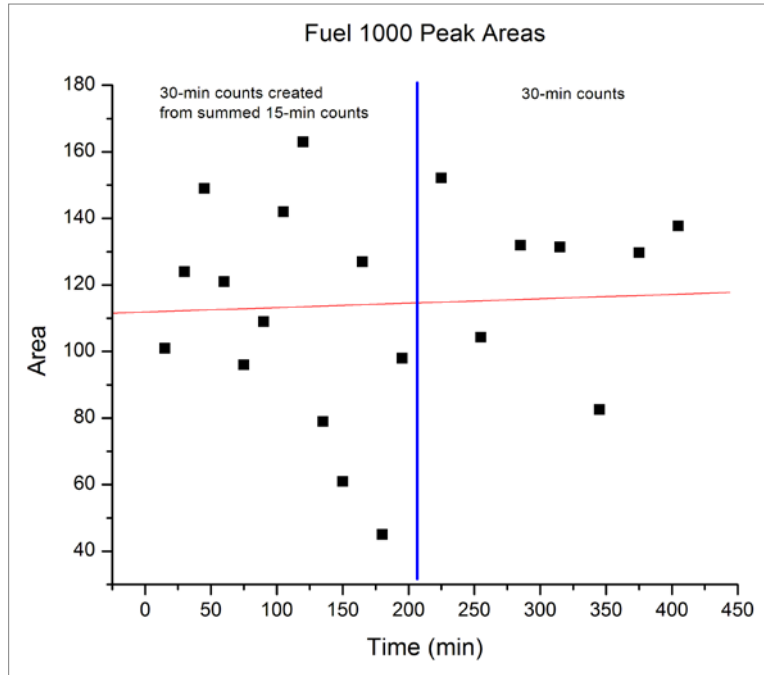
Figure B3. Fuel 1000 Radioactive Data over Test Period

Following removal of the 3000-g fuel the Detroit Diesel unit injector rig was charged with the 1000-g scuffing load fuel. The rig was operated on the 1000-g fuel for 5.3 hours when it seized. The radioactive detection sample time was set at 15 minutes in anticipation of the wear rates being higher than the 2000-g fuel. The number of counts was below a threshold level for the 15 minute samples, so the integrating period was changed to 30 minutes after 3 hours of operation. Even with the 30 minute integration period very small wear rates were observed. Neighboring 15 minute sample counts were added to analyze as 30 minute samples, and the results are plotted as Figure B3. A wear rate is not discernable from the data. It is being suggested that the mechanism for seizure was evident from the beginning, with metal transferred between surfaces occurring, and wear material not showing up as activity in the fuel.

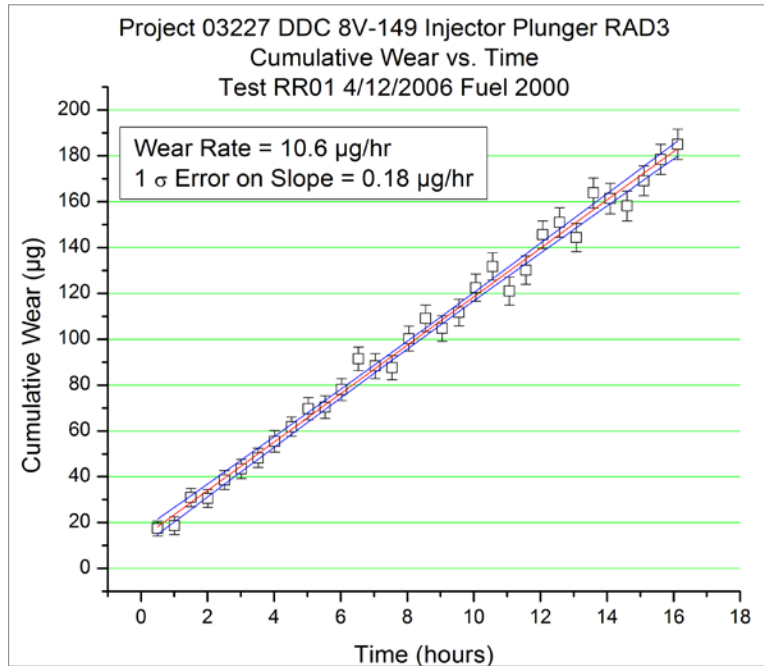
Figure B4. DD 149 Unit Injector Wear with Fuel 2000

A decayed plunger was reactivated at MIT and the calibrations performed. Wear was checked with Fuel 2000 with the new plunger and revealed a wear rate (10.6 ug/hr) very similar to the wear rate of the first trial with Fuel 2000 (12.9 ug/hr), see Figure B4.

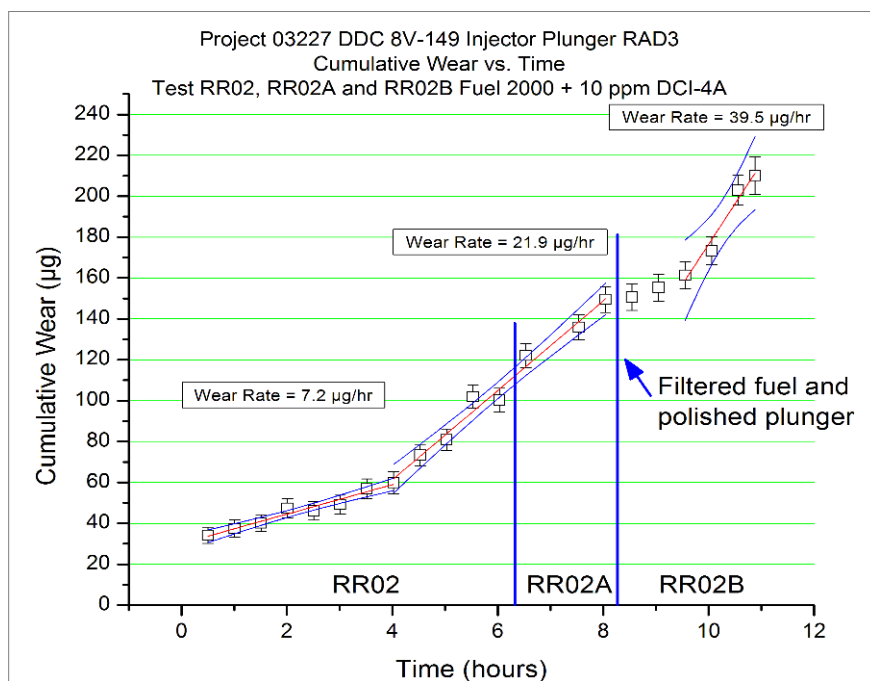
Figure B5. DD 149 Unit Injector Wear with Fuel 2000 + 10 ppm DCI-4A

The decision was made to add 10 ppm DCI-4A to the Fuel 2000 and look at the wear rate. The initial rate of wear seen (Figure B5) was at a lower level of 7.2 ug/hr before a sudden change in wear occurred. Inspection of the plunger revealed some scoring that might have occurred when the rack was adjusted to match flow rates with earlier work.

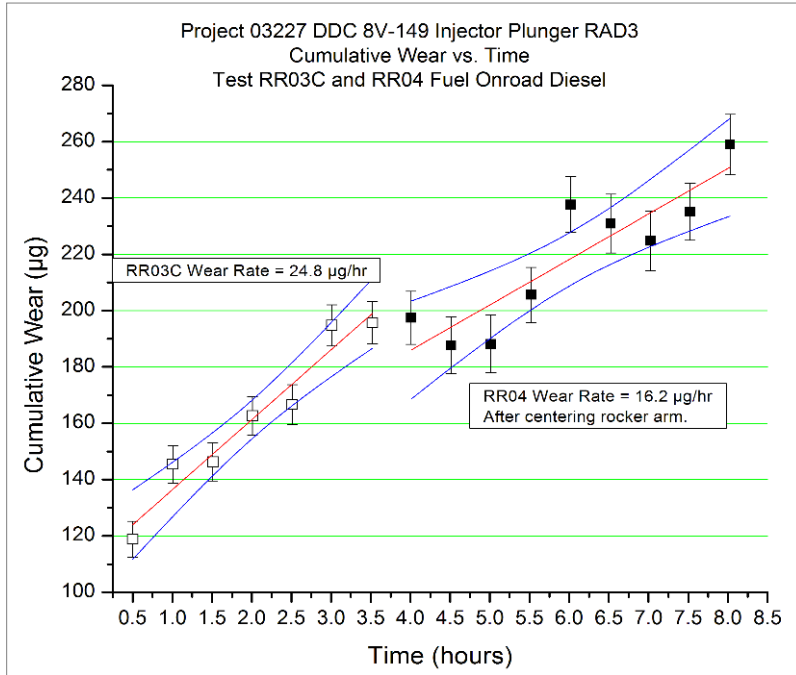
Figure B6. DD 149 Unit Injector with Diesel Fuel and Centered Rocker Arm

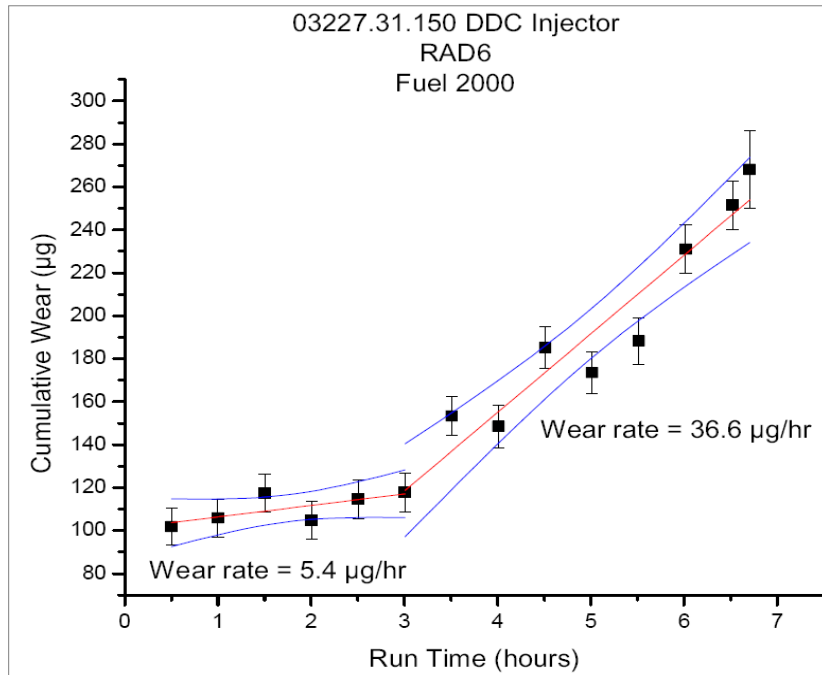
Figure B7. Wear Rate Deviation Attributed to Head Movement

The rig had been reconfigured in an attempt to resolve an alignment issue. Initially the wear rate started out low then shifted to a higher wear rate as seen in Figure B7. The cylinder head seemed to start bouncing around on the gasket material (which seals oil from leaking) and the wear rate started going up.

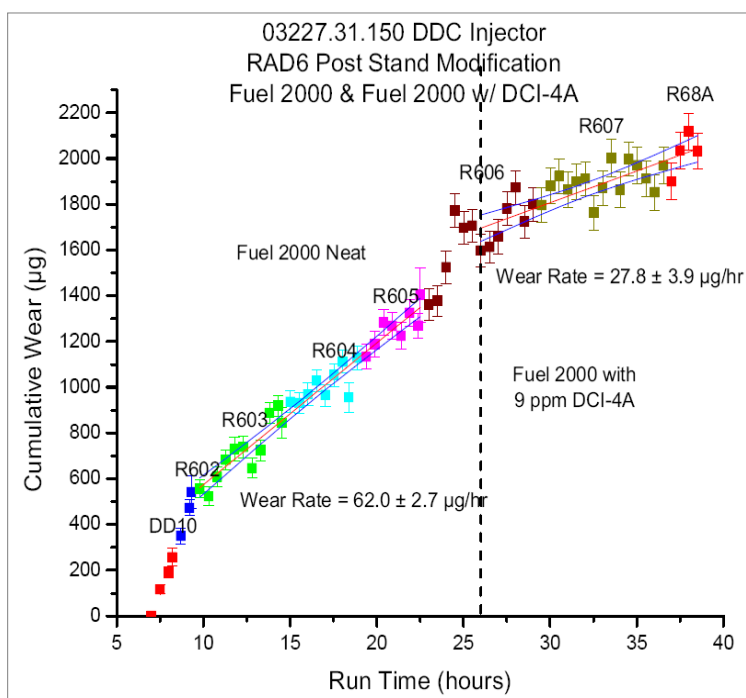
Figure B8. Fuel 2000 and Fuel 2000 + DCI4A DDC Unit Injector Wear Rates

Several experiments were performed with Fuel 2000 to determine adequacy of the injection rig repairs. Prior to operation the barrel and plunger were lapped together in an attempt to polish the surfaces after running misaligned. The plot for Fuel 2000 is shown in Figure B8. The high wear rate eventually decayed to a steady value that repeated day to day, as represented by R603 through R605 in Figure B8. The wear rate stabilized at 62.7 micrograms/hour of material removed from the plunger. During run R606, 9 ppm of corrosion inhibitor fuel additive DCI-4A was added to the fuel, at the time denoted by the dashed vertical line. As seen in Figure B8 the wear rate decreased to a steady value of 27.8 micrograms/hour of material removed from the plunger. This wear rate appeared to stabilize over several days as reflected in runs R606, R607, and R68A. During operation of R68A, a fuel line broke and the test charge leaked out. It should be noted that the data collected was integrated over 30 minutes for the Fuel 2000 runs. At that time it was suggested that Fuel 3000 be put in the system to see the wear results. The Fuel 3000 runs are shown in Figure B9, which reveal an initial high wear rate that eventually stabilizes to a lower value. What is interesting, is the initial wear rate is higher than the rate seen at the end of the Fuel 2000 runs. The system was cleaned between fuels, and flushed with the test fuel until background counts were low, and then filled with the batch of the test fuel. There appears to be a run-in period with a fuel change that is not completely understood. It should be noted the statistics with the lower wear rate, higher lubricity fuel indicate more variability for the 30 minute counting period. More variability is evident because the wear rate is lower and also because the activity of the isotope being monitored is decaying.

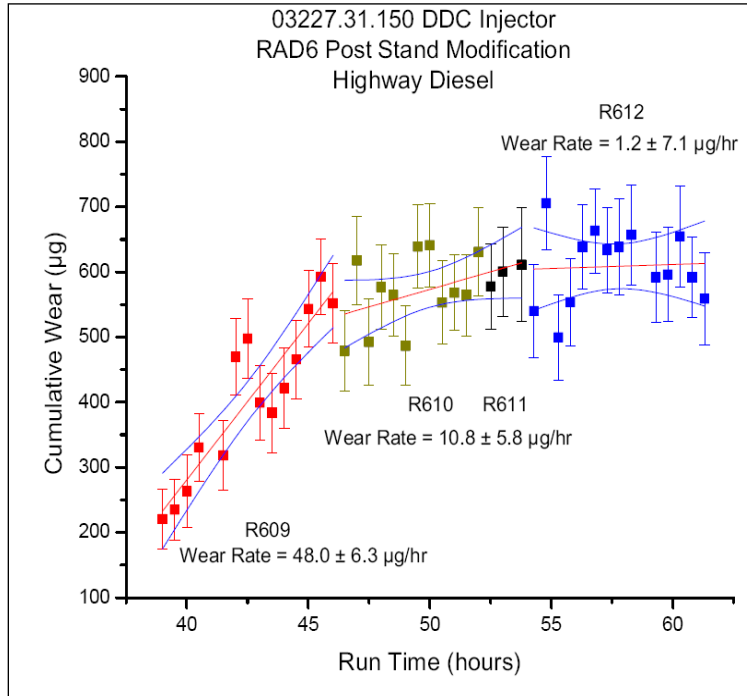
Figure B9. Fuel 3000 DDC Unit Injector Wear Rates
