**AFRL-RH-WP-TP-2013-0073**

## **GLATZ PROTOTYPE SEAT IMPACT TESTING**

**Interim Report for January 2012 to May 2013**

| REPORT DOCUMENTATION PAGE | | | | Form Approved<br>OMB No. 0704-0188 | |
|---|---|---|---|---|---|
| 14. ABSTRACT<br>A series of dynamic tests with the Glatz prototype H-60 troop seat was performed to determine occupant protection during a crash event. These were re-tests of the Glatz prototype seat detailed in AFRL-RH-WP-TR-2012-0103. The re-tests were of Combined Vertical tests at which the Glatz prototype seat structurally failed during the initial study due to the manufacturer deviating from design drawings. A Pure Horizontal test was also conducted to determine structural strength of the Glatz prototype seat. Biodynamic response data were compared to standard injury criteria recommended by the Full Spectrum Crashworthiness Report as well as other seats tested at the same conditions. A total of eight tests were conducted. Additional manufacturing errors were found in several of the prototypes. The Glatz prototype seat structurally survived impact conditions at which it failed during the original troop seat comparison testing. Peak lumbar Z forces were high

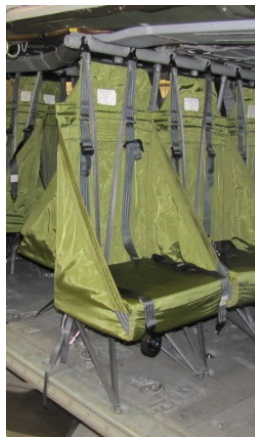
The Glatz seat is shown in Figure 1.

**Figure 1. Glatz Aeronautical Prototype Seat**

*The Glatz Aeronautical Corporation (GAC) prototype seat has been termed as the Next Generation Troop Seat (NGTS). It is an unconventional design that has limited hard structure and consists of a large foam seat pan with fabric side supports. The seat hangs from the H-60A/L upper seat attachments and has 1-inch webbing to secure the seat structure to the floor attachments.*

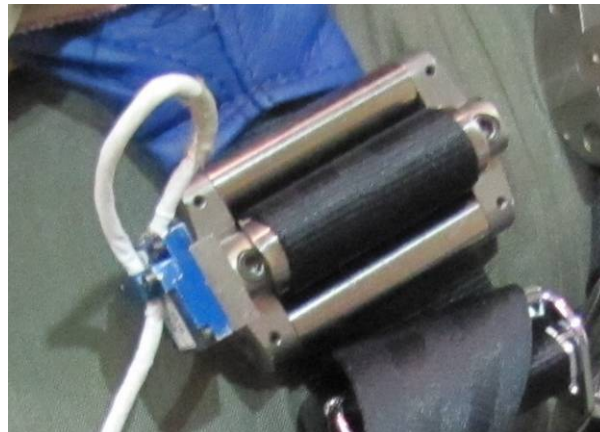
The restraint instrumentation included in-line belt load cells (Figure 5). For several tests use of the lap belt load cells were not used as they would interfere with the restraint operation.

**Figure 5. Restraint Belt Load Cell**

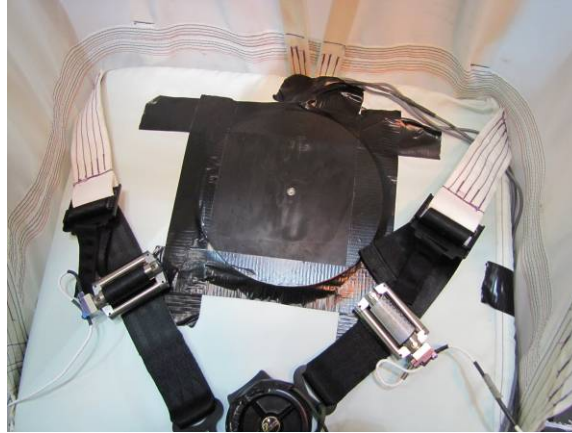
The seat instrumentation included three linear accelerometers encapsulated in a disk that was taped to the top of the seat pan fabric just under the manikin's buttocks. This is seen in Figure 6.

**Figure 6. Seat Pan Accelerometer Pack**

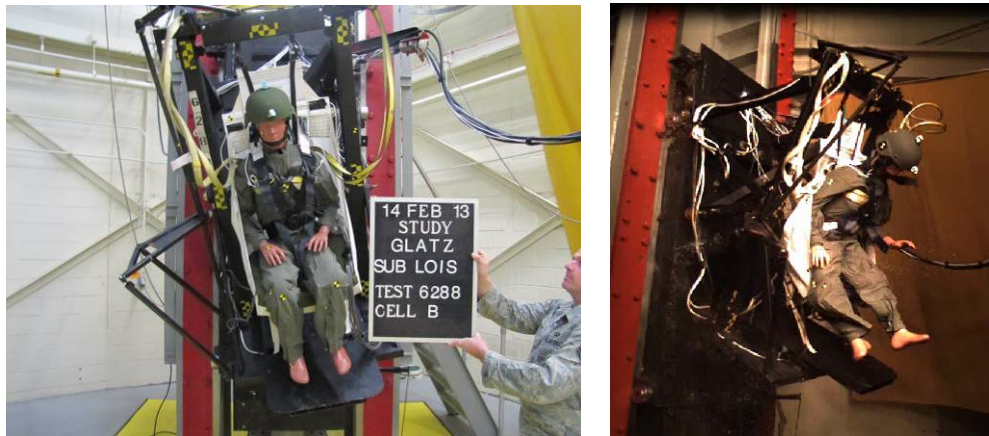
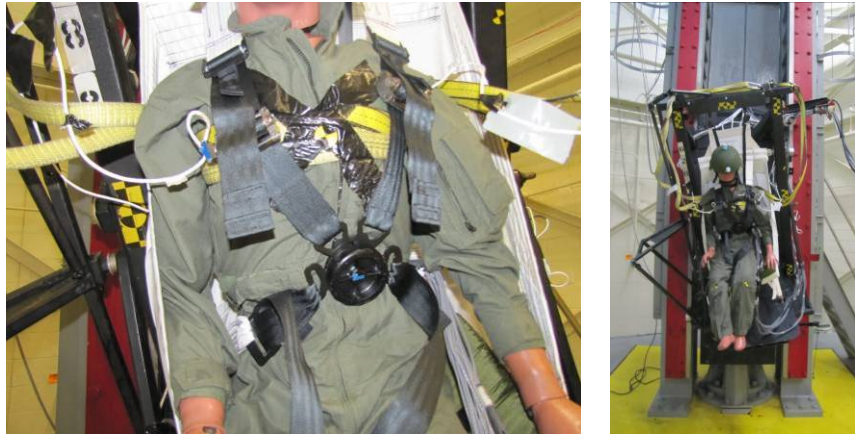
VDT6288 is a retest of VDT6223. Pictures from the test are shown in Figures 7 and 8. The lap belt load cells were not used during the test as there was no additional belt length available due to the size of the manikin. The lap restraint was tightened as far a possible, though a pre-load was not possible. The seat structurally stayed intact during the test. There was no ripping of the seat seen post test. However, the manikin rebounded and ‘bounced’ up off the seat pan after the initial impact, causing a high chest acceleration with a peak of 82.42g and a lumbar Z force of 1469.94lbs, exceeding the lumbar load limit of 933lb compression limit. The restraint buckle came up into the chest of the manikin.

**Figure 7. VDT6288 (L) Manikin position pre-test (R) Manikin rebound after initial pulse**

**Figure 8. VDT6288 (L) Restraint Buckle post-test (R) Manikin position post test**

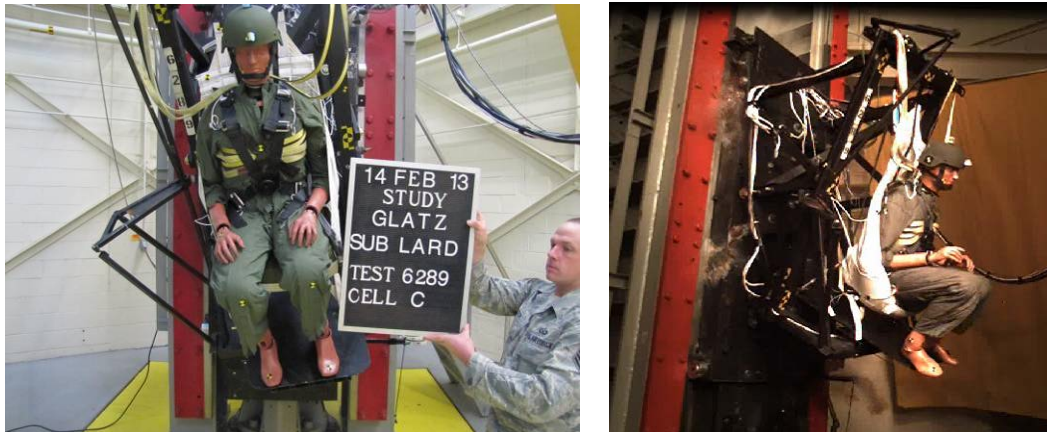
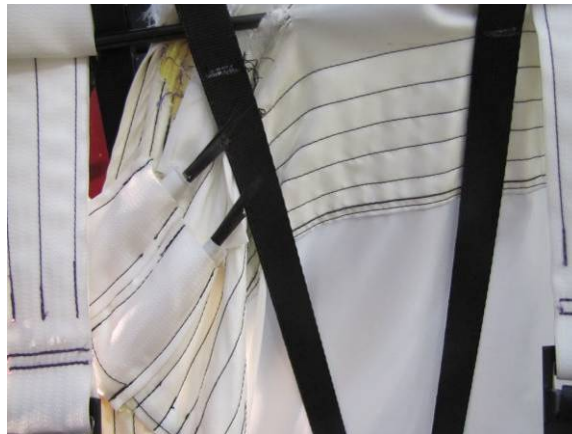
VDT6289 is a retest of VDT6226. Pictures from the test are shown in Figures 9, 10, 11, and 12. The lap belt load cells were usable with LARD. As the seat descended during the impact, the fabric on the upper right seat back ripped, and the spreader bars broke. The junction of the seat pan and the seat back ripped as well. However, the seat stayed attached to the fixture. As with VDT6288, the manikin rebounded after the initial pulse, though the resultant chest acceleration and peak lumbar Z force are within limits. It was decided not to continue testing with this version of the seat. After inspection of the seat, it is believed that there were deviations from the drawings supplied to the manufacturer that could have contributed to the structural failure of the seat.

**Figure 9. VDT6289 (L) Manikin initial position (R) Seat ripping during test**

**Figure 10. VDT6289 (L) Manikin rebound (R) Manikin post test**

**Figure 11. VDT6289 (L) Seat back ripping (R) Seat pan ripping**

**Figure 12. VDT6289 Spreader bar break**

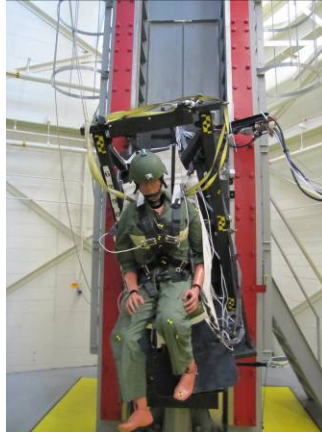
VDT6290 is a re-test of both VDT6226 and VDT6289. Pictures from the test are shown in Figures 13, 14, and 15. The seat structurally stayed intact during the impact, and all mounts remained attached to the fixture. There was some ripping of the stitching in the left spreader bar area. As with VDT6289 the manikin rebounded after the initial pulse, though the resultant chest acceleration and peak lumbar Z force are within limits.

**Figure 13. VDT6290 (L) Manikin initial position (R) Restraint**

**Figure 14. VDT6290 (L) Impact (R) Manikin rebound**

**Figure 15. VDT6290 Manikin post test**

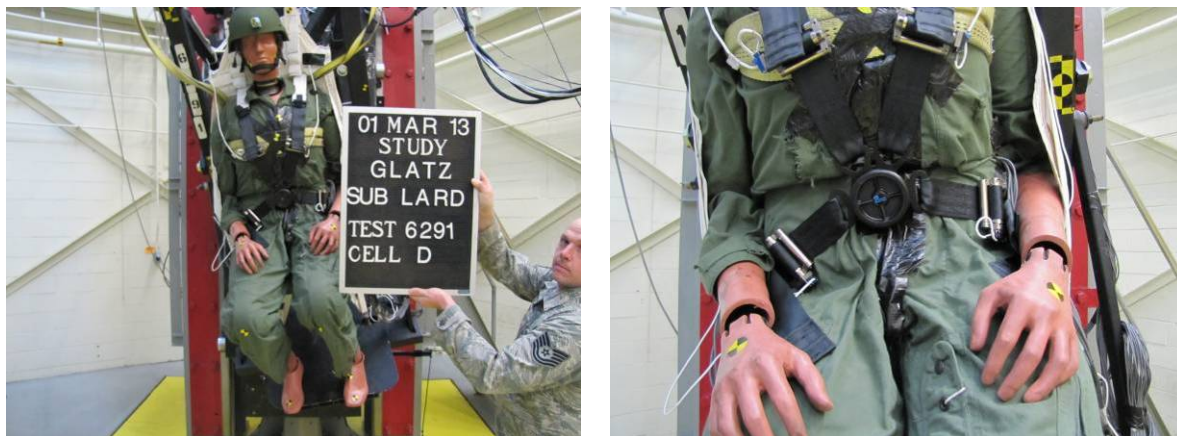
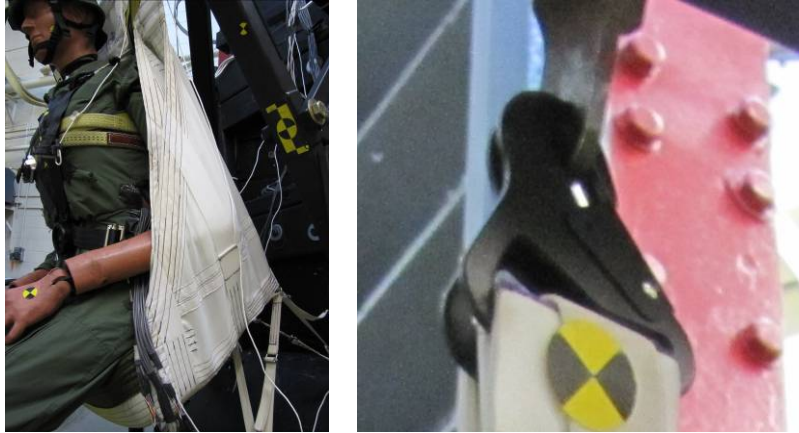
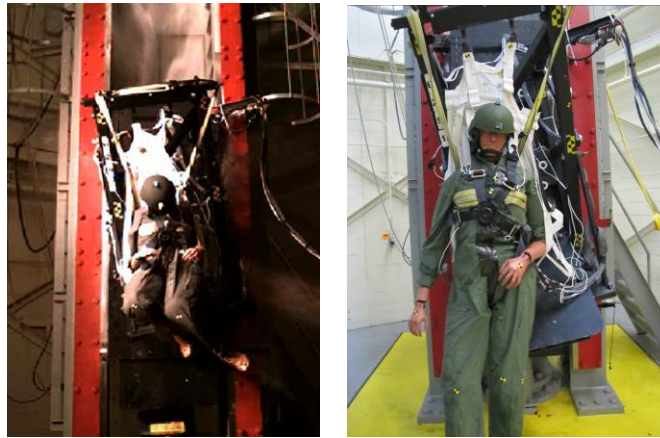
VDT6291 is the first Glatz test in Cell D. Pictures from the test are shown in Figures 16, 17, 18, and 19. One seat structure was embedded within another seat. Two upper attachment hooks were used on each side. During the impact one of the left upper attachment hooks broke. The manikin submarined out of the seat and was held by the restraints and safety tethers. Peak chest resultant acceleration was 57.09G, close to the limit of 60G. Peak lumbar Z force was 2045.31lb, below the limit of 2234.77lbs.

**Figure 16. VDT6291 (L) Manikin initial position (R) Restraint**

**Figure 17. VDT6291 (L) Double seat structure (R) Double hooks**

**Figure 18 VDT6291 (L) Manikin impact and seat rip (R) Manikin post test**

**Figure 19. VDT6291 (L) Seat upper attachment (R) Broken upper attachment**

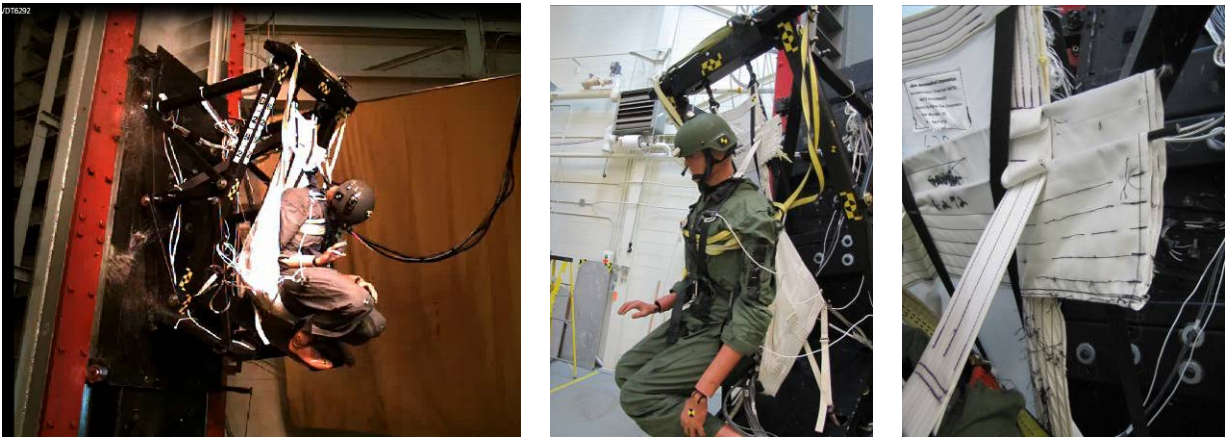
**VDT6292 – Cell C2, CV, Mrk5Mod2C, LARD, 31.48g, 44.58ft/s, 27.4ms rise time**  
 VDT6292 used a remanufactured seat from test VDT6290. Pictures from the test are shown in Figure 20. The purpose of the test was to see how a remanufactured seat responded to a second

crash pulse. As previous testing showed that the seat structurally survived at the ~26g pulse, an intermediate crash pulse between the 26 G and 36 G test was chosen. There was ripping of stitching by the upper left spreader bar, though the seat successfully restrained the manikin during the impact. The manikin swung from left to right while rebounding after the primary crash pulse. The manikin began to submarine out of the seat, though the restraint prevented the manikin from fully coming out of the seat. The chest resultant acceleration was 50.09g with a peak lumbar Z force of 1882.27lb. Both are within the injury criteria used for this program.

Figure 20. VDT6292 (L) Impact (M) Manikin final position (R) Ripping upper left

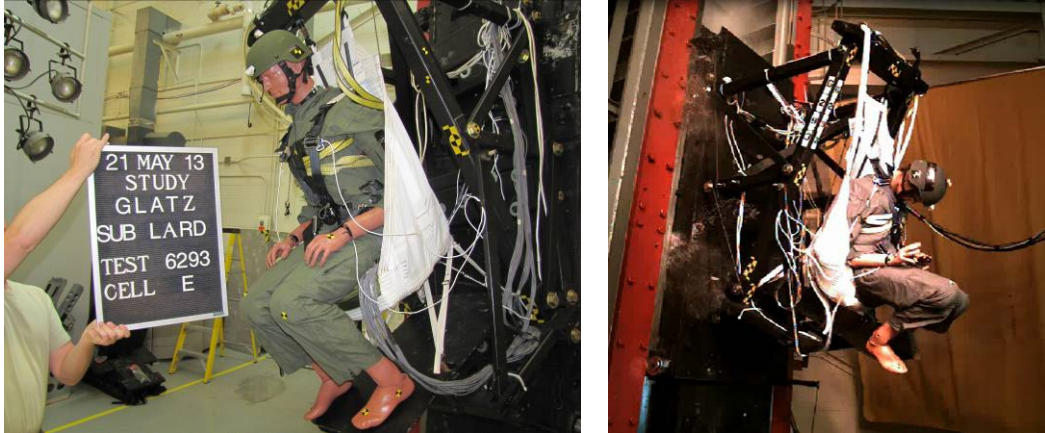
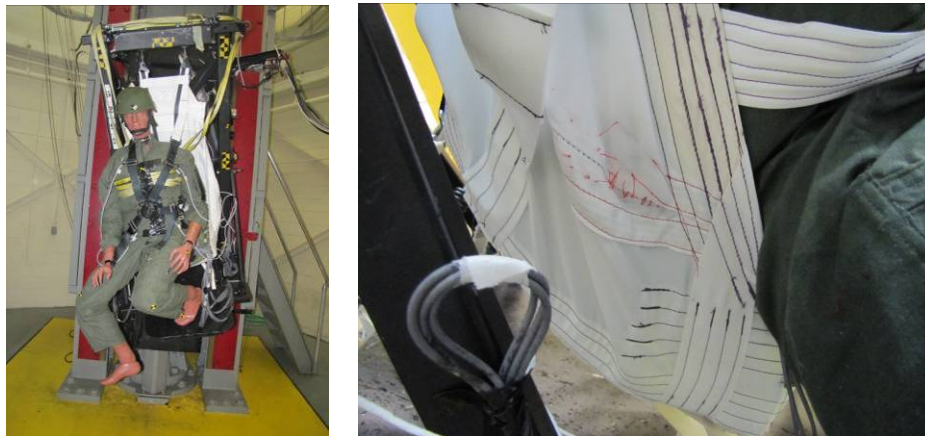
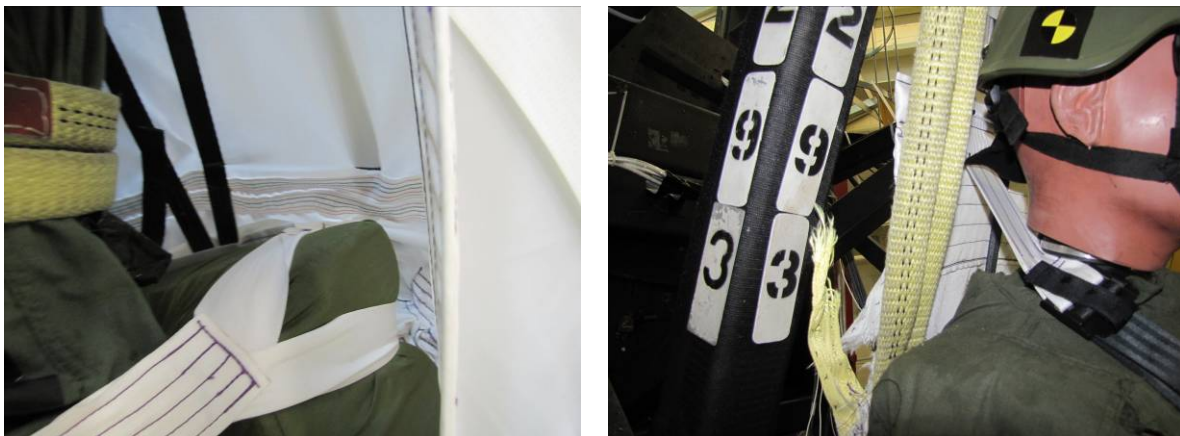
VDT6293 was the second test at the intermediate crash impact level. Pictures from the test are shown in Figures 21 and 22. The seat was a new seat and not one re-manufactured from a previously-tested seat. The manikin was successfully restrained in the seat during the test. As with VDT6292 the manikin began submarining in the seat, though the restraint successfully held the manikin during the impact. Rip stitching along the back and side of the seat pan successfully broke during the impact. The lap belts remained fixed to the seat structure. There was ripping of stitching close to the upper right spreader bars, though the seat successfully restrained the manikin during the impact. The peak chest resultant acceleration was 45.48g with a peak lumbar Z force of 1757.42lb. Both are within the injury criteria used for this program.

Figure 21. VDT6293 (L) Manikin pre-test, (R) Seat and manikin during test

Figure 22. VDT6293 (L) Manikin Post Test (R) Rip stitching on right seat pan

Figure 23. VDT6293 (L) Lap belt restraint post-test (R) Upper right stitching ripping

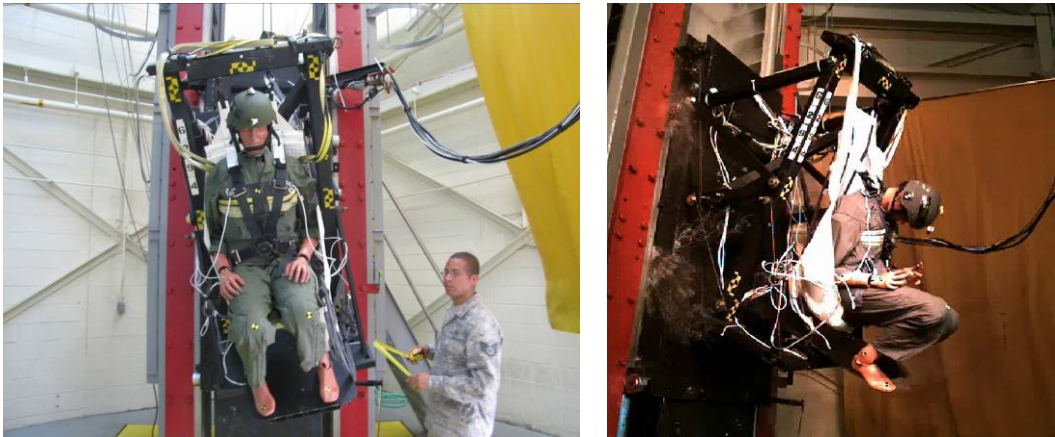
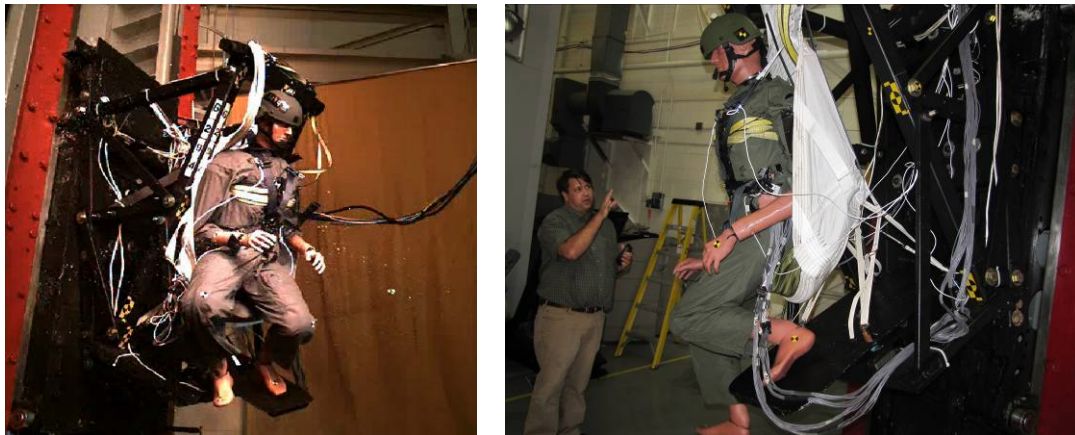
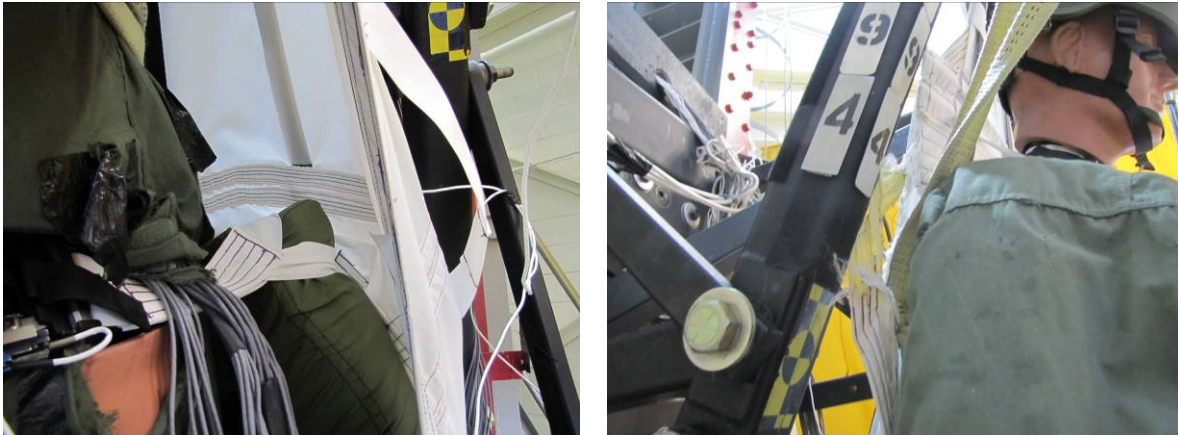
Pictures from the test are shown in Figures 24, 25, and 26. The upper right portion of the seat close to the spreader bars broke. The manikin remained in the seat, though considerable rebound of the manikin was seen after the primary crash impact. Also, considerable submarining of the manikin was seen during the impact as the restraint buckle was forced into the manikin's abdomen and chest. The manikin's spine was out of position post-test. A peak chest resultant acceleration of 55.31g and a peak lumbar Z force of 2118.09lb were recorded. Both are within the established injury criteria used for this program.

**Figure 24. VDT6294 (L) Manikin position pre-test (R) Manikin during impact**

**Figure 25. VDT6294 (L) Manikin swinging left to right during rebound (R) Manikin position post-test**

Figure 26. VDT6294 (L) Right lap belt post-test (R) Right upper ripping

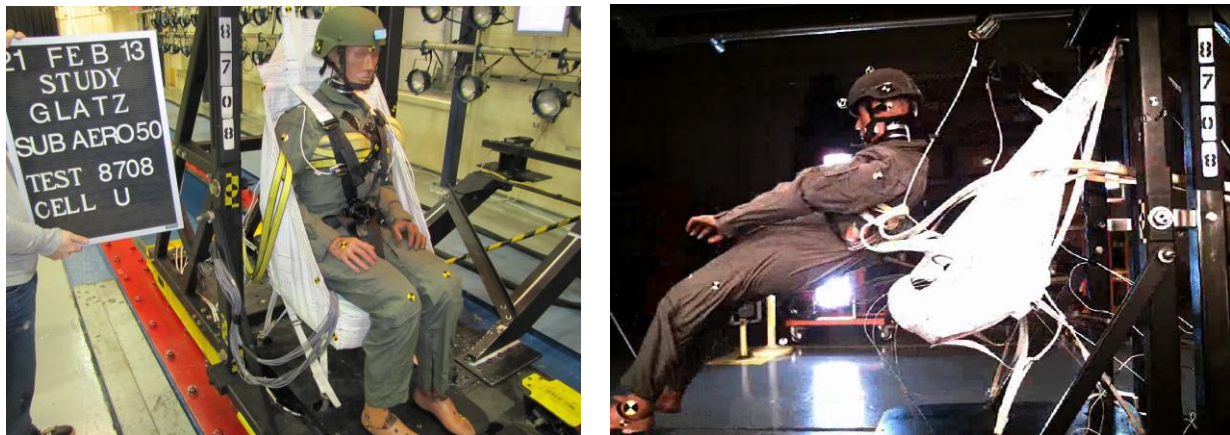
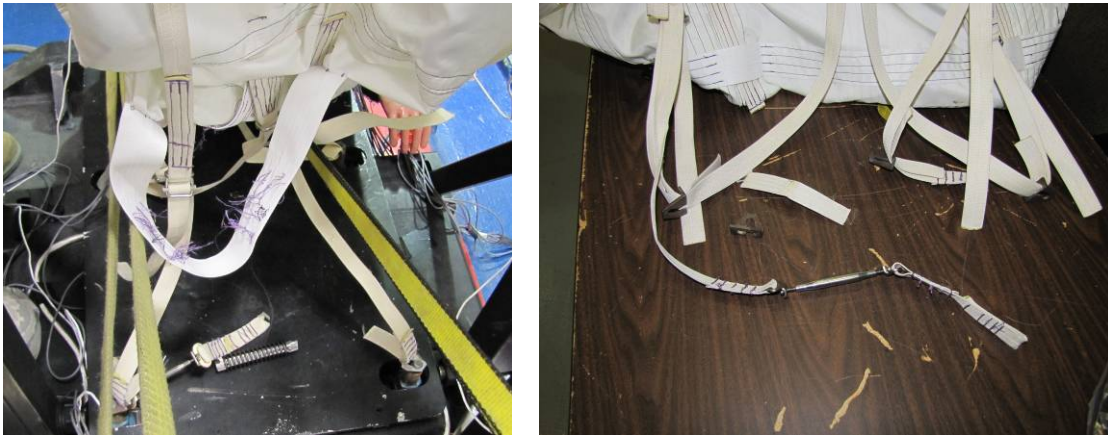
This HIA test was the only PH test conducted with the Glatz seat and the only test with a HB50 manikin. Pictures from the test are shown in Figures 27, 28, and 29. The test was conducted to determine structural integrity of the seat. The torso belts appear to detach during the impact, fully loading the lap belt. The lap belt completely detached from the seat structure, and the manikin was no longer restrained in the seat. The rear attachment webbing tensioners broke during the impact as the seat and manikin are pulled towards the front of the sled.

Figure 27. HIA8708 (L) Manikin initial position (R) Manikin flying off seat

**Figure 28 HIA8708 (L) Manikin position post test (R) Lap belt**

**Figure 29. HIA8708 Broken webbing tensioners**

will require additional modifications to improve energy attenuation capability during a crash event. In the Pure Horizontal test, the seat structurally failed, suggesting that further redesign is necessary.
