# Real-Time Micro-Explosive Damage Detection in an Unmanned Rotorcraft Vehicle Using Embedded Sensing

H. EDGE, H. CHUNG, M. COATNEY, B. MARY, P. TIBBITS,  
M. MURUGAN, A. GHOSHAL, D. LE and M. PAPPAKOSTAS

Patrick Tibbits, Muthuvel Murugan, Michael Coatney, Brian Mary, Harris Edge, Aninidya Ghoshal, Dy Le: Army Research Laboratory, Aberdeen Proving Ground, MD 21005 Mark Pappakostas, Howard Chung: Acellent Technologies, Inc., 835 Stewart Drive, Sunnyvale, CA 94085

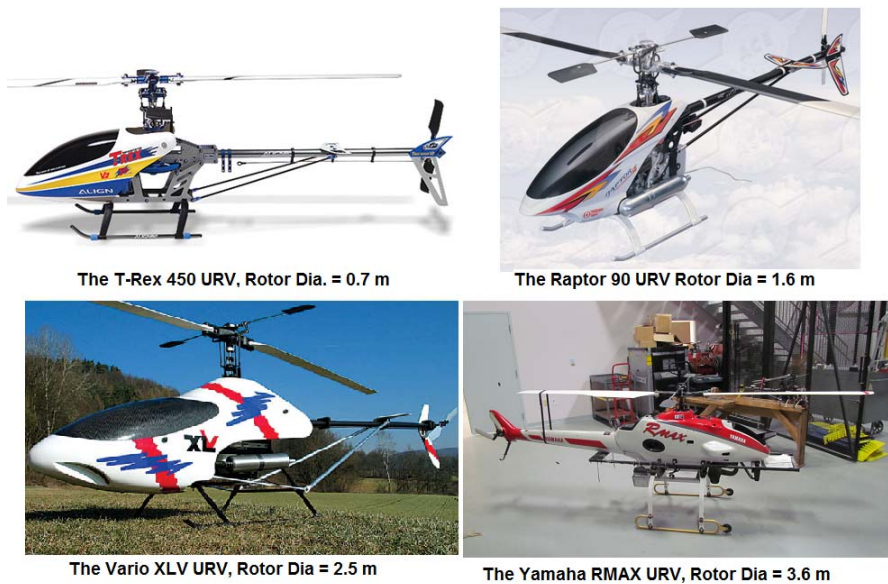
Figure 1: ARL Available URVs

In collaboration with the ARL-VTD Mobility and Manipulation Team at the Aberdeen Proving Ground (APG), four URVs have been made available. The available URVs include the Yamaha RMAX, Vario XLV, Raptor 90, and T-Rex 450. The URVs are shown in Figure 1 and their development is described in [2]. One of the smaller URVs, the Raptor 90, is currently used to gain full confidence prior to incorporating flaws into selected PSEs using a larger URV. The Raptor 90 URV side plate structure was selected as the PSE to assess and demonstrate advanced sensor system capabilities for damage detection and damage growth monitoring. The

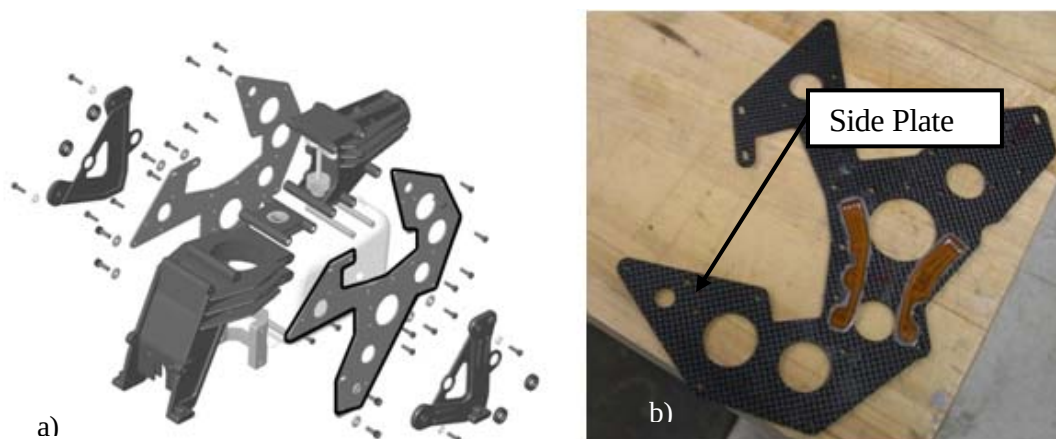
Figure 2: a) The Raptor 90 Airframe and Selected PSE b) The Side Plate with Sensors Installed

exploded view of the Raptor 90 airframe is illustrated in Figure 2 a), in which the side plate is indicated.

Acellent SMART Layer sensors [4-7] were selected and installed on a composite Raptor 90 side plate, after flaw creation, as shown in Figure 2 b). Each of the Kapton-based sensor strips contained three piezoelectric transducers capable of generating Lamb waves. Each transducer can detect the Lamb waves produced by the other transducers. The flawed, instrumented side plates were then connected to Acellent ground-based instrumentation, which interrogated the sensors and collected the resulting data. The data was examined with the Acellent SmartPatch software using time-history analysis to generate the damage image, Figure 5 b). To increase flexibility in sensor installation, which in turn facilitates optimization of sensor location, a version of the side plate was fabricated without lightening holes. The lightening holes are the seven largest holes which appear in Figure 2 b). Later iterations of this experimental effort will focus on this design.

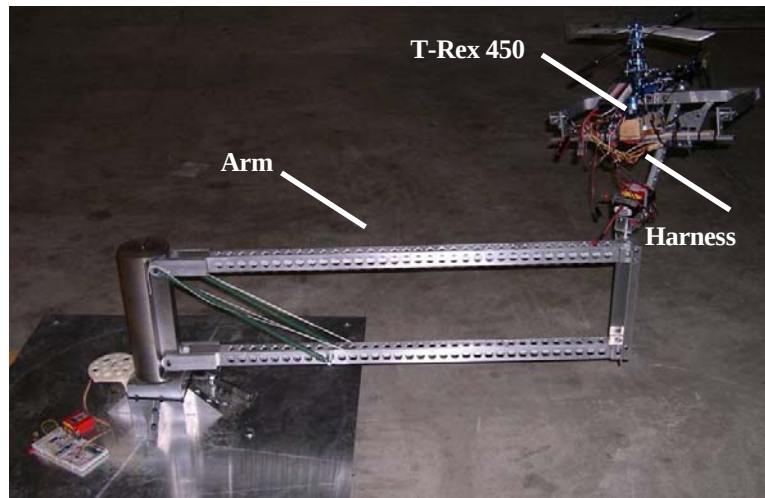
Figure 3: Ground-based Flight Test Stand with T-Rex 450

strut, which compensated for arm weight. The stand's harness can accommodate URVs having rotor diameters of 0.6 to 1.5 m. The URV movements allowed by the test stand appear in Table I. Initial flights to assess the test stand were carried out with a small URV, the T-Rex 450, which was mounted on the test stand as shown in Figure 3. Manual flights were performed first. Then system identification experiments were performed to develop controls for stabilizing the URV autonomously on the ground test stand [6]. Also, a previously developed microcontroller-based autopilot [7,8] (ARL Open Autopilot) was modified for experiments on the stand with the T-Rex 450 URV. This autopilot allows custom control software to be written and developed quickly. It is also small enough and light enough to be flown on the T-Rex 450.

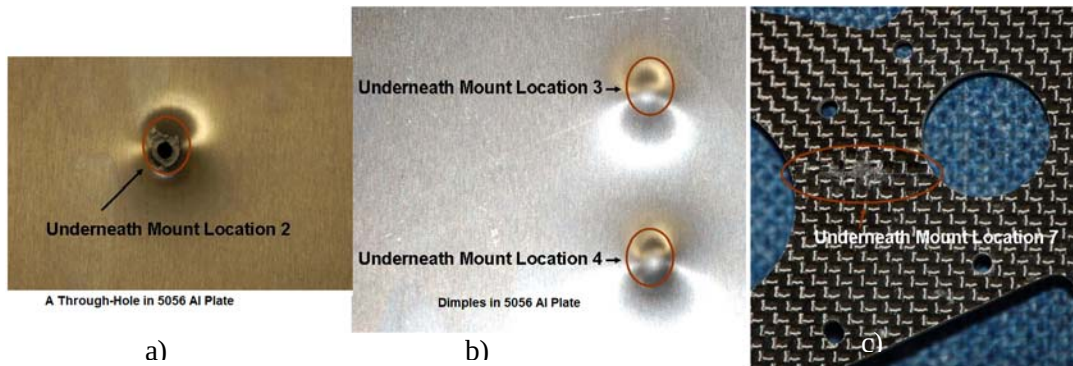
Figure 4: a) &amp; b) Underneath M100 Test on Flat Al 5056 Plates c) on Composite Raptor 90 Side Plate

Table II summarizes the test parameters and damage achieved in each flaw initiator test. A typical hole and typical dimples appear in Figure 4a) and b). The flaw created on the carbon fiber composite side plate using the micro-explosive device appears in Figure 4 c), in which a crack along with possible underlying delamination, not readily visible, connects the two holes. Results were most sensitive to the presence/absence of the butterboard attenuator. In aluminum, the butterboard moderated damage from a through-hole to a dimple while, in composite, the crack width was decreased from 7/16 inches to 1/8 inches wide (11 to 3 mm). Because the detection of a crack in metallic components is an important SHM problem, neither the through-holes nor the dimples induced on the aluminum are entirely satisfactory.

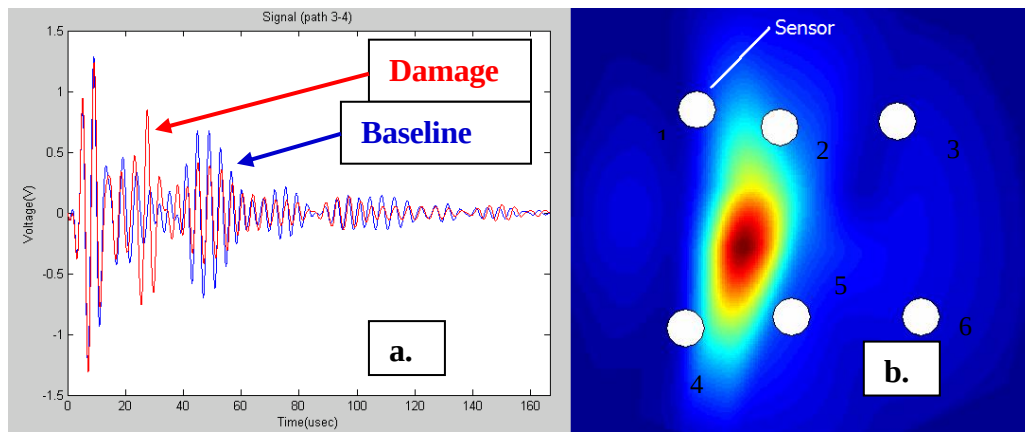
Figure 5: a.) Baseline and Post-Damage Data b.) Post-processed Image

The Lamb waves generated by transducer 3 and the sensor signal received by transducer 4 is shown in Figure 5 a). The sensor locations and numbers are illustrated in Figure 5 b). Transducers 1, 2 and 3 were used as actuators and transducers 4, 5, and 6 were used as sensors, resulting in a total of 9 actuator-sensor paths that formed a grid encompassing the target damage detection monitoring area. The baseline data, collected before initiation of damage, appear in blue while the post-damage data appear in red. Acellent ACCESS software post-processed data from the 9 actuator-sensor paths, which have been used to generate the diagnostic image, appears in Figure 5 b). Contour colors graduate from blue to red to indicate the probable damage location. The Acellent's data collection hardware uses discrete actuator and sensor connectors, facilitating low noise/low crosstalk signal generation and capture. Close sensor spacing can be utilized without signal degradation, allowing for high-resolution damage detection.
