# **Coastal Barrier Breaching, Part 1: Overview of Breaching Processes**

*by Nicholas C. Kraus, Ty V. Wamsley*

| Report Documentation Page | | | | Form Approved<br>OMB No. 0704-0188 | | |
|---|---|---|--|---|---|---|
| 4. TITLE AND SUBTITLE<br><b>Coastal Barrier Breaching, Part 1: Overview of Breaching Processes (ERDC/CHL CHETN-IV-56)</b> | | | | 5a. CONTRACT NUMBER | | |

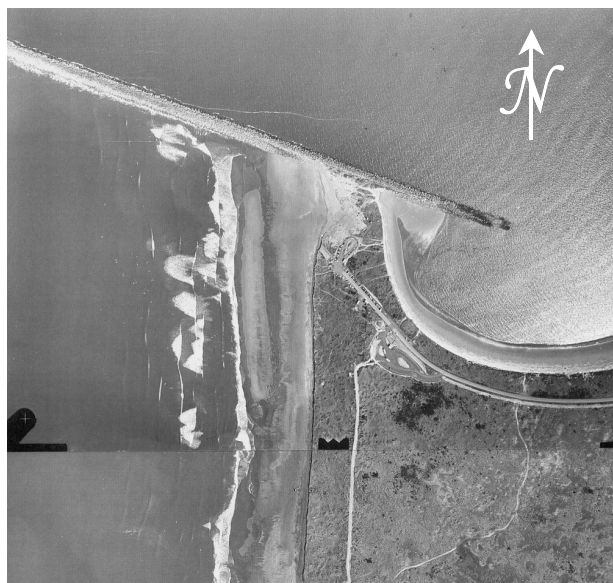
a. May 1993, 7 months before breaching

Figure 5. South jetty, Grays Harbor, WA

**Breach at Grays Harbor, WA, December 1993.** Grays Harbor is a large bay facing the Pacific Ocean (Figure 5). Two jetties constructed 2.4 km (1.5 miles) apart protect a deep-draft channel and stabilize the entrance. Grays Harbor has one of the largest tidal prisms in the United States. The tidal range exceeds 2 m, and the average annual wave height is greater than 2 m, with deepwater storm waves reaching heights of 8-10 m annually. Large wave heights and long wave periods, typically in the 12-20-sec range, contribute to large setup and runup during storms.

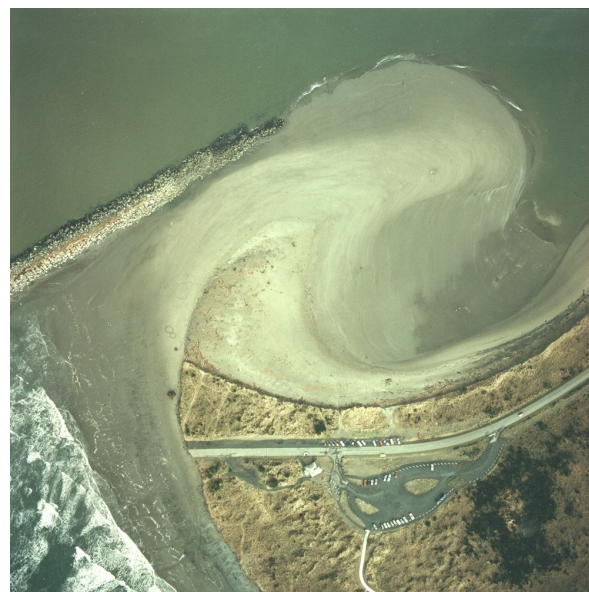
b. February 1994, 1 month after breaching
