BABIL RAILWAY STATION  
REHABILITATION  
HILLA, IRAQ

**SIGIR PA-05-019**  
**MARCH 10, 2006**

## **Babil Railway Station Rehabilitation in Hilla, Iraq**

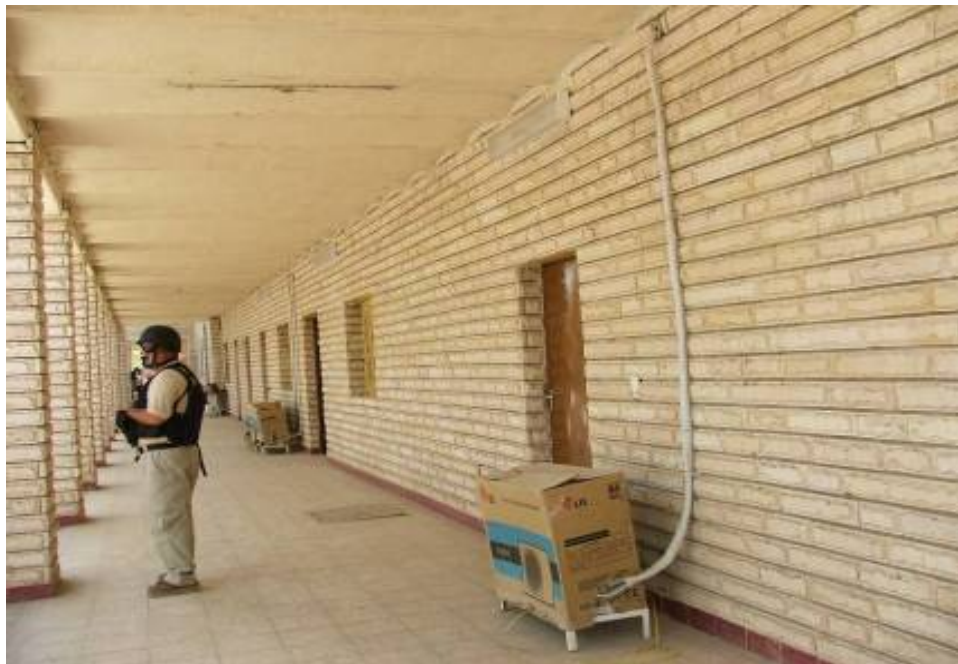
The contract's BOQ required the supply and installation of 100 square meters (m<sup>2</sup>) of Shafqueem facing brick and 115 m<sup>2</sup> of brickwork. We observed new facing brick and brickwork on the complete front and rear sections of the Babil Railway Station and around the supporting columns of the front and rear breezeway area. Installation of facing brick appeared to be consistent with the requirements of the contract.

Site Photo 1 shows the facing brick on the rear wall of the Babil Railway Station and the columns.

**Site Photo 1. Facing Brick on Rear Wall and Columns**

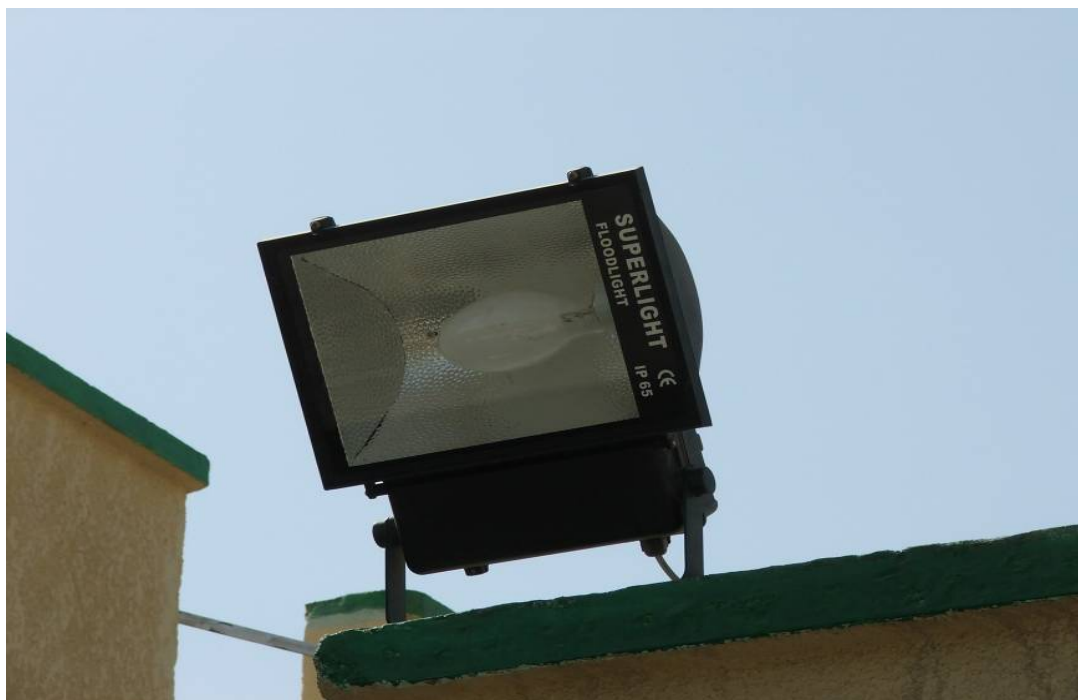
The contract's BOQ required the supply and installation of 124 double 2x40 watt (w) fluorescent luminaire type F-I interior lights and wiring, and the supply and installation of twelve outdoor 250 w type FL12 lighting fixtures. In addition, the BOQ required the electrical wiring of sixteen 24,000 British Thermal Unit (BTU) air conditioning (A/C) split units, two 30,000 BTU A/C split units, and four 36,000 BTU A/C split units. During the site assessment, we observed new exterior lighting fixtures, interior lighting fixtures, and wiring for the A/C split units. We did not note any deficiencies concerning the electrical lighting and electrical upgrades.

Site Photo 2 shows one of the exterior lighting units mounted on the backside of the Babil Railway Station. The recessed fluorescent lighting and false ceiling inside the Babil Railway Station can be seen in Site Photo 3.

**Site Photo 2. Mounted Exterior Light Unit**

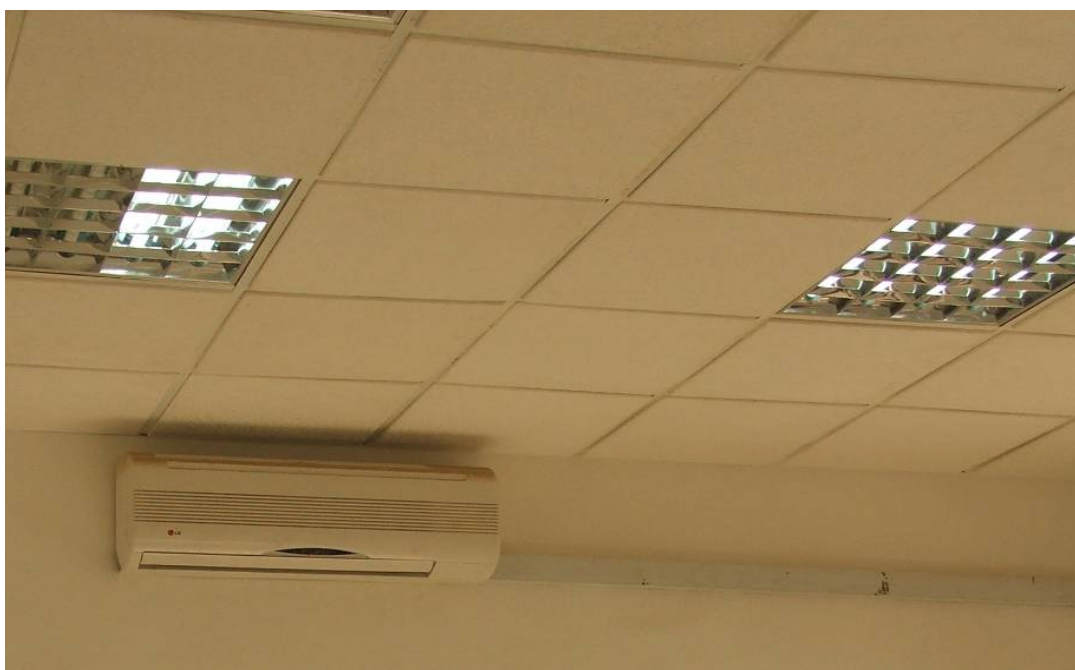
**Site Photo 3. Interior Recessed Lighting and False Ceiling**

The contract's BOQ required the supply and installation of 714 m<sup>2</sup> of false ceiling, consisting of Gypsum tiles on metal grid. During the site assessment, we observed installed false ceiling tile in all three of the interior rooms visited. The installation of false ceilings appeared to be consistent with the requirements of the contract. Site Photo 3 shows the false ceiling inside the Babil Railway Station.

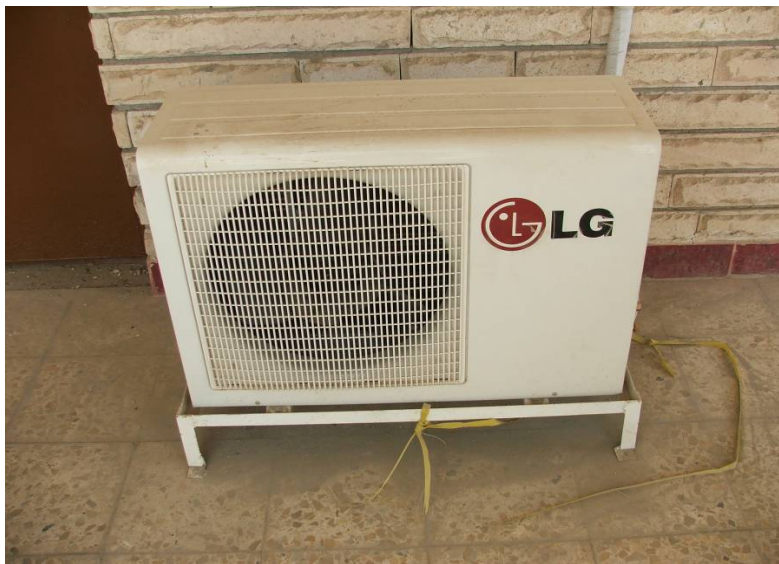
The contract's BOQ required the supply and installation of sixteen 24,000 BTU A/C split units, two 30,000 BTU A/C split units, and four 36,000 BTU A/C split units. We observed new split A/C units (condensing unit located on the exterior and cooling/blower unit in the interior) at the Babil Railway Station. Electrical connections were completed; however, operation of the A/C units was not verified. See Site Photo 4 shows the exterior condensing unit of 24,000 BTU LG Industries, LTD A/C split unit, which was located in the rear of the railway station. A cooling/blower unit mounting in an interior office of the railway station can be seen in Site Photo 5. Installation of A/C units appeared to be consistent with the requirements of the contract.

**Site Photo 4. Exterior Split A/C Condensing Unit**

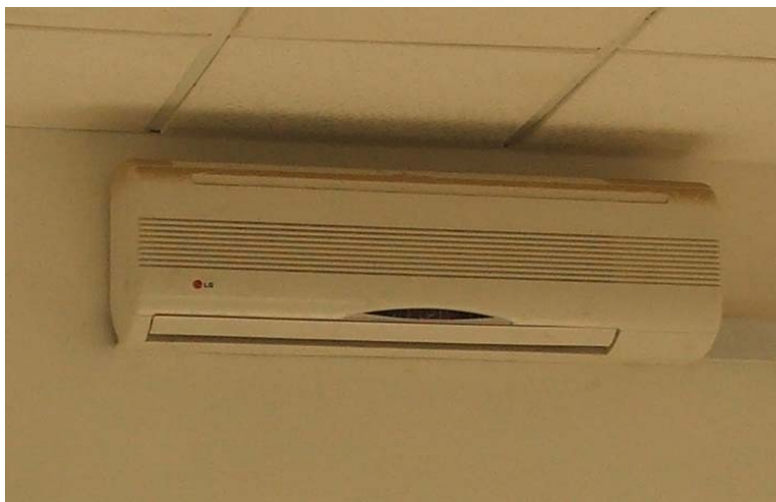
**Site Photo 5. Interior Split A/C Cooling/Blower Unit**

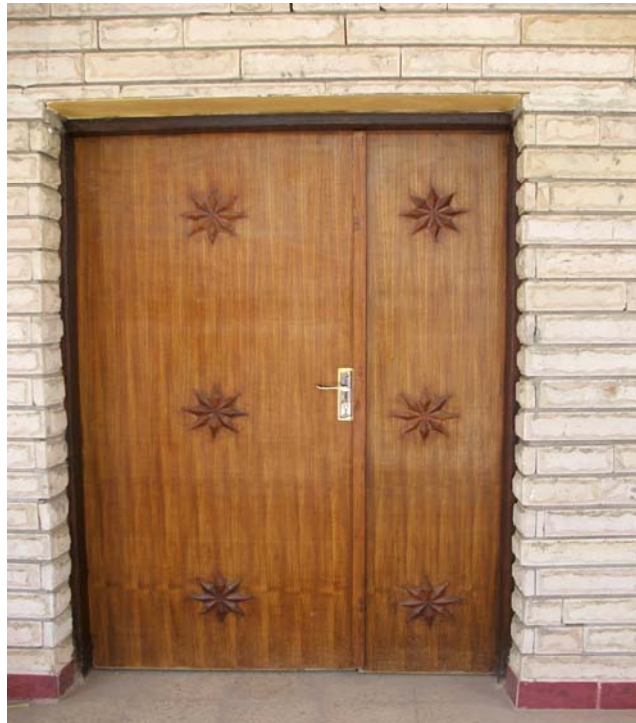
The contract's BOQ required the supply and installation of thirty heavy wood doors and frames, eight new aluminum windows, and the repair of twenty-nine windows. During the site visit we observed installed windows, which appeared new, and new and/or refurbished doors. No deficiencies were noted; however, only a small percentage of the doors and windows were inspected.

The exterior wooden door can be seen in Site Photo 6. Site Photo 7 shows a rear exterior aluminum window.

**Site Photo 6. Exterior Wooden Door**

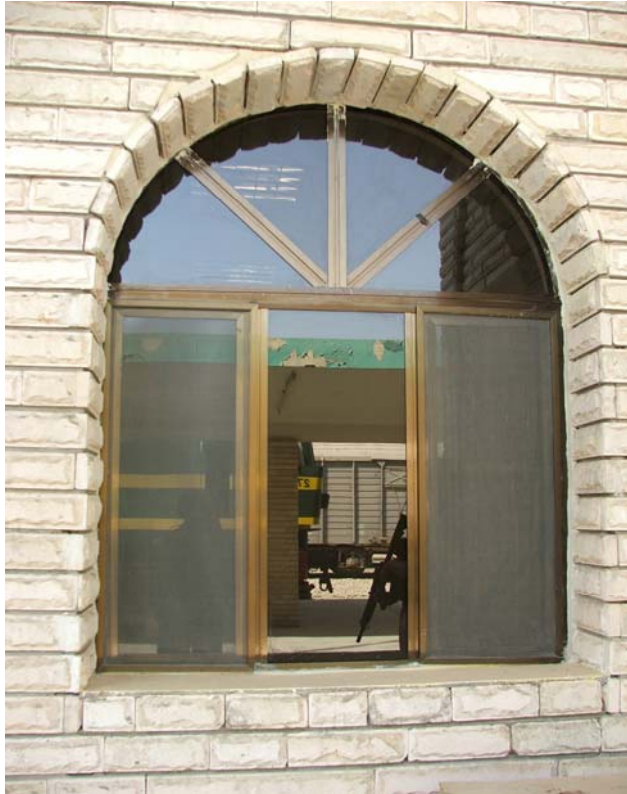
**Site Photo 7. Rear Exterior Aluminum Window**

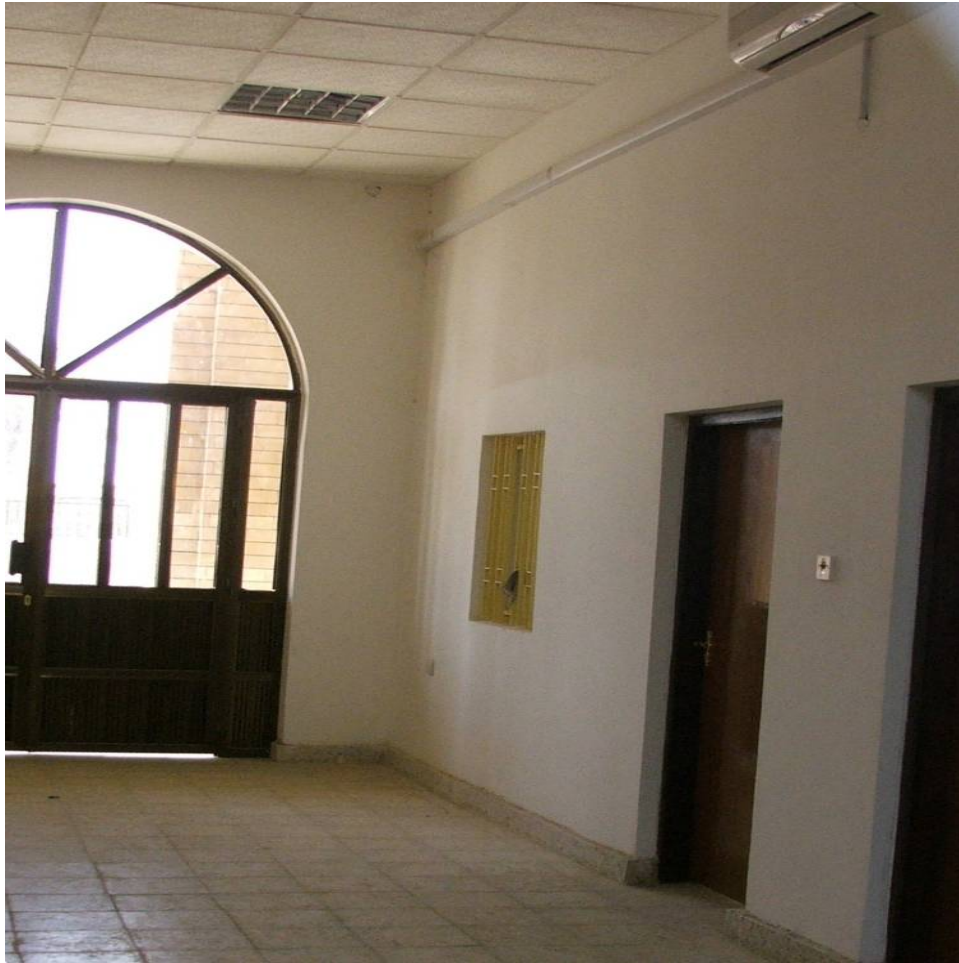
The contract's BOQ required the supply and installation 1342 m<sup>2</sup> of ceramic and terrazzo floor tile and 178 m<sup>2</sup> of ceramic wall tile. During the site assessment, we observed installed tile in all three of the interior rooms visited. The Babil Railway Station Manager stated he was not pleased with the choice of tile and the tile surface was not cleaned properly. The USACE QAR on site during the assessment said the previous station manager and engineer selected the tile. The installation of tiles appeared to be consistent with the requirements of the contract.

Site Photo 8 shows the installed terrazzo floor tile in the center entry room inside the Babil Railway Station.

**Site Photo 8. Terrazzo Floor Tile Located in the Center Entry Room**
