# KIRKUK CANAL CROSSING KIRKUK, IRAQ

**SIGIR PA-05-011**  
**MARCH 7, 2006**

## Kirkuk Canal Crossing, Kirkuk, Iraq

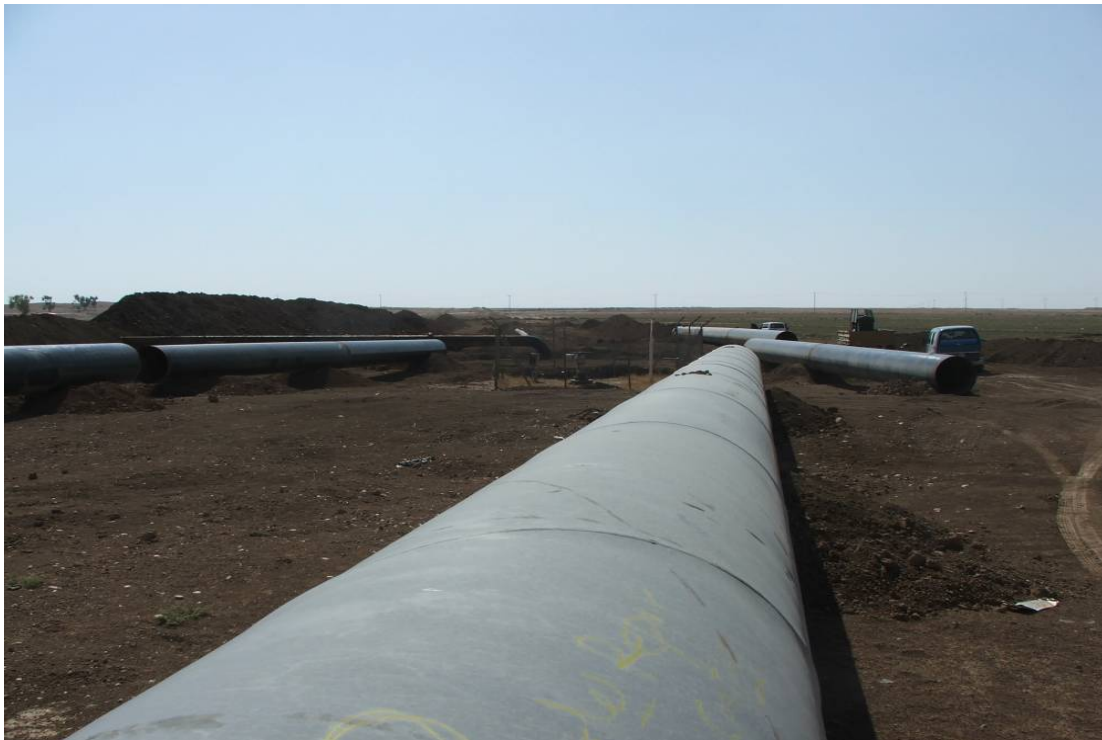
The 40-inch diameter with 0.688-inch WT pipe will be used for the canal crossing itself, including the length required to the ball valve location. The PIJV has completed an inventory and has determined that the amount is sufficient to accommodate the proposed pipeline routing. The valves and flanges were inspected by PIJV and found to be in good condition.

**Site Photo 1: Pipes Purchased By Prior Contractor**

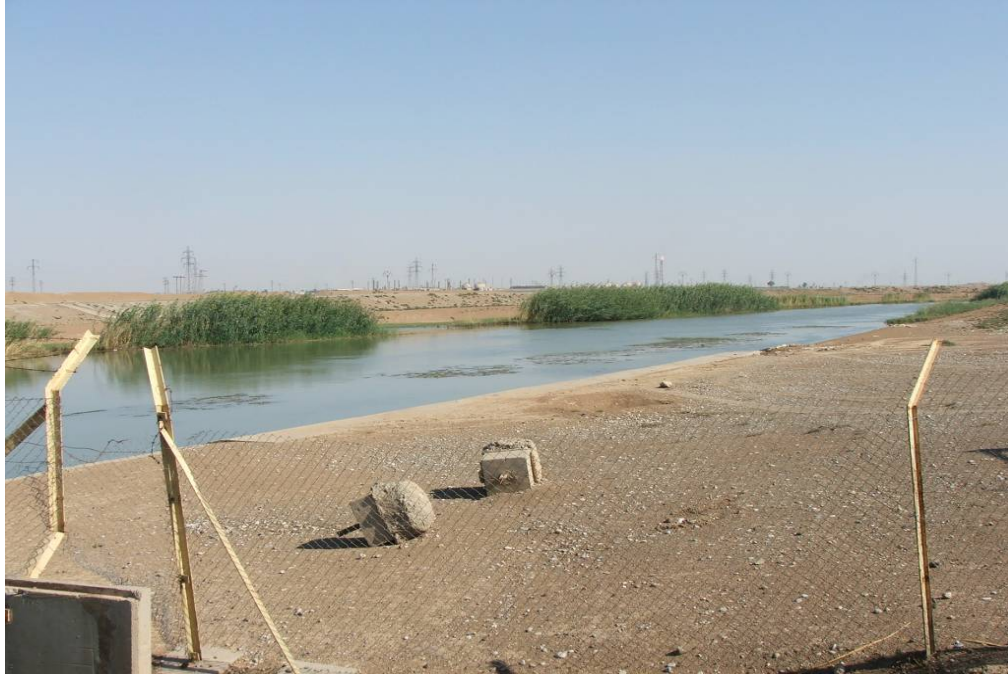
Site Photo 2: Kirkuk Irrigation Canal

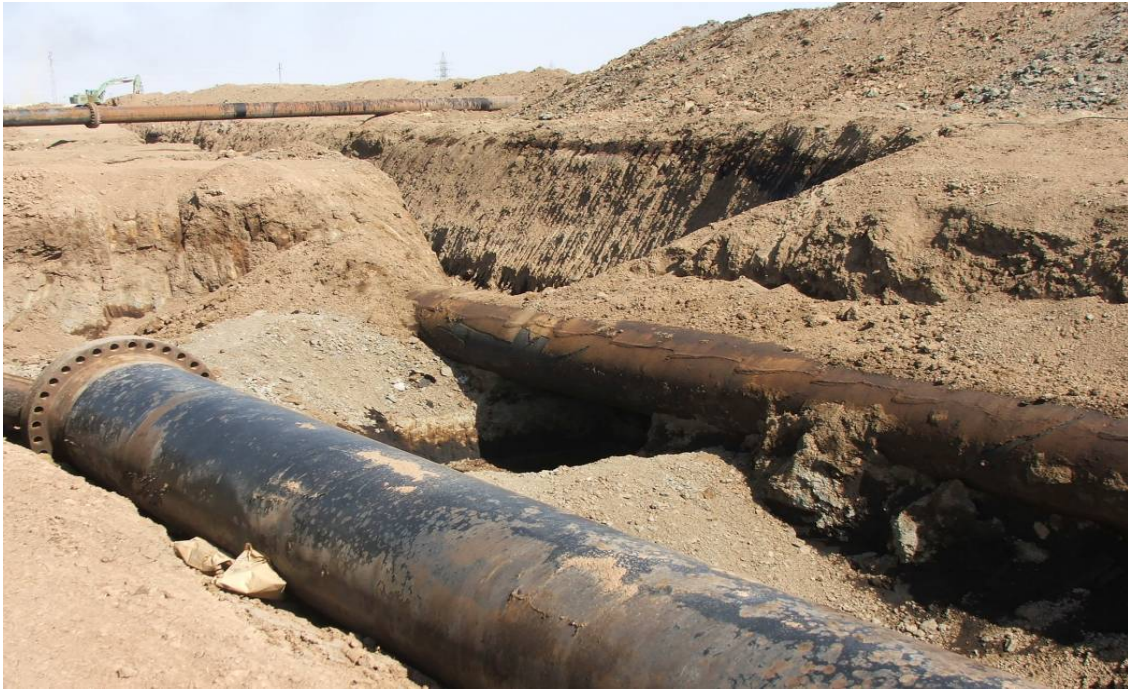
During the site visit, the assessment team verified that the excavation of the trenches was progressing. While most of the excavation for the pipeline trench was complete, a few areas required additional excavation to straighten the trench to comply with contract specifications. The trench was estimated to be about 750 m in length and approximately eight to ten feet in depth. Old pipelines were encountered in the pipeline trench, so the excavation was adjusted accordingly. Oil was observed seeping from the ground or leaking from other pipes and accumulating in the pipeline trenches, on the soil, and on top of the standing water. Procedures were implemented by the subcontractor to mitigate the hazards of toxic fumes to the workers and the fire hazard of flammable materials near welding activities. The subcontractor was observed pumping oil out of the excavations at the time of the site visit. Site Photo 3

**Site Photo 3: Pipeline Excavation Work**

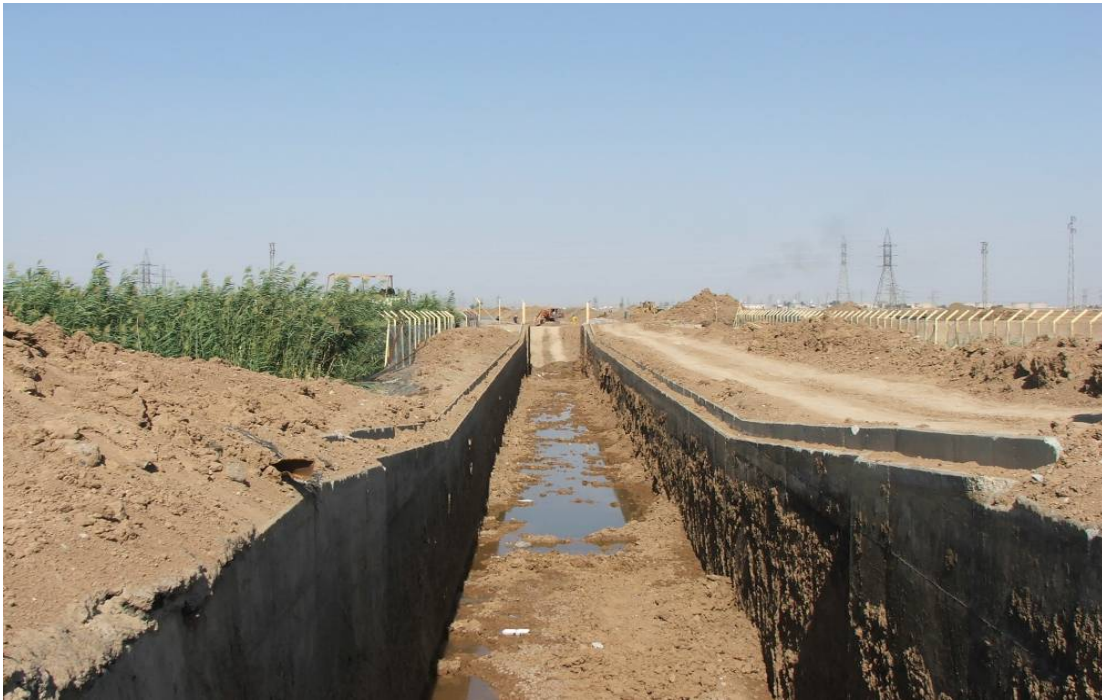
shows excavation of trenches for placement of the pipeline. Site photo 4 shows excavation of soils in the culvert crossing the KIC. Site photo 5 shows excavations with oil seeps.

**Site Photo 4: Culvert Over Canal with Soil Removed**

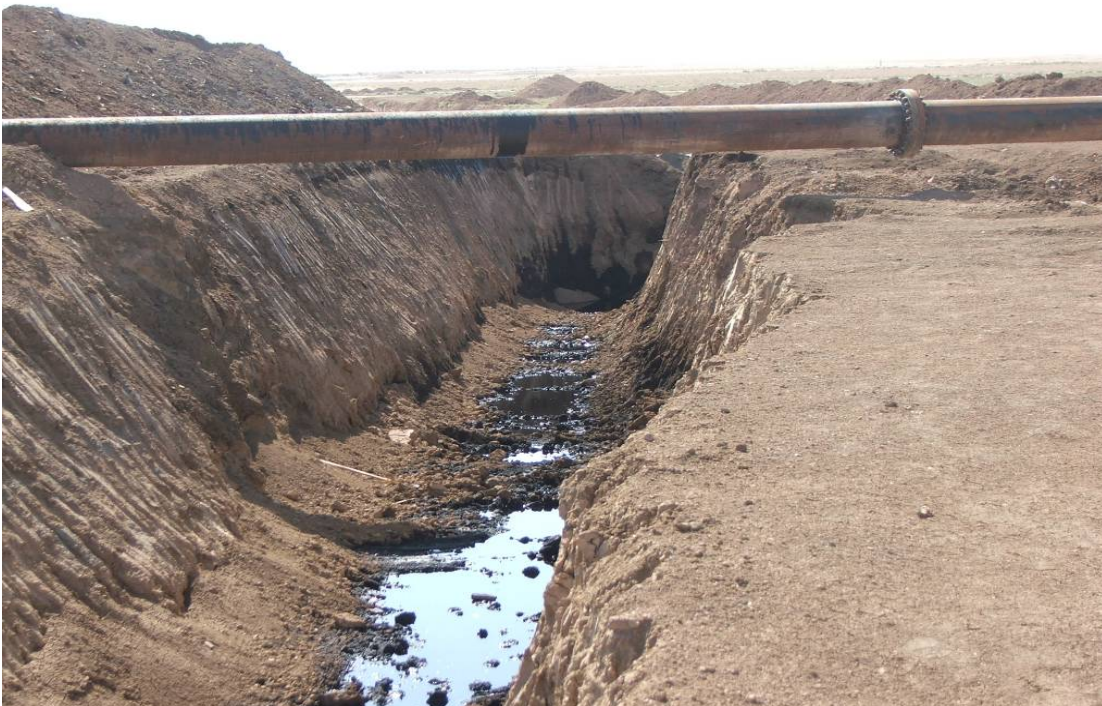
**Site Photo 5: Common Example of Pipeline Excavation with Oil Seepage**

In another instance, we observed the contractor's QC Manager discuss a pipe placement problem with subcontractor personnel. Specifically, oil that seeped into the pipeline's excavation presented a fire and safety hazard to welders and construction workers. To ensure safety and quality workmanship, the contractor's QC Manager explained how to place clean sand and a heavy duty plastic material (tarp) in the excavation to form a protective barrier between the oil and workers. Site Photo 9 shows a contractor's QC manager explaining how to place protective liner in the pipeline excavation.

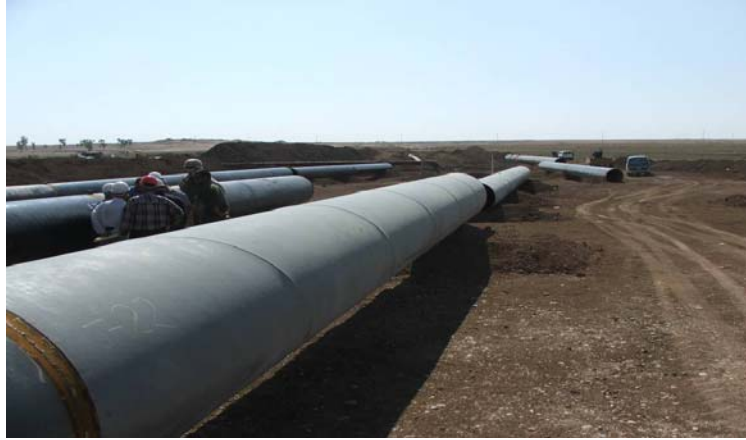
During the site visit, the assessment team observed that the fabrication of the pipeline was in progress. The subcontractor was fabricating and connecting pipeline sections on both sides of the canal. The fabrication of the bridge section pipeline had not begun at the time of the site visit. The assessment team noted that some of the pipeline had been marked for repair with corrosion control epoxy coating. Radiography testing was not observed during the site visit. Site photo 6 shows pipe sections on site before placement into excavations. Site photo 7 shows a weld connecting two pipeline sections. The fabrication of the pipeline appeared to be consistent with contract and design requirements.

**Site Photo 6: Pipe Section on Site before Placement into Excavations.**

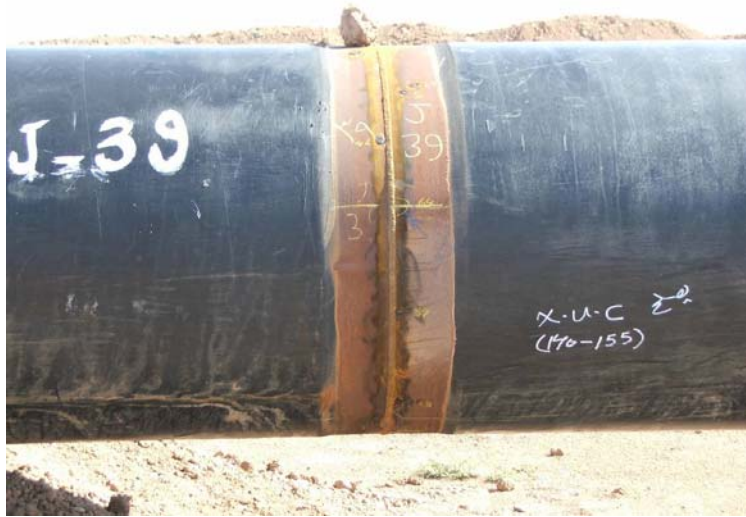
**Site Photo 7: Weld Connecting Two 40-Inch Pipe Sections.**

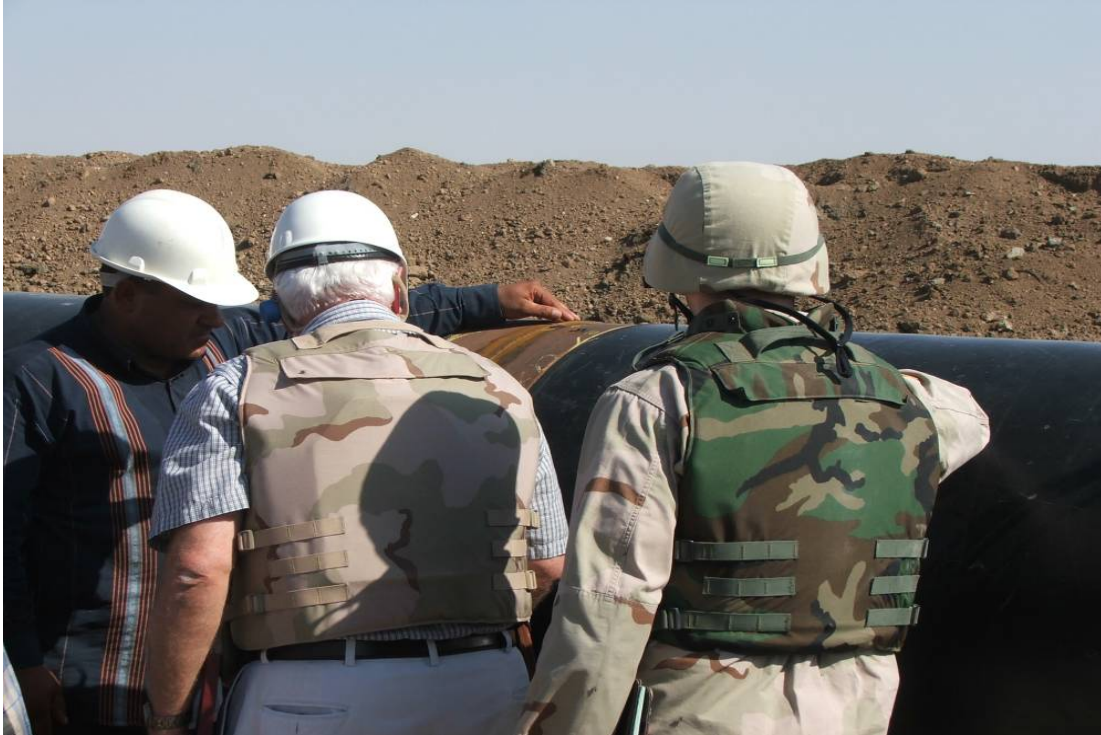
During the site visit, the assessment team observed the contractor's QC Manager effectively working with the subcontractor's QC Inspector and other subcontractor supervisors. In one instance, the contractor's QC Manager pointed out welding and pipe cover problems. The message was presented in a positive manner and it appeared that the subcontractor's QC Inspector became more aware of the expected quality level. Site Photo 8 shows a subcontractor's QC inspector, contractor's QC manager and QAR discussing a weld that needs rework.

**Site Photo 8: Subcontractor QC Inspector, Contractor's QC Manager, and QAR Discuss a Weld That Needs Rework**

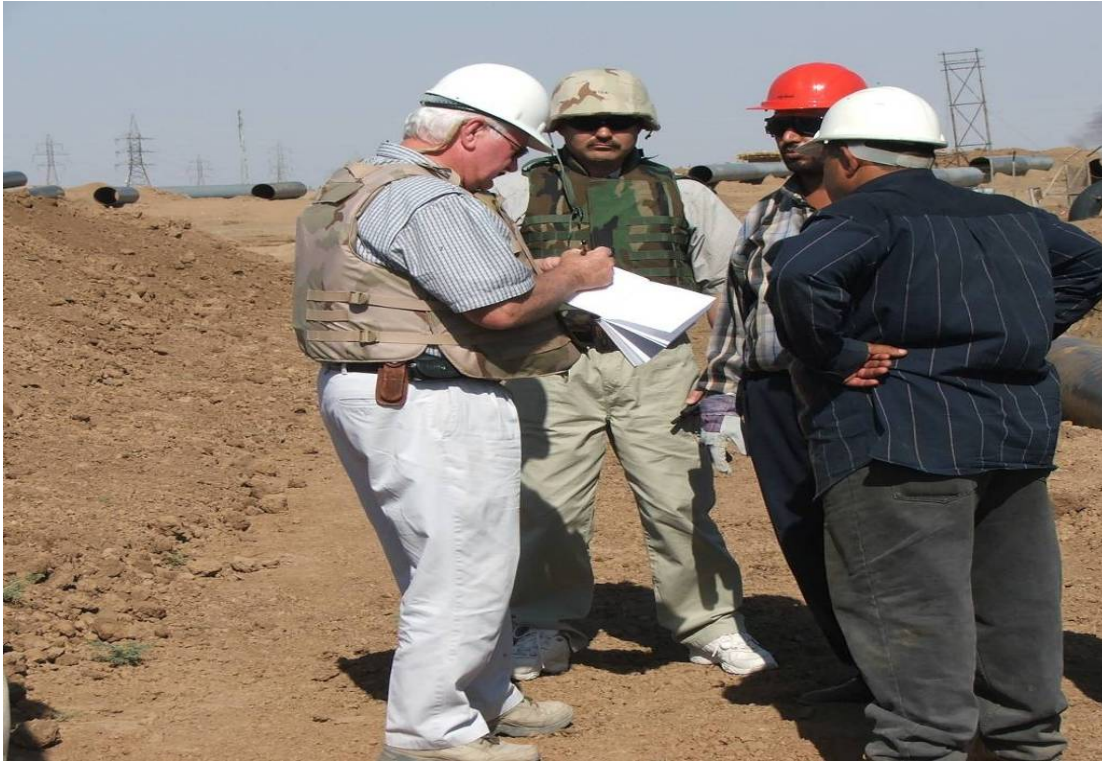
**Site Photo 9: Contractor's QC Manager Explains How to Place Protective Liner in the Pipeline Excavation**
