**NSWCCD-65-TR-2003/09**

## **Long-Term Health Monitoring of the Composite Road Bridge on Delaware Route 896 – 2002 Update**

**NSWCCD-65-TR-2003/09** April 2003

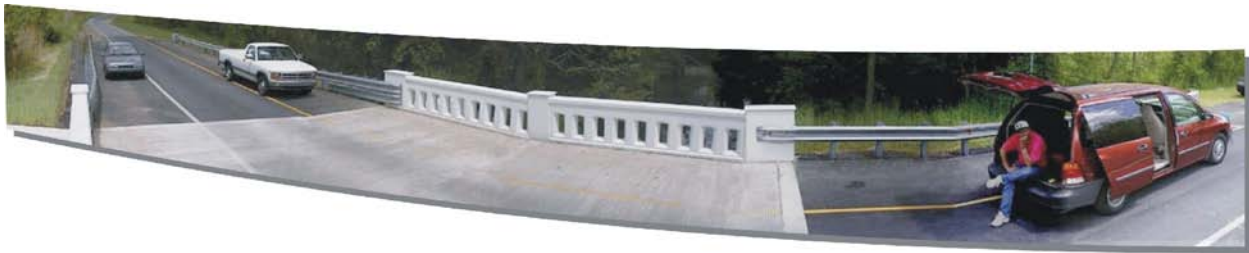
**Figure 1. Panoramic View of Composite Bridge Deck**

The new bridge was installed and opened to traffic on November 20, 1998. This bridge carries a single-lane one-way road. Figure 1 is a panorama of the bridge, compiled from several still images. In this picture, north is left and south is right.
