NSWCCD-65-TR-2004/37 January 2005

SIDER Testing of Impact Damaged Sandwich Panels

Subj: **SIDER INSPECTIONS OF FOUR COMPOSITE SANDWICH PANELS**

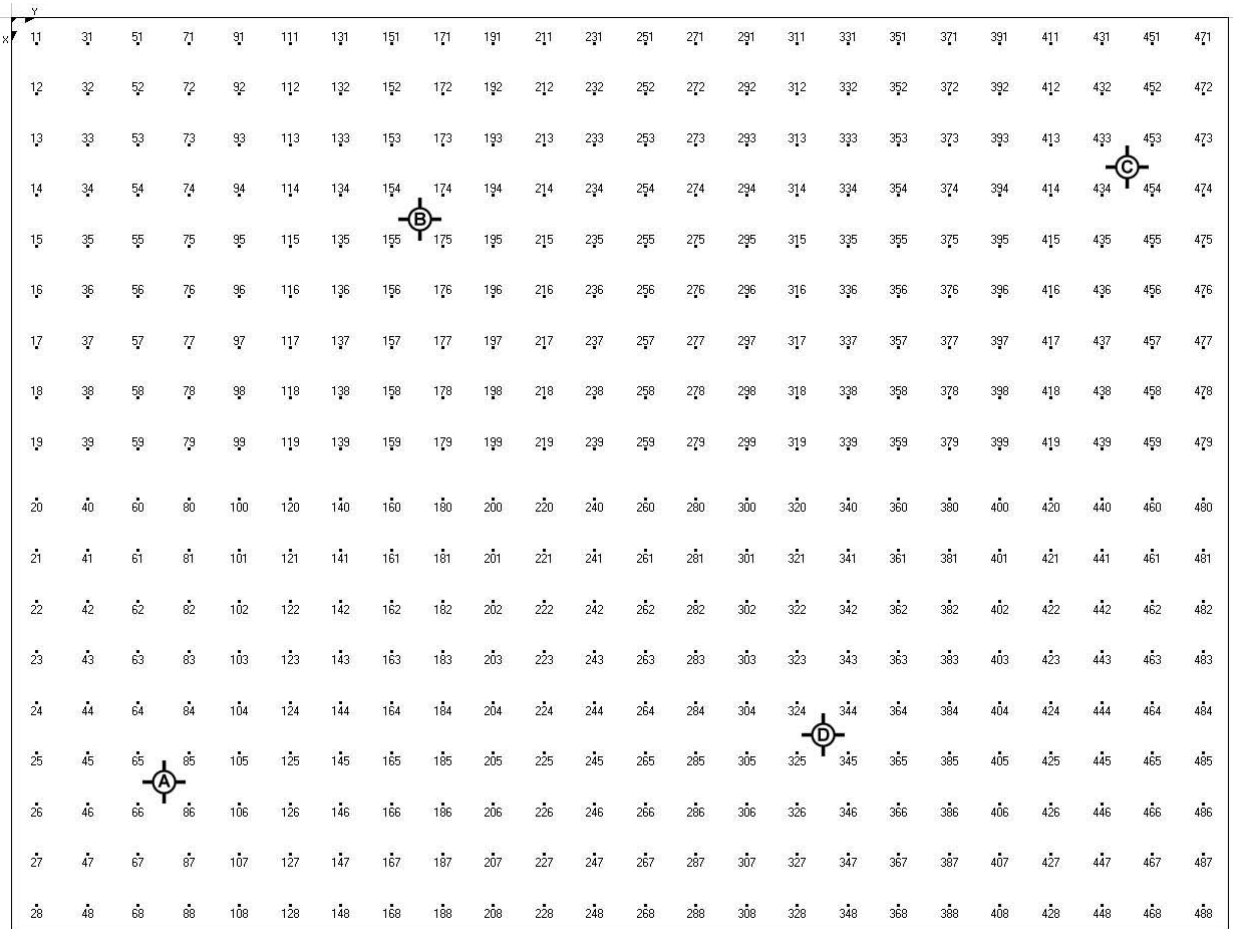
The test meshes are shown in Figure 1 through Figure 3. The individual test points are the uniform mesh of numbered crosses. For this series of tests, four response accelerometers were used. Their locations are shown as symbols with the letters A, B, C and D. The origin for the test mesh was chosen as the “top-left” corner of each panel. The x-axis direction was in the direction of the 3-foot side (down), the y-axis was in the direction of the 4-foot side (right), and the z-direction was up (out of the page). The first test point was located at coordinate position (1, 1, 0) inches. Note that some of the panels were slightly smaller than the nominal size and therefore rows and columns of test points were dropped from the test mesh as necessary. Also, the undamaged Webcore panel had end fixtures that covered several test points. The test mesh for this panel was established using the same origin (corner of the panel), but several rows of test points had to be dropped from the test. The figures include the outside frame of the nominal size of the panels.

The first point was identified as point # ‘11’. The point numbers incremented along the x-axis direction, with the last point on the first row being point #28. The first point on the second row, at coordinate (1, 3, 0) inches, was point #31. The final test point was #488. Thus the mesh was 18×24, with 432 test points.

Figure 1. Test Mesh for: Foam core, 662-lb 1-ft (Li_1) and Foam Core, 662-lb 2-ft (Front (Li_2) and Backside Li_4) Tests)

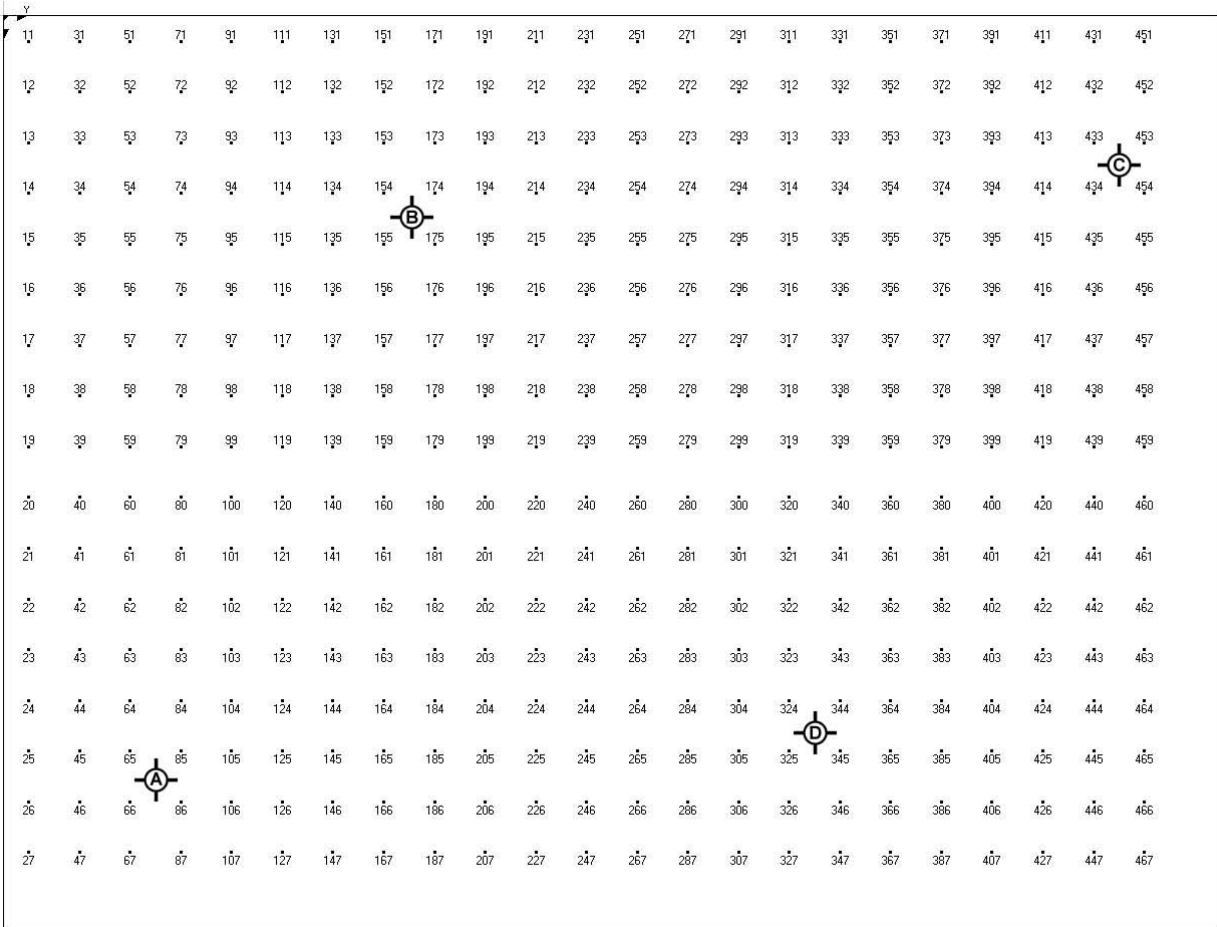
Figure 2. Test Mesh for the Webcore 662-lb 3-ft Panel (Li_3) Backside Test

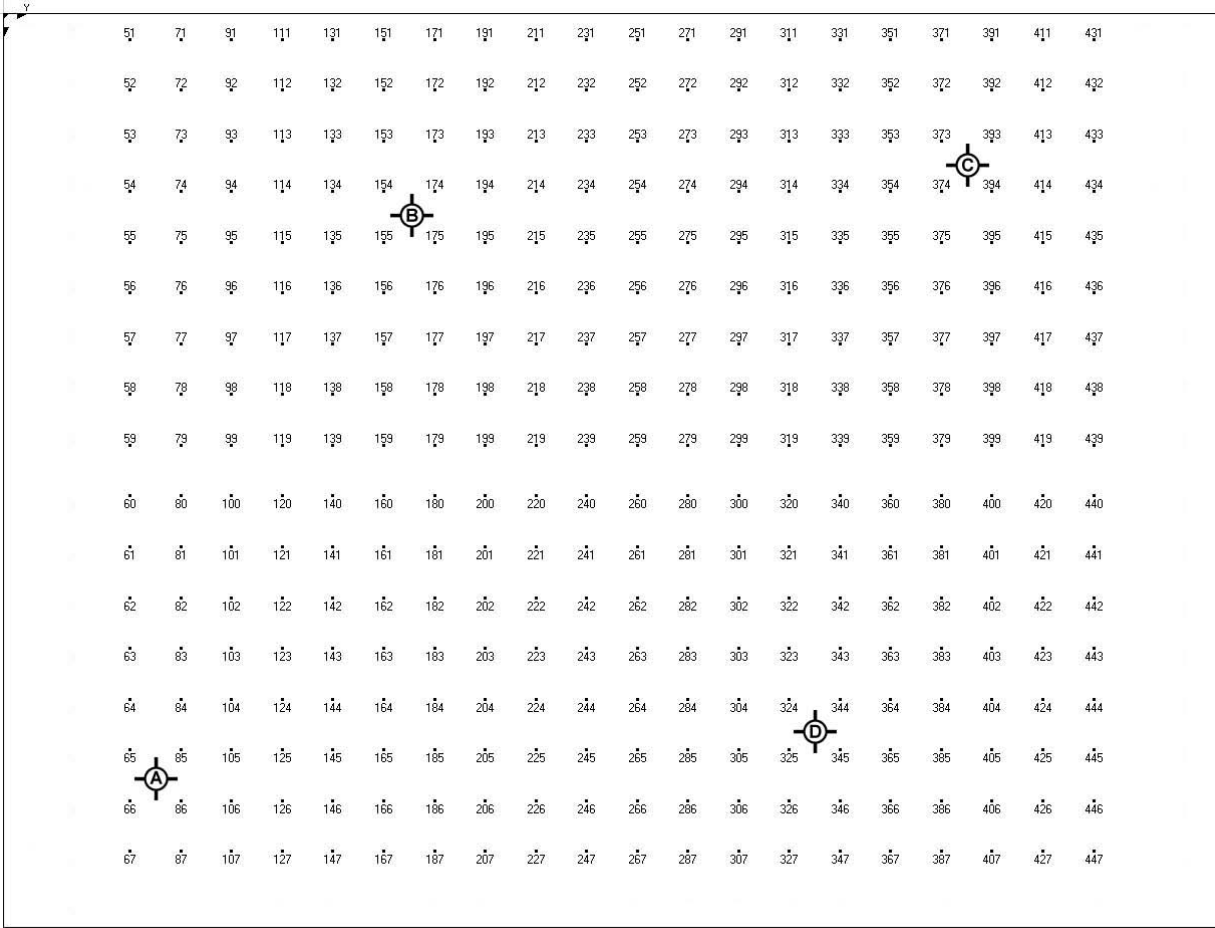
Figure 3. Test Mesh for the Undamaged Webcore Panel (Li_5) with End Fixtures

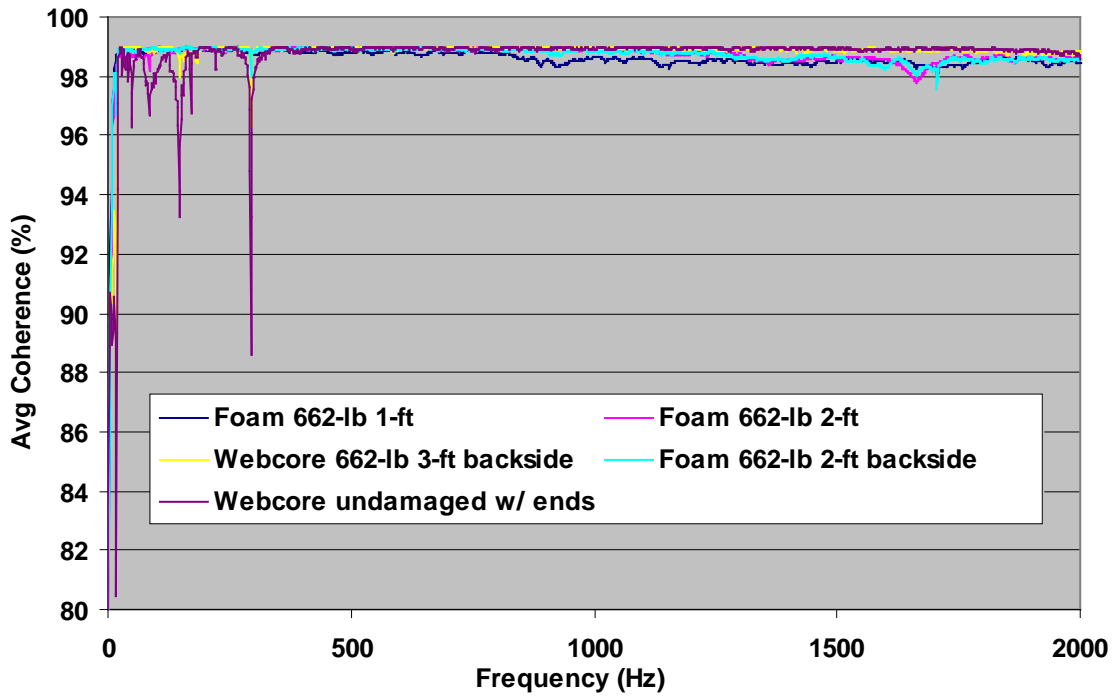
Figure 4. Average Coherence Comparison between Test Parts

For all panels and all accelerometers the data have a very good quality in the range of about 200 Hz to 1200 Hz, although all data are acceptable for SIDER analysis up to the maximum recorded frequency of 2 kHz.

Based on these results, it was decided to conduct all the SIDER analyses using data from the frequency range 200 Hz to 1200 Hz.

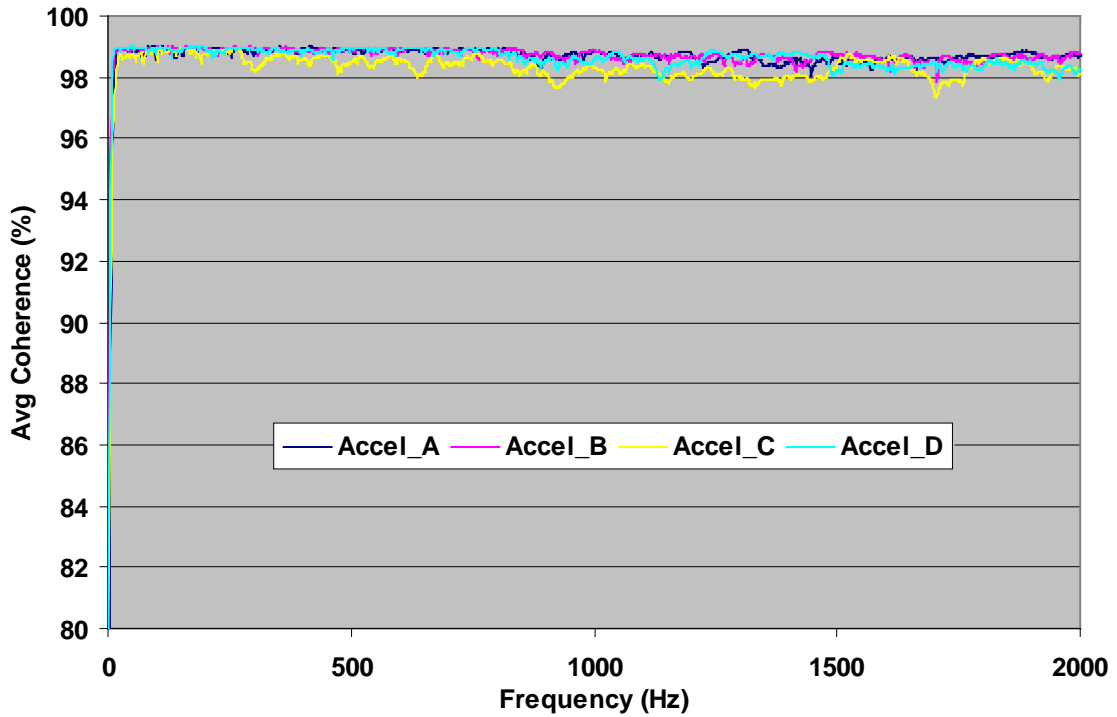
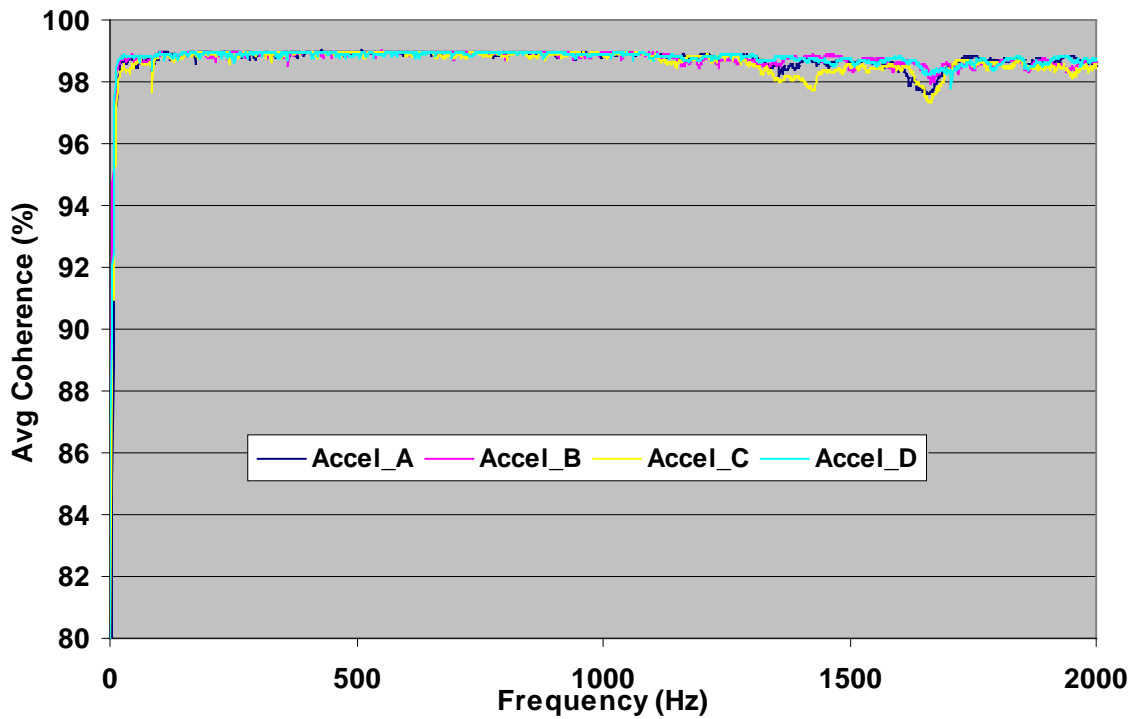
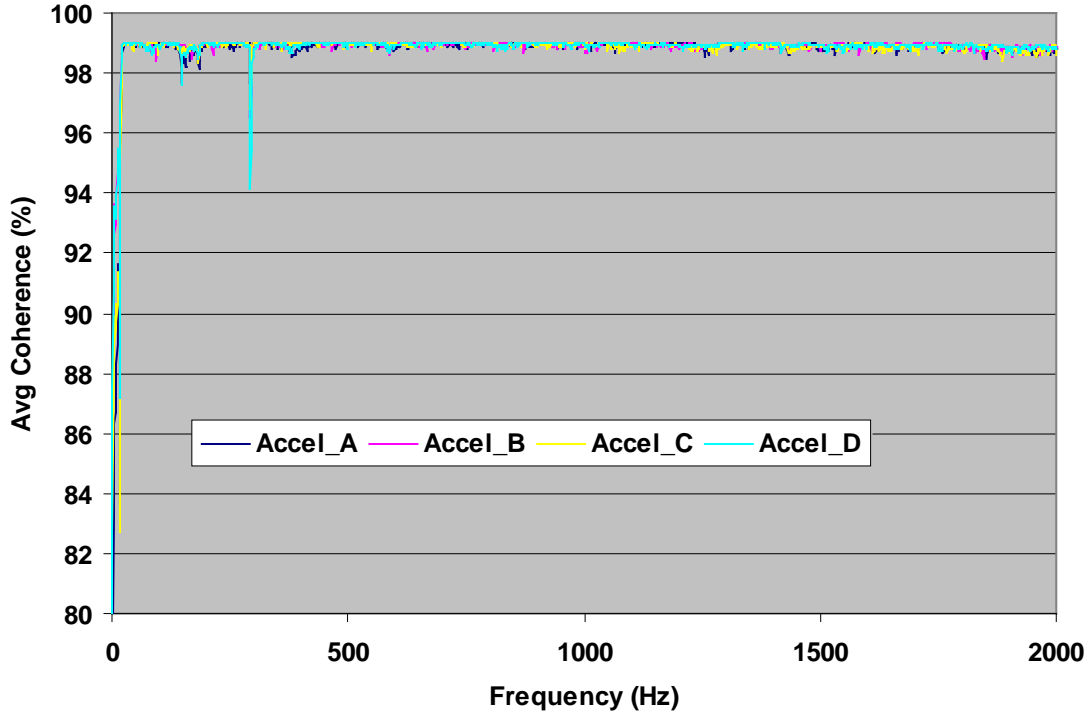
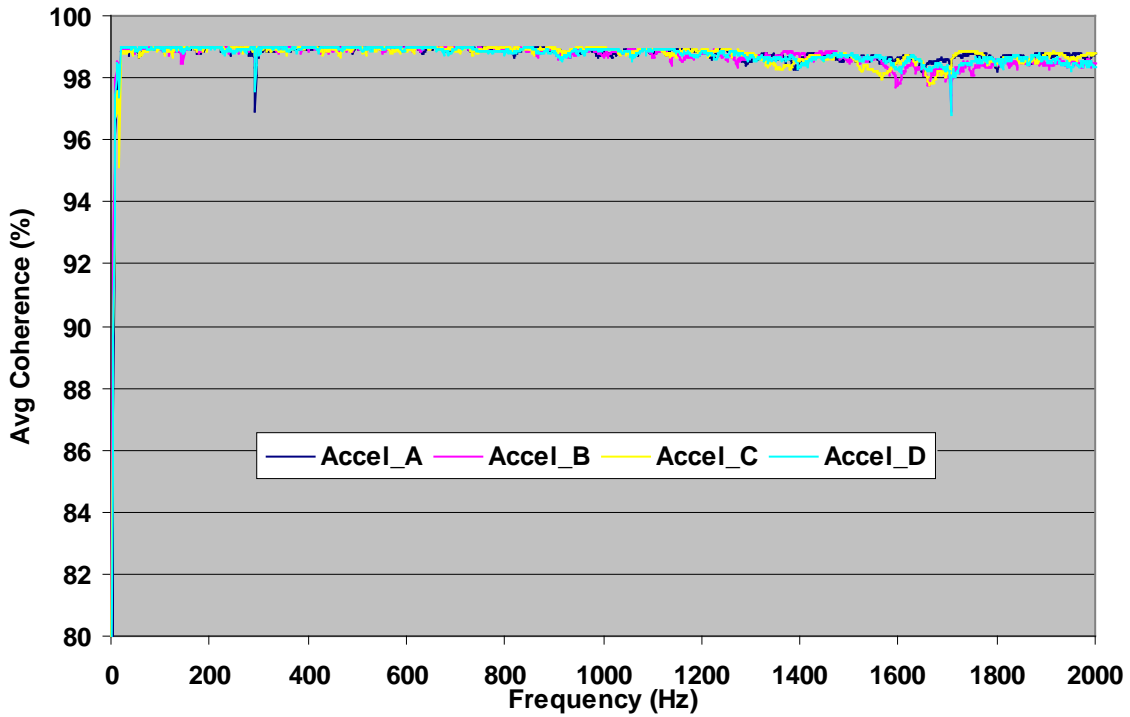
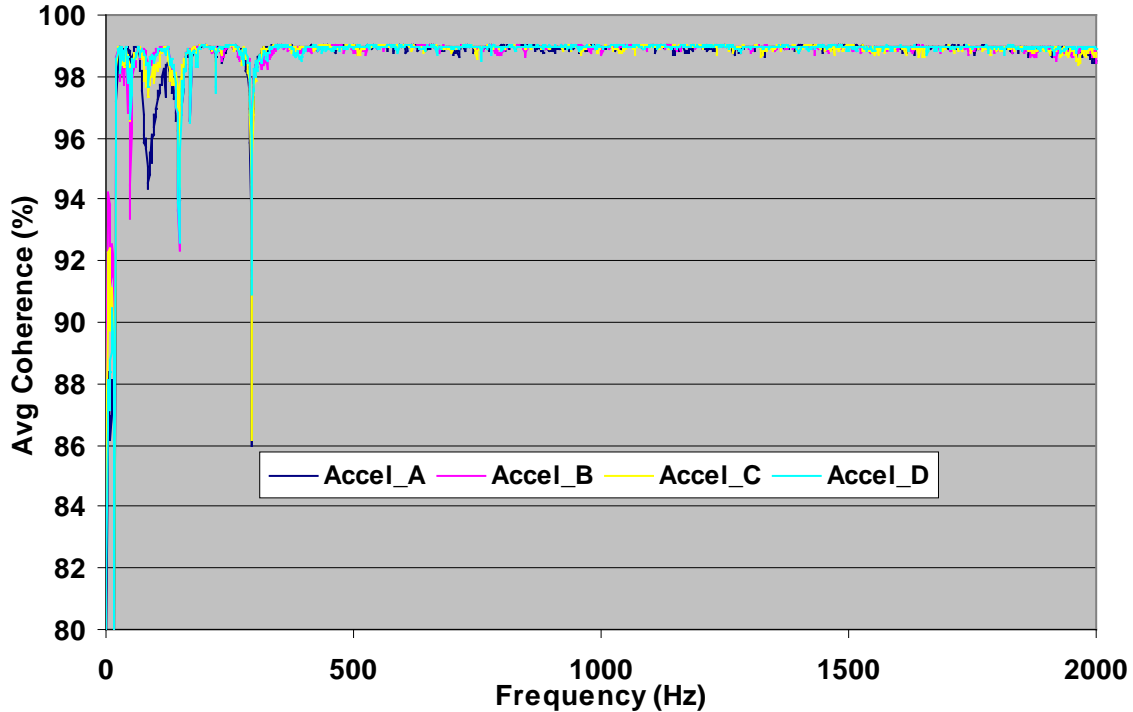
Figure 5. Average Coherence by Accelerometer for Foam Core 662-lb 1-ft

Figure 6. Average Coherence by Accelerometer for Foam Core 662-lb 2-ft

Figure 7. Average Coherence by Accelerometer for Webcore 662-lb 3-ft Backside Test

Figure 8. Average Coherence by Accelerometer for Foam Core 662-lb 2-ft Backside Test

Figure 9. Average Coherence by Accelerometer for Webcore Undamaged with End Fixtures

Data below 200 Hz are more variable, though still of good quality. This slight degradation is typical for resonant structures and is not of concern for the SIDER analysis that typically uses higher frequency data.

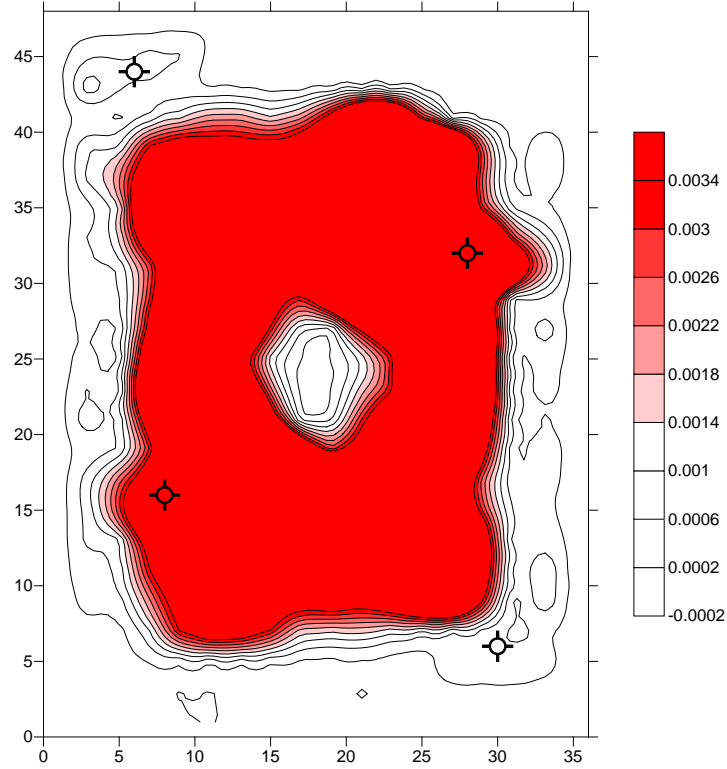
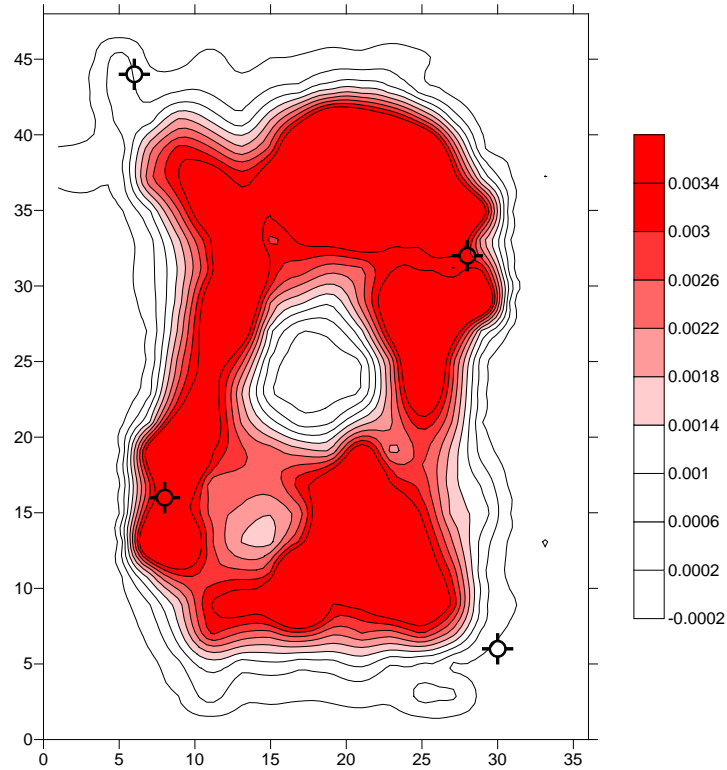
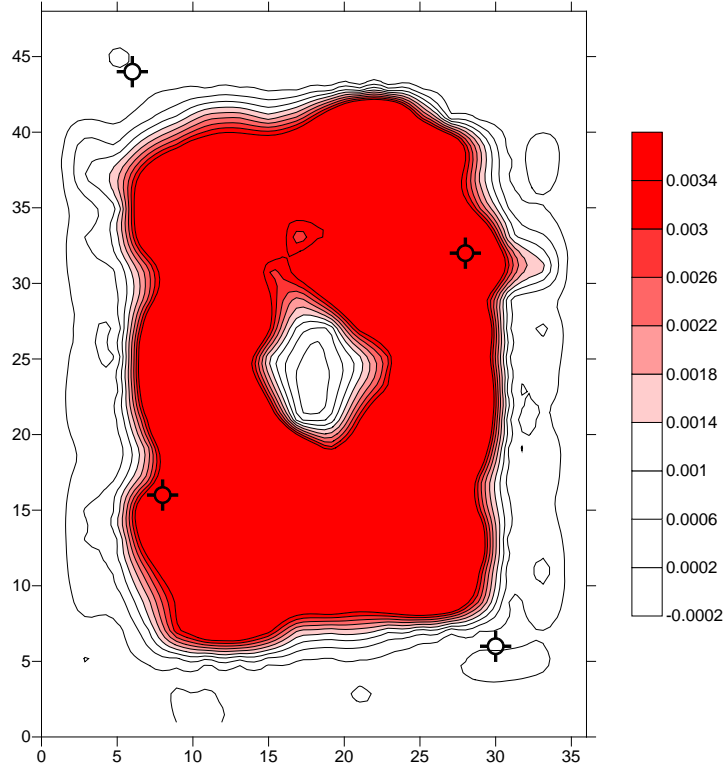
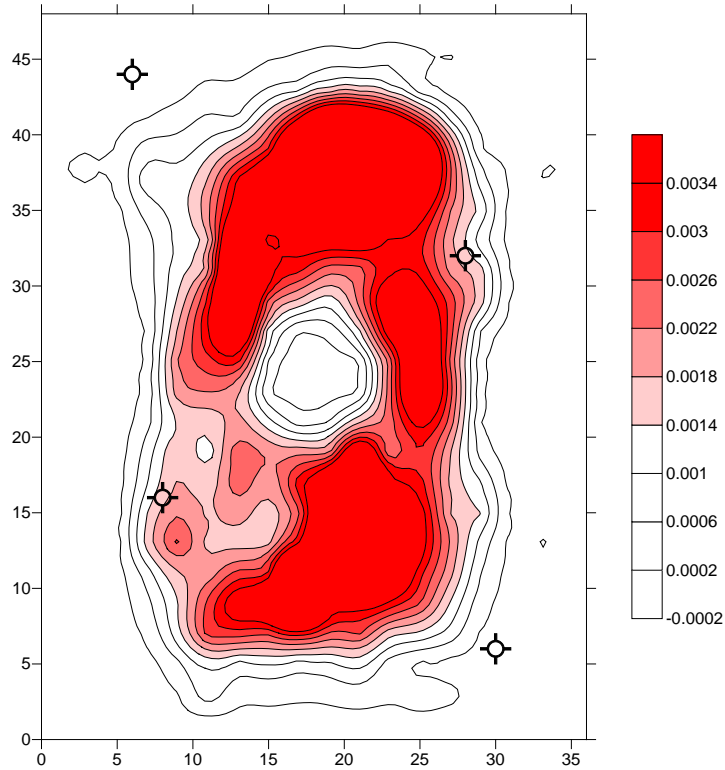
Figure 10. Foam 662-lb 1-ft (Li_1) X-Direction Analysis -Unweighted

Figure 11. Foam 662-lb 1-ft (Li_1) Y-Direction Analysis -Unweighted

Figure 12. Foam 662-lb 1-ft (Li_1) X-Direction Analysis -Pie-Plate Weighting

Figure 13. Foam 662-lb 1-ft (Li_1) Y-Direction Analysis -Pie-Plate Weighting

The SIDER test results of the foam core panels is more complex. One consistent feature for each of these panels is that the location where the impact occurred did not indicate a stiffness variation. This is typical of foam core materials. Typically, the impact area does not see a large variation in spatial stiffness. Damage emanates a certain distance from the actual impact site. The other features indicated by SIDER are more confusing. The lower impact energy panel, L_1, shows a larger area of structural variation than panel L_2, which was impacted with twice the impact energy. It is not known if there was any difference in the way that the panels were impacted. There is the possibility that when panel L_1 was impacted, that the impactor was allowed to rebound and impact a second time since the height of the drop was only 1 foot. In any event, SIDER would indicate that there is a larger area of concern than for panel L_1 than for L_2.

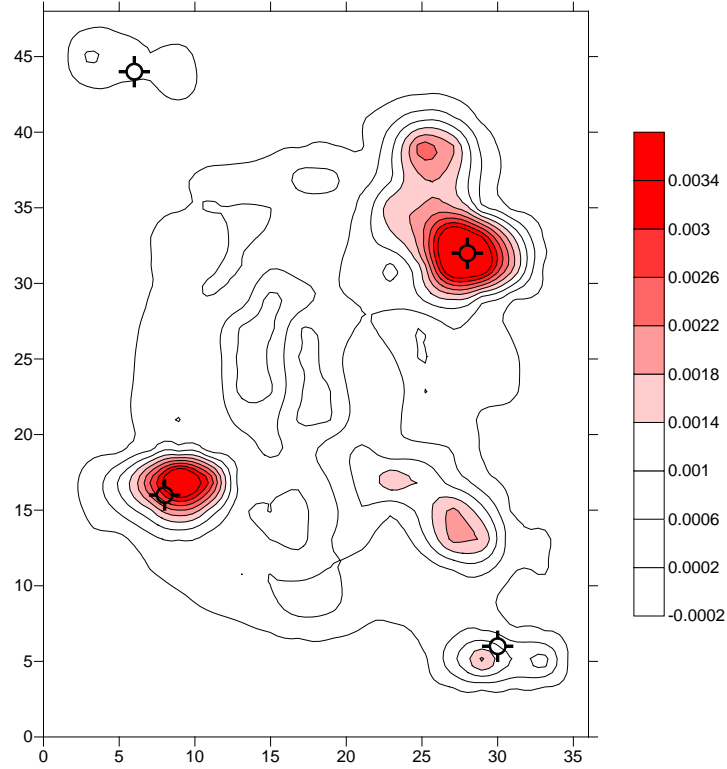
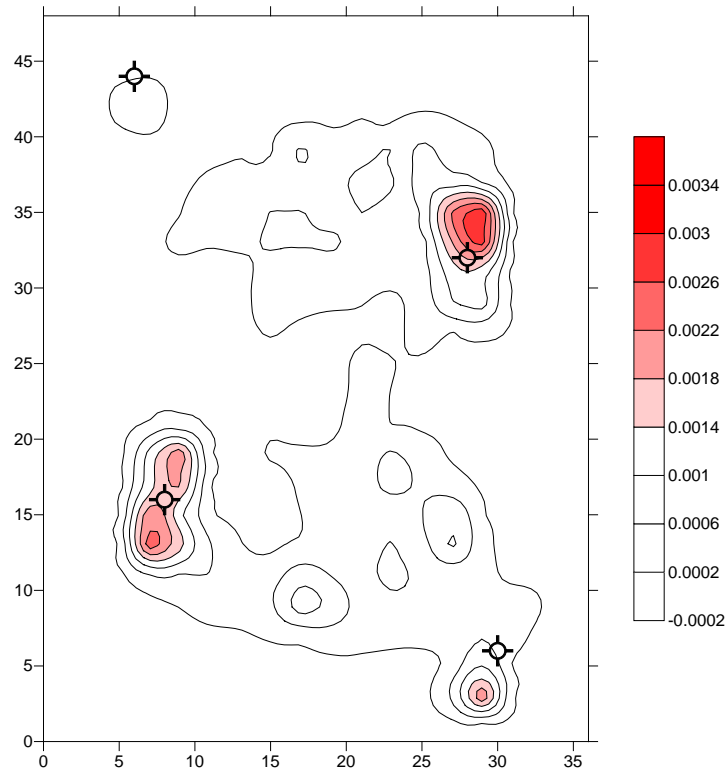
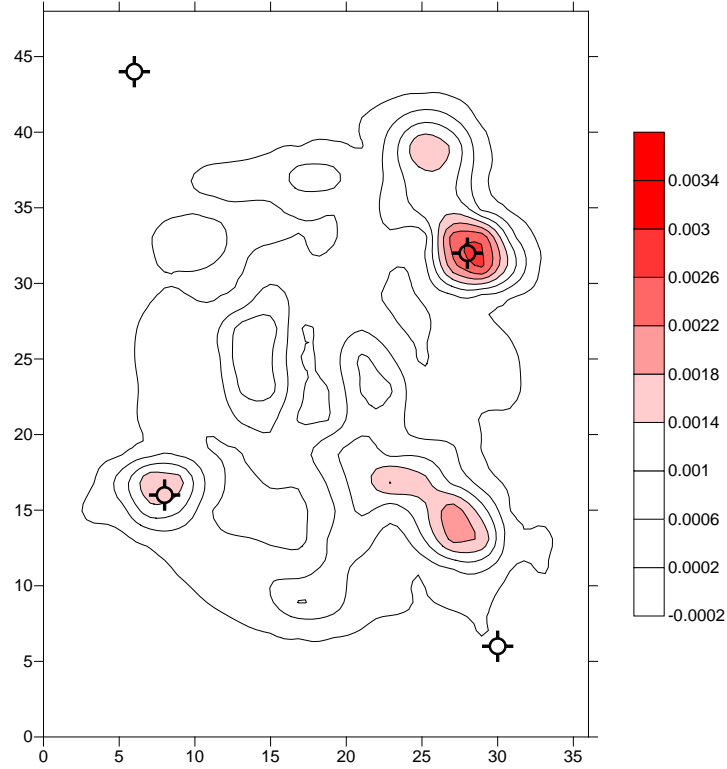
Figure 14. Foam 662-lb 2-ft (Li_2) X-Direction Analysis -Unweighted

Figure 15. Foam 662-lb 2-ft (Li_2) Y-Direction Analysis -Unweighted

Figure 16. Foam 662-lb 2-ft (Li_2) X-Direction Analysis -Pie-Plate Weighting

Figure 17. Foam 662-lb 2-ft (Li_2) Y-Direction Analysis -Pie-Plate Weighting

The other comparison that needs addressing is the SIDER result from testing panel L_2 on the impact side and the side opposite the impact, indicated as Backside test in the figures. There is an obvious difference between the SIDER results from these two tests. Figure 22 through Figure 25 show a much larger area of structural variability than on the backside of the panel, which is shown in Figure 14 through Figure 17. This is not atypical since flexural deformation of composite sandwich structures often have more damage on the tensile surface than the compression surface. What is consistent, though, is that the areas of structural variability occur more along the y-axis of the panel than in the x-direction.

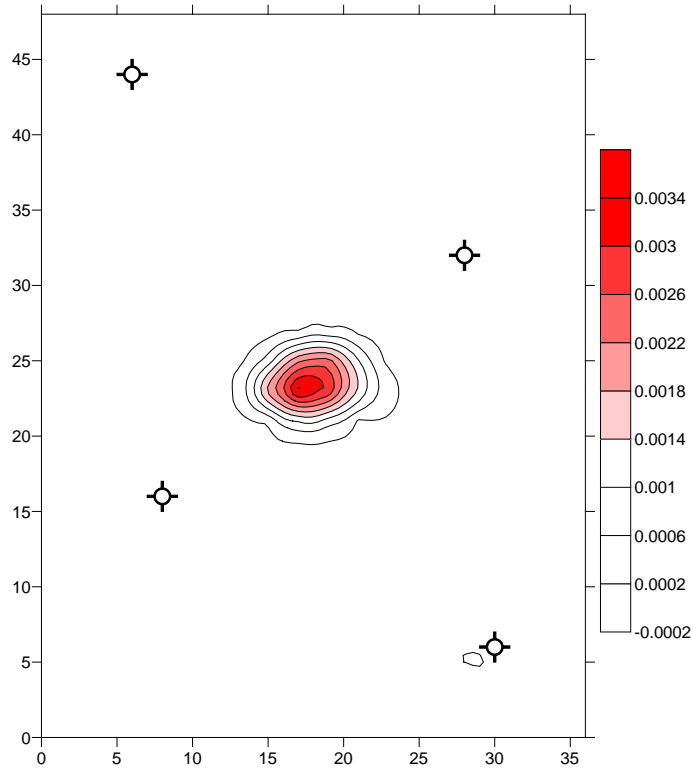
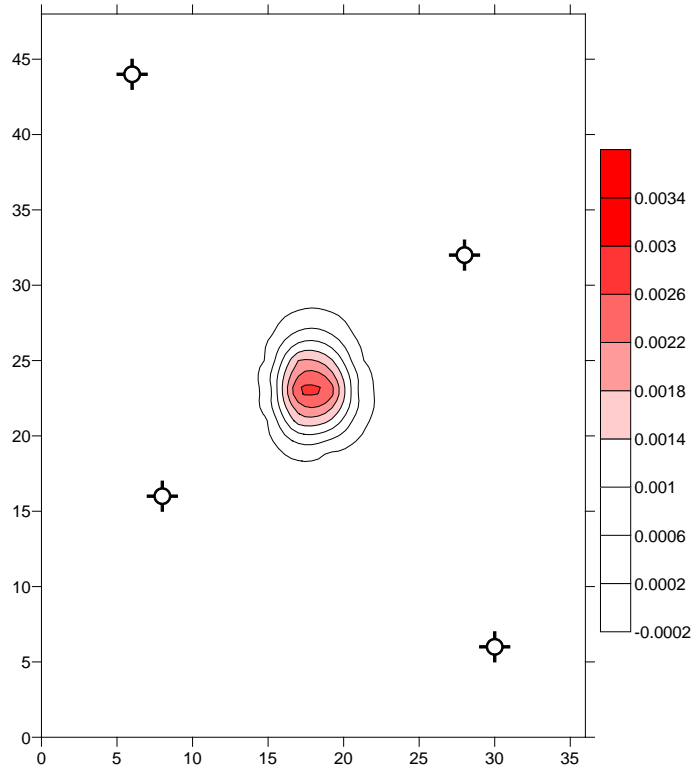
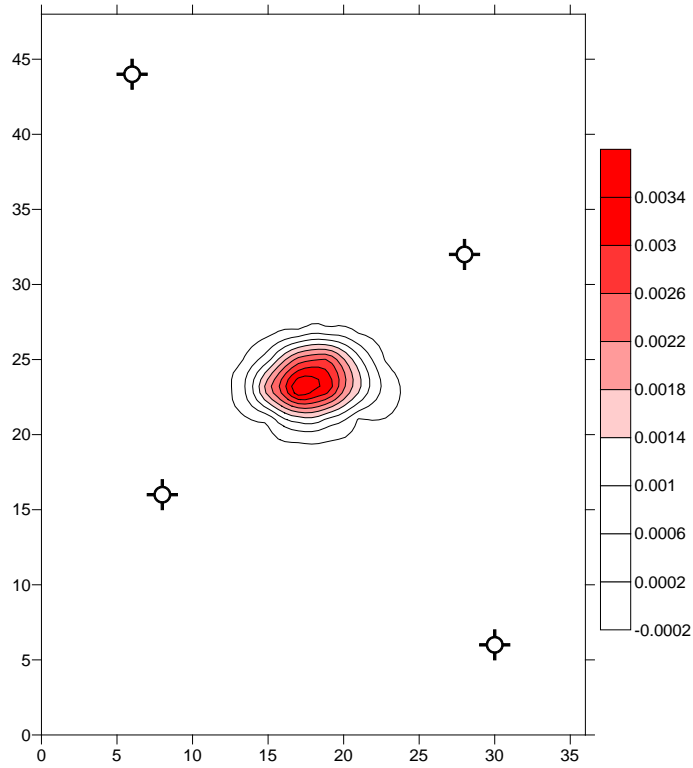
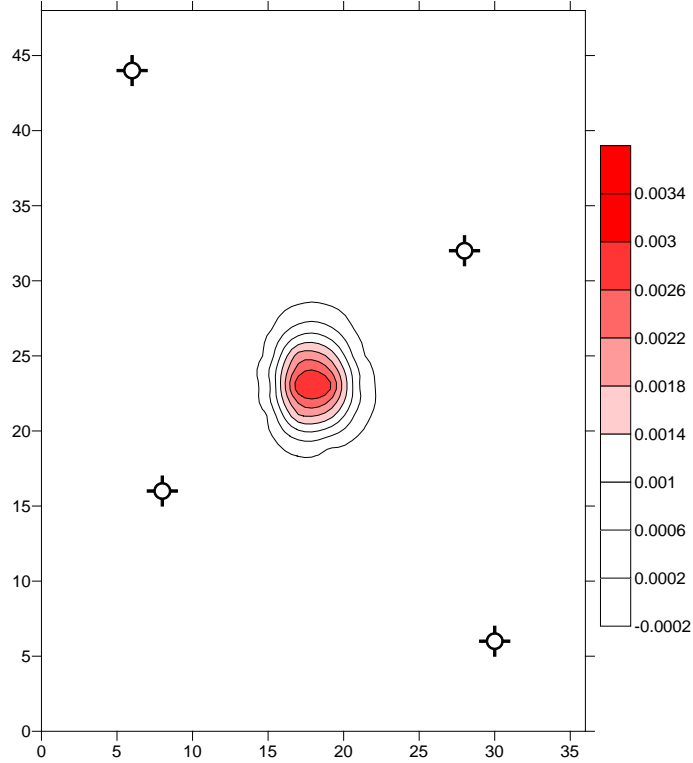
**Figure 18. Webcore 662-lb 3-ft (Li_3) X-Direction Analysis
- Unweighted - Backside Test**

**Figure 19. Webcore 662-lb 3-ft (Li_3) Y-Direction Analysis
- Unweighted - Backside Test**

Figure 20. Webcore 662-lb 3-ft (Li_3) X-Direction Analysis - Pie-Plate Weighting – Backside Test

Figure 21. Webcore 662-lb 3-ft (Li_3) y-Direction Analysis - Pie-Plate Weighting – Backside Test

The SIDER test results from two Webcore panels are discussed first. The panel that had not been tested, L_5, showed a uniform SIDER value over most of the panel with only minor indications near the end fixtures. This shows that the panel was manufactured with a consistent quality. For impacted Webcore panel, L_3, the only indication of structural variation is in the center of the panel, where it was impacted with the drop weight. This is consistent with prior SIDER testing on Webcore impacted panels. The damage has been shown to be highly localized and of a minimal size.

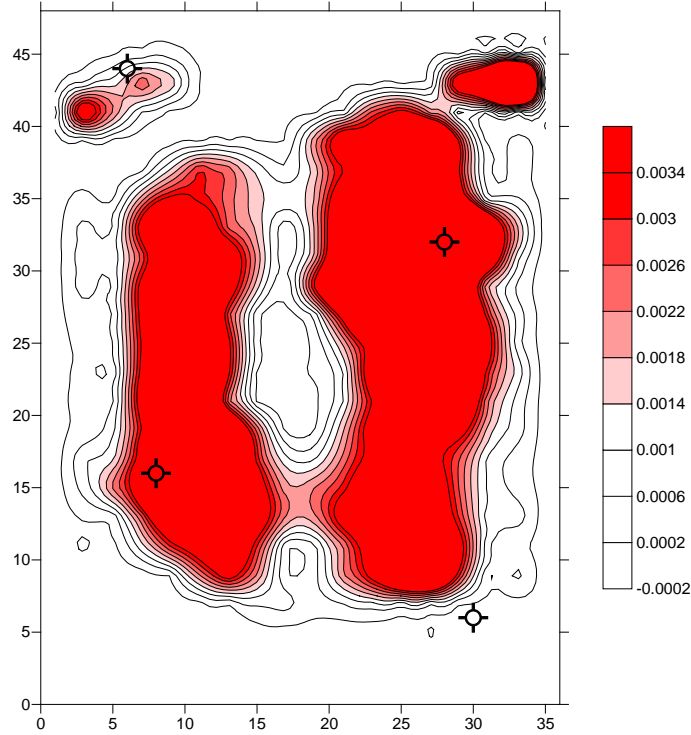
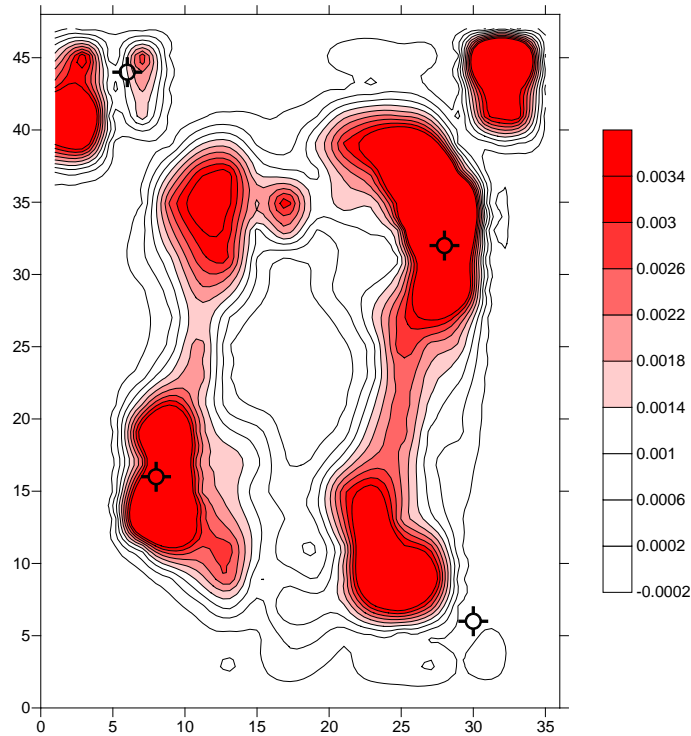
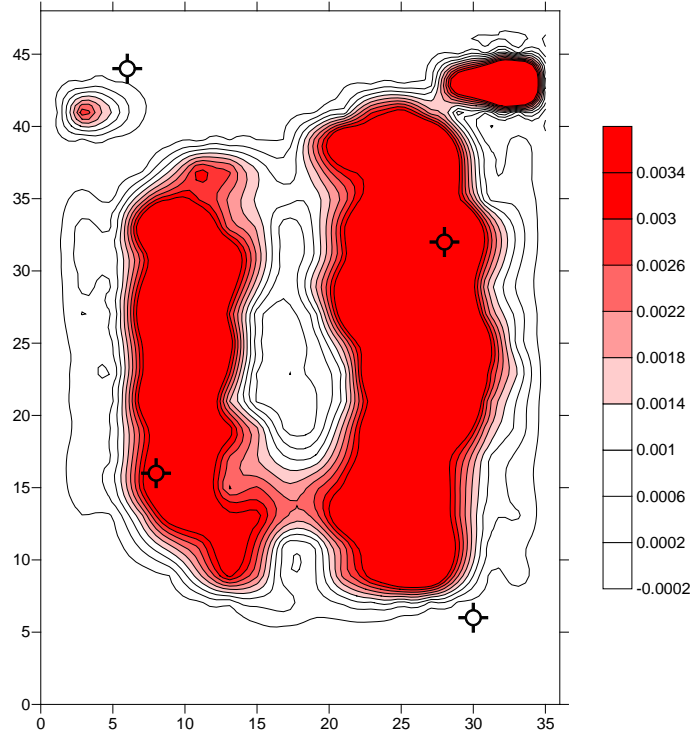
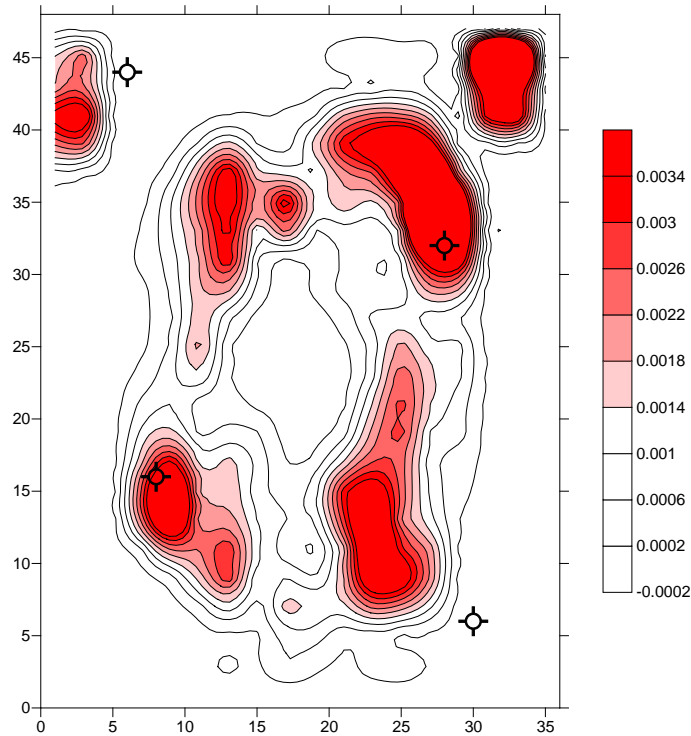
**Figure 22. Foam 662-lb 2-ft (Li_4) x-Direction Analysis
– Unweighted – Backside Test**

**Figure 23. Foam 662-lb 2-ft (Li_4) Y-Direction Analysis
– Unweighted – Backside Test**

Figure 24. Foam 662-lb 2-ft (Li_4) x-Direction Analysis -Pie-Plate Weighting – Backside Test

Figure 25. Foam 662-lb 2-ft (Li_4) y-Direction Analysis -Pie-Plate Weighting – Backside Test

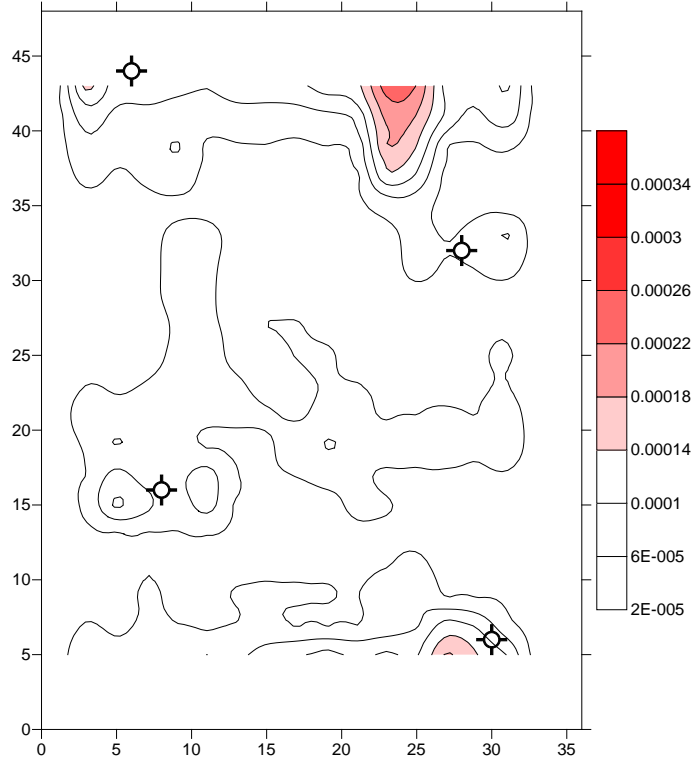
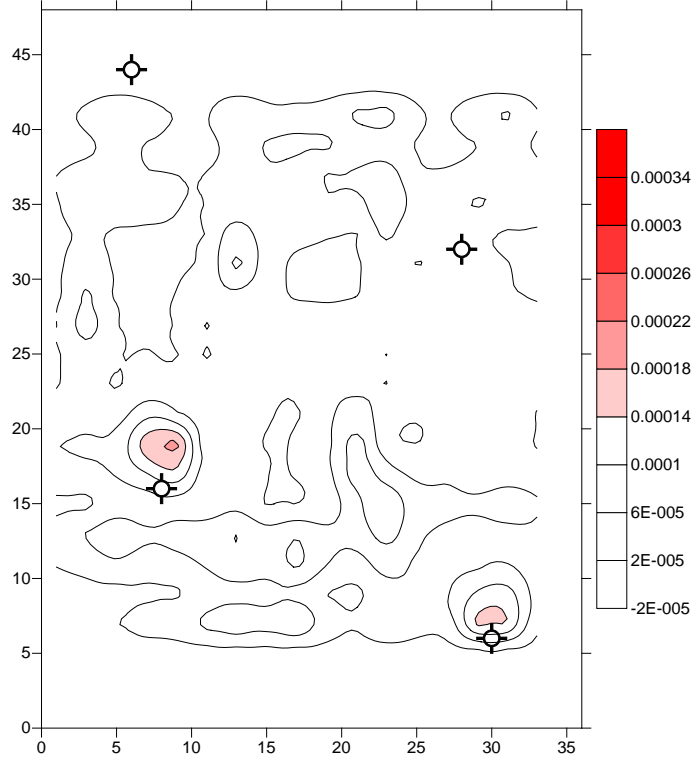
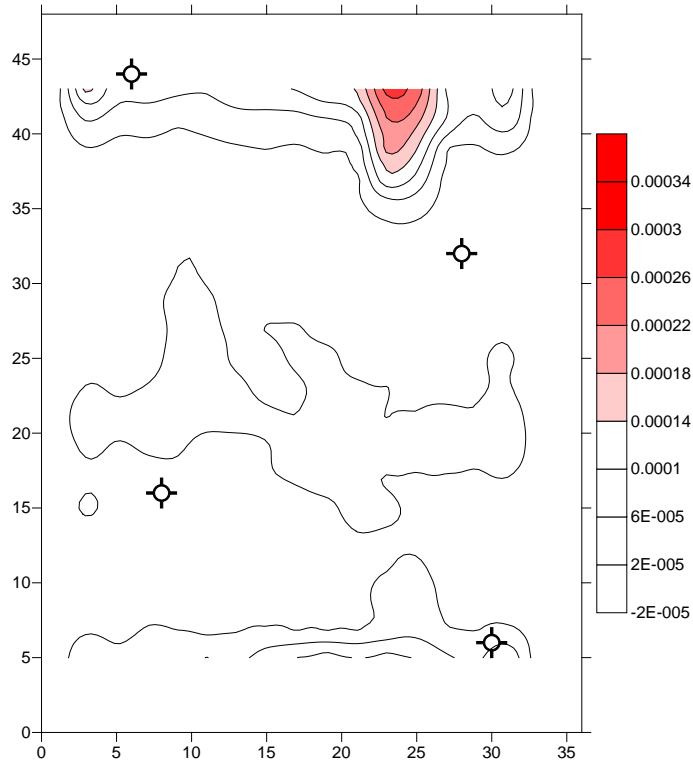
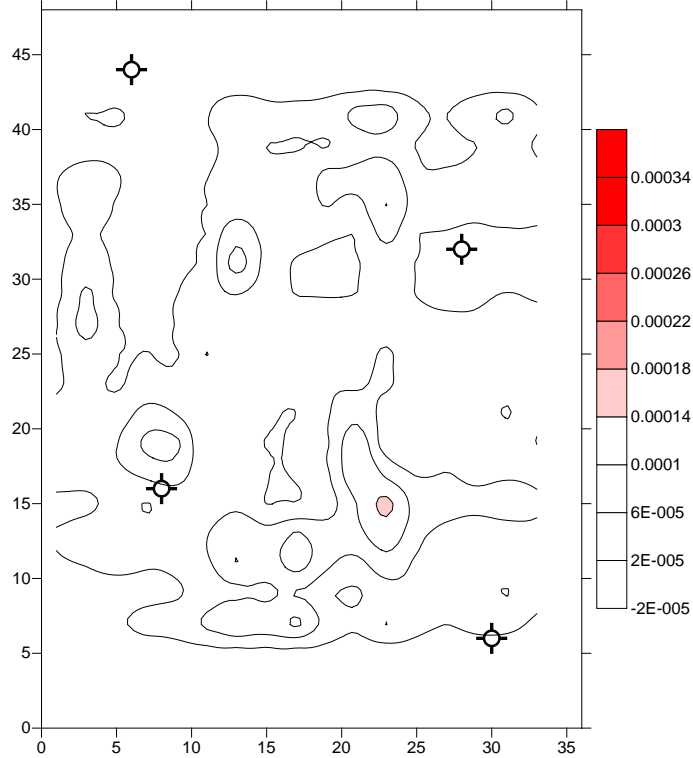
**Figure 26. Webcore Undamaged (Li_5) x-Direction Analysis
– Unweighted 10 × Magnification**

**Figure 27. Webcore Undamaged (Li_5) y-Direction Analysis
– Unweighted 10 × Magnification**

**Figure 28. Webcore Undamaged (Li_5) x-Direction Analysis
-Pie-Plate Weighting 10 × Magnification**

**Figure 29. Webcore Undamaged (Li_5) y-Direction Analysis
-Pie-Plate Weighting 10 × Magnification**
