Composite Bridges: Health Monitoring with the Diagnostic Prognostic System (DPS) and an Evaluation of a Temporary Field Repair System

Frank Abdi†*, Rashid Miraj†, Ayman Mosallam‡, and Jian-Juei Wang§, and Ramki Iyer¶

Abstract

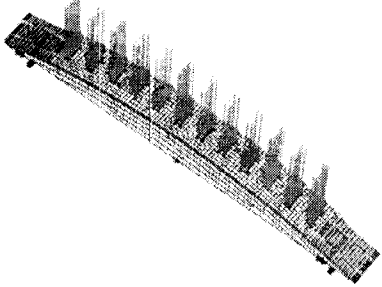
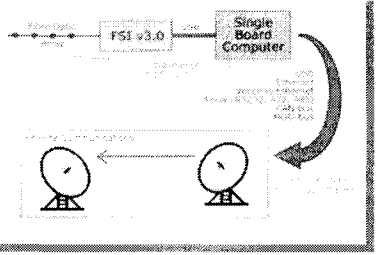
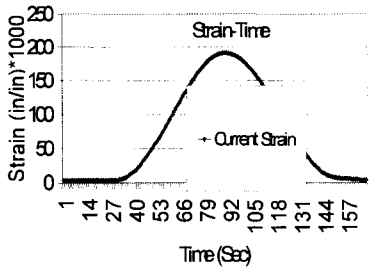
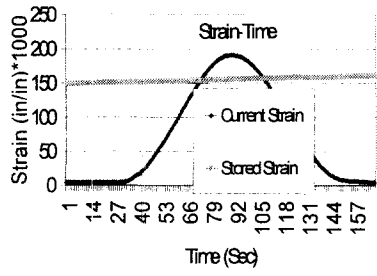
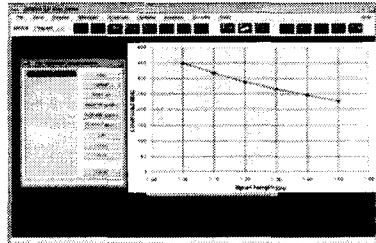
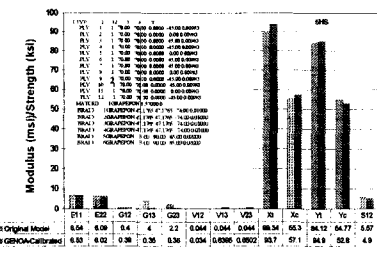
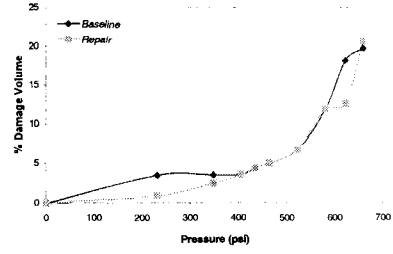
Figure 1 - DPS System Step by Step

Diagnostic Component

Step 1 Run Model with GENOA	Step 2 Send Live Data from Bridge	Step 3 Receive Live Data from Bridge

Step 4 Compare Live Data to Stored Data	Step 5 Multi-site Damage Assessment Identify Location of Damage and Corresponding Load or Cycle Number	Step 6 Evaluate Residual Stiffness & Strength Run Material Characterization Analysis (MCA) with Residual Damage to plot/find Residuals
Prognostic Component

Step 7 Assess Available Materials for Repair List Available Repair Material in Databank Plot Corresponding Strength and Stiffness	Step 8 Suggest Materials for Repair Run Material Uncertainty Analysis (MUA) to Find Material Failure Sensitivity and Suggest Percentage Mix of Constituents	Step 9 Evaluate/Compare Performance of Baseline versus Repaired Specimen
