Full-Scale Accelerated Pavement Testing of Warm-Mix Asphalt (WMA) for Airfield Pavements

Mariely Mejías-Santiago, Jesse D. Doyle, and John F. Rushing

January 2014

Final report

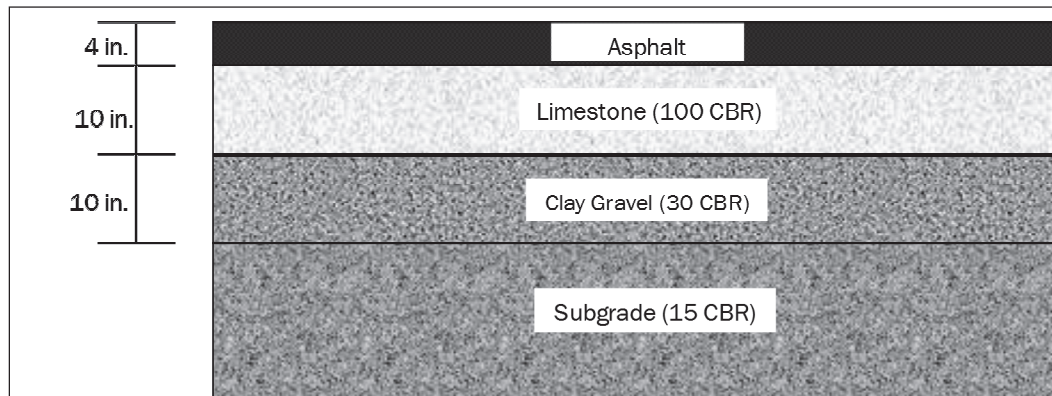
Figure 3. Test-section pavement structure.

The pavement structure was designed to minimize deformation in the unbound layers so that failure would occur predominantly in the surface layer. Pavement Transportation Computer Aided Structural Evaluation (PCASE) software and Pavement Engineering Utility (PSEVEN) were used

to determine the optimum pavement structural design in accordance with DOD airfield design criteria (UFC 3-260-02). Locally available materials that would withstand over 100,000 passes of an F-15E aircraft fully loaded to approximately 35,000-lb load and 325-psi tire pressure without failure were used. Failure for this analysis was defined as 1 in. of rutting mainly attributed to the subgrade or subbase layers. The resulting pavement structure consisted of 4 in. of asphalt concrete over 10 in. of base course with a California bearing ratio (CBR) of 100, over a 10-in.-thick subbase course with a CBR of 30. The subgrade had an assumed CBR of 15. Each test item was designed using the same pavement structure (Figure 3). The asphalt concrete layer was varied to include three WMAs and one HMA surface.

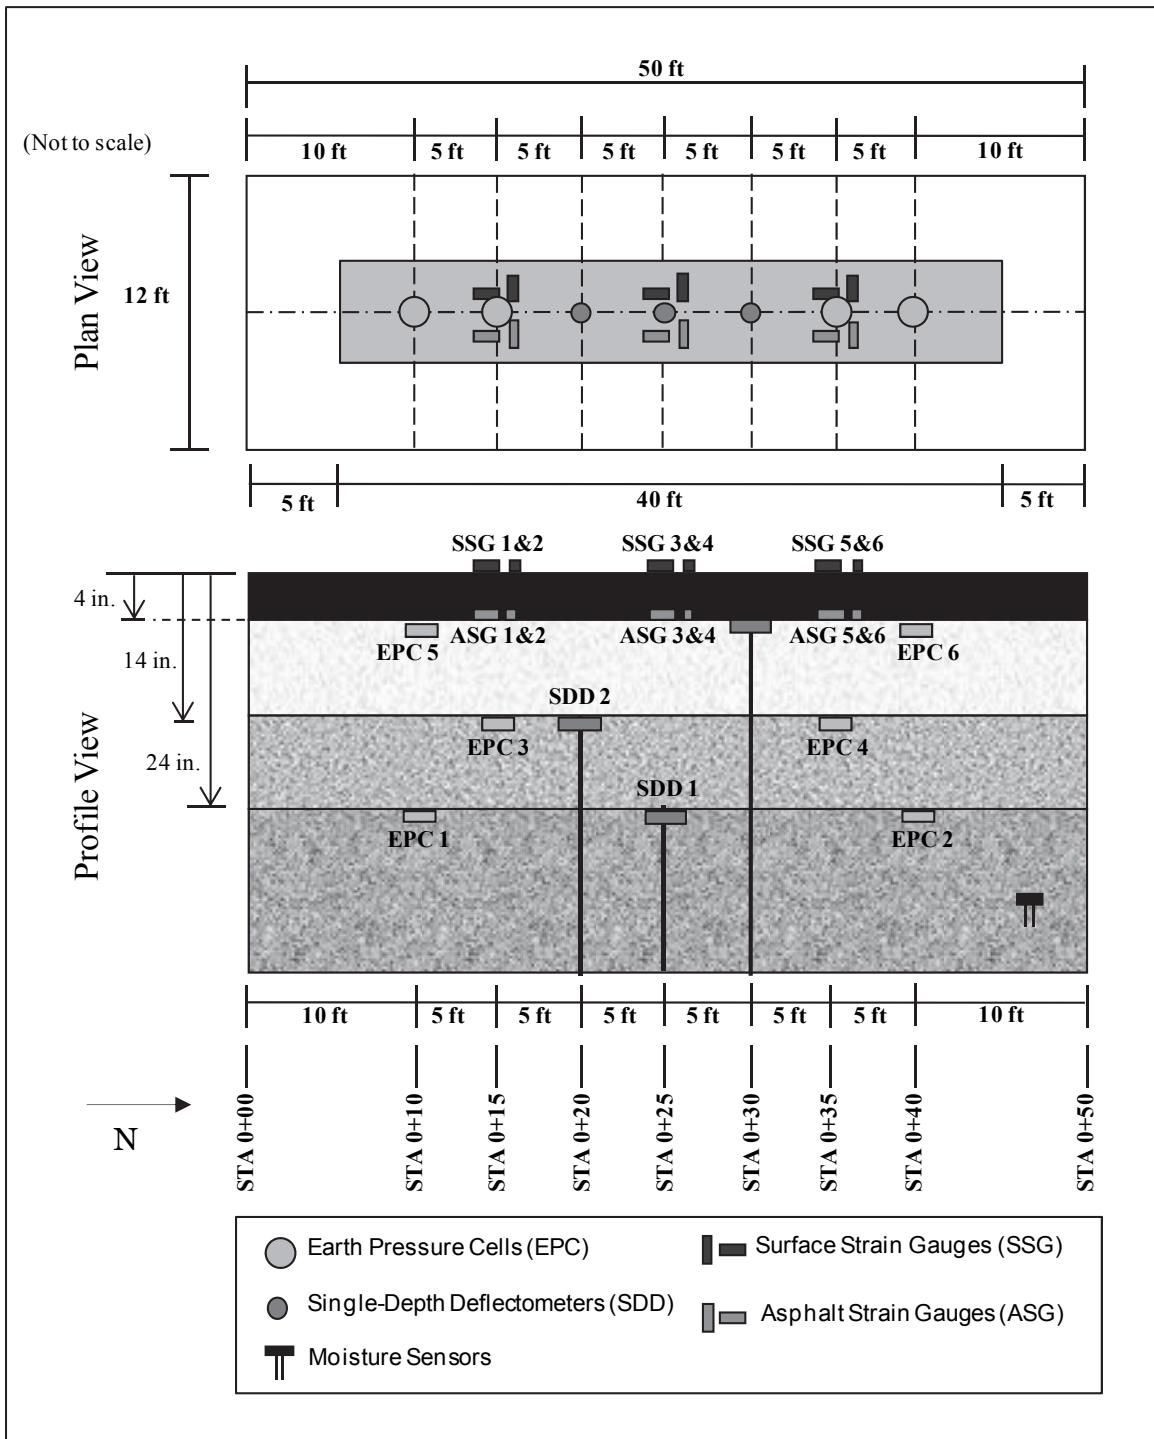
Figure 5. Instrumentation layout.

During construction, each test item was instrumented with earth pressure cells (EPCs), single-depth deflectometers (SDDs), asphalt strain gauges (ASGs), and surface strain gauges (SSGs) to measure the pavement response to simulated aircraft loading. Moisture sensors were also installed in the subgrade of all four test items to monitor moisture changes throughout the test period. Figure 5 shows the instrumentation layout.

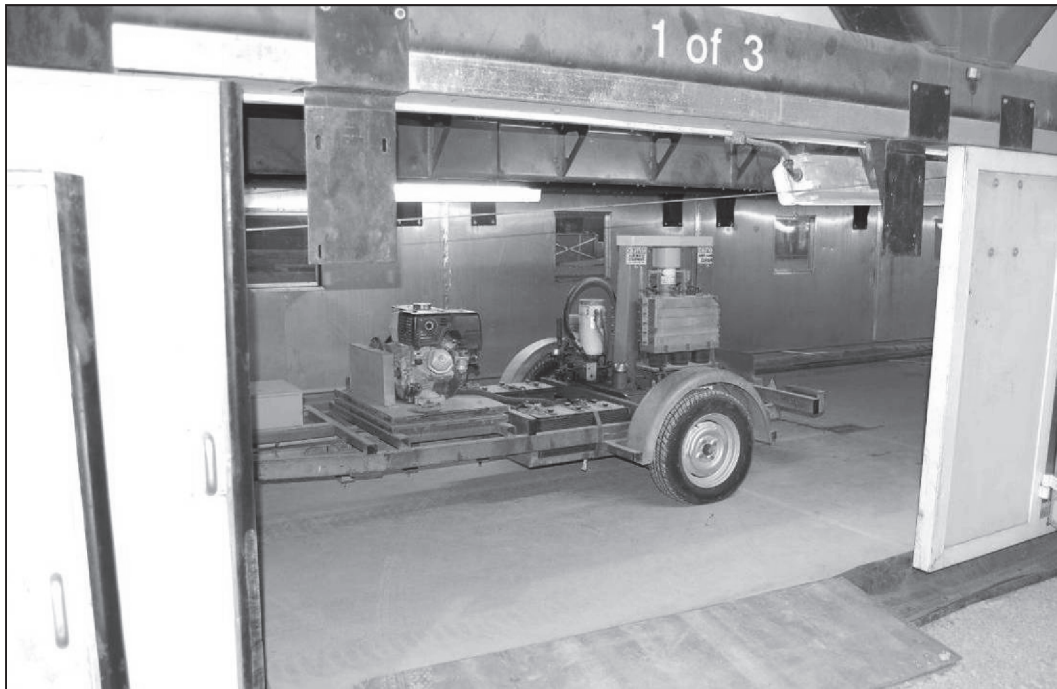
Figure 17. FWD testing on Item 4.

The FWD is normally trailer-mounted on a vehicle; however, for this project, the FWD was manually moved under the HVS-A and the pavement was tested at Stations 10, 15, 20, 25, 30, 35, and 40 before trafficking at both ambient and at high temperature conditions, and later after trafficking at the high temperature condition. Figure 17 shows FWD testing on Item 4.

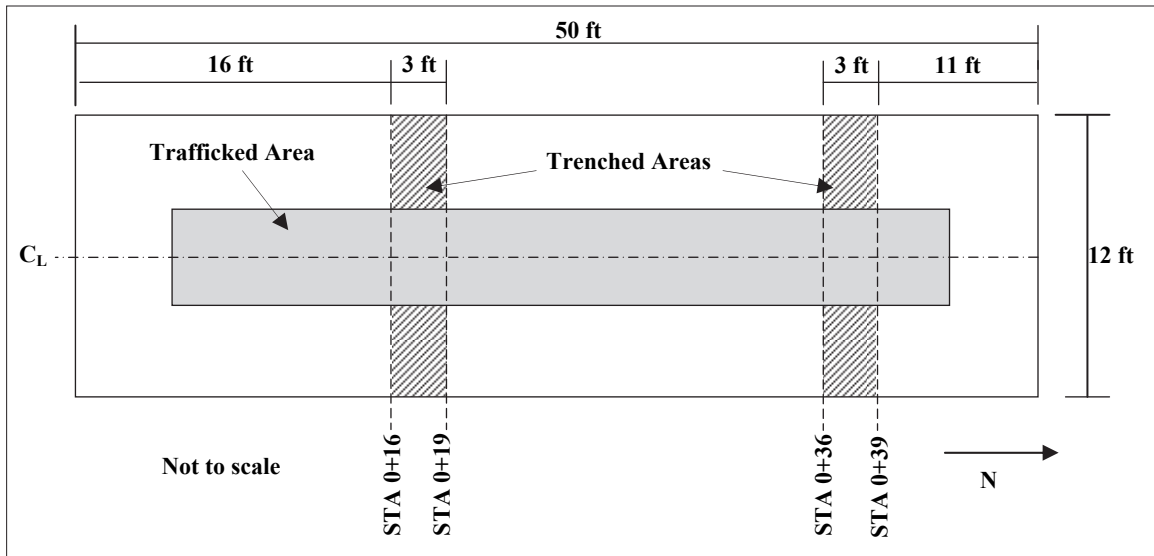
Figure 18. Trenching Layout.

After trafficking of the test section was complete, 3-ft-wide by approximately 3-ft-deep trenches were excavated on each test item as indicated in Figure 18. These locations were selected to avoid trenching over the instrumentation and to get a good assessment of the pavement failure. The trenches on the north end of the test items were used to assess the areas with the least rutting measured, and the trenches on the south end were used to assess the areas with the deepest rutting measured.

All four test items were trenched 6 months after trafficking was completed. Each layer of the pavement structure was removed individually and assessed at the center of the rut and outside the traffic lane. CBR tests, nuclear density and moisture measurements, and oven moisture tests were completed at each location on each foundation layer. Furthermore, visual inspection and manual profile measurements were performed to aid in determining where failure occurred.

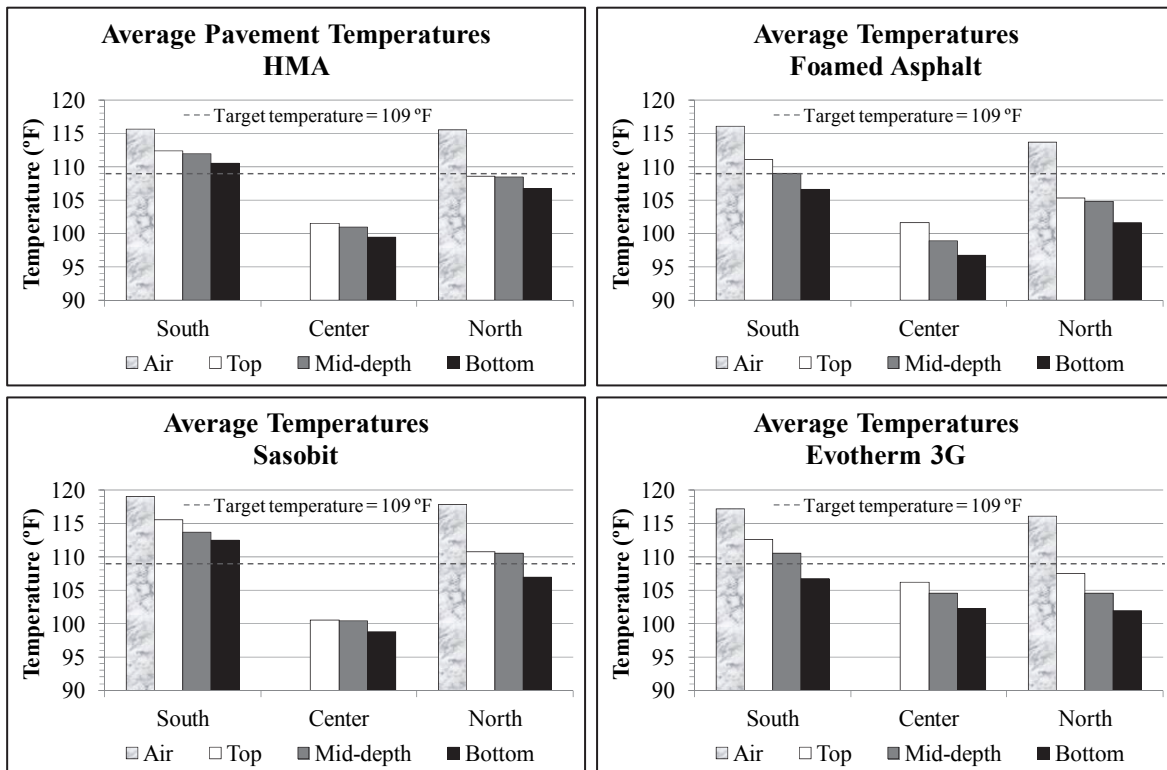
Figure 19. Average pavement temperatures as measured at the top, middle, and bottom of the asphalt layer during traffic.

The target pavement temperature for this study was 109 °F, and it is indicated by a dashed line in the plots in Figure 19. An almost linear temperature gradient was observed in most cases, going from a higher temperature at the top of the asphalt layer to a lower temperature at the bottom. In some cases, the top and mid-depth temperatures were very similar. This was due to installation errors (i.e. I-buttons were installed at the same depth). The inside air temperature varied slightly from the north end to the south (the biggest difference was 3 °F in Foamed Asphalt). This slight discrepancy was reflected in an average difference in pavement temperatures between the north and south ends of 5 °F.

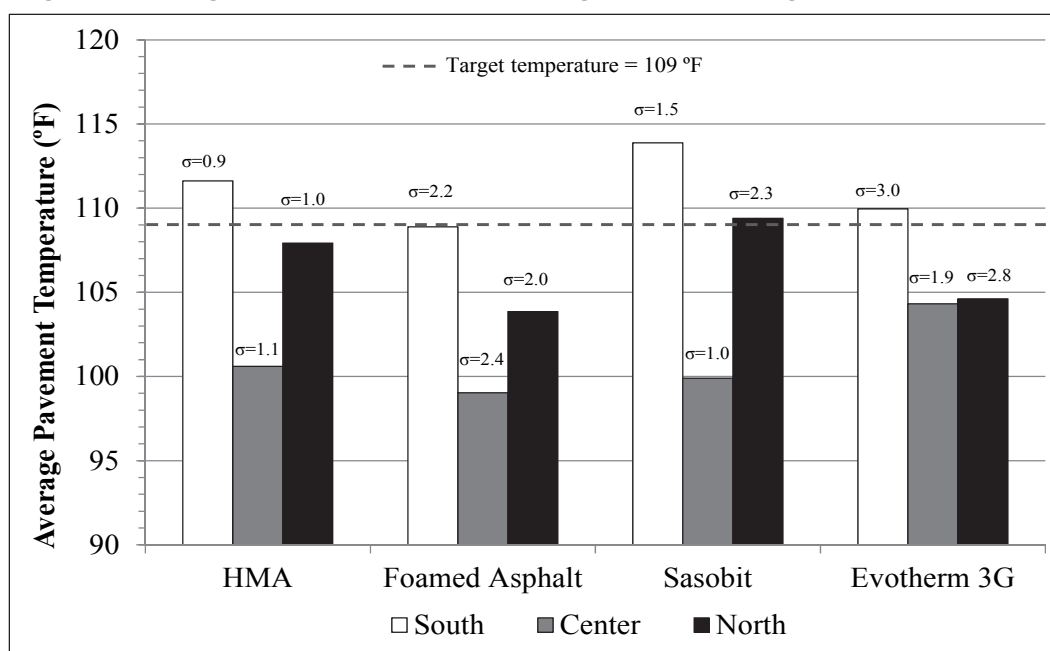
Figure 20. Average pavement temperatures during traffic in three regions on each test item.

The temperatures at the top, mid-depth, and bottom of the asphalt were combined to determine the average pavement temperature at each location. These average temperatures were compared to the temperatures that were measured at mid-depth of the asphalt layer, and they were very similar in most cases. The average pavement temperatures for the south, center, and north areas of the four test items are presented in Figure 20.

The temperature variation within each test item can be observed in Figure 20. Generally, the temperature variations were caused by the locations of the I-buttons in relationship to the heat vents and the efficiency of the heating system which caused a difference in the airflow between vents. Table 6 and Figure 21 show the locations of the I-buttons and their layout in relation to the vents.

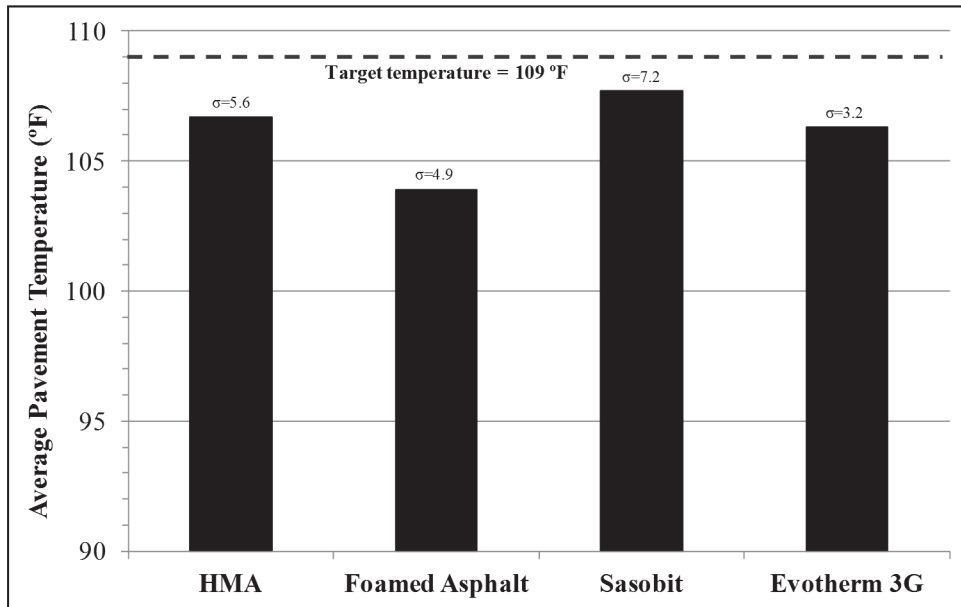
Figure 23. Average pavement test temperatures of each test item.

The average pavement temperature was calculated for each test item and plotted in Figure 23. In average, all test items were tested at temperatures lower than the target temperature of 109 °F. The largest temperature difference (4 °F) was between Sasobit® and Foamed Asphalt. As shown in Figure 24, Foamed Asphalt was tested during the coolest period of the winter (average outside air temperature 44 °F), and the HVS-A heating

system had trouble maintaining the test temperature inside the chamber, while the outside conditions were cold. As the chamber was opened to collect data after each traffic interval, the pavement also experienced heat loss and the pavement temperature decreased. Not enough time was provided between traffic intervals for the pavement to recover the heat lost and reach the test temperature. This caused the pavement temperature to stay lower than the test temperature of the other items.

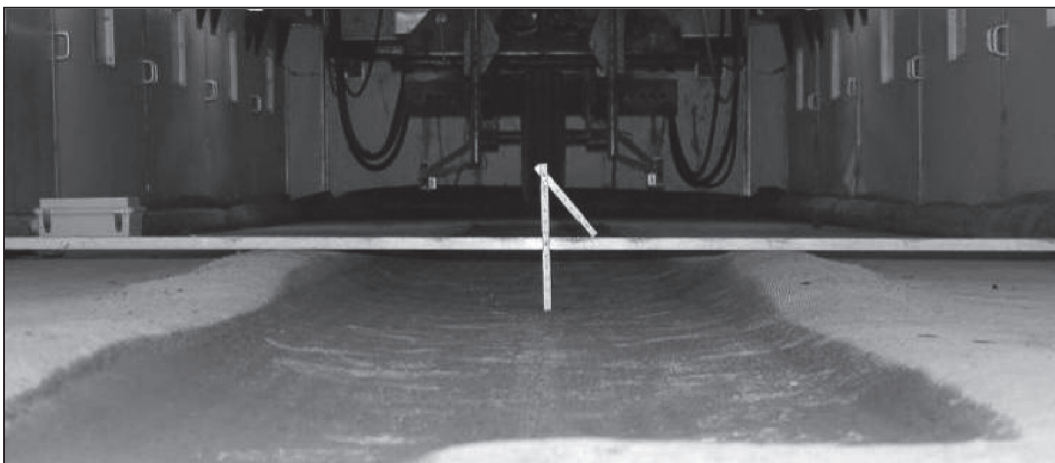
Figure 25. HMA rutting after 3,326 passes.

Generally, rutting and cracks were the surface distresses observed in all four test items. Rutting is a load-related distress caused by an accumulation of vertical compressions (Collop, 1995). The presence of rutting indicates that a permanent deformation occurred in one or more of the layers of the pavement structure. This deformation occurs as a result of densification, shear movement or a combination of both. Figure 25 shows the rutting on the HMA after 3,326 passes. This rutting profile was typical in all four items. All items experienced pavement upheaval along the sides of the rut and at the ends of the traffic lane. Figure 26 shows the pavement upheaval at STA 0+15 of the Foamed Asphalt item. Upheaval typically indicates that there is shear movement, or an outward and upward movement of material, somewhere within the pavement structure. The pavement uplifts at the ends of the traffic lane were generated as the wheel stopped to change directions during traffic. A depression was observed at STA 0+30 in all four items after the first few passes of the F-15E wheel. This distress was attributed to the presence of a SDD, which was installed on top of the base course at that station. Insufficient compaction during gauge installation combined with the high stresses caused by the oversized plate of the SDD under loading could have caused the early base failure at that location. As shown in Figure 27, the absence of pavement uplift along the sides of the rut at that location indicated that failure was taking place in the sub-layers and not in the asphalt layer. Surface cracks were also observed at this location in all items as shown in Figure 28. Surface cracks were also observed around the SSGs in all four test items as shown in Figure 29. The cracks were observed on the surface of the rapid set epoxy that was used to install the gauges.

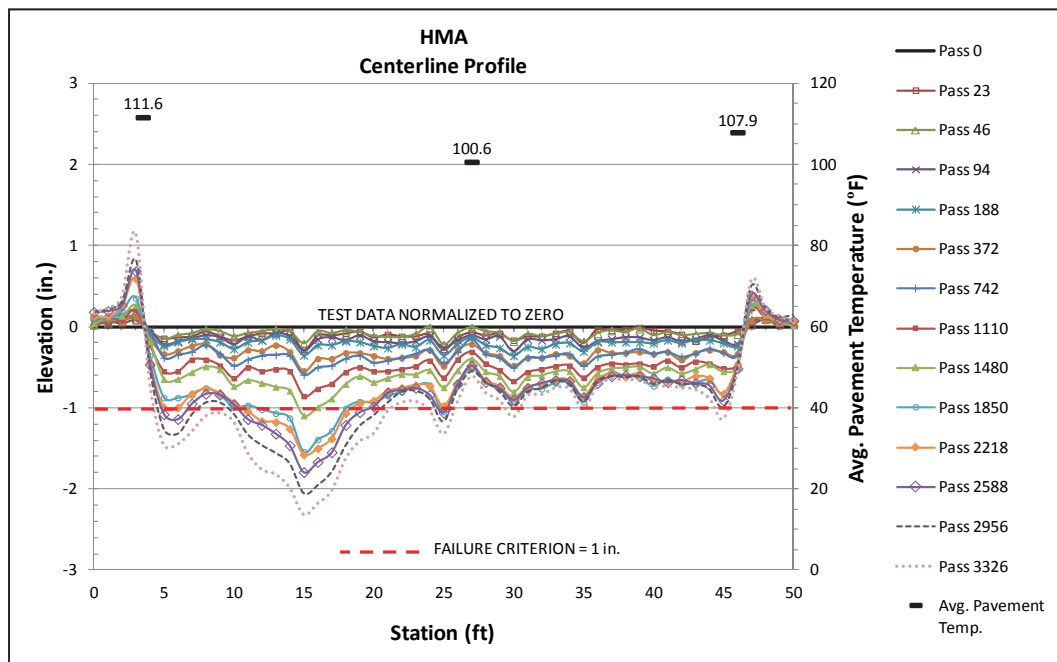
Figure 30. HMA centerline profiles and average pavement temperature.

Figures 30-33 present the permanent deformation centerline profiles for all four test items. The data were normalized to zero starting at 0 passes. The failure criterion of 1 in. permanent deformation is marked with a horizontal dashed line. The average pavement temperatures are presented in a

secondary axis for reference. Greater permanent deformations were observed at the stations where instrumentation was located. Also, in all four items, a difference in permanent deformation between the south and north ends of the traffic lane was observed. The area between stations 0+10 and 0+20 had greater permanent deformation than the rest of the traffic lane in most of the test items. Specifically, STA 0+15 had the greatest permanent deformation in all four test items, and it was attributed to the greater amount of heat that was coming out from the vent that was located close to that location, as it was discussed in the first section of this chapter. As traffic progressed, the heated pavement at that location deformed more quickly than the rest of the traffic lane, with the exception of STA 0+30. At STA 0+30, the pavement experienced large deformations in all four test items but, as discussed in the previous section, this failure was attributed to inadequate compaction of the base material during instrumentation installation. Therefore, the data from this station were treated as outliers and were not used in the calculation of average deformations. Other areas where excessive deformations were observed include the areas near STA 0+05 and STA 0+45. These were the areas where the wheel stopped to change directions during traffic. These areas were also treated as outliers.

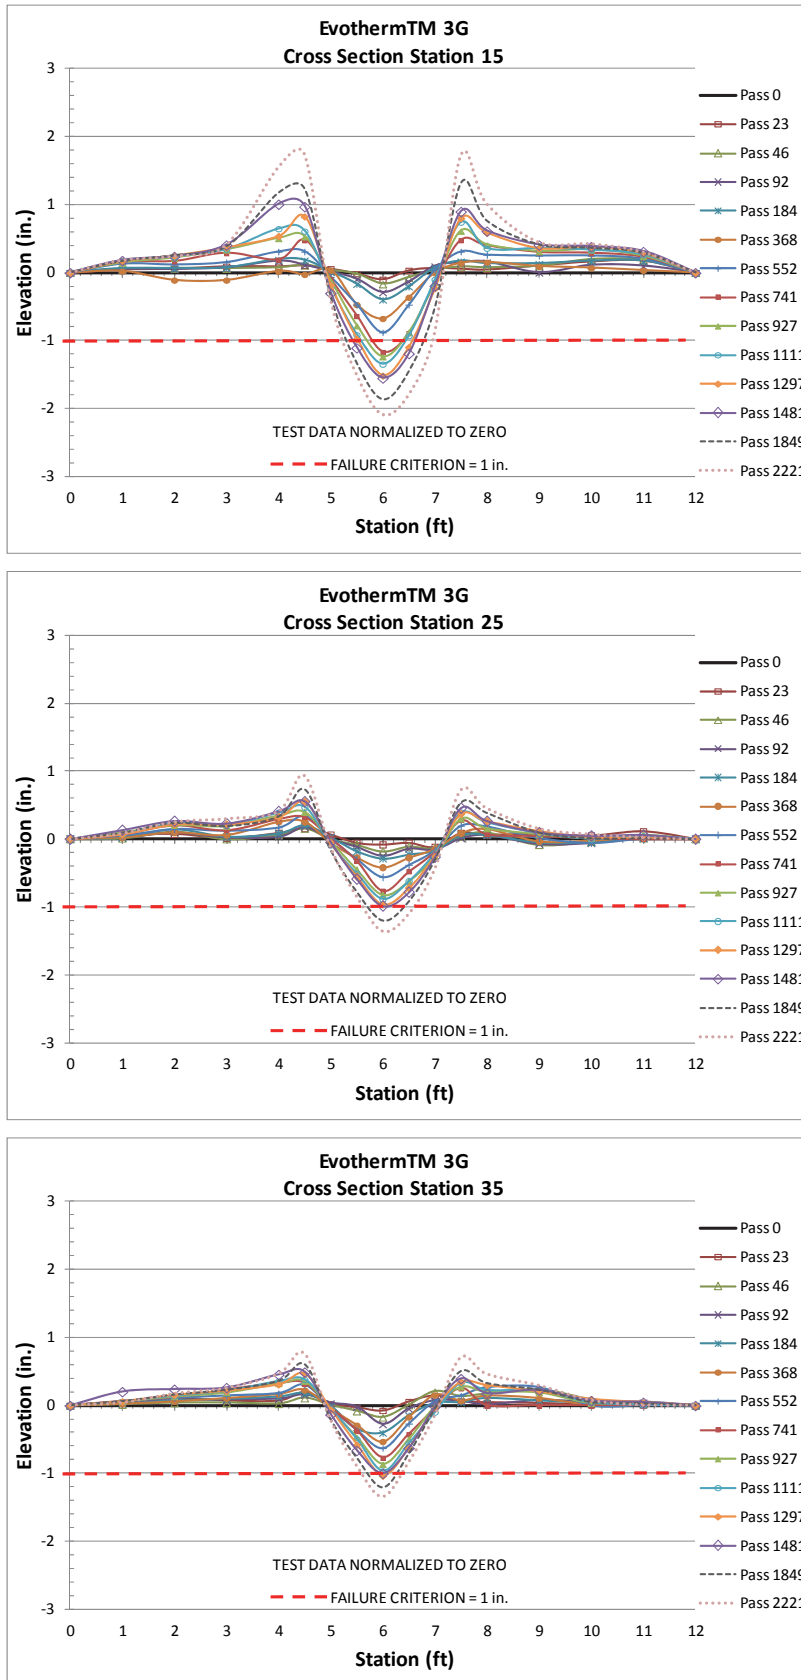
Figure 34. Evotherm™ 3G cross-section profiles.

Evotherm™ 3G cross sections showing the representative permanent deformation at the three main areas of interest (south, center, and north) are presented in Figure 34. These cross sections show the typical rutting failure that was experienced by all the items under the F-15E simulated traffic. The cross sections measured at seven different stations on all four test items are presented in Appendix B. The humps on the sides showed that there was tertiary flow of the asphalt pavement during traffic. The STA 0+15 cross section showed excessive rutting when compared to the other two cross sections for all test items. As traffic progressed, rutting at STA 0+15 increased rapidly due to the higher temperature, while rutting in the other areas increased at a slower rate, because the temperature was lower. Since the failure criterion was established at 1 in. of average centerline permanent deformation, STA 0+15 was rutted excessively in order to allow the rest of the traffic lane to fail. As mentioned previously, traffic was discontinued when the items reached an average centerline permanent deformation of 1.2 in. After this point, the exposed aggregate in the humps on the sides of STA 0+15 represented a tire hazard for the F-15E gear.

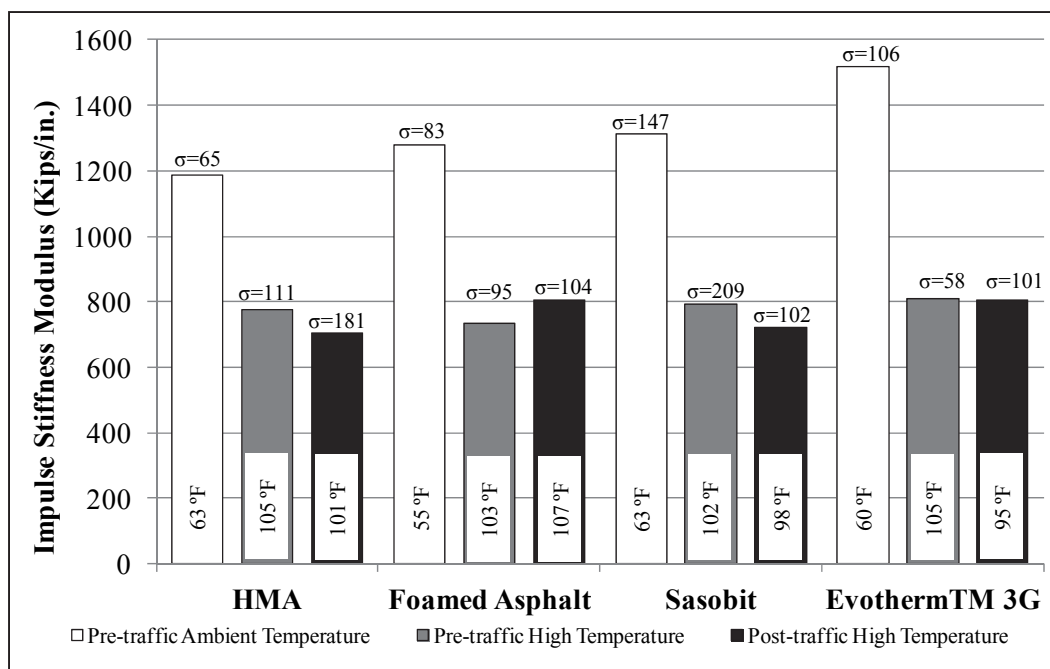
Figure 35. ISM values for all four test items.

shows the average ISM values for each test item as calculated from data collected during FWD testing conducted before and after heat was applied to the pavement, and also after trafficking was discontinued. The raw FWD data are provided in Appendix C. The plot includes the standard deviation between seven data points from different locations. The pavement temperatures shown were determined by averaging the temperatures at the surface, mid-depth, and bottom of the asphalt measured at three locations within each test item at the time of each FWD test. Raw FWD data are available in Appendix C.

The initial differences in stiffness between items were not attributed to a specific technology but to the initial pavement temperature, which varied per test item. As expected, the stiffness of the asphalt pavement decreased as the temperature was increased. At the high temperature, no significant differences were observed across WMA technologies or when WMA was compared to HMA. There was little or no change in stiffness between before and after traffic for HMA and Evotherm™ 3G. The stiffness of Foamed Asphalt increased a little after trafficking, while on the other hand, the stiffness of Sasobit® decreased after trafficking. Differences in temperatures could have affected these stiffness values, producing mixed results. To place the FWD on each test item for testing, some of the protective panels in the HVS had to be removed, letting the heat escape for the duration of the test. When the outside temperature was lower, the heat

escaped more quickly; this caused the differences in temperature and, thus, the differences in stiffness. Considering all the factors that affect the variability of the FWD test, the differences were minimal.

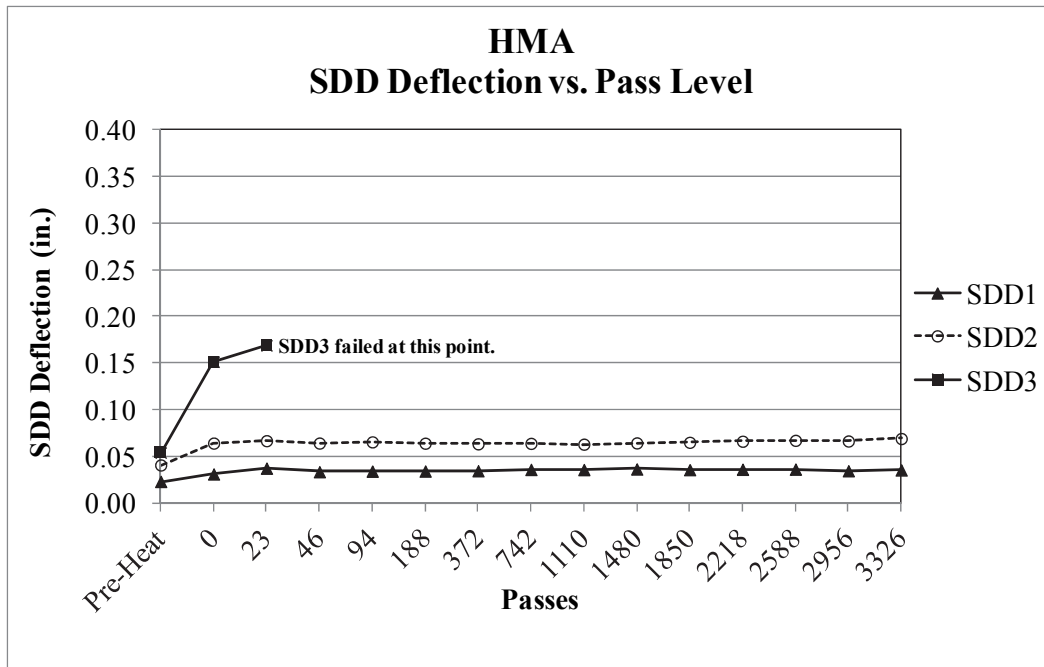
Figure 42. HMA maximum deflection measured at the base, subbase and subgrade during dynamic slow roll test at each pass level.

A summary of the maximum deflections measured at each sublayer with the SDDs during dynamic slow roll tests is presented in Table 8. The maximum deflections measured during the dynamic slow roll test at each pass level on each test item are presented in Figures 42-45. Some of the SDDs did not record any measurements during testing, and some of them failed during the test. Multiple factors affected the proper functioning of the SDDs. For example, during installation of the SDDs at the base course, the soil that was placed underneath the plate to level it and the backfill soil on top of the sensor could have been poorly compacted. This caused the large early deformations observed on the asphalt pavement at those locations in all four test items during traffic, as previously discussed. The deflection measured by the SDDs at the base course included the deformation from the poorly compacted fill material. Therefore, the magnitudes of the deflections were not considered to represent movement of the unbound layers. However, the deflection trend lines indicate minimal or no movement of the subbase and subgrade layers in all test items where data were recorded.

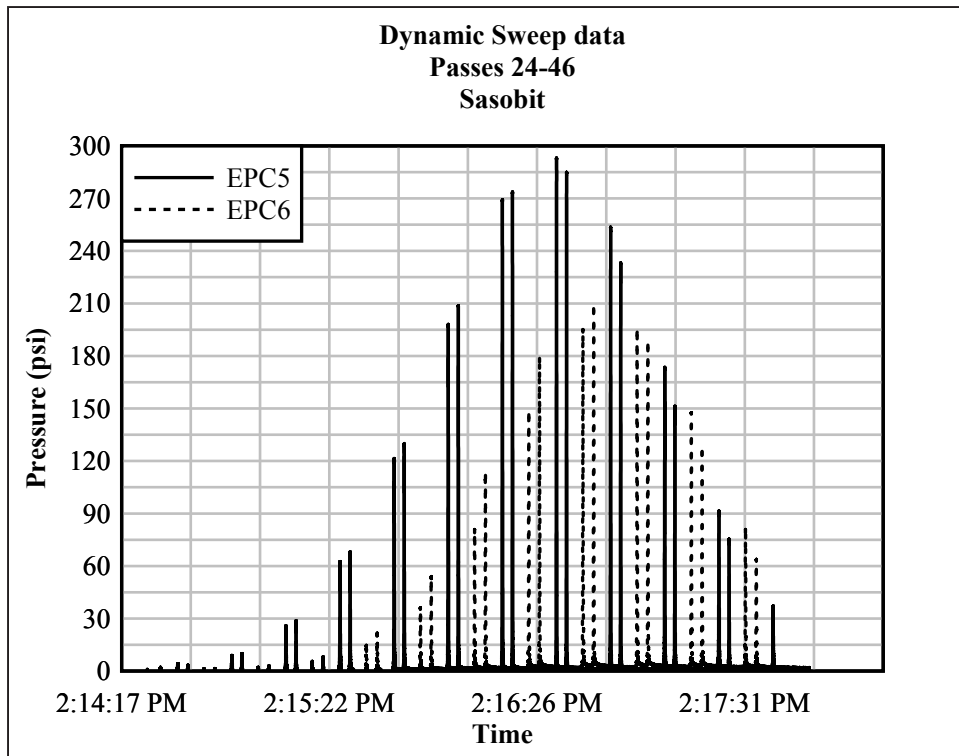
Figure 50. Pressure difference between EP5 and EP6 at the top of the base in Sasobit®.

Figure 50 shows the typical difference in pressure observed between the two EPCs in the base layer (EP5 and EP6). The horizontal gap between both bell-shaped curves in the plot is due to the way the wheel trafficked over one EPC first and then over the other going in one direction. The vertical difference shows the difference in pressure between these two EPCs, which is believed to be caused by the horizontal positioning of the instruments relative to the load application and also to pavement temperature effects on the pressure measurements. Figure 51 shows the maximum pressure distribution with depth for all four items from the dynamic sweep test data. This plot is very similar to the one obtained from the dynamic slow roll data, and it confirms the efficiency of the pavement structure in withstanding the heavy traffic loads for which it was designed.

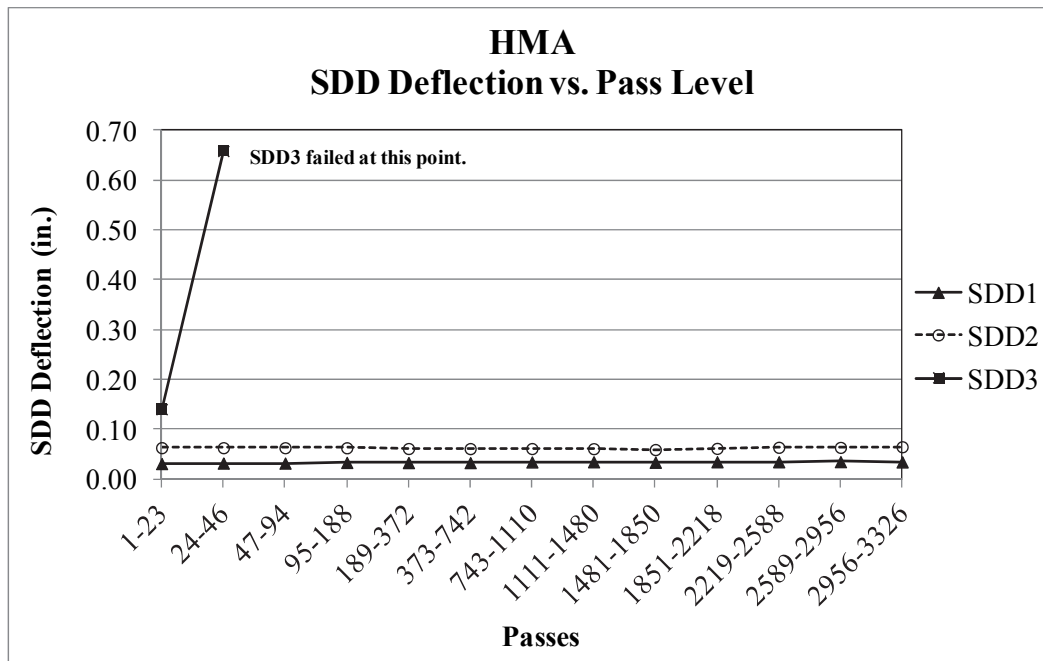
Figure 52. HMA maximum deflection measured at the base, subbase and subgrade during dynamic sweep test at each pass level.

The maximum deflections measured at each sub-layer with the SDDs during dynamic sweep tests are presented in Table 10. The maximum deflections measured during the dynamic sweep test at each pass level on each test item are presented in Figures 52-55. As previously discussed,

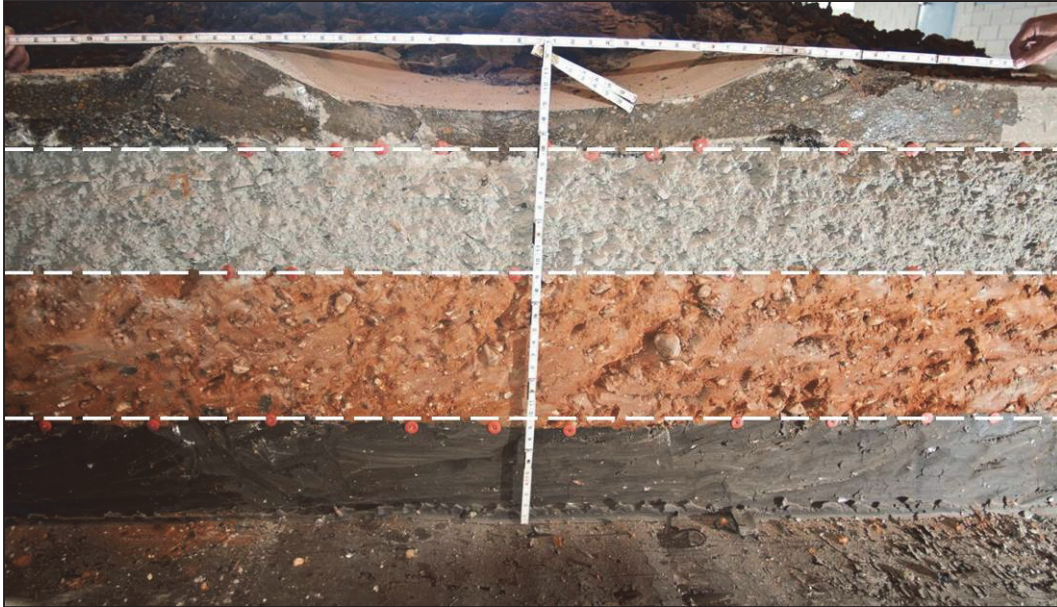
Figure 65. HMA South Trench (STA 0+16).

Pictures of the trenches showing the final conditions of the pavement structure in all four items at both locations (north and south) are shown in Figures 65 through 72. These pictures show no evidence of significant movement of the sub-layers after trafficking and confirm the observations from the instrumentation data.

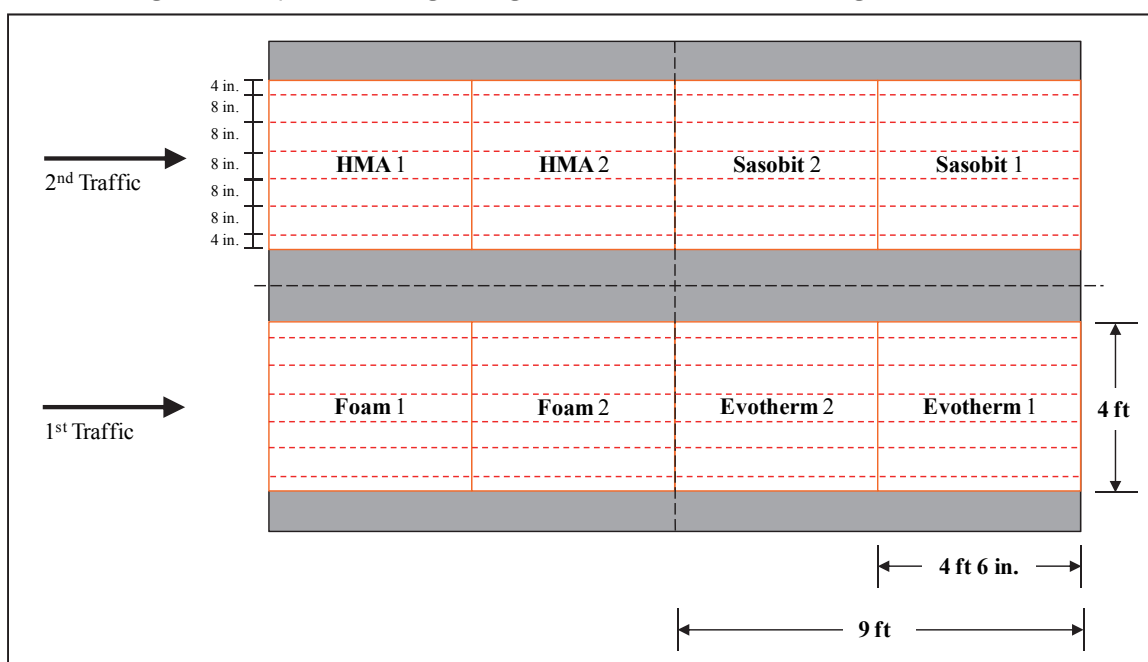
Figure 76. Layout of WMA grooving evaluation experimental design (not to scale).

The grooving evaluation was conducted six months after HVS-A traffic operations were completed, which is about one year after construction. This allowed conducting the evaluation during the summer when pavement temperatures are elevated. The grooves were cut individually on the asphalt surface using a concrete saw (MK Diamond Model MK-1614K Premium). The grooves were cut following the depth and spacing specifications on UFGS 32 01 26.71 and FAA AC 150/5320-12C. Once the grooves were cut, the surface was washed and swept to facilitate baseline measurements of groove depth and length.

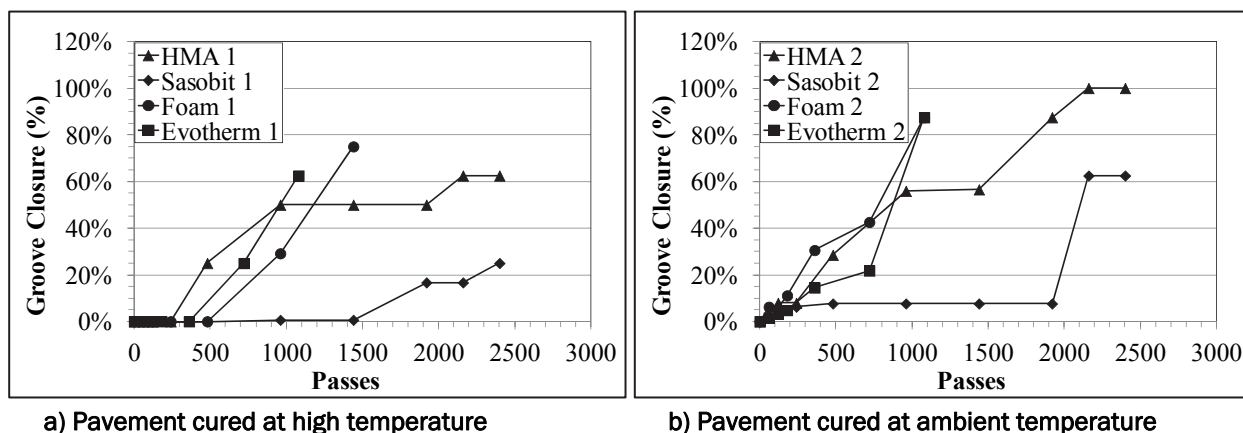
Figure 80. Groove closure at each pass level.

Groove closure results are shown in Figure 80. Pavement surface temperatures were monitored using a temperature laser camera at each pass level and are shown in Figure 81. Of all the mixtures under both curing conditions, Sasobit® was the top performer. Sasobit® performed better than HMA even when both were trafficked at the same time and at the same surface temperatures. The pavement surface temperatures were very consistent for HMA and Sasobit®. At the beginning trafficking, the pavement surface temperatures for Evotherm™ 3G and Foamed Asphalt were about 10°F lower than those of Sasobit® and HMA. Then, halfway through trafficking the temperature increased and that difference was about 5°F.
