# Improved Concrete Cutting and Excavation Capabilities for Crater Repair

## Phase 1

## **Final report**

Prepared for Headquarters, Air Force Civil Engineer Center  
Tyndall Air Force Base, FL 32403-5319

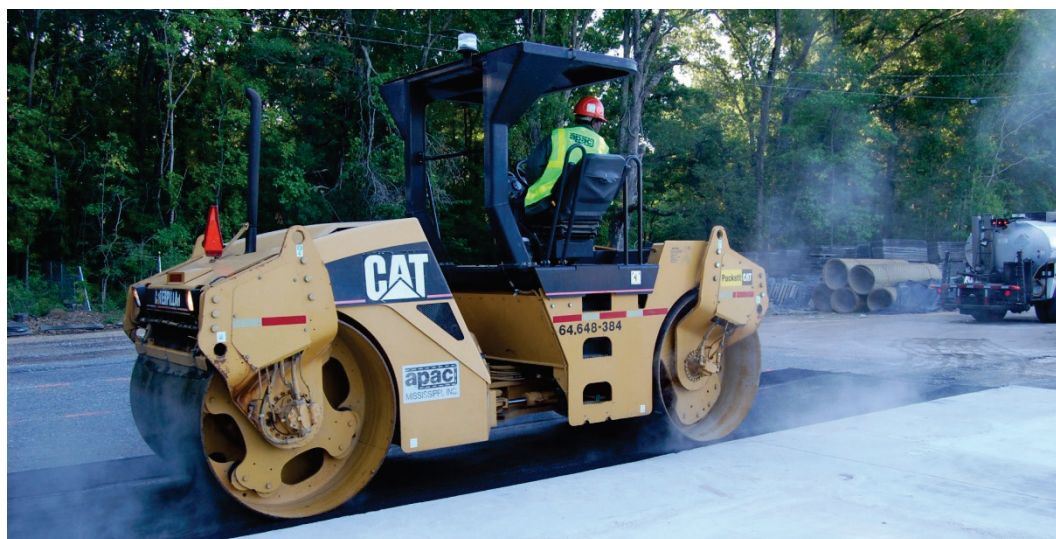
Compaction between lifts was completed with a Caterpillar CB-534D double drum roller (Figure 6), Ingersoll Rand PT-125R pneumatic roller, and Ingersoll Rand DD-28HF vibratory double drum compactor (Figure 7). Density was measured with the Troxler nuclear moisture-density gauge and was determined to be adequate for the purposes of this test. The laboratory mix properties were out of specification limits resulting in a tender mix and some movement of the material during compaction (Table 8 and Table 9). The base course was uneven and had some poorly compacted or wet areas resulting in some movement of material during compaction and some unevenness of the final surface. Two nuclear gauge readings were taken with a Troxler 3440 in each location and averaged (Table 10), and cores (Table 11) were taken in areas where the base was firmly compacted. The data indicated that sufficient compaction was achieved. In-place density should be 92-95 percent of the theoretical maximum density (TMD). Final thickness of the compacted mat was on the order of 5 in. with one area being slightly thinner on the order of 4.5 in. thick. The condition of the HMA test section did not affect the research.

Figure 6. HMA compaction with a double drum vibratory compactor.

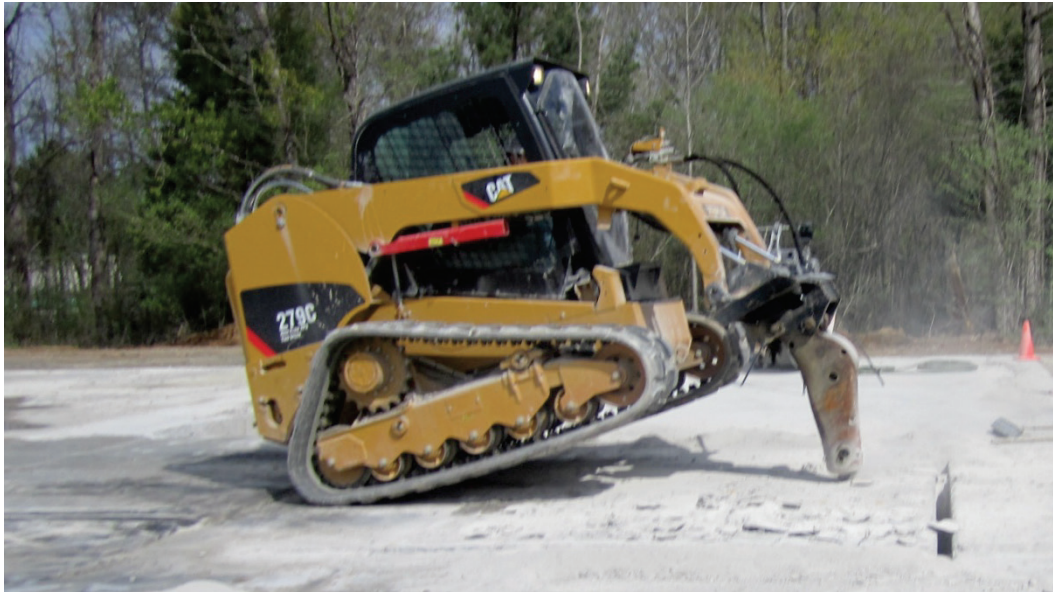
Figure 9. Caterpillar CTL279C with the H65D S hammer attachment.

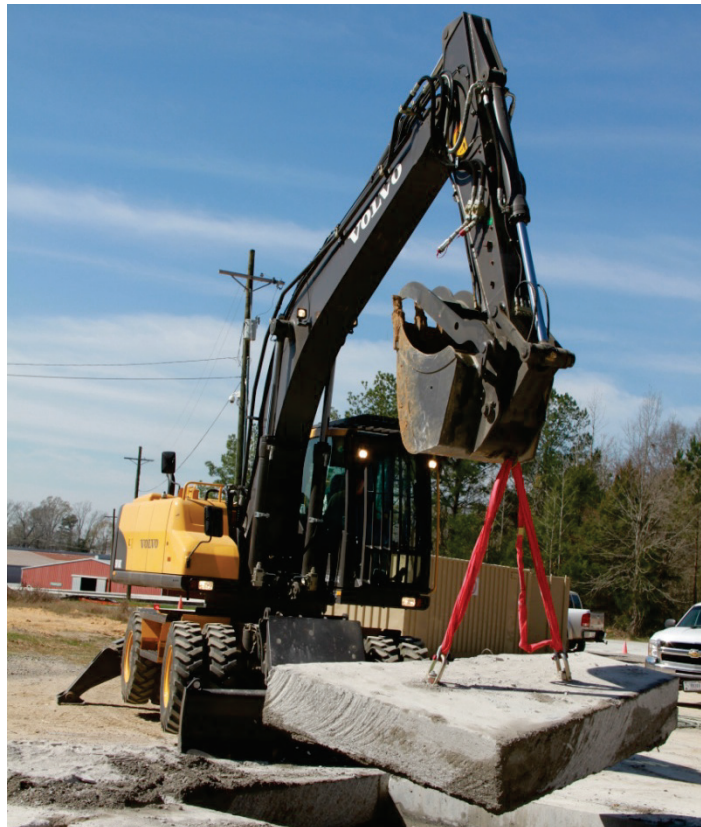
Figure 34. Removing with the excavator.

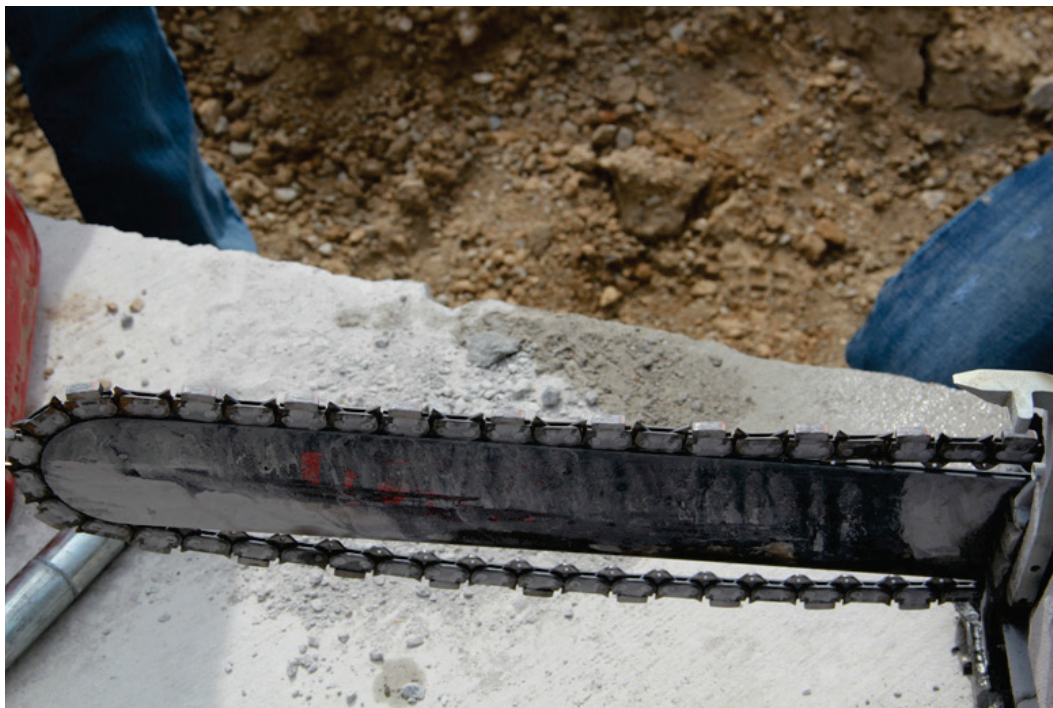
Figure 41. Utility saw blades after cutting through PCC and dowel rod.
