# Results of materials testing for **ElectroSpark Deposition**

**Norma Price**  
**Advanced Surfaces and Processes, Inc.**

***HCAT Program Review Meeting***  
**Hilton San Diego Resort**  
**1775 East Mission Bay Drive**  
**San Diego, CA 92109**

| Report Documentation Page | | | | Form Approved<br>OMB No. 0704-0188 | |
|---|---|---|---|---|---|
| 13. SUPPLEMENTARY NOTES<br><b>26th Replacement of Hard Chrome and Cadmium Plating Program Review Meeting, January 24-26, 2006, San Diego, CA. Sponsored by SERDP/ESTCP.</b> | | | | | |

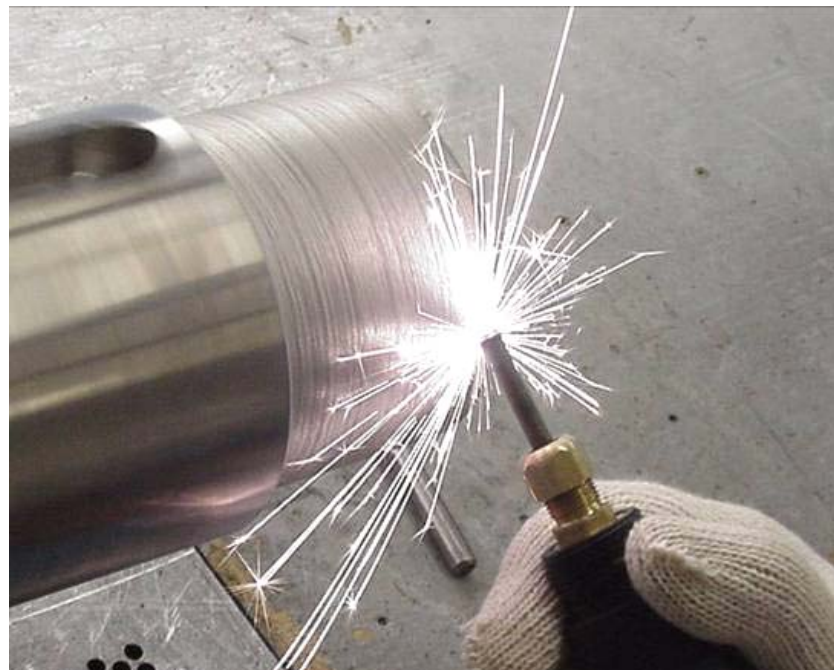
# *What is ESD?*

The ESD process is a capacitive discharge micro-arc process using a consumable electrode.

The electrode and substrate materials are melted, rapidly solidify, and build-up occurs incrementally.

- Metallurgical bond
- Low heat input
- Rapid solidification
- No pre-ESD preparation
- No post-ESD processing
- Environmentally benign
- Portable
- Applicable for NLOS

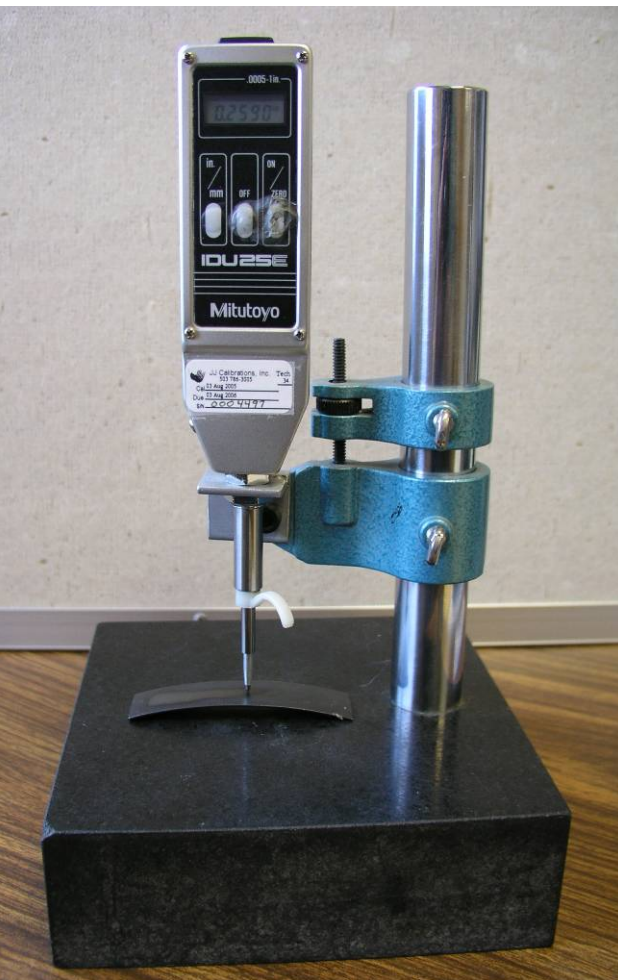
# Residual Stress

- The objective of including residual stress analysis in the JTP was to obtain an indication of the presence of residual stresses due to the ESD process.
- Results: Tensile stresses with ESD, Higher tensile stresses with increased energy (V4).

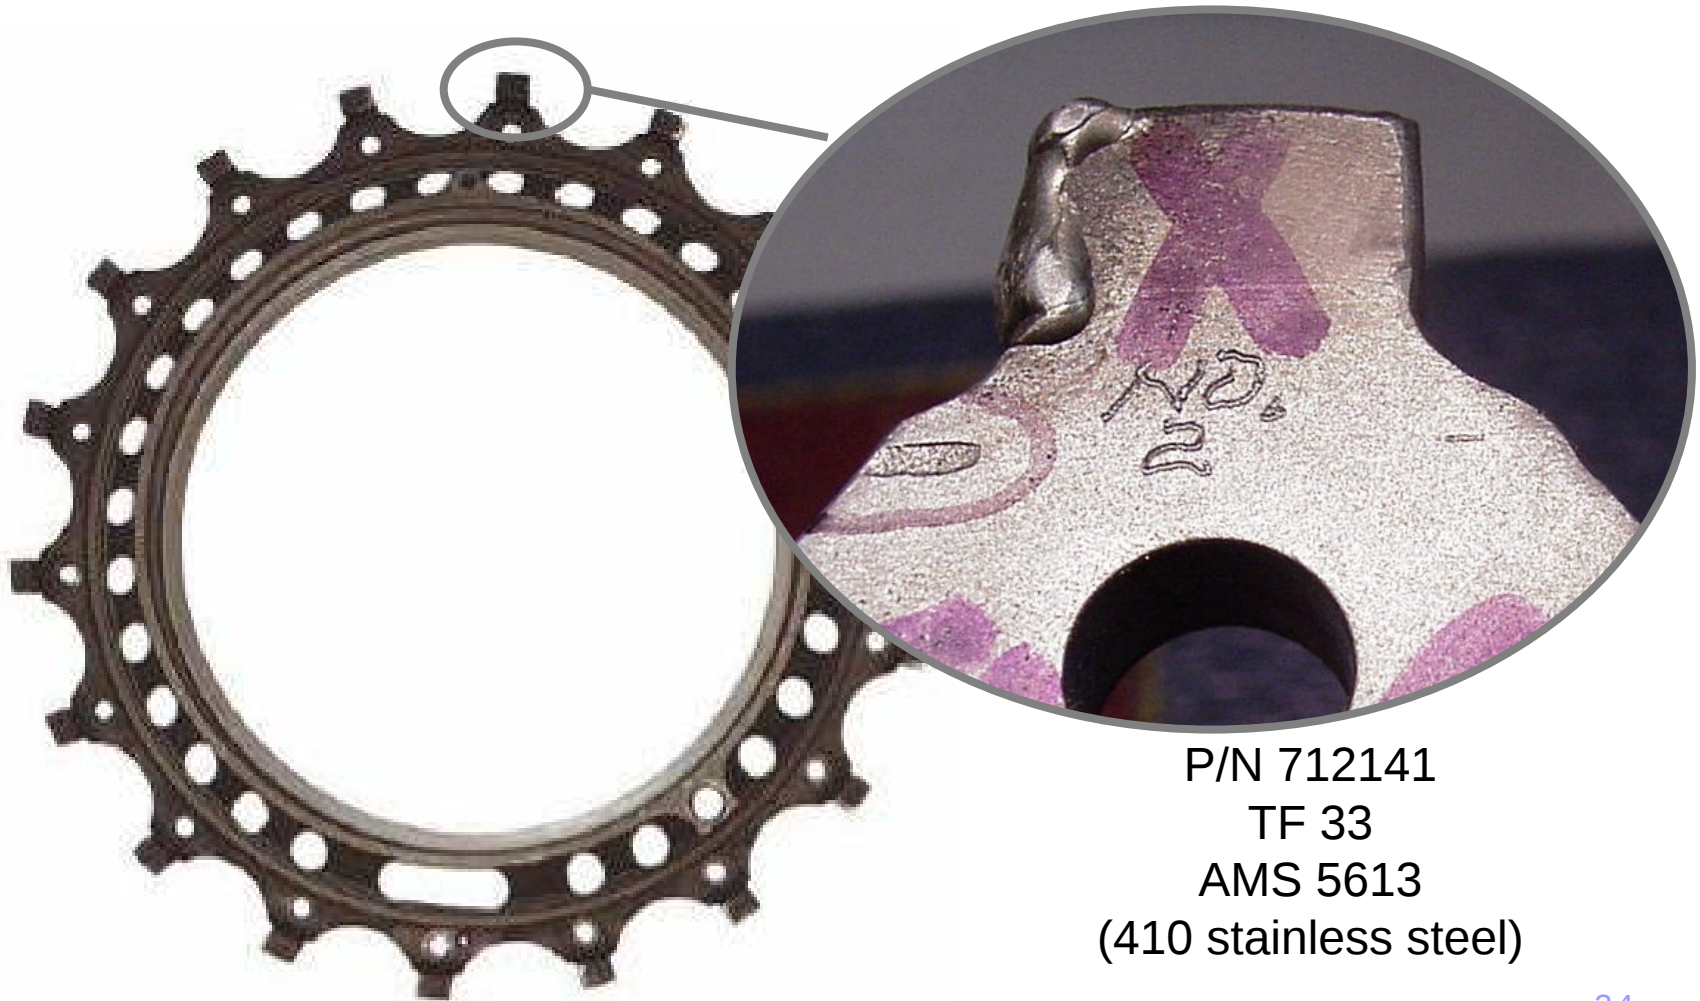
# #5 Bearing Housing

P/N 712141

TF 33

AMS 5613

(410 stainless steel)

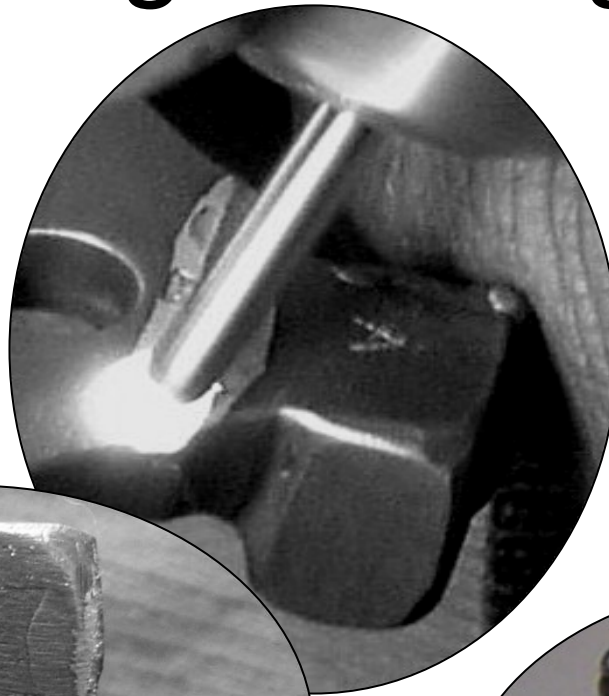
# #5 Bearing Housing

Excavate  
the defective area

Fill with ESD

Blend to original surface

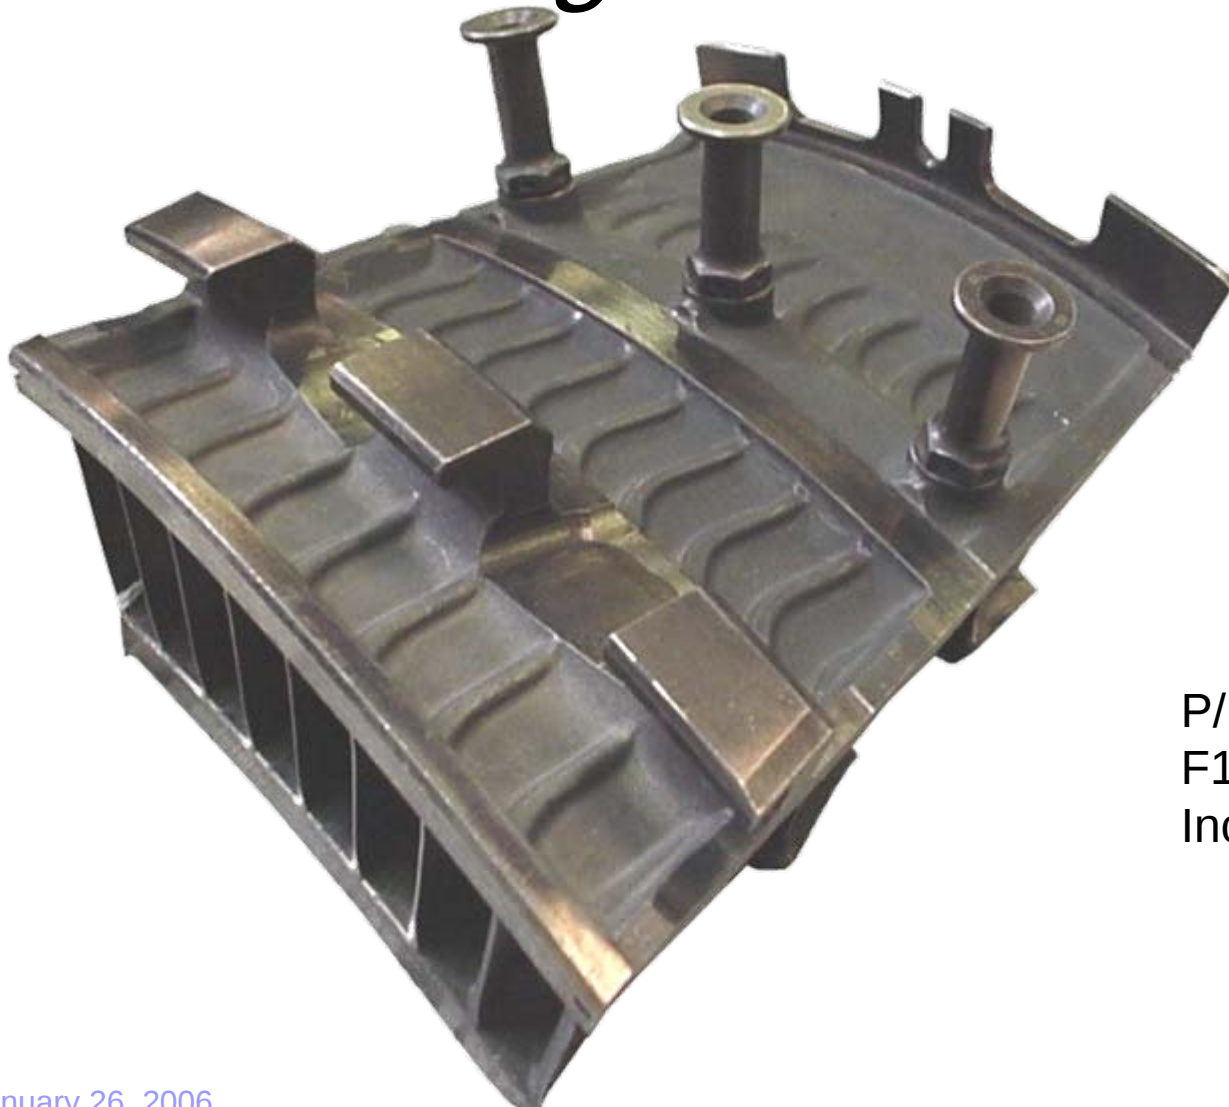
# *Stator Segment 10-12 Stage*

P/N 4077880  
F100 – 229  
Inconel 718
