## Hill AFB HVOF Implementation

**HCAT  
27 Feb 08**

13. SUPPLEMENTARY NOTES <b>Surface Finishing and Repair Issues for Sustaining New Military Aircraft Workshop, February 26-28, 2008, Tempe, AZ. Sponsored by SERDP/ESTCP.</b>

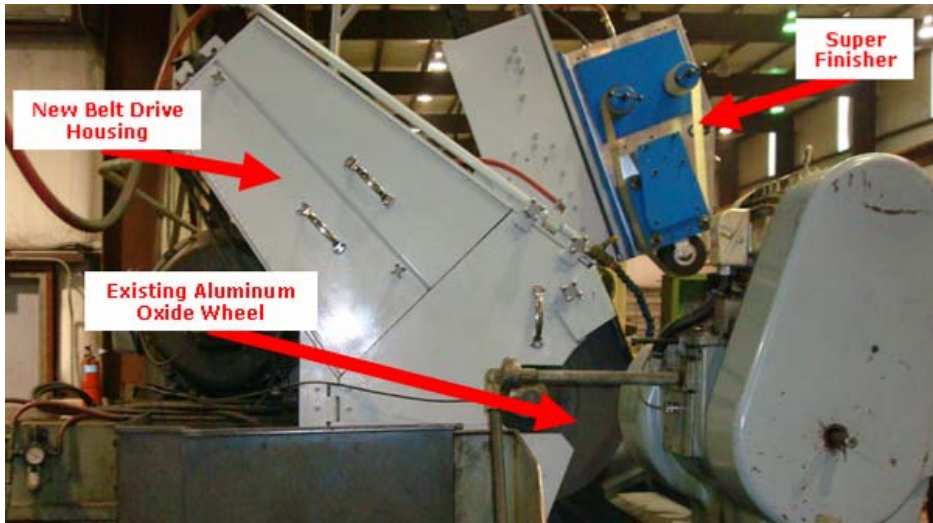
## ■ Equipment configuration

Abbot Machine Belt Grinding Housing Attachment for 3M Belts  
Side View

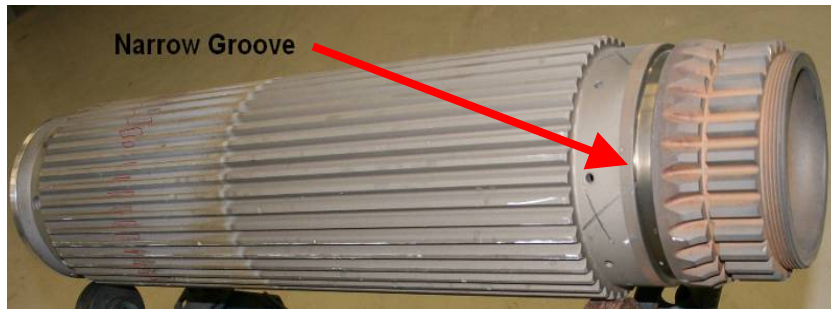
- Testing to investigate interface wear of landing gear components using different finishing techniques

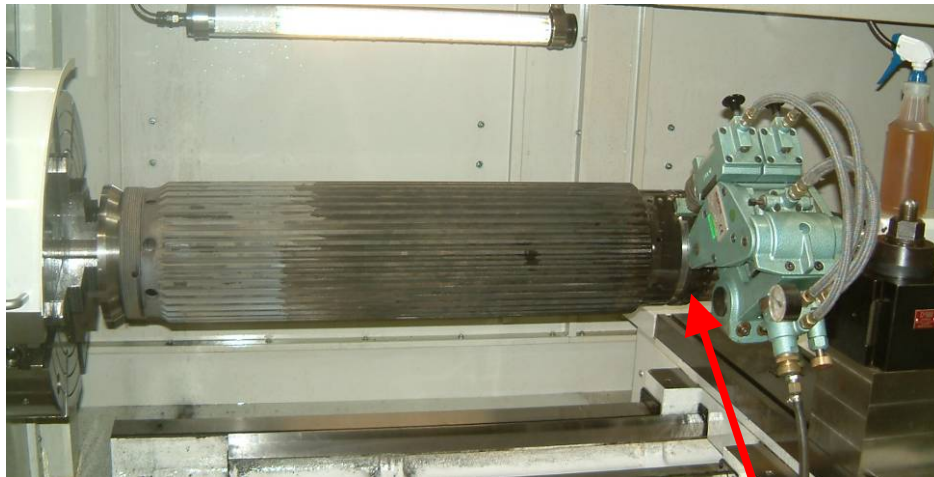
C-5 Spline Tube Narrow Groove  
Super Finished

Surface Finish Parameters for seal surfaces Per Air Force Drawing 200310642 Rev A	
Ra	4 micro-inch Max
Rp	8 micro-inch Max
Rz	40 micro-inch Max
Tp	10-90% at c=5% and 0.25 Rz

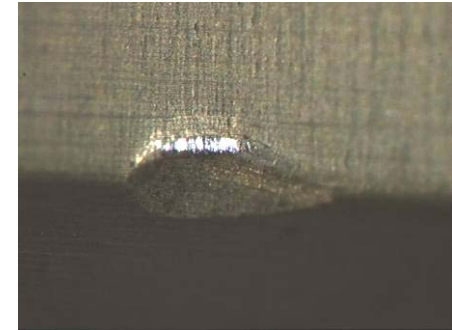
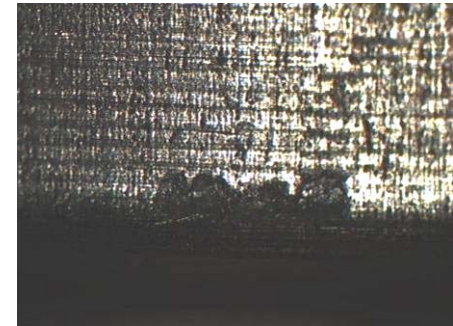
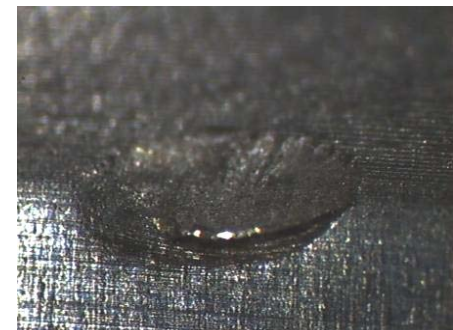
- The C-5 Lower Metering Tube (P/N 4G13518-101) has a history of leaks due to longitudinal scratches. The Lower Metering Tube develops scratches on its working surfaces both during new part assembly and during use in the field.

- The scratches are created by imbedded particles in the seals of the C-5 Floating Carrier Piston and/or anodize defects in the surface of the C-5 Floating Carrier Piston. The Lower Metering Tube is stainless steel or flash chrome and both surfaces have become scratched in service.

Three images (35X) of damage on mating surface, creating fine line scratches

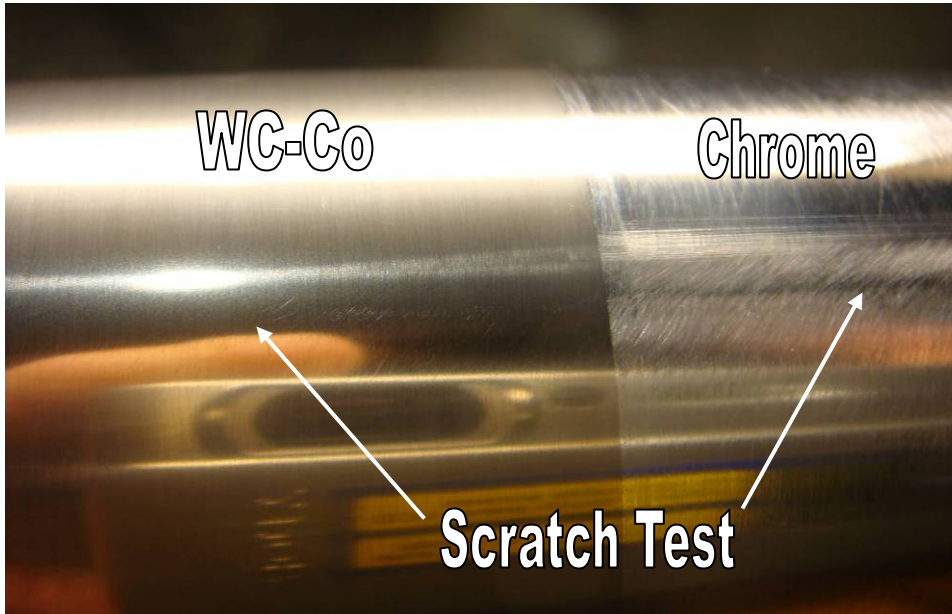
400 Grit: WC-Co

Chrome	WC-Co
Super Finish		.96 Ra
400 Grit	5.8 Ra	1.72 Ra
240 Grit	7.18 Ra	2.4 Ra

- The cause of the initial scratches could not be determined. Damage was noted on the mating part, imbedded particles in the seal were not found. As a result both 240 and 400 grit aluminum oxide cloth was used to create a controlled, worst case test.
- As expected, the WC/Co performed better than the CrC/NiCr and NiCr coatings
- The application cost differences between the three coatings was relatively insignificant based on performance levels
- Currently both the Lower Metering Tube and its corresponding part on the C-5 Nose Landing Gear are being converted from Chrome to an HVOF applied WC/Co eliminating the in-service failures.

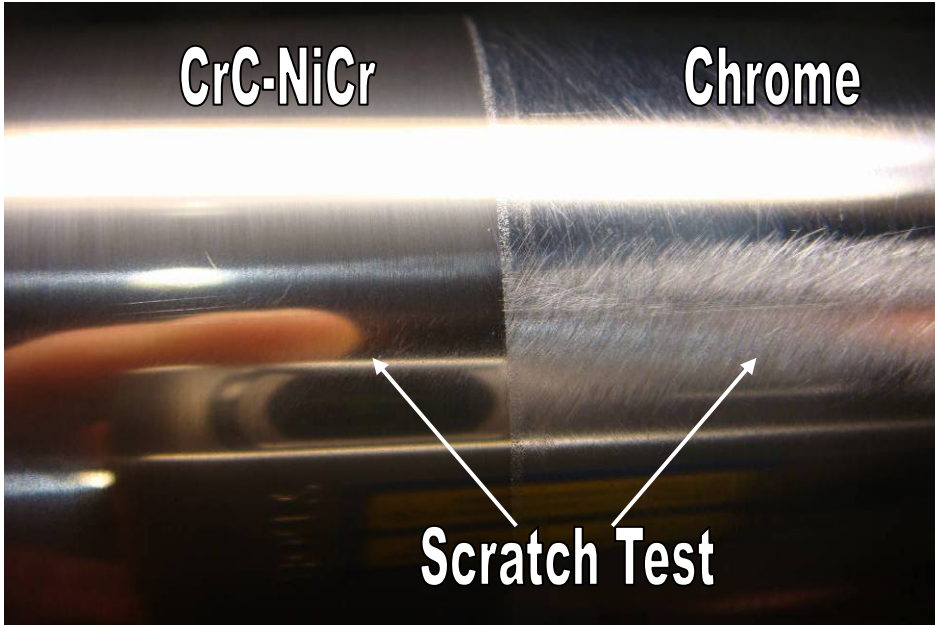
400 Grit: CrC-NiCr

Chrome	CrC-NiCr
Super Finish		1.03 Ra
400 Grit	5.8 Ra	2.04 Ra
240 Grit	7.18 Ra	3.79 Ra

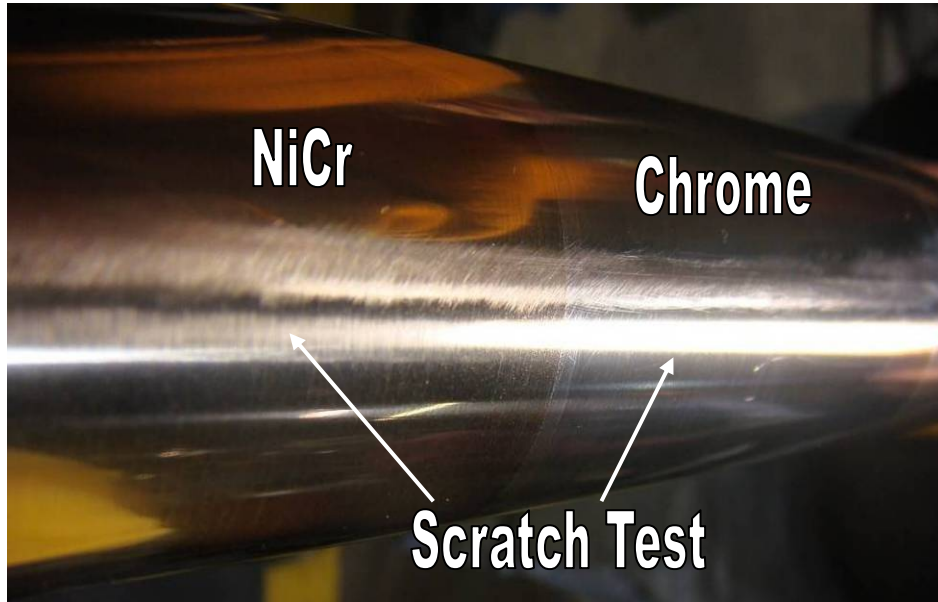
400 Grit: NiCr

Chrome	NiCr
Super Finish		1.36 Ra
400 Grit	5.8 Ra	7.47 Ra
240 Grit	7.18 Ra	14.4 Ra

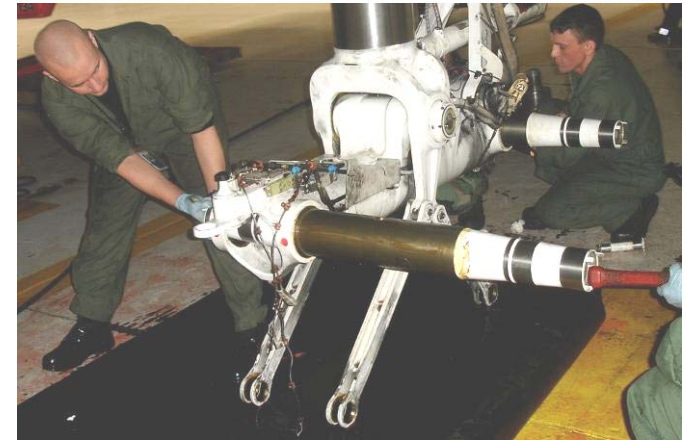
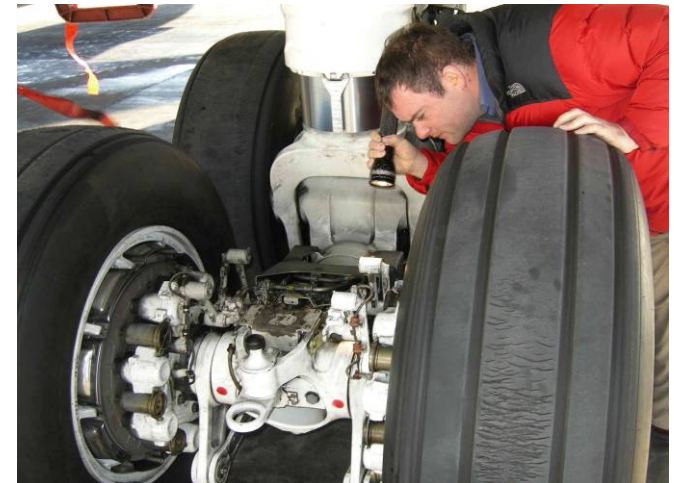
- When the axle bushings migrate, the brake swivels in a direction it was not designed for and may be cause of failures which may have led to major fire mishaps.

- This is very important, and a major reason for switching to HVOF 100% at both Depot and for new axles spare buys.
- An Engineering Change Order was recently created, new parts will have HVOF coatings only, no chrome.
