## **Fort Leonard Wood – Building 2101**

Interior Character-Defining Features, Inventory and Assessment

April 2014

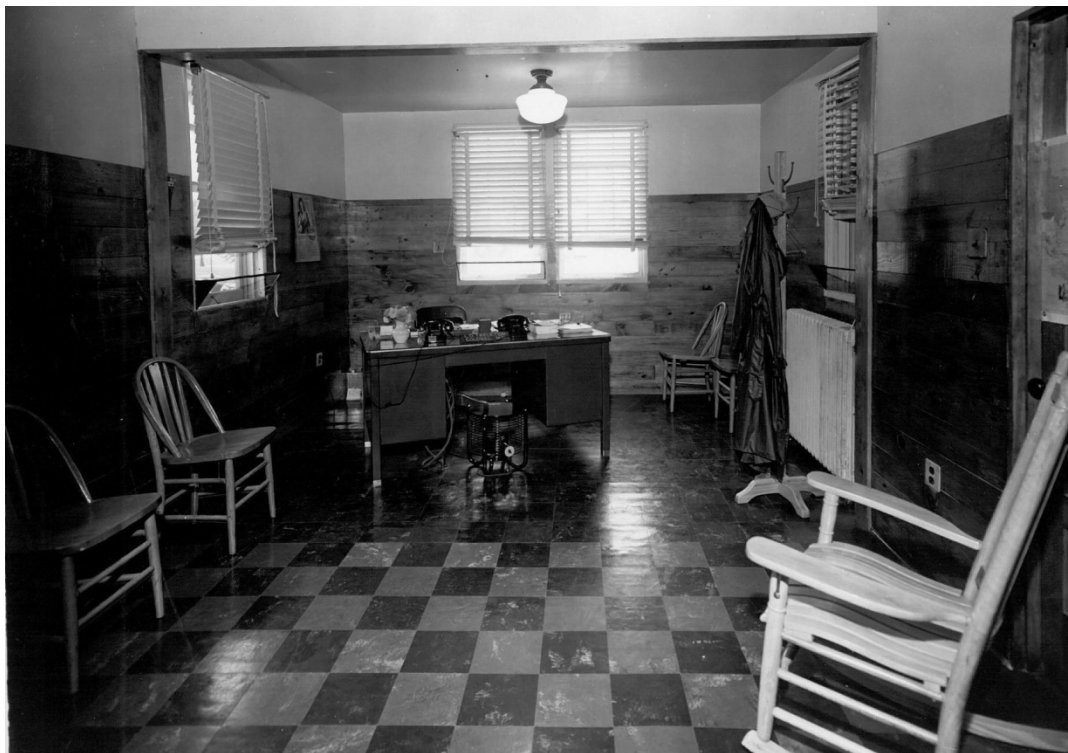
Figure 9. Company administration office at Fort Leonard Wood, no date (DPW at FLW).

Figure 39. Example of a "Type C" light fixture found in Series 700 temporary buildings (Plan Number 700-243, 1937 – ERDC-CERL files). This type of fixture can be seen at FLW in Figure 9 of this report.

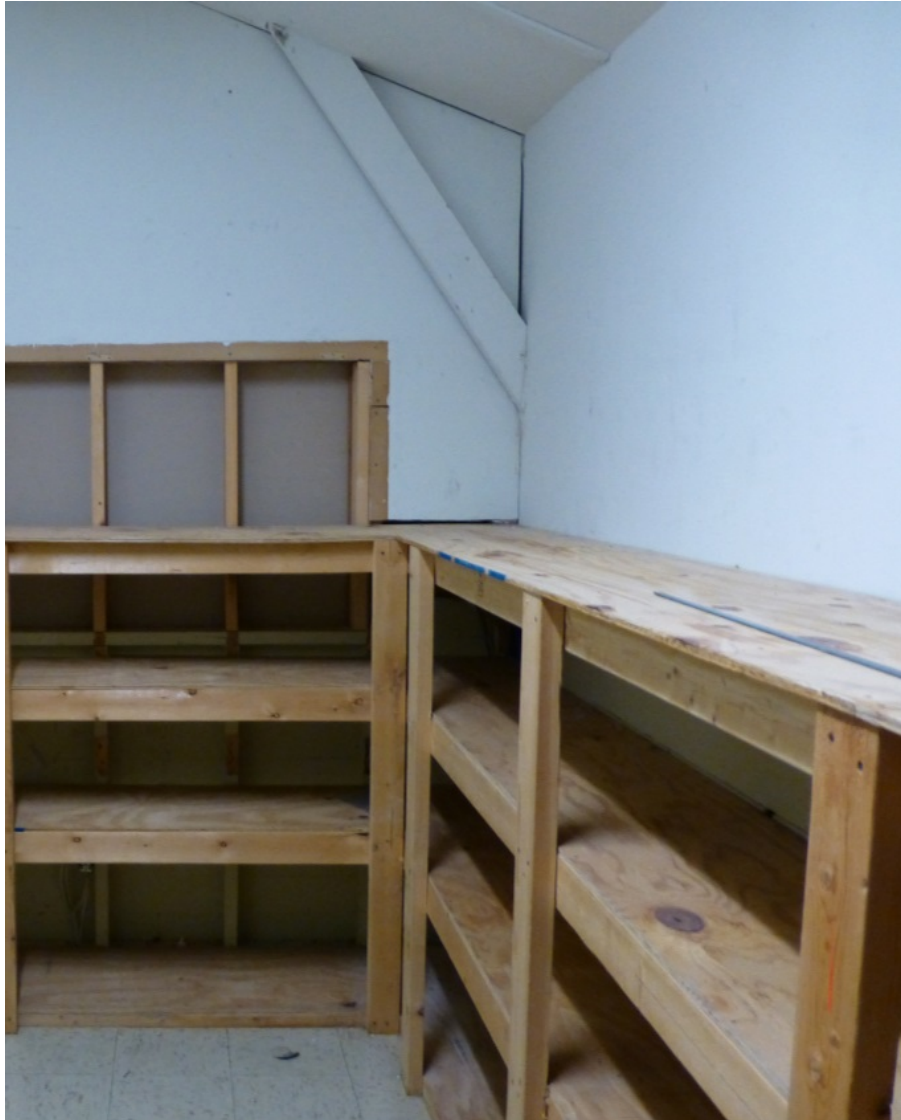
Figure 19. An example of an exposed structure (ERDC-CERL, 2013).

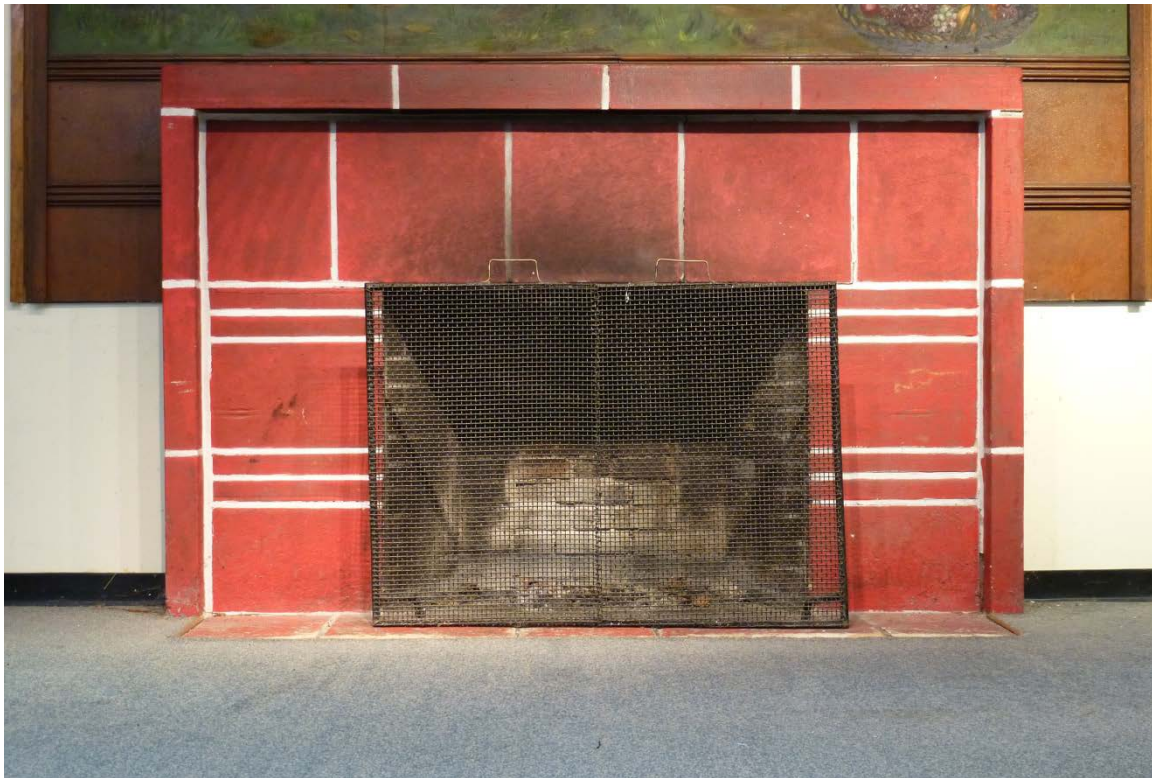
The stone fireplace on the main floor (Figure 30) was added to the building during summer 1945 by German prisoners of war (POWs) who were being held at FLW (US Army 1945). This fireplace is a primary character-defining feature of the building, along with the ell where it is located. This fireplace is heavily documented in the Building 2101 maintenance manual (Smith et al. 2005). In addition, a second stone fireplace was added to the building in the crawlspace when the chimney for the fireplace on the main floor was added (Figure 31). The second stone fireplace also is a character-defining feature.

Figure 30. German POW stonework fireplace on the main level. The red paint is not original, but it is unknown when the stone was painted (ERDC-CERL, 2013).

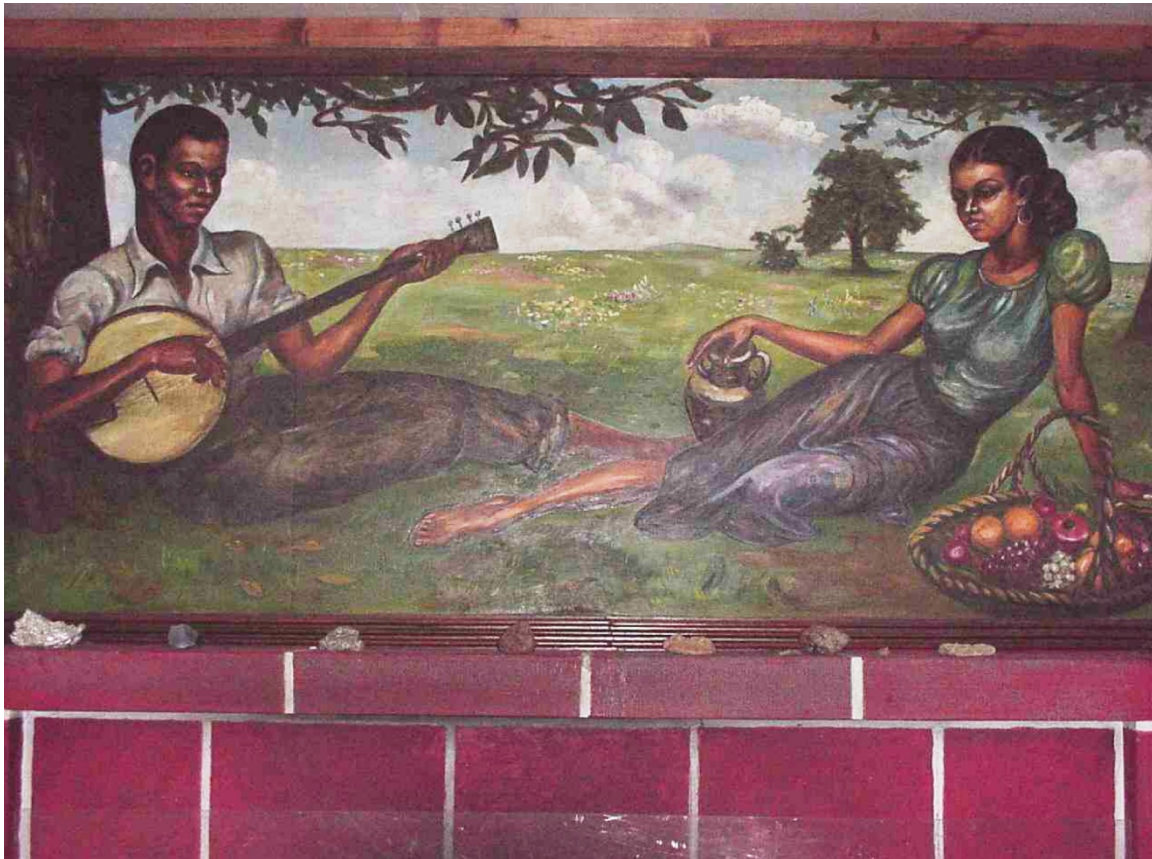
The mural was painted by Samuel Countee and placed above the German POW fireplace on the main floor in the summer of 1945 (Figure 32). It is a primary character-defining feature of the building.

Figure 32. Mural by Samuel Countee (ERDC-CERL, 2013).

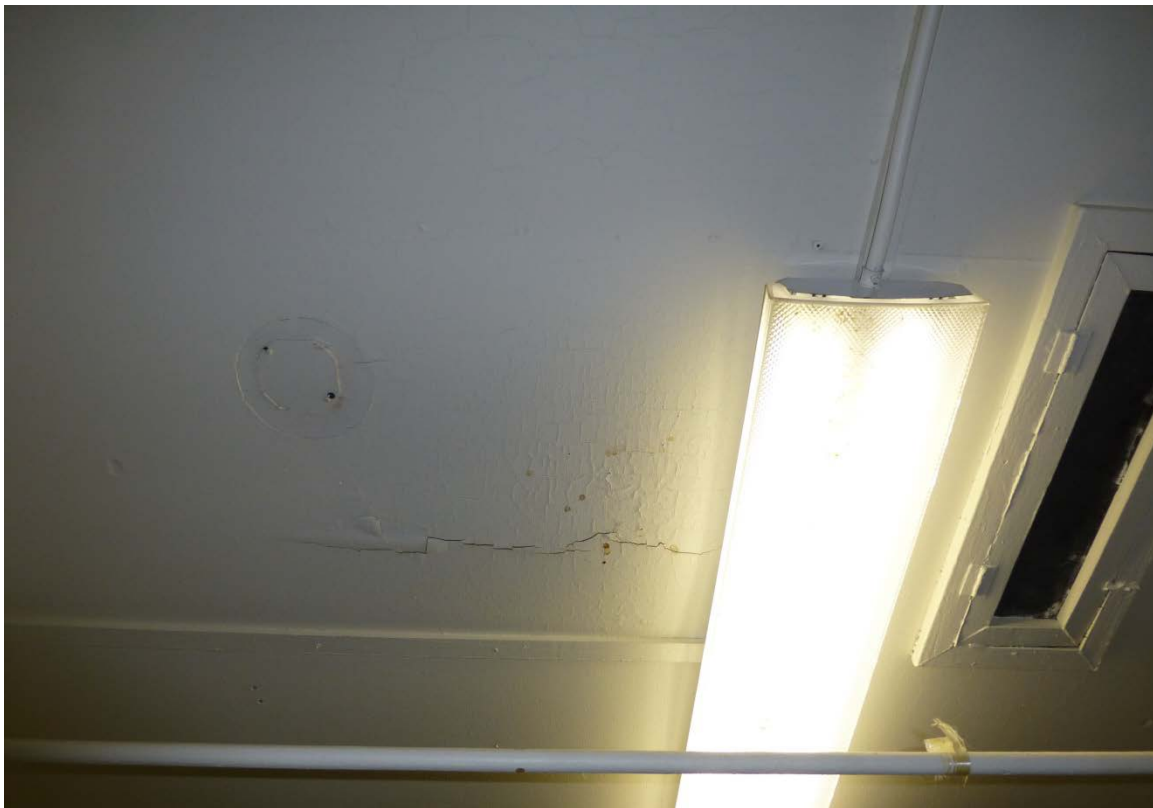
Figure 44. Example of an electrical box (center, left) marking the location of an original light fixture (ERDC-CERL, 2013).

Light fixtures typical to the same type of building plan for WWII-era Series 700 buildings can be seen in Figure 39–Figure 41. These drawings informed the conclusion that none of the current light fixtures in the building are original (e.g., Figure 42). There are retro-style light fixtures in the ell of the building (e.g., Figure 43), but these are not replicas of the original light fixtures. In addition, there are electrical connection boxes on the ceiling that appear to mark the location of the original light fixtures (e.g., Figure 44).
