Field Evaluation of Ultra-High Pressure Water Systems for Runway Rubber Removal

April 2014

Final report

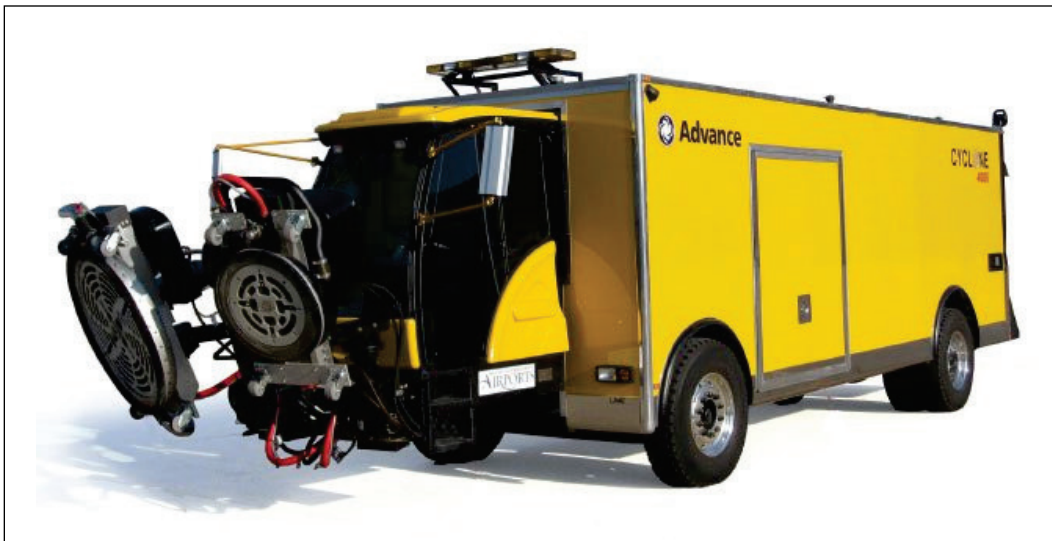
Figure 5. Cyclone 4006 rubber removal system.

The system as tested had a 36-in.-diam cleaning head, powered by a Tier III turbocharged liquid cooled engine, residing in a cast aluminum housing. This system has a debris recovery system which uses cyclonic action in conjunction with a macerator pump to pump runway contaminants to a galvanized reclamation tank with powered dump and powered door for easy maintenance. The Cyclone 4006 can be operated by a single operator using a joystick controlled hydrostatic drive. Water is pumped at 6 gallons per minute (gpm) at operating water pressures of up to 43,000 psi for rubber removal. The 30-ft-long by 10-ft-tall by 8-ft-wide vehicle had a maximum travel speed of 12 miles per hour (mph). The Cyclone 4006 houses a 1,600-gal fiberglass water tank. The entire system has a dry weight of

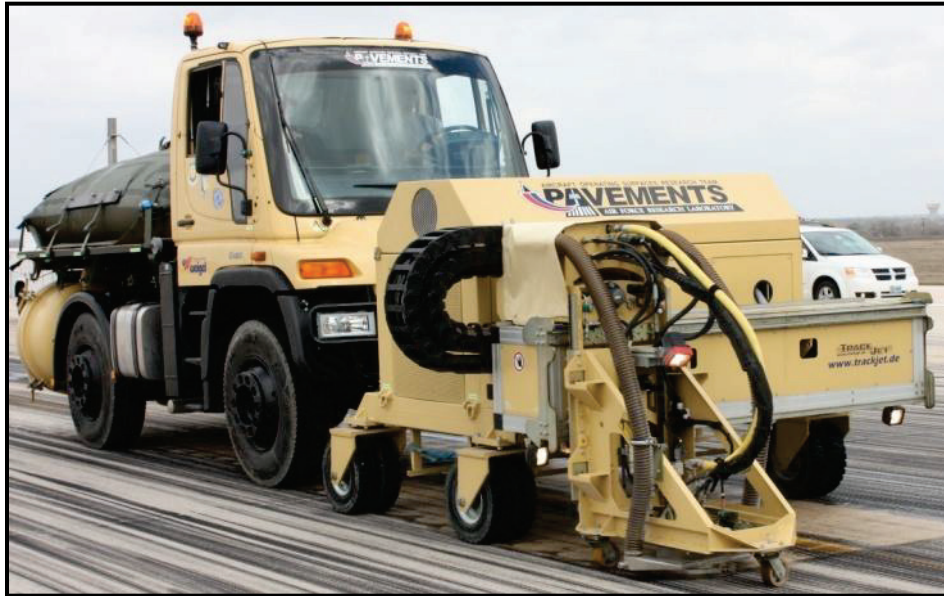
Figure 7. Trackjet UHPW rubber removal system.

The U400 is powered by a 200 hp Euro III liquid cooled diesel engine with a top speed governed at 15 mph. It has a wheel base span of 121 in. and dry weight of 13,327 lb. Its dimensions are 95 in. wide by 219 in. long. The loading height of the vehicle is 91 in. A 660-gal Musthane water bladder is fitted to the rear of the vehicle.

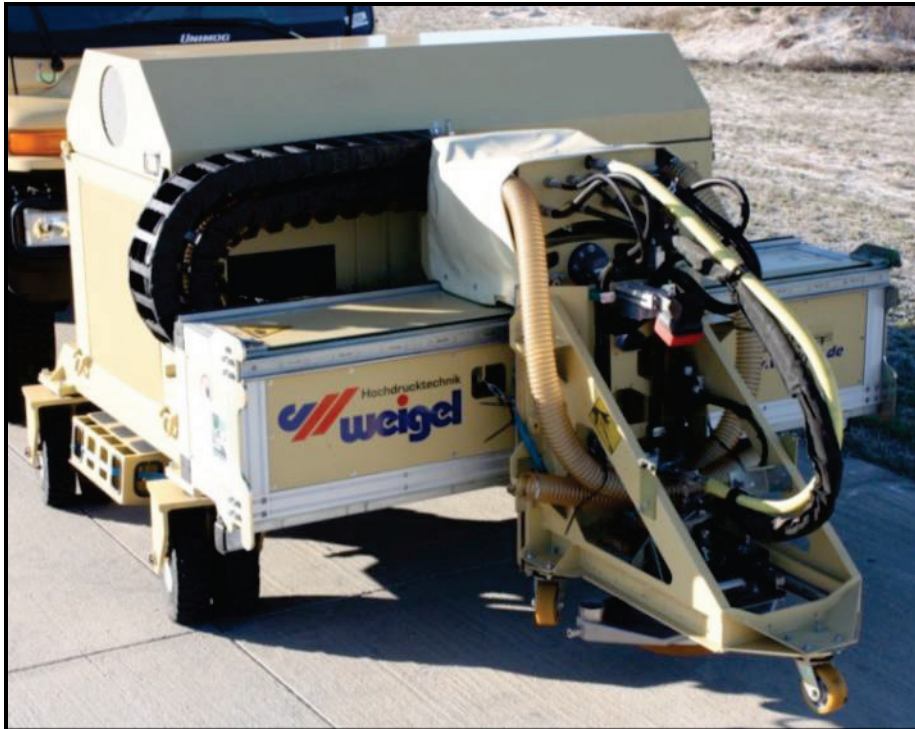
Figure 8. Trackjet cleaning module.

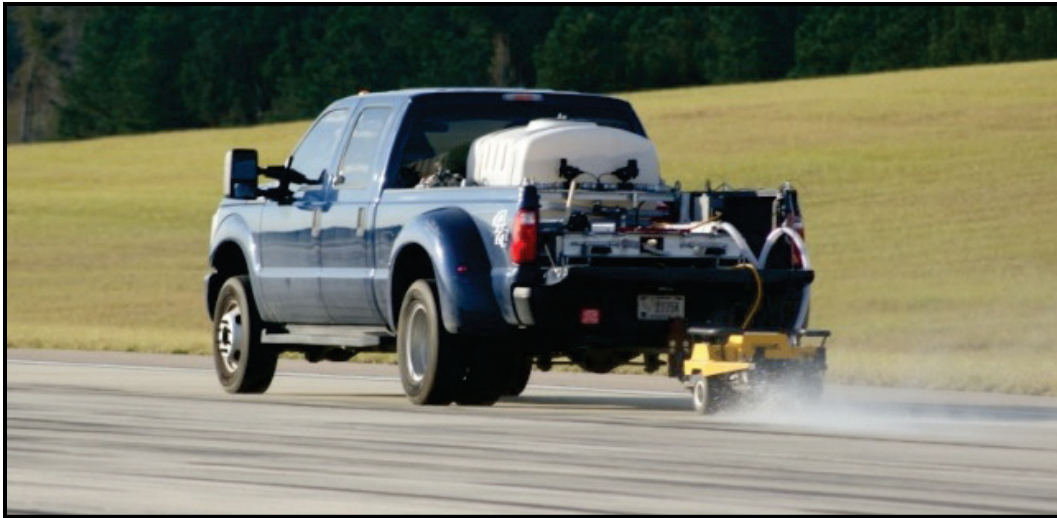
Figure 12. GripTester MK1 C-type.

As the GripTester is in tow, the measuring tire is slipped by a chain drive transmission from the primary two-wheeled axle. Dynamic friction readings are calculated from strain gauge data and are stored in a computer tethered to the GripTester by serial cable. Movement of a drive sprocket on the front axle is measured by an inductive proximity sensor. These data determine speed and distance during operation. The on-board computer calculates and stores the survey speed for each 32.8 ft of friction readings.

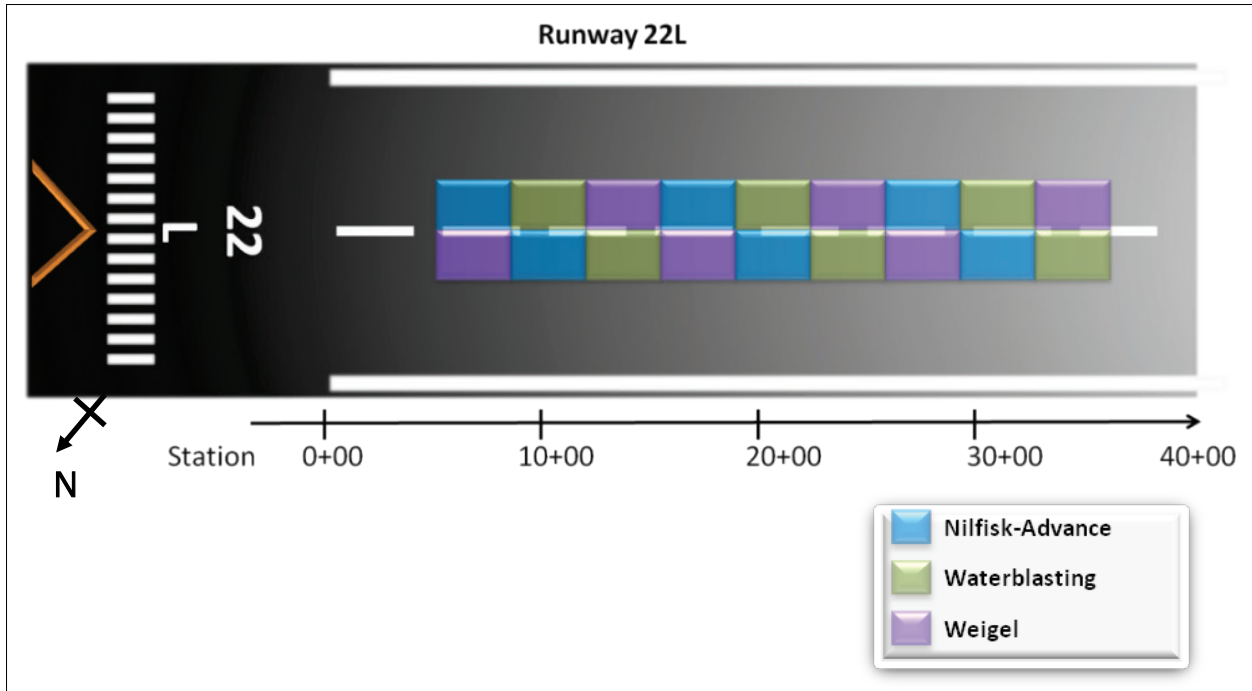
Figure 17. Runway 22L test sections.

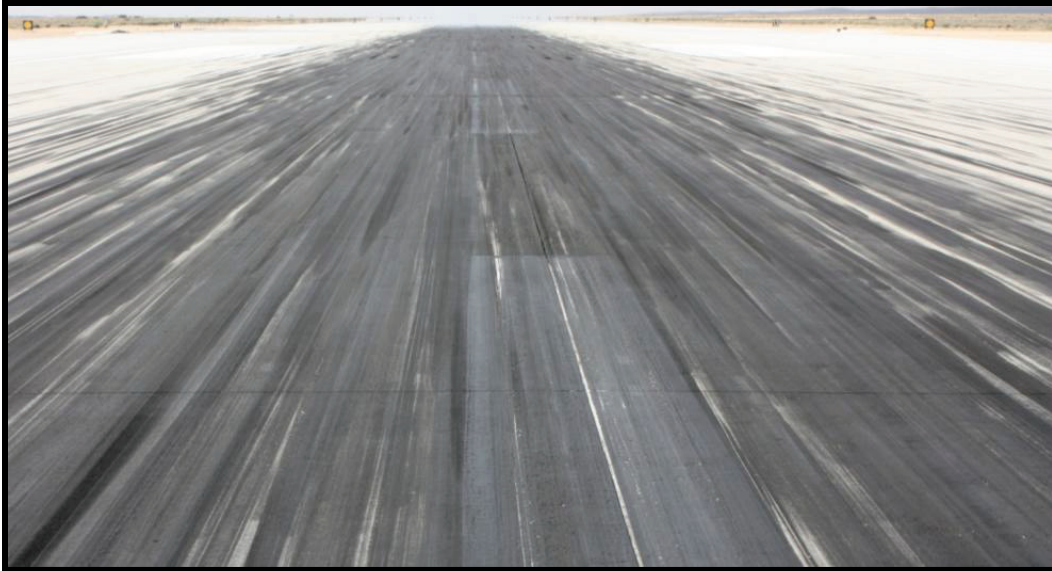
Figure 19. Runway 22L contaminated with rubber deposits prior to testing.

Figure 19 shows the surface condition of Runway 22L contaminated with rubber deposits prior to testing.

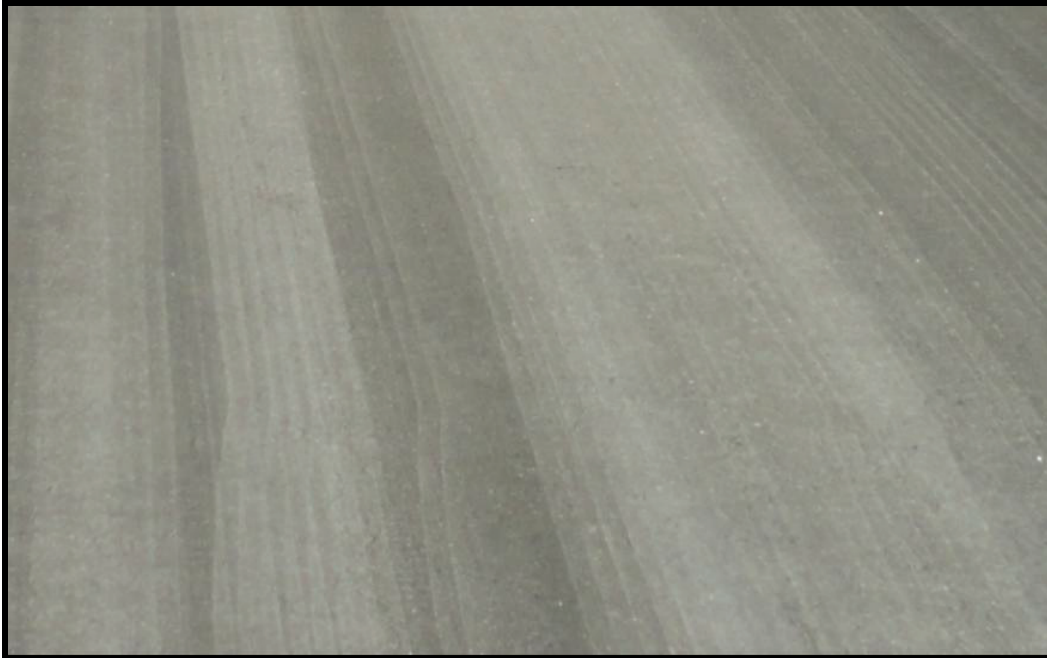
Figure 24 presents a typical pavement surface on Runway 22L after Cyclone 4006 rubber removal. Cyclone 4006 rubber removal produced a uniformly clean pavement with some light staining, but the pavement surface is visibly free of rubber deposits.

Figure 24. Typical pavement surface on Runway 22L after Cyclone 4006 rubber removal.

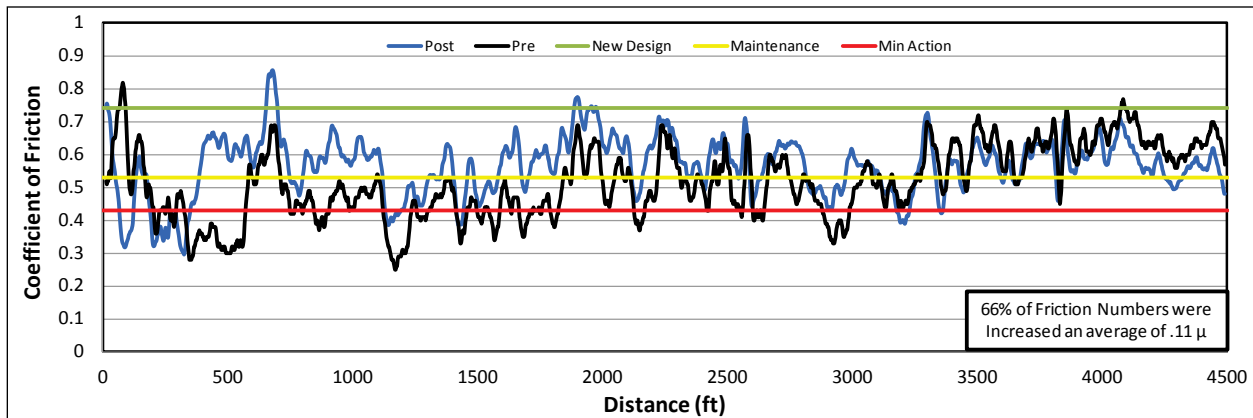
Figure 30. Runway 22L GripTester results 8 ft right of center line (40 mph).

Figure 29 presents the pre- and post-rubber removal GripTester results in the left offset lane when operated at 40 mph. Figure 30 presents results from the right offset lane at 40 mph. These charts represent friction measurements from all 16 test sections. There are three condition thresholds on each chart: green, yellow, and red. These criteria are defined in Table 3 and originate from the FAA standards adopted from FAA AC 150/5320-12C (FAA 1997).

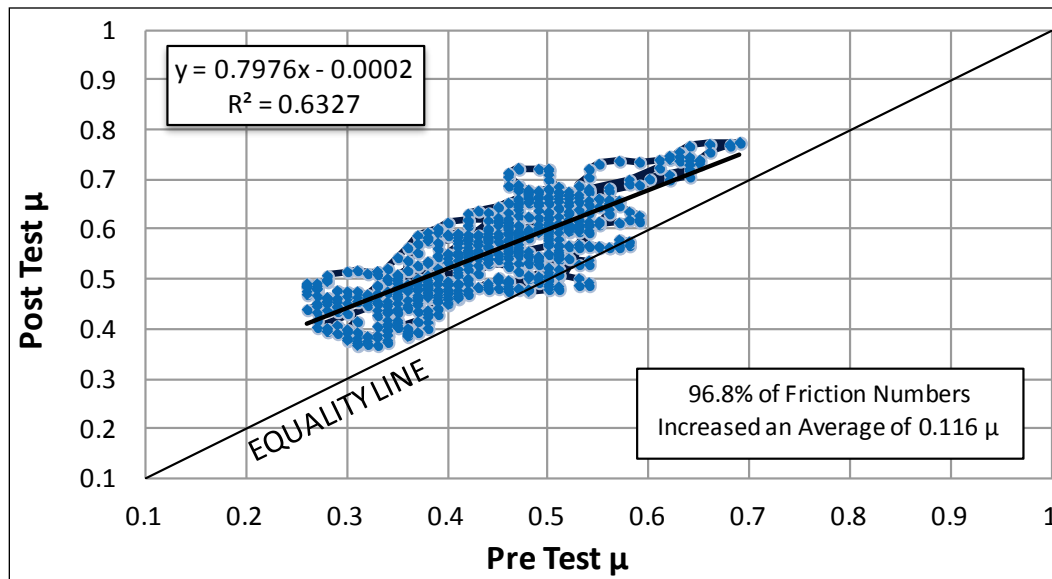
Figure 31. Cyclone 4006 pre- and post-friction coefficients (40 mph).

Comparison of initial friction measurements ($M = 0.439$, $SD = 0.0894$) and post-rubber removal friction measurements ($M = 0.550$, $SD = 0.0892$) indicate a statistical gain in available friction after rubber removal using the Cyclone 4006, with a $t(1,498) = 24.21$ and $p = 1.58E-109$.

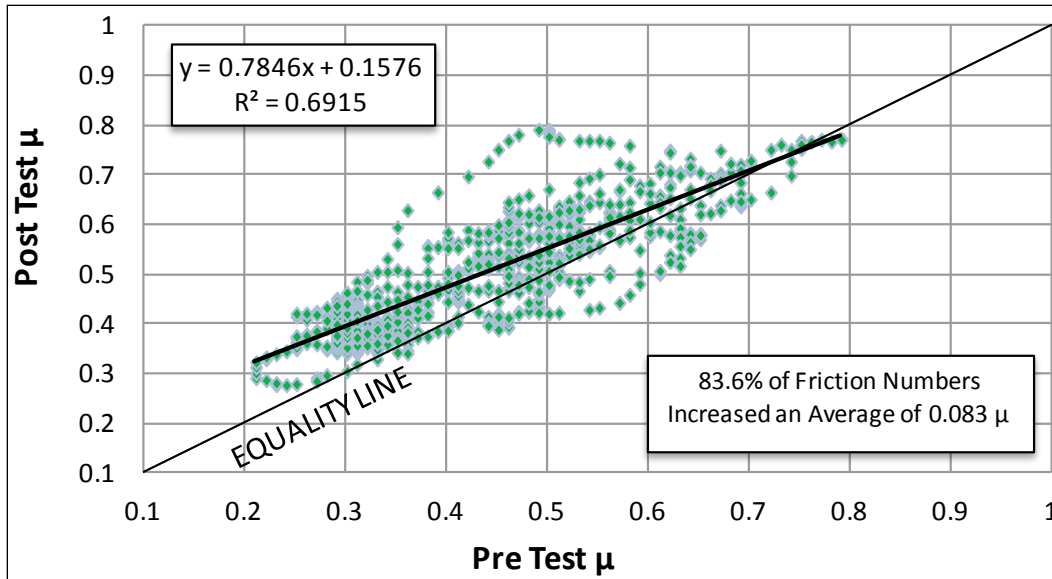
Figure 32. SH8000R pre- and post-friction coefficients (40 mph).

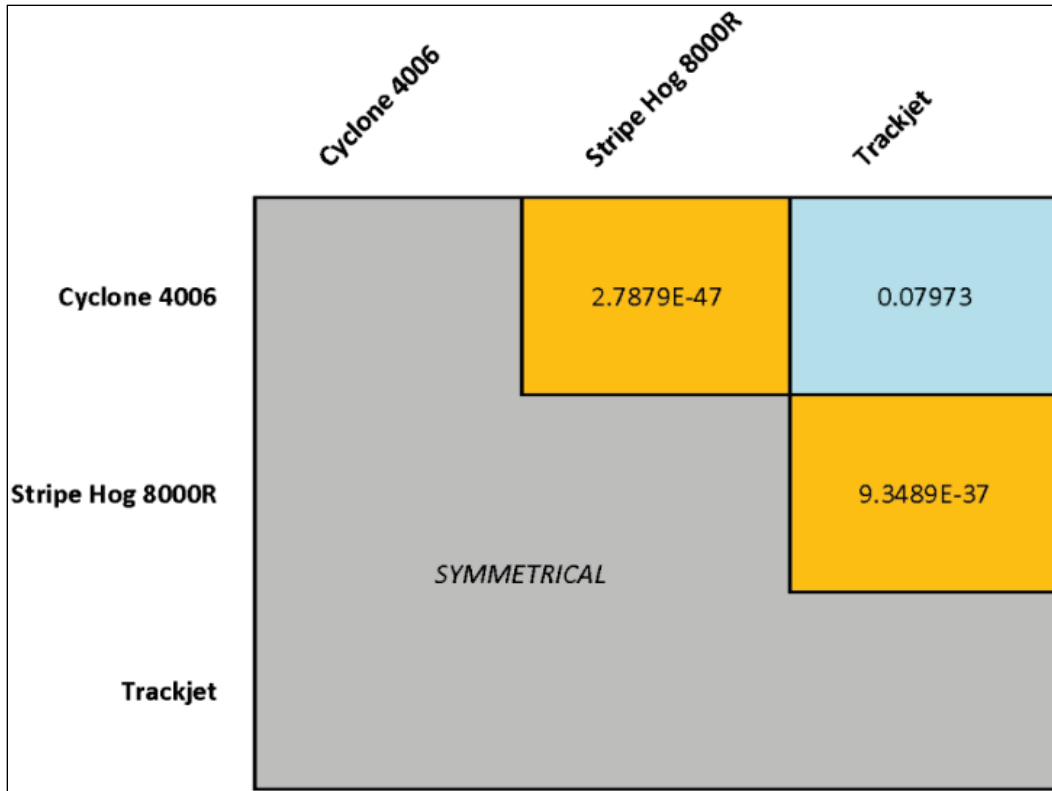
Figure 34. P value matrix for post-rubber removal friction gains (40 mph).

Using these analyses, it was calculated that friction gains in test sections cleaned by the Cyclone 4006 ($M = 0.112$, $SD = 0.0571$) were statistically greater than friction gains in test sections cleaned by the SH8000R ($M = 0.0619$, $SD = 0.0708$), $t(1,499) = 14.96$, $p = 2.79E-47$. No statistically significant distinction was found between friction gains in test sections cleaned by the Cyclone 4006 and Trackjet ($M = 0.106$, $SD = 0.0628$), $t(1,536) = 1.75$, $p = 0.08$. However, friction gains measured in Trackjet test sections were statistically greater than friction gains measured in SH8000R test sections, with a $t(1,537) = 13.00$ and $p = 9.35E-37$. A comparison of mean friction gains following rubber removal is provided in Figure 35.

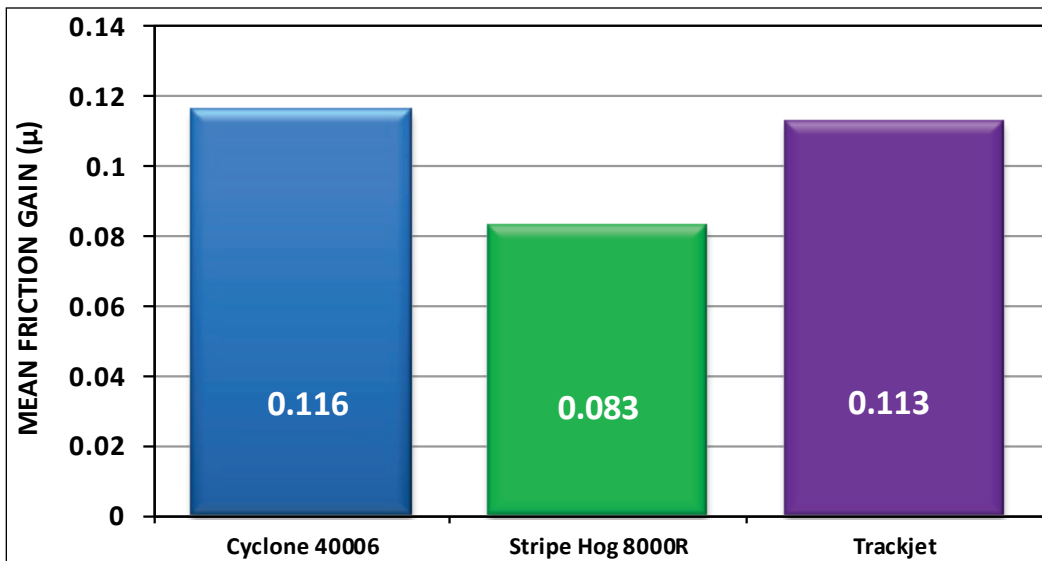
Figure 35. Comparison of mean friction gains following rubber removal (40 mph).

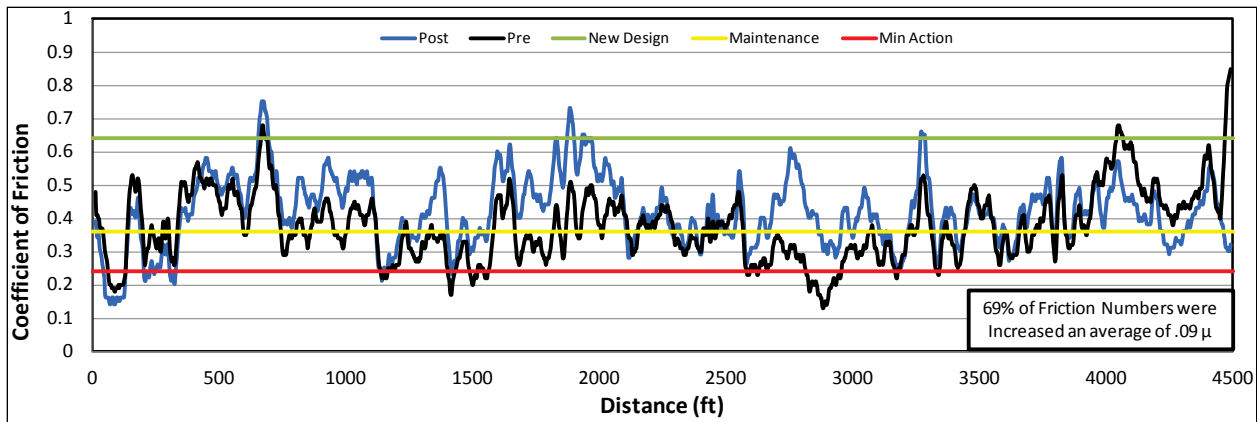
Figure 37. Runway 22L GripTester results 8 ft right of center line (60 mph).

friction measurements from all 16 test sections. There are three condition thresholds on each chart: green, yellow, and red. These criteria are defined in Table 4 and originate from the FAA standards adopted from FAA AC 150/5320-12C (FAA 1997).

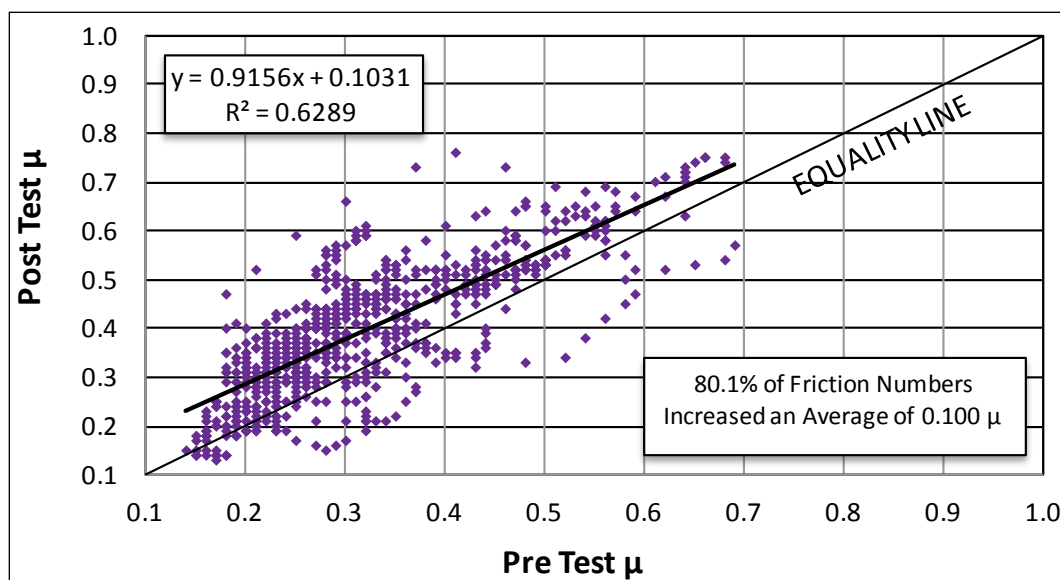
Figure 40. Trackjet pre- and post-friction coefficients (60 mph).

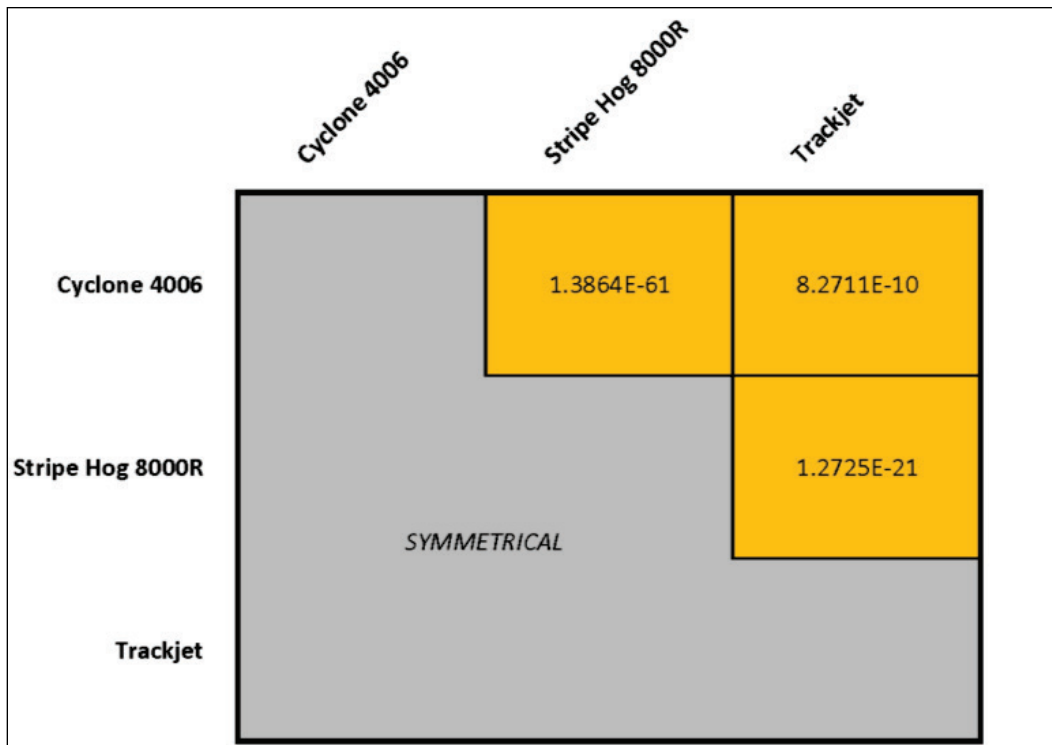
Figure 41. P value matrix for post-rubber removal friction gains (60 mph).

exhibited statistically significant gains in available skid resistance. A one-way ANOVA comparing friction gains from each treatment revealed statistically significant differences between the groups, with an $F(2, 2,249) = 134.72$ and a $p = 5.51E-56$.

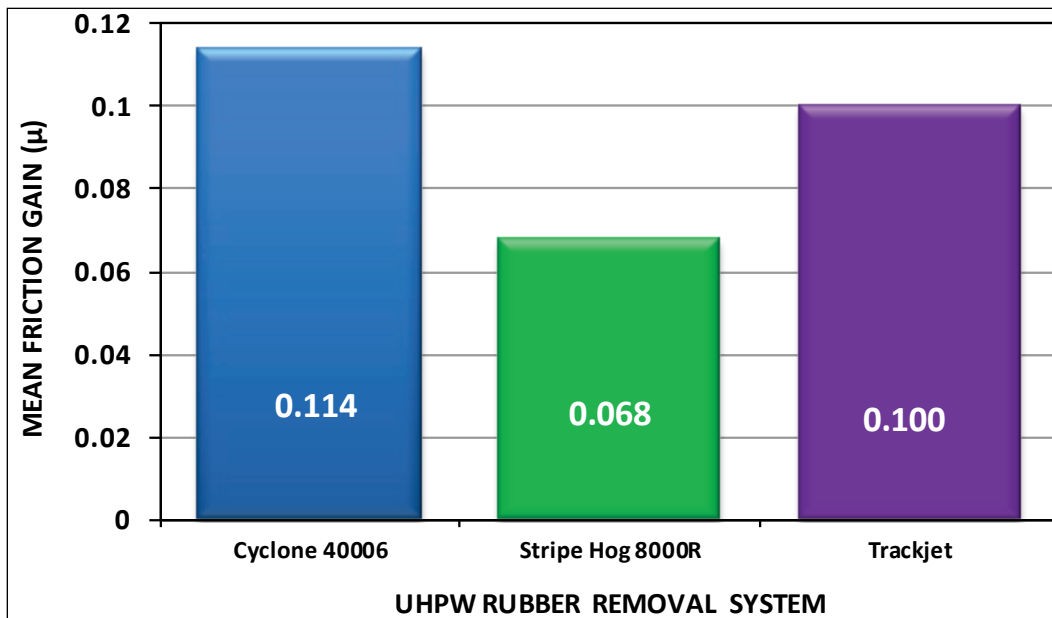
Figure 42. Comparison of mean friction gains following rubber removal (60 mph).

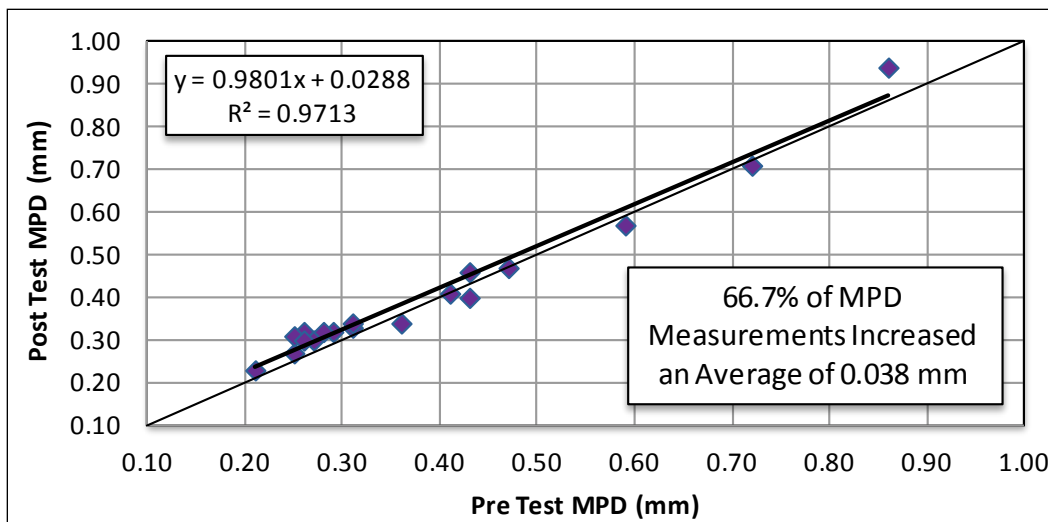
Figure 50. Trackjet pre- and post-MPD.

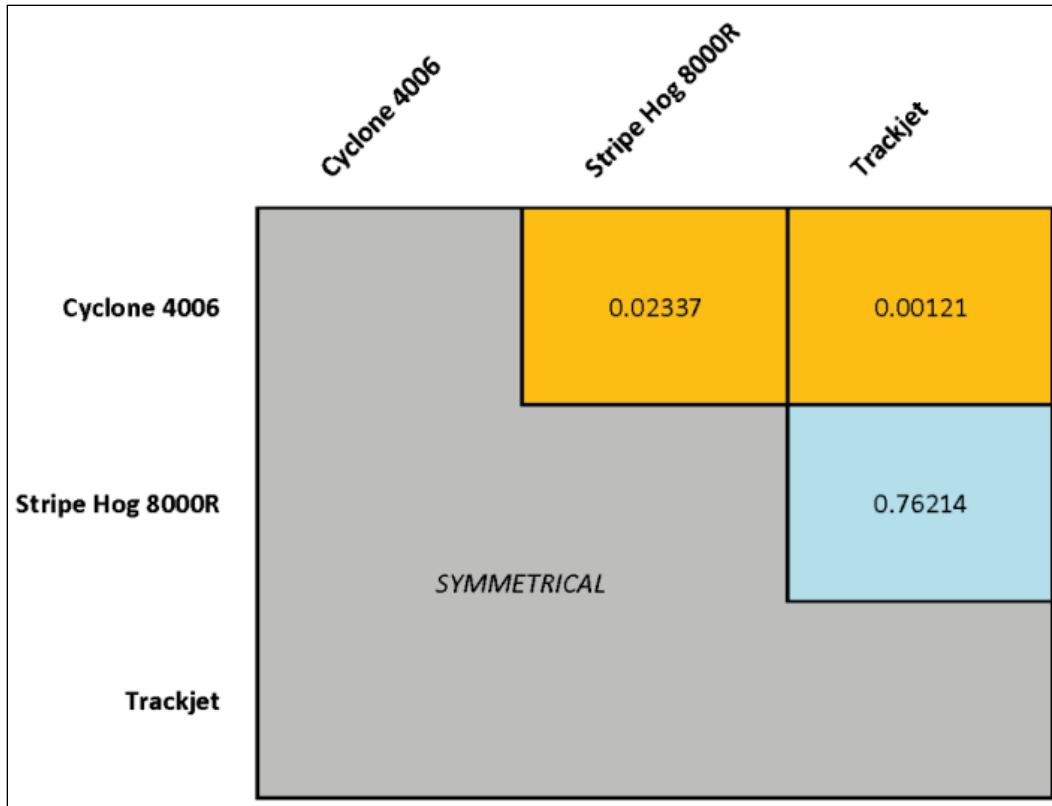
Figure 51. P value matrix for post-rubber removal MPD gain.

Since the ANOVA indicates statistically significant differences in treatment effects, a pair wise t-test procedure was used to compare the means to determine if the calculated differences in means were statistically significant given the scatter of data. Tests of the three a priori hypotheses were conducted using Bonferroni adjusted alpha levels of 0.0167 per test (0.05/3). The results of these tests are presented in Figure 51. The value tabulated in each cell is the P value that resulted from the pair-wise t-test for the combination of treatments represented by the cell. A lower P value indicates a greater significance. In Figure 51, all cells with a P value less than 0.05 are highlighted in orange. This indicates that there is a greater than 95 percent probability that differences calculated between the two methods are statistically significant.

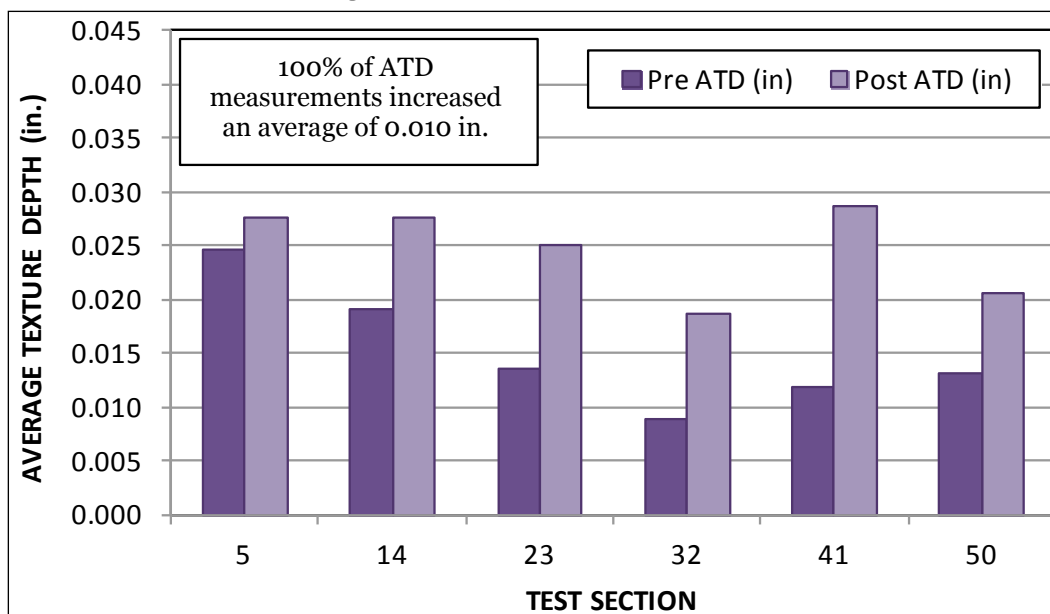
Figure 54. Trackjet pre- and post-ATD.

Comparison of initial ATD measurements ($M = 0.015$, $SD = 0.00571$) and post ATD measurements ($M = 0.025$, $SD = 0.00417$) indicated that there was a statistical increase in ATD after rubber removal using the Trackjet, with a $t(10) = 3.29$ and a $p = 8.14E-3$.

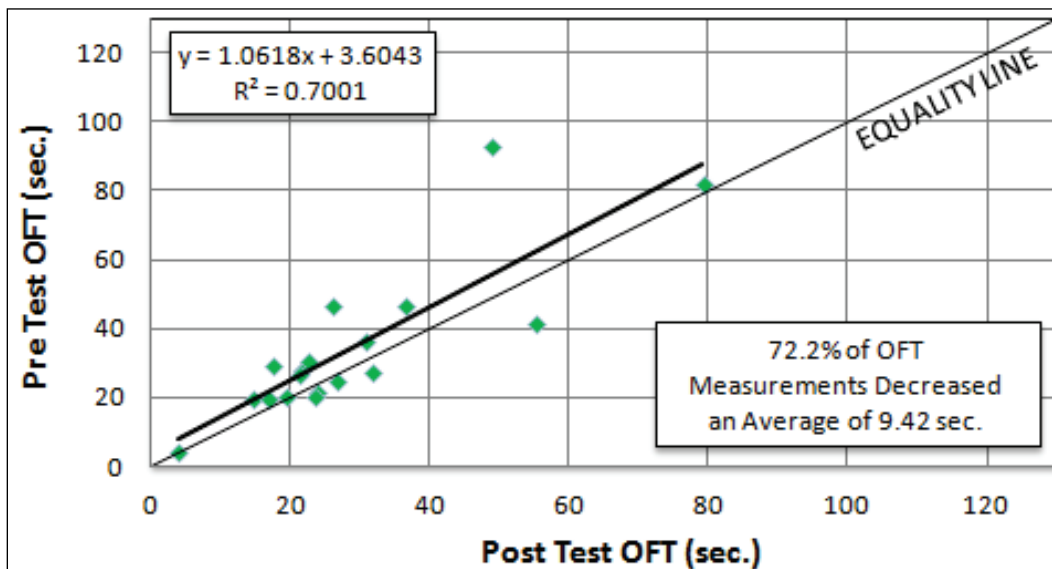
Figure 60. SH8000R pre- and post-OFT.

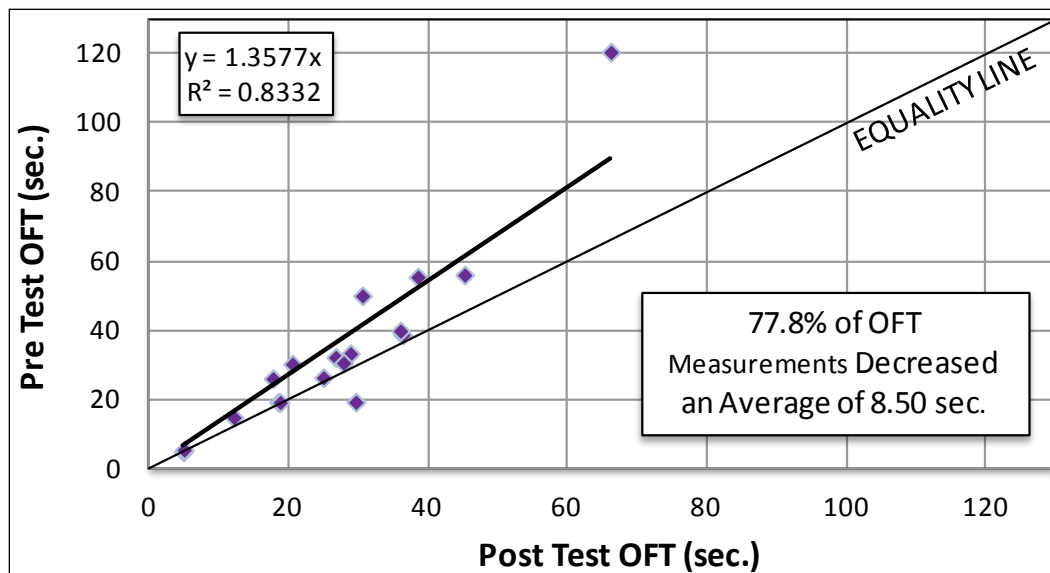
A reduction in OFT was measured over 78 percent of the pavement sections cleaned by the Trackjet. The mean OFT loss for these areas was 8.50 sec. Data in Table 15 were used to develop the chart shown in Figure 61, which compares pre- and post-rubber removal OFT measurements. Comparison of initial OFT measurements ($M = 34.56$, $SD = 26.07$) and post-OFT measurements ($M = 27.11$, $SD = 14.67$) revealed no statistically significant reduction in OFT after rubber removal using the Trackjet, with a $t(34) = 1.06$ and a $p = 0.30$.

Figure 61. Trackjet pre- and post-OFT.

The outflow meter did not materialize as a good device for judging quality of rubber removal due to poor reproducibility and large data scatter in this experiment.

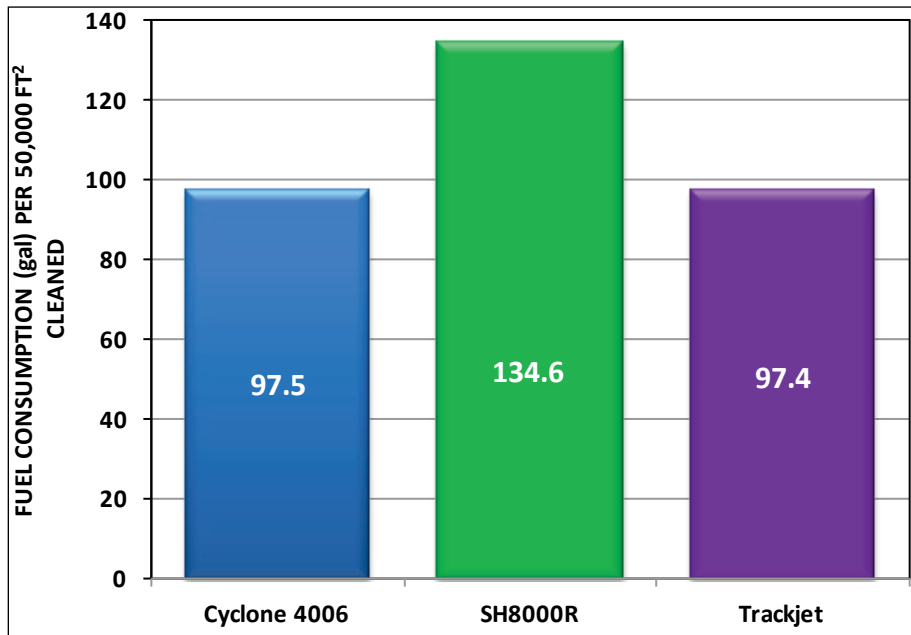
Figure 63. Fuel consumption.

**For reference only. Trackjet system not manufactured for production.
Fuel consumption is not part of evaluation criteria.*

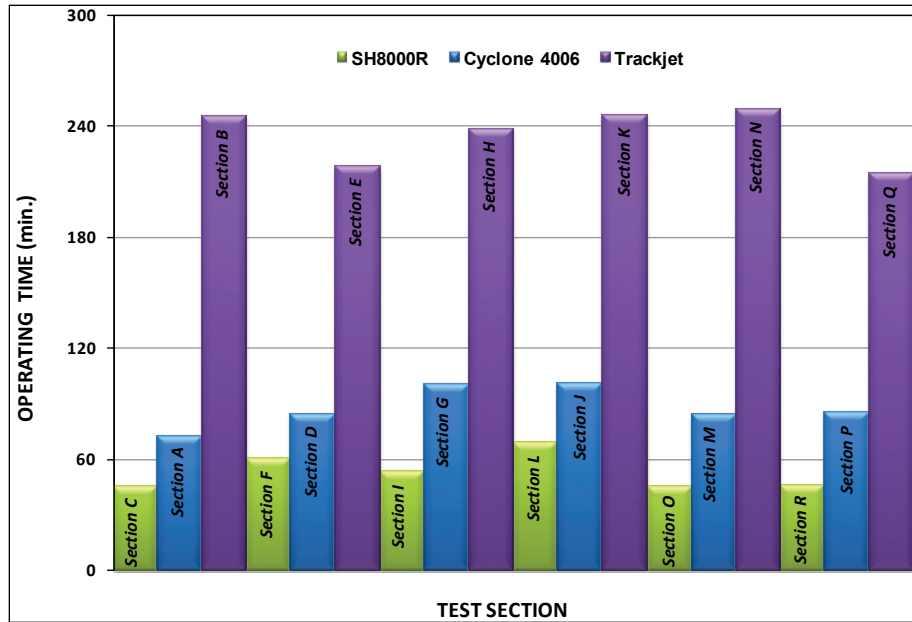
Figure 64. Elapsed test section cleaning times.

*For reference only. Trackjet system not manufactured for production. Cleaning production rate is not part of evaluation criteria.

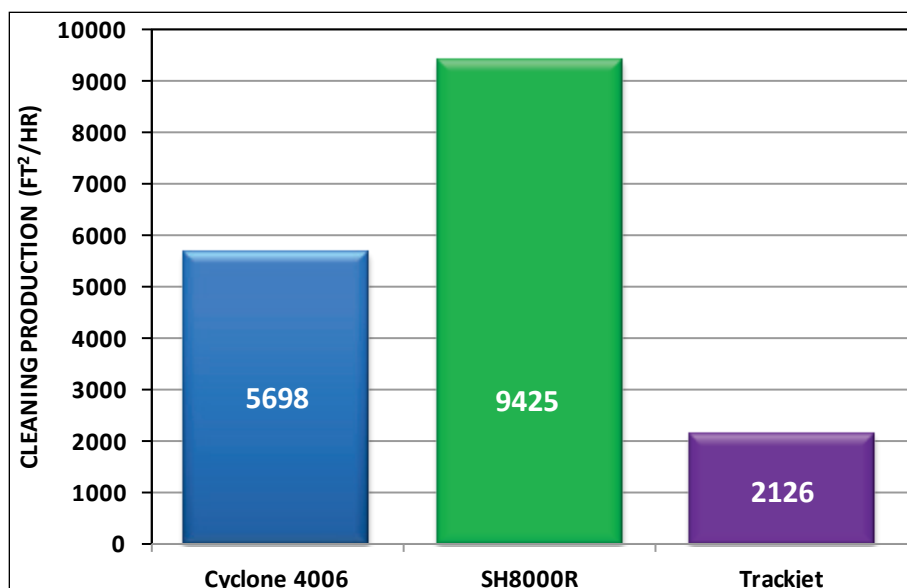
Figure 65. Overall cleaning production rate.

**For reference only. Trackjet system not manufactured for production.
Cleaning production rate is not part of evaluation criteria.*

These metrics were measured while having each system maneuver within six separate 25-ft by 333-ft test sections. Ideally, UHPW systems make long passes along the length of a runway touchdown zone with fewer overlaps and maneuvers during cleaning. It is reasonable to assume that each system is capable of higher production and improved efficiencies under normal operational conditions.

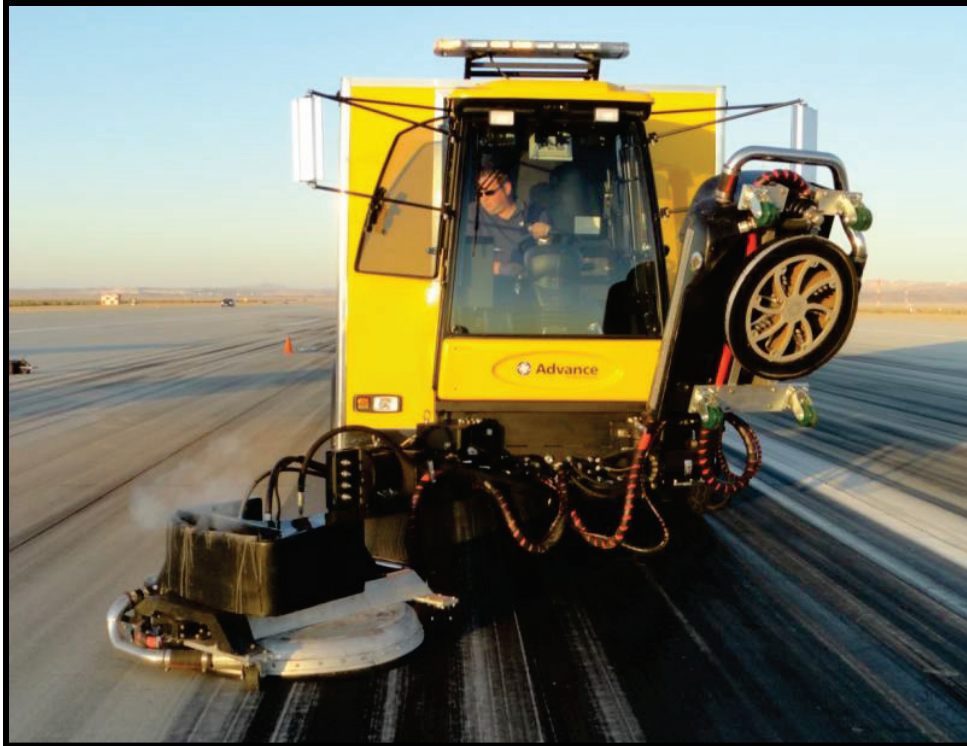
Figure 68. Cyclone 4006 removing rubber on Runway 22L.

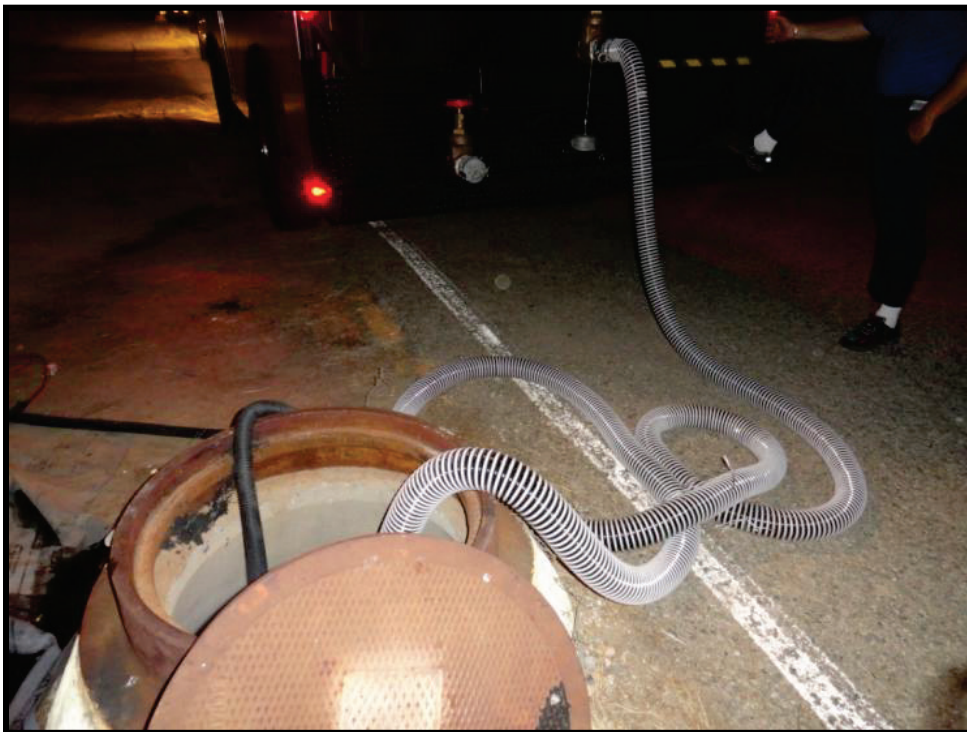
Figure 69. Cyclone 4006 gray water discharge.

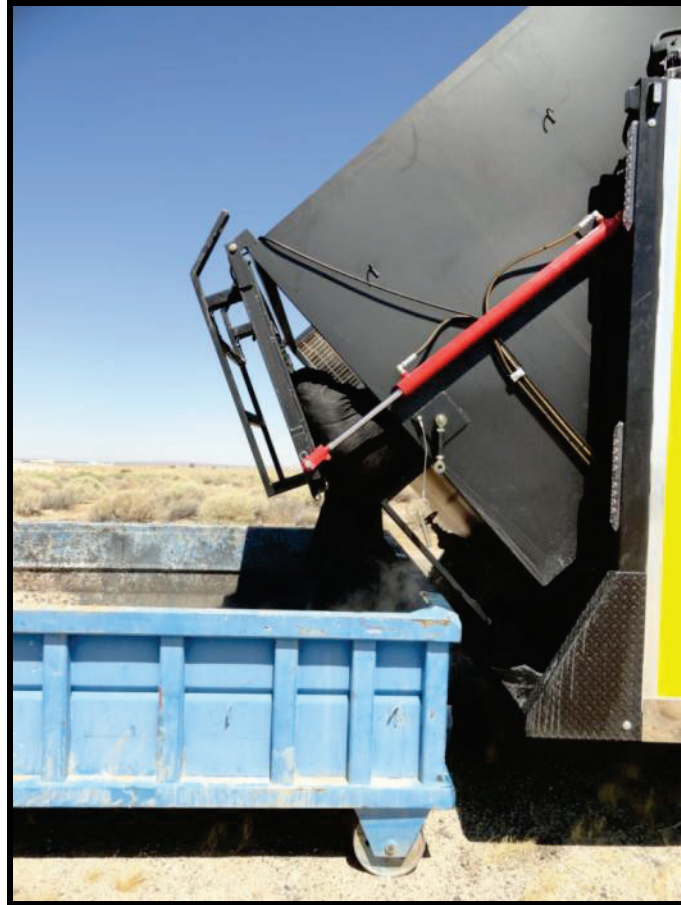
Figure 70. Cyclone 4006 dumps solids.

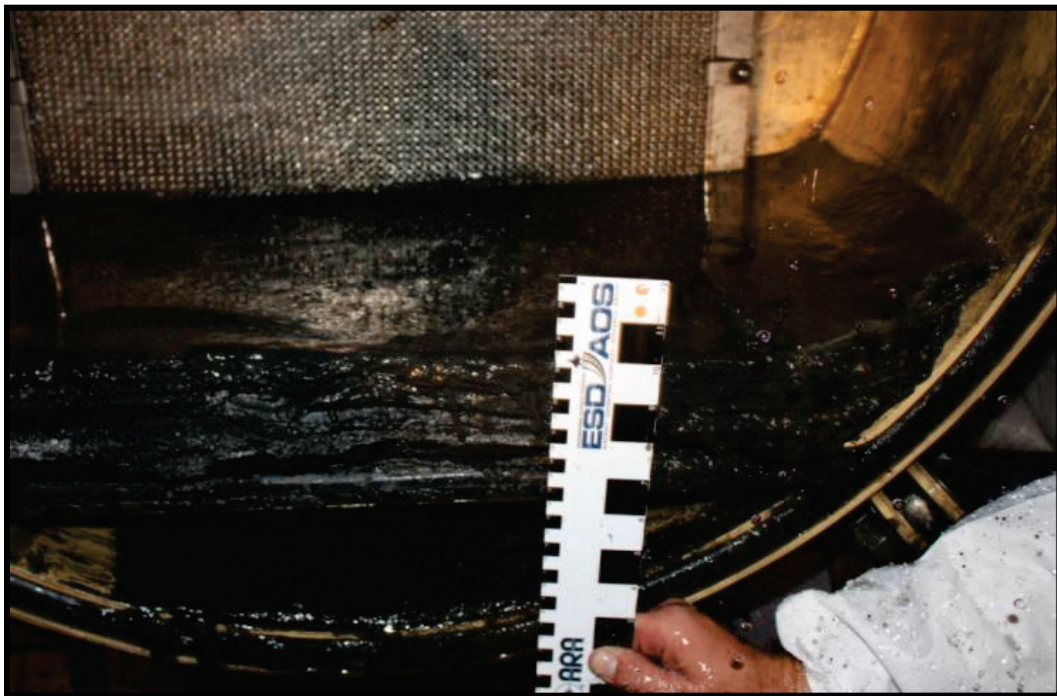
Solid wastes have to be removed frequently from two vacuum chambers at the rear of the Unimog due to the scaled-down design of its debris recovery system. Cleaning the vacuum chambers requires a designated cleanout area set up to handle the process. Figure 72 shows the Trackjet cleanout process. A generator, halogen lights, a pressure washer, shovels, a sump pump, and container to transfer solids were used to support the cleanout process. A berm lined with heavy plastic and sandbags was constructed to capture gray water during this cleaning. Mesh filters in each chamber had to be thoroughly cleaned by high pressure water in order for the chambers to maintain adequate vacuum pressure for debris recovery. Figure 73 shows solids collected in a Trackjet vacuum chamber.

Figure 73. Solids collected in a Trackjet vacuum chamber.

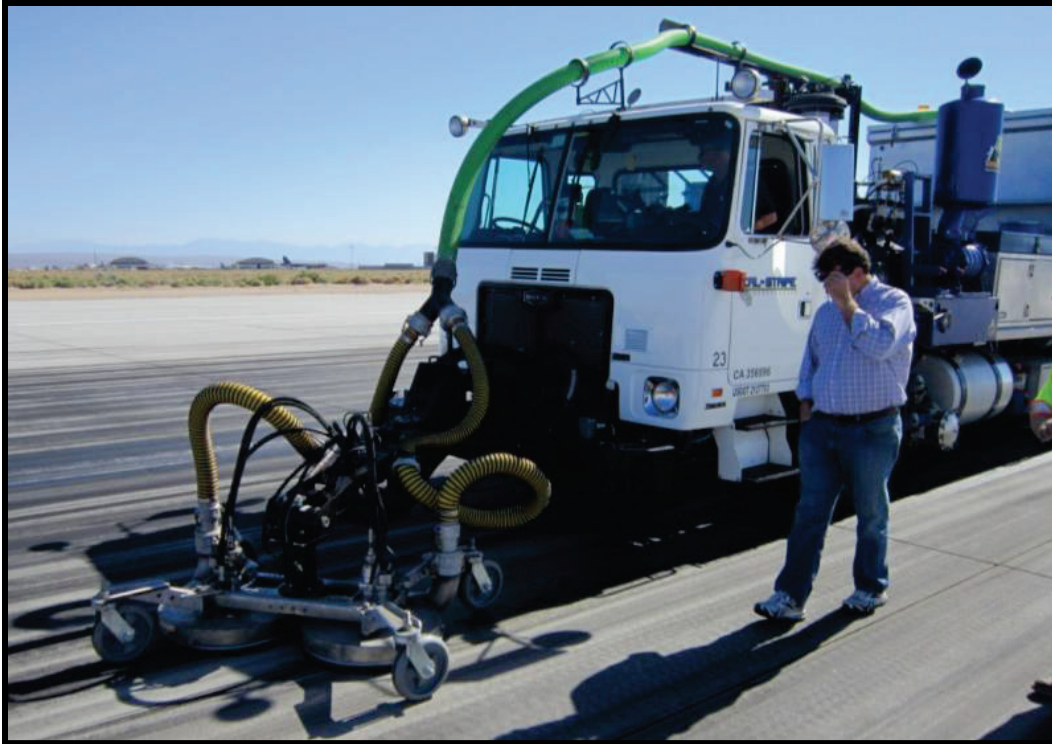
Figure 74. SH8000R removing rubber on Runway 22L.

The SH8000R is outfitted with two cleaning heads supplied with a 12-gpm flow rate, approximately twice the flow rate used by the Cyclone 4006 and Trackjet technologies. The SH8000R used the least water and had the highest production rate.

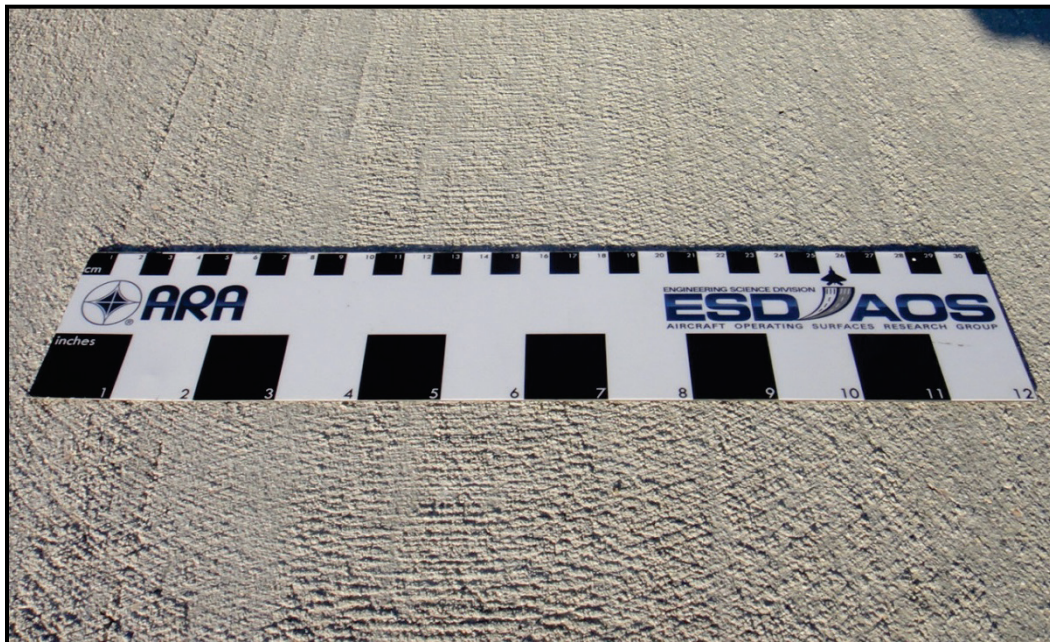
Figure 76. SH8000R PCC etching.

In select areas, the SH8000R operator had difficulty establishing an effective combination of water pressure and speed settings to achieve a uniformly clean pavement surface. Inadequate settings contributed to a less than uniform distribution of water at the pavement surface, resulting in some rubber deposits left on the runway. In this case, it was often difficult to determine if rubber was simply being left on the pavement or if water jets were lightly etching the pavement surface. An example of this condition is shown in Figure 75. Evidence of light scoring was found behind the SH8000R in one isolated area. This pavement damage area is shown in Figure 76. Once noted by the researchers, this issue was corrected by the contractor. It was noted that one of the shrouds was damaged while the unit was cleaning near the aircraft arresting system.

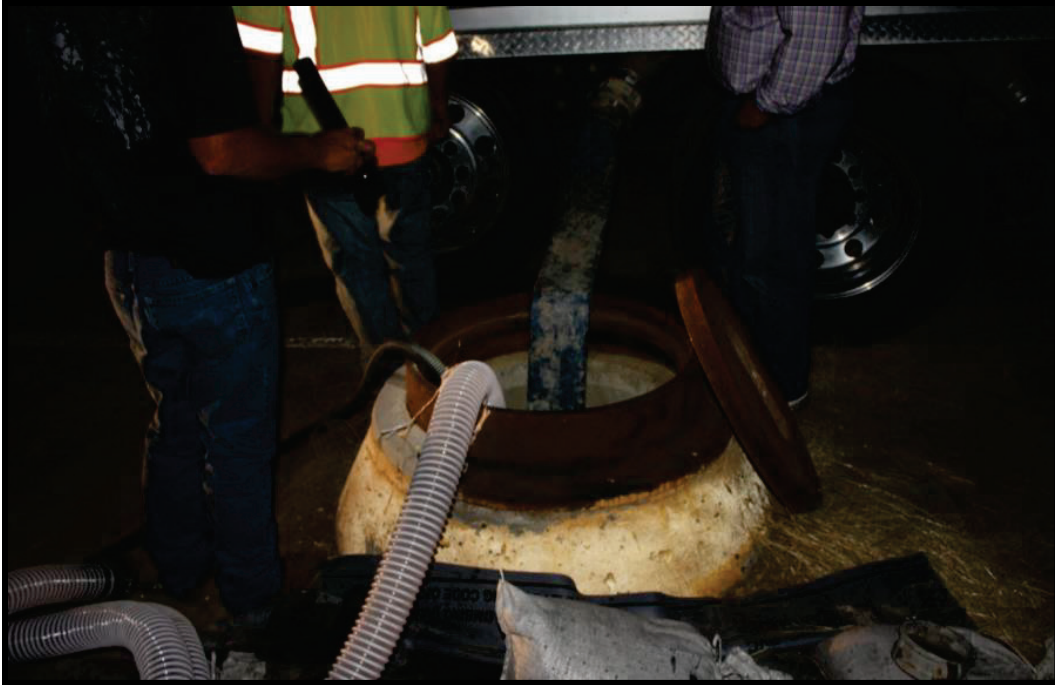
The SH8000R gray water discharge process is shown in Figure 77, and the dump process is presented in Figure 78. The dump process required two individuals at the rear of the bed to dislodge solids resting on a fabric material.

Figure 77. SH8000R gray water discharge.
