Field Evaluation of Ultra-High Pressure Water Systems for Runway Rubber Removal

April 2014

Final report

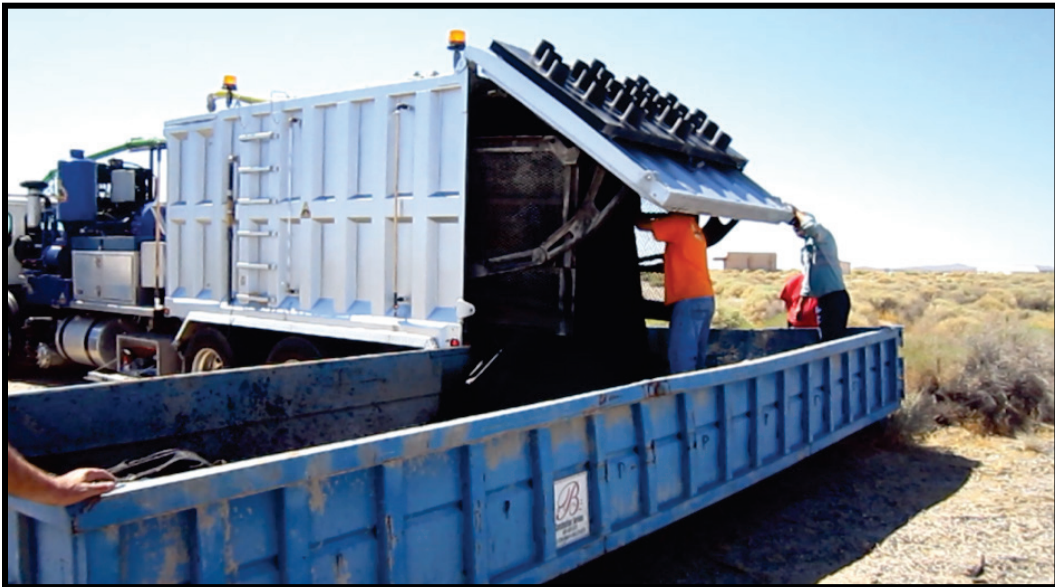
The SH8000R gray water discharge process is shown in Figure 77, and the dump process is presented in Figure 78. The dump process required two individuals at the rear of the bed to dislodge solids resting on a fabric material.

Figure 78. SH8000R dumps solids.
