Analysis of Building 839

Carlisle Barracks, Pennsylvania

Final report

This document presents a historic context, integrity analysis, and evaluation for the National Register of Historic Places for Building 839 at Carlisle Barracks, Pennsylvania. The report meets the requirements in the National Historic Preservation Act (NHPA) for federal agencies to address their cultural resources—defined as any prehistoric or historic district, site, building, structure, or object. Identification of potentially significant properties is achieved only through a survey and evaluation to associate a property within a larger historic context. Building 839 was likely constructed in the middle 1850s by Daniel Kieffer and was utilized as a farmhouse for the farm. In 1860, Kieffer sold the farm to Richard Parker who continued to farm the land. The Carlisle Indian Industrial School acquired the farm in 1887 and utilized the house as living quarters for the farmer and classroom space for the farm unit of the school until 1918. After the War Department reacquired Carlisle Barracks in 1918, the farmhouse was used for officer housing. It is the determination of the current survey that Building 839 should

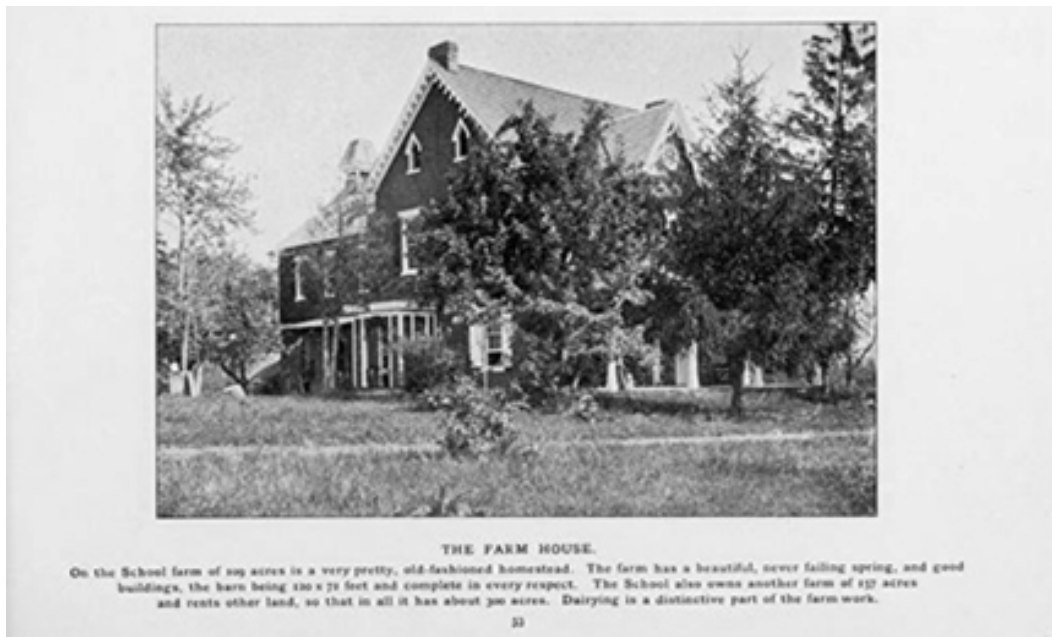
Figure 9. Building 839 from an 1895 photo album of the CIIS (USAHEC).

As with the farm in general, many instances of repairs and maintenance actions were required to keep the farmhouse in good shape. This process began nearly as soon as the CIIS had acquired the farm, with CIIS carpenter-students repairing the house in August and September 1888, adding a new roof and fresh paint, with a repainting five years later.⁸⁵ The farmhouse as it appeared in 1895 is shown in Figure 9 below.

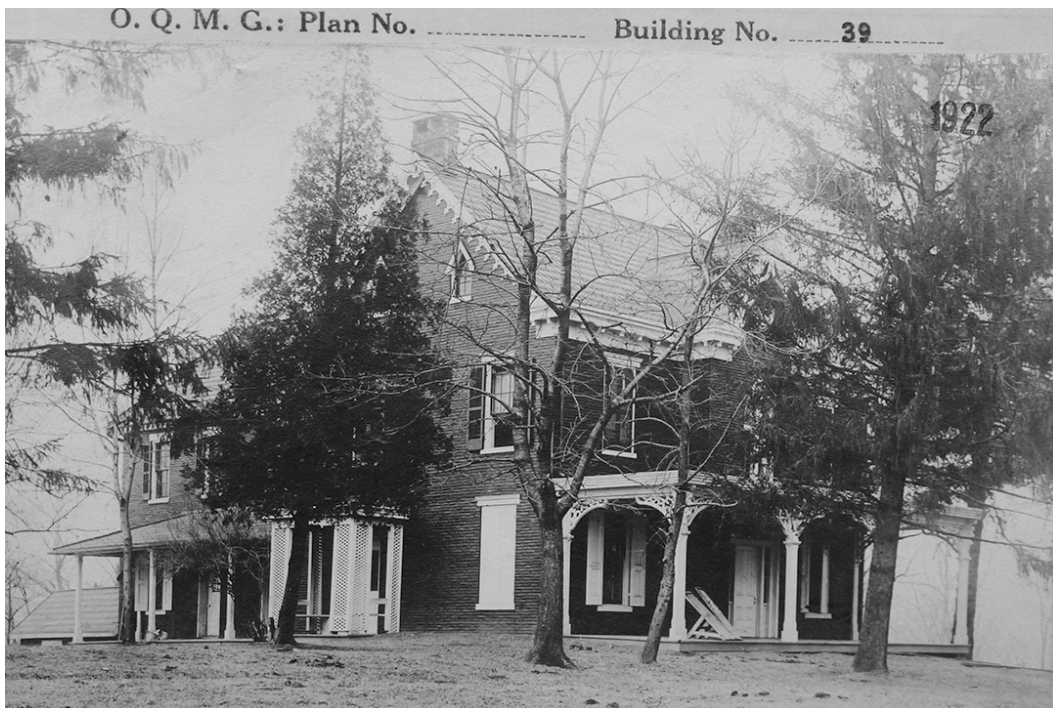
Figure 10. Building 839 in 1922 (NARA RG 77).

After reversion to Army control in 1918, the exterior of Building 839 was largely undisturbed, but some alteration of interior rooms took place by 1922 (Figure 10). The building was converted to a duplex for noncommissioned officers in 1933, with the cost of the remodeling recorded as \$4,472.65.⁹⁰ The outward appearance was altered, with the window to the right of the front door changed to a second door (Figure 11). The quarters received \$201 in repairs for 1941, making a total for repairs up to that date of \$11, 247, in addition to the total original cost (acquisition and remodeling into two quarters) of \$7,472. A replacement value of \$30,000 was assigned as of 30 June 1941.⁹¹

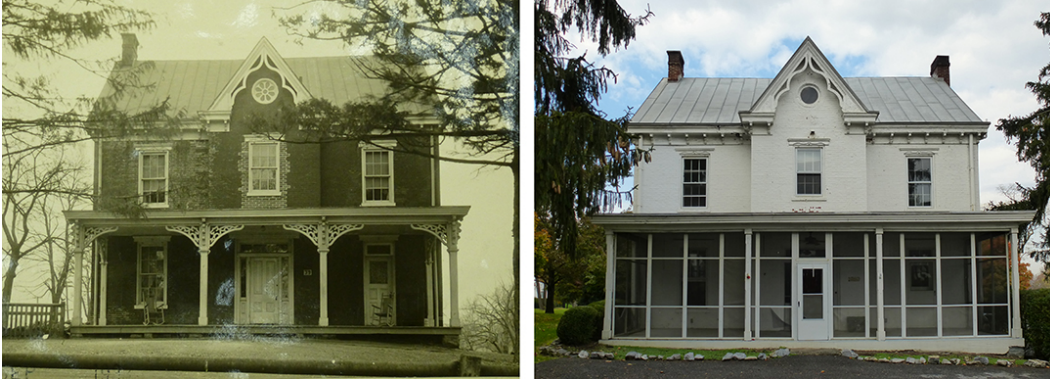
Figure 15. Front (south) façade comparison—left in 1933 (NARA) RG 77, right in 2012 (ERDC-CERL, 2012).

brick of the house was also painted white at some point after the period of significance.

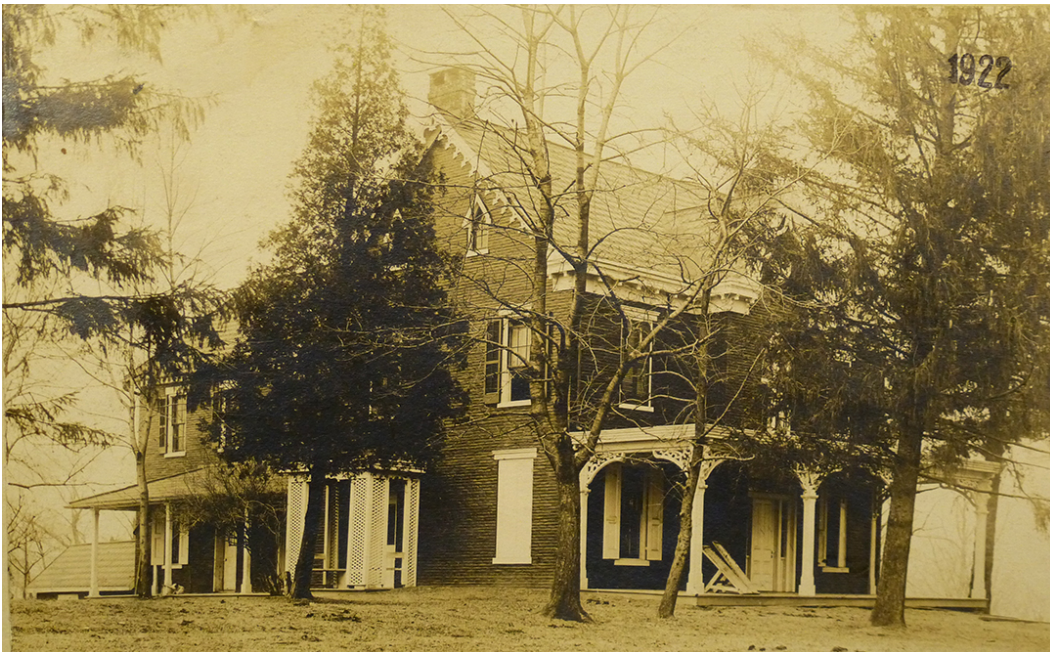
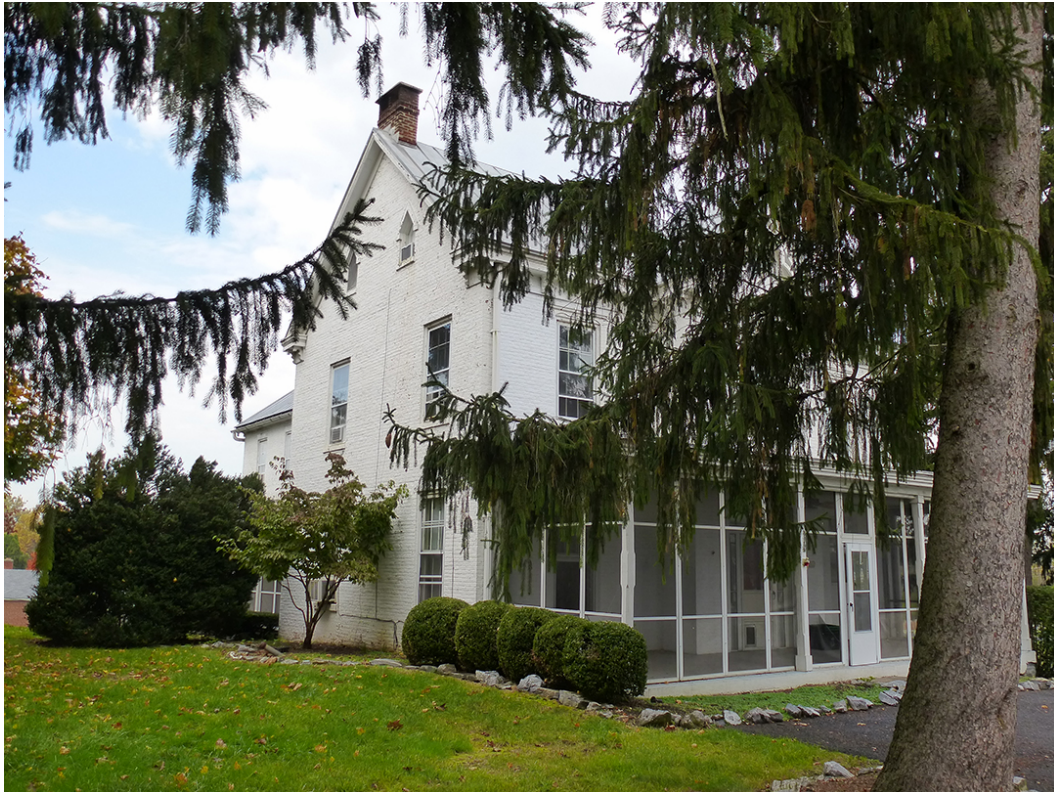
The south and west façades of the house were the most photographed. The west side saw the removal of a door/stoop and possible changes to the porch on the ell (Figure 16 and Figure 17).

Figure 16. A 1922 oblique of the west and south [front] of the house (NARA RG 77).

Figure 17. An oblique of the west and south façades in 2012 (ERDC-CERL).

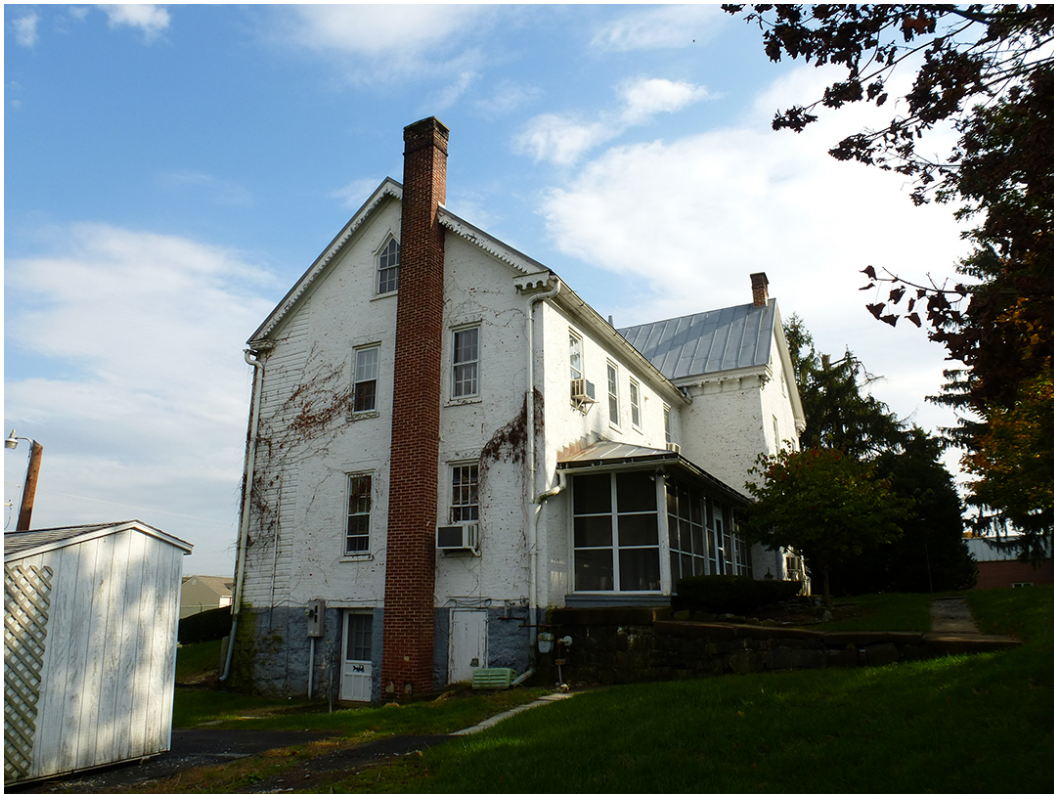
Figure 18. North façade (rear) in 2012 (ERDC-CERL, 2012).

The north façade has not seen much change to its integrity from what can be discerned from the architectural evidence, and the same is true with the east façade (Figure 18 and Figure 19).

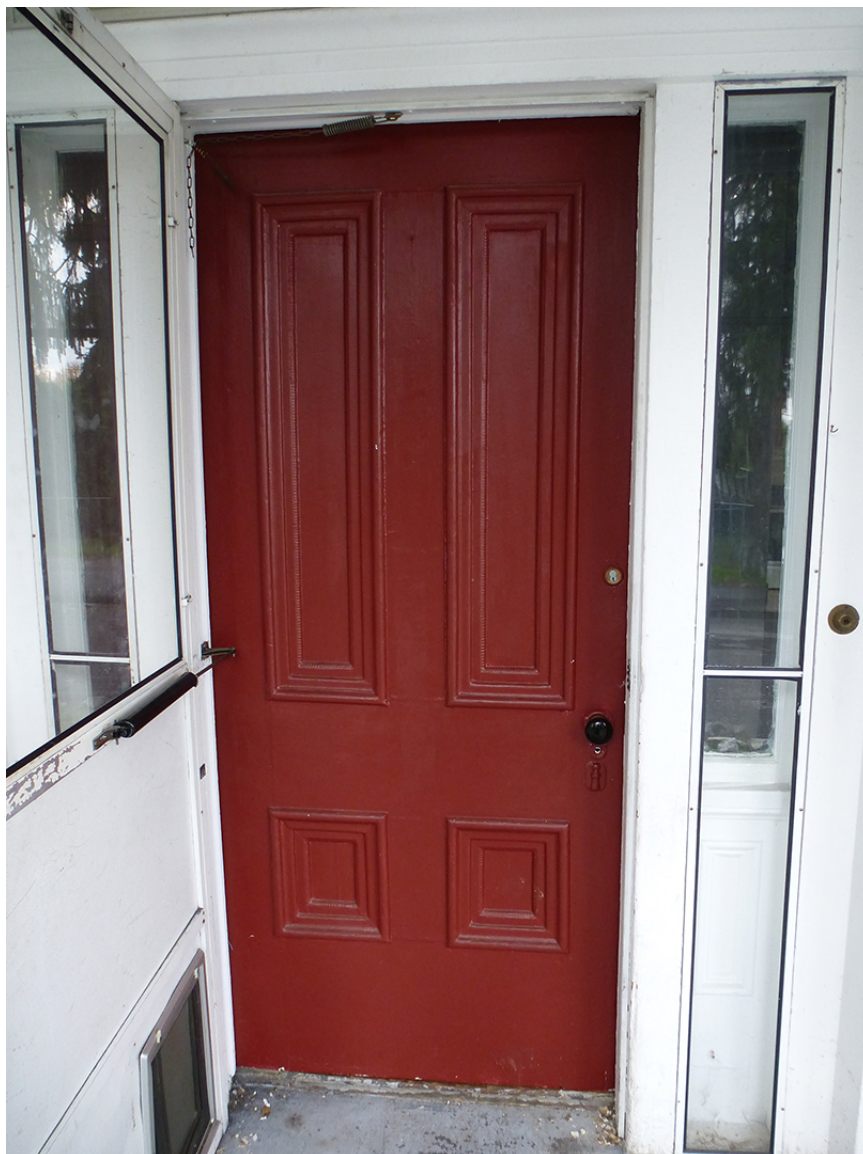
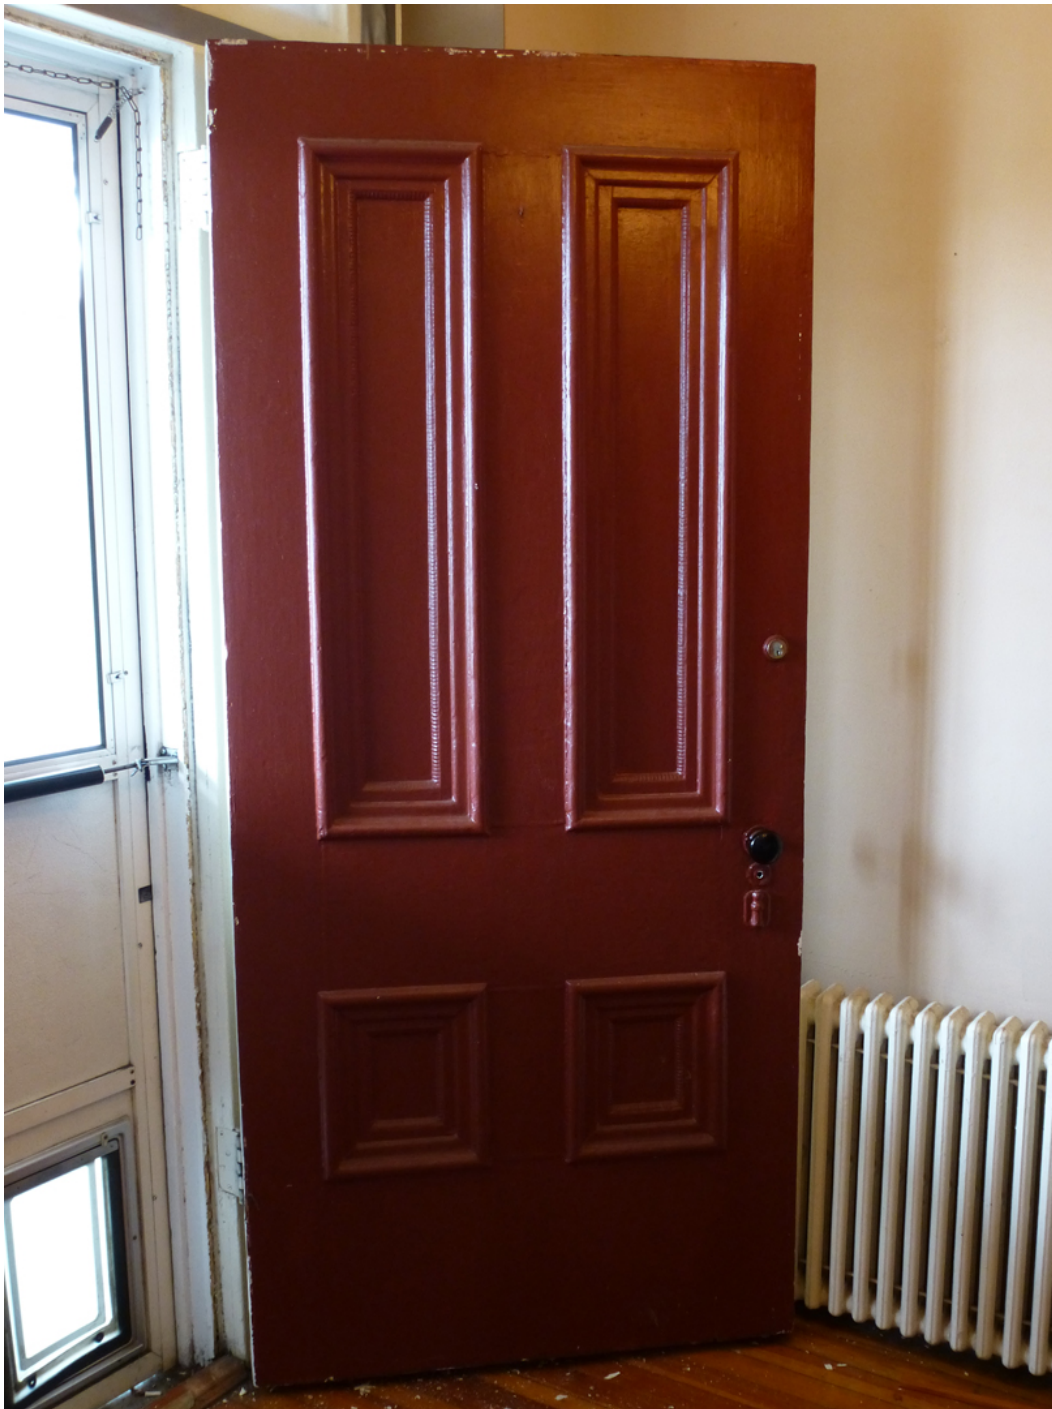
The front door is a single four-panel door that opens into the foyer. It appears that it has its original hardware. It has two sidelights. The front door has a storm door, and each sidelight has storm windows (Figure 20 and Figure 21).

Figure 20. Front door in 2012 with sidelights (ERDC-CERL, 2012).

Figure 21. Front door (ERDC-CERL, 2012).

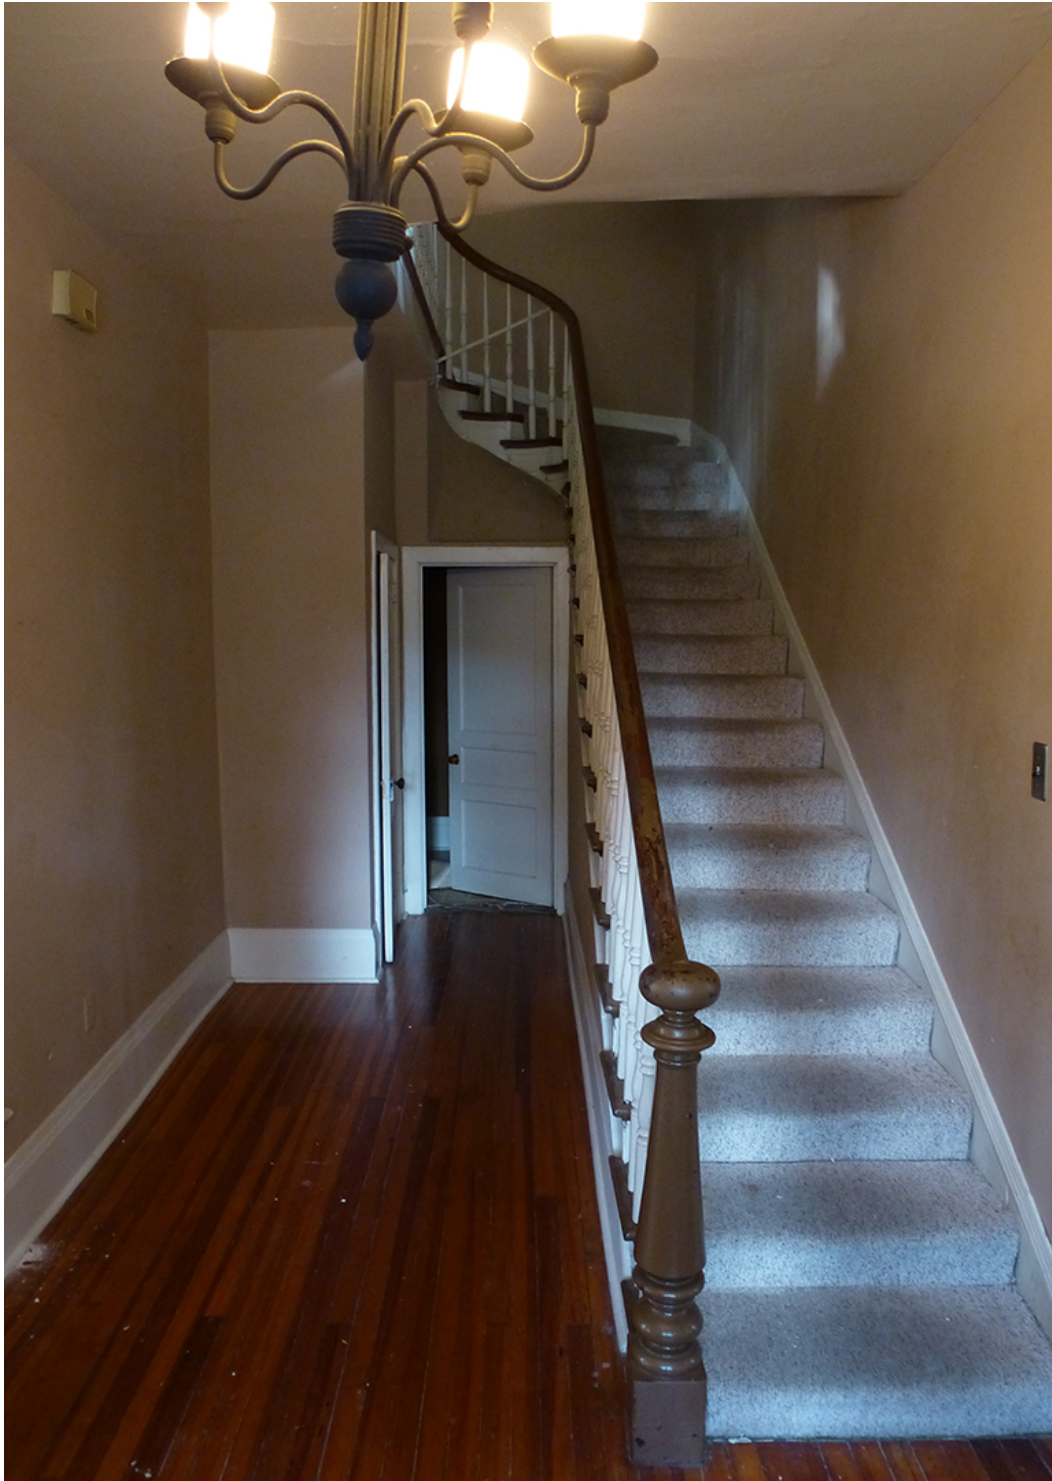
the house are covered in modern drywall. Typically in a house of this era with an ell, there should be an opening in the foyer into the rooms of the ell. It is unknown when such an opening was covered. The light fixture is not original.

Figure 22. Foyer showing staircase (ERDC-CERL, 2012).

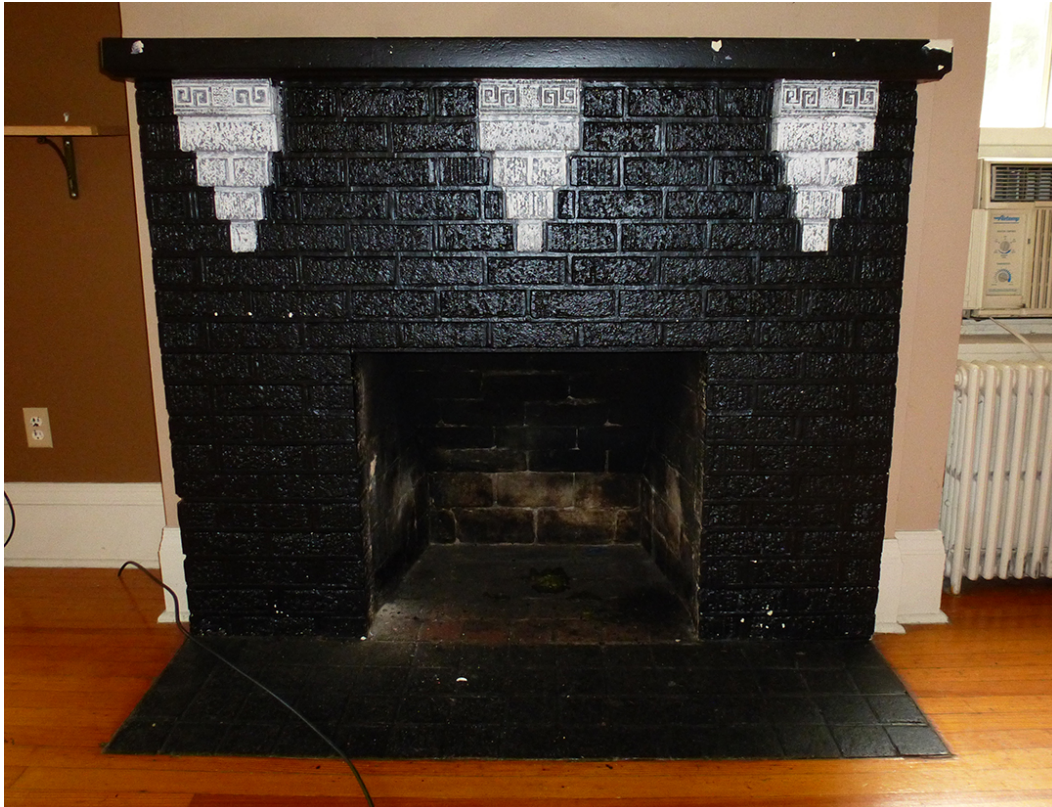
The living room is to the left of the foyer. It is a large open space with a brick fireplace. From the details of the fireplace (Figure 23), it is not original to the house nor probably from the period of significance. As in the rest of the house, the original plaster walls are covered in modern drywall.

Figure 23. Living room fireplace surround (ERDC-CERL, 2012).

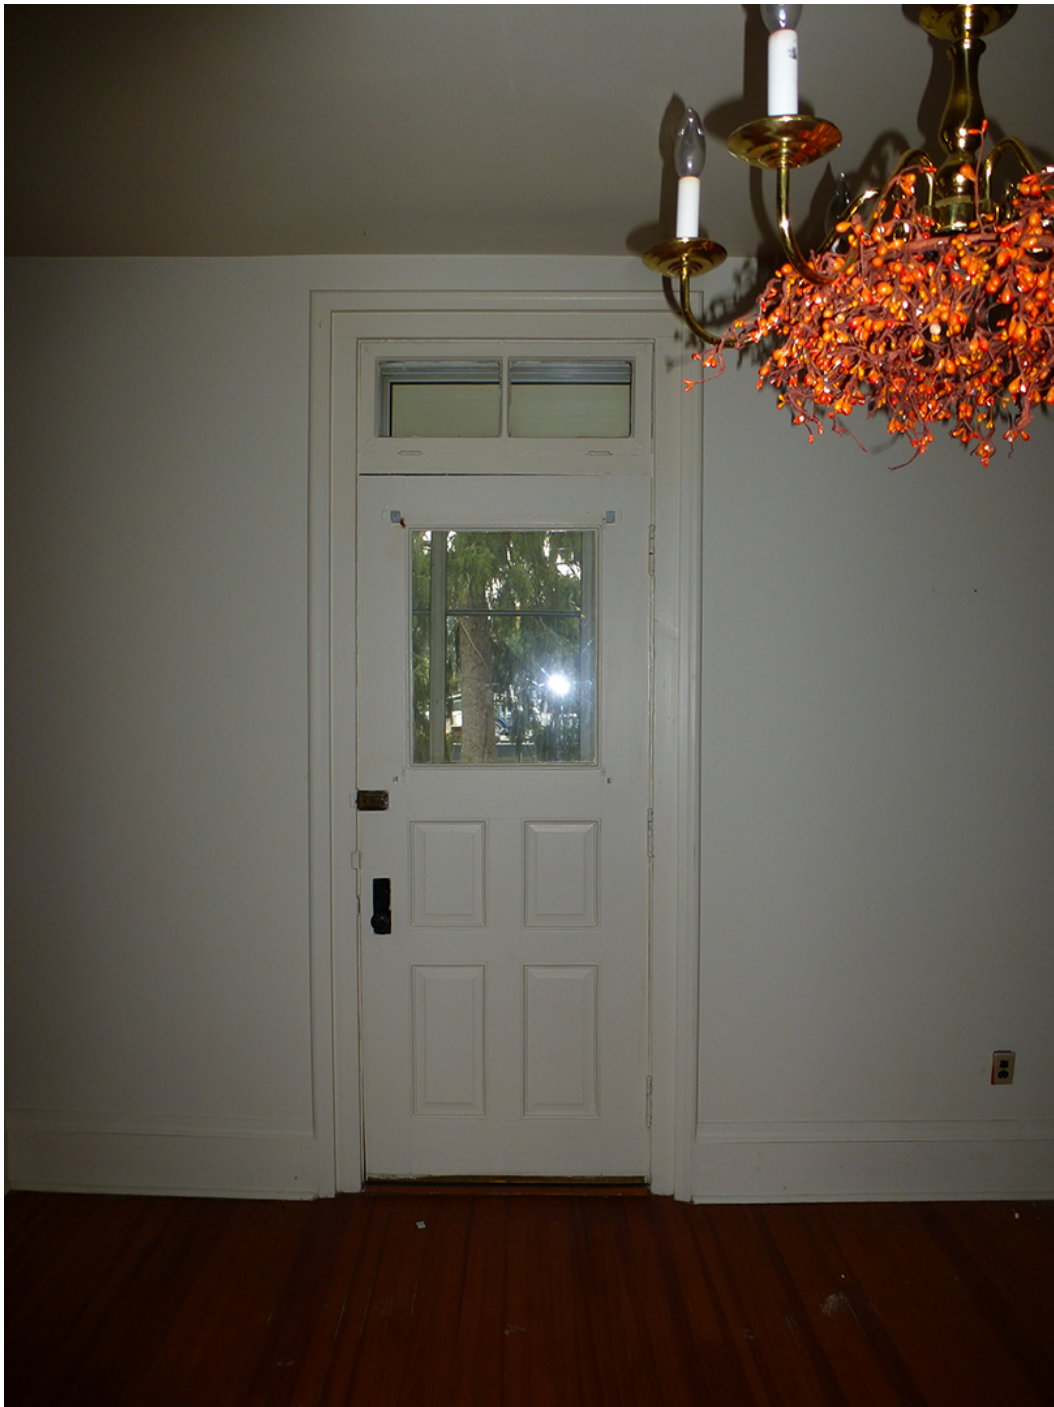
The dining room is located to the right of the foyer (Figure 24). It is unknown if the door from the dining room out to the front porch is original or if it dates to the period of significance. Typically, dining rooms from this era would not have an exterior door. The light fixture is not original.

Figure 24. Dining room (ERDC-CERL, 2012).

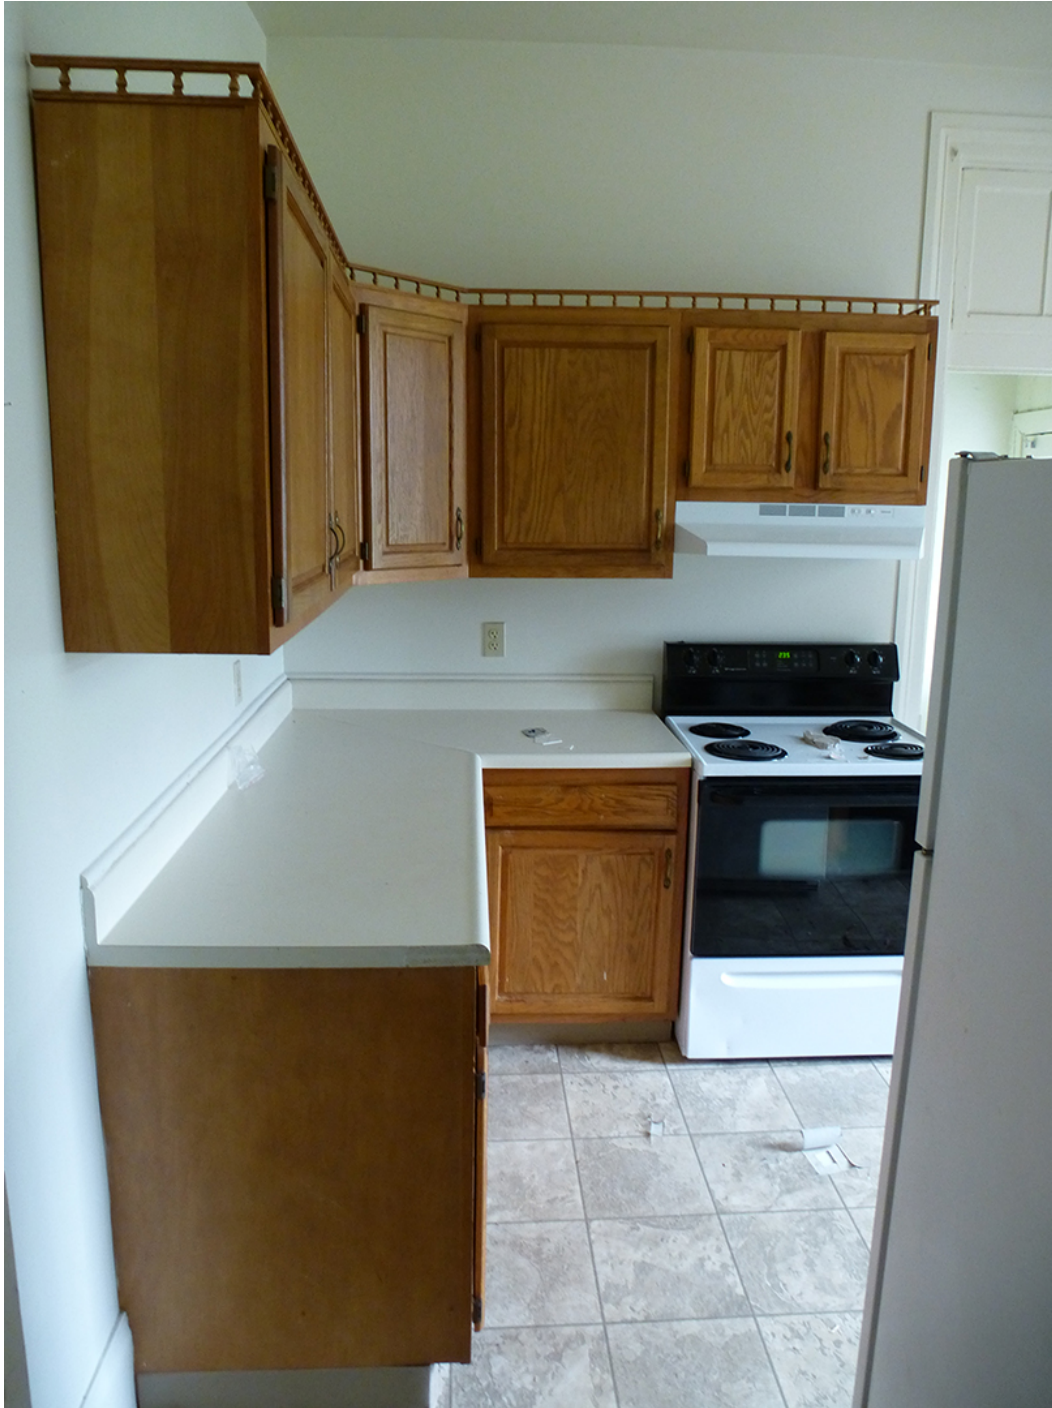
Figure 25. Kitchen (ERDC-CERL, 2012).

The kitchen is to the rear of the dining room. Its space and fixtures are not original nor do they date to the period of significance (Figure 25). It could not be determined from the architectural investigation what the use of this

room was originally; it possibly could have been part of a larger dining room or was a butler's pantry.

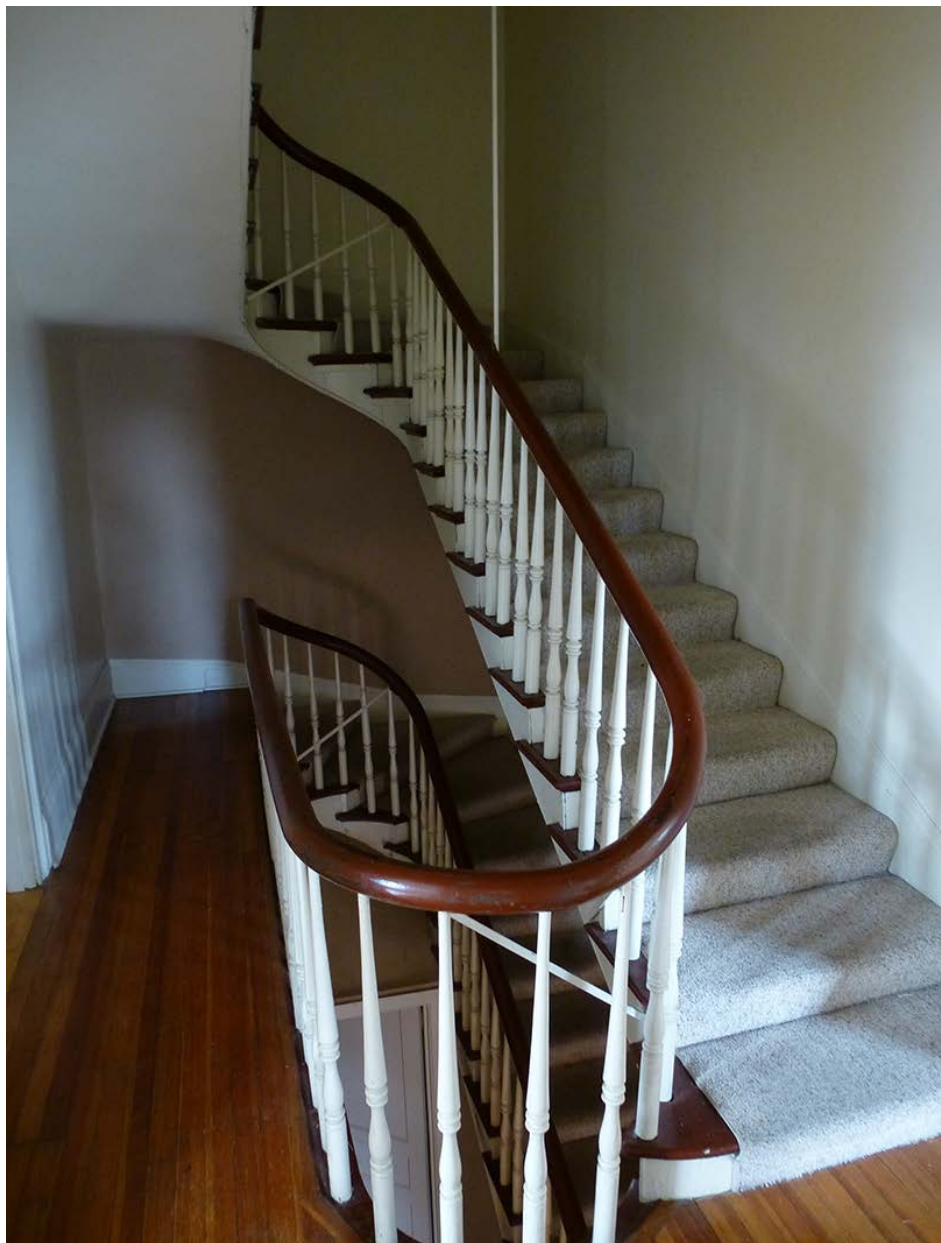
The second floor has a hallway and stairs that proceed up to the attic level (Figure 26). The second floor contains a large bedroom (Figure 27), two smaller bedrooms (Figure 28), and a bathroom (Figure 29). All walls are covered with modern drywall. The bathroom probably dates to after the period of significance when the doorway was converted to a window by the Army, but the fixtures are not more than twenty years old. The items that do date to the period of significance are the banister and balusters of the staircase.

Figure 26. Second-floor hall detailing original banister and balusters (ERDC-CERL, 2012).

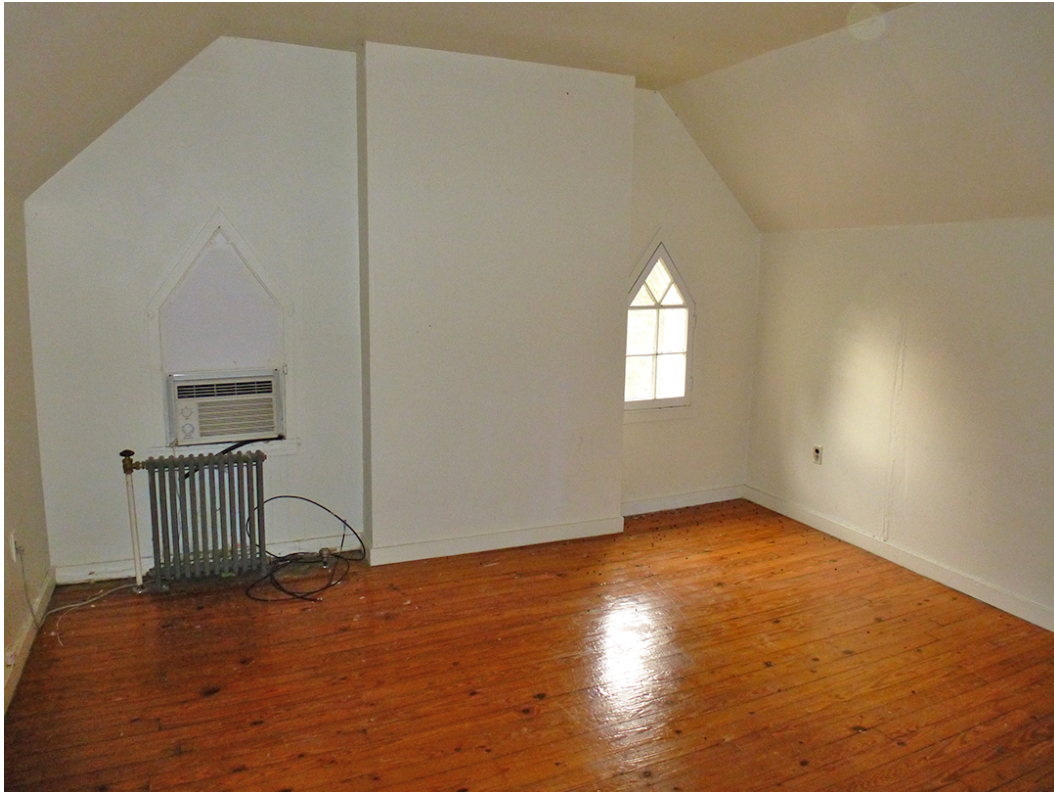
Figure 31. Attic-level bedroom, south side of duplex (ERDC-CERL, 2012).

The attic level has a hallway (Figure 30) that accesses the top of the stairs, a large bedroom (Figure 31), a bathroom, and a large unfinished storage room (Figure 32) that has access to the attic above the ell. Nothing dates to the period of significance.

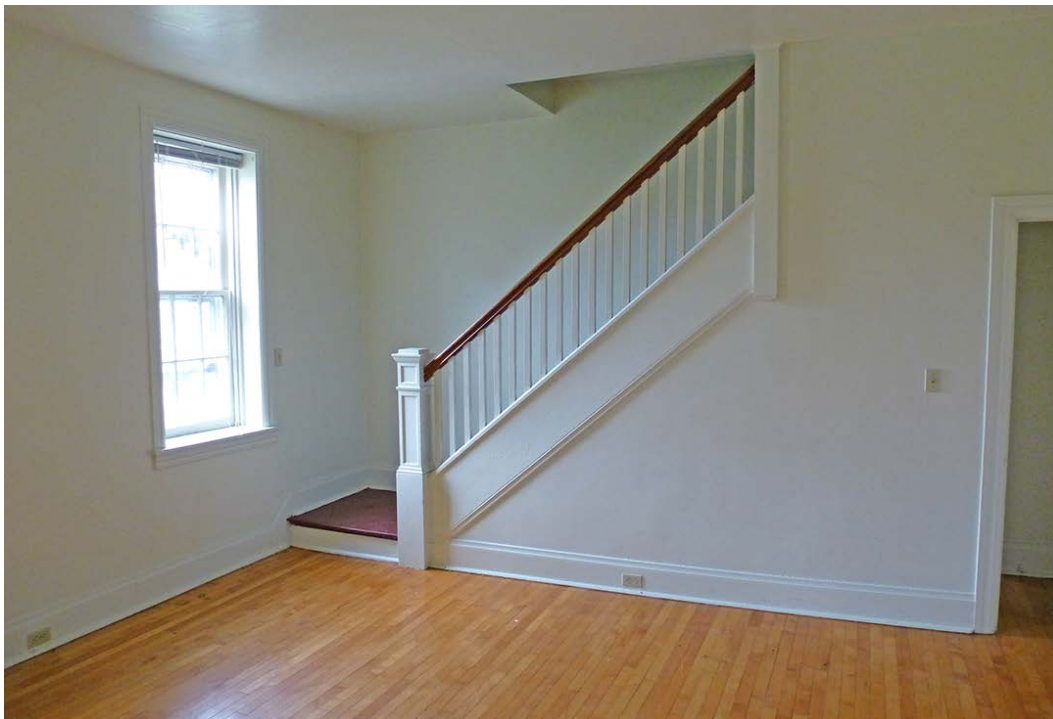
Figure 33. Living room in the ell and stairs providing access to second floor (ERDC-CERL, 2012).

A door from the south porch directly accesses the first-floor living room (Figure 33). There is no foyer in the ell. The living room has wood floors and wood casework. A stair provides access to the second floor (Figure 34). As in the southern portion of the building, all of the original plaster walls have been covered over with modern drywall. From the architectural investigation, nothing in this part of the building dates to the period of significance.

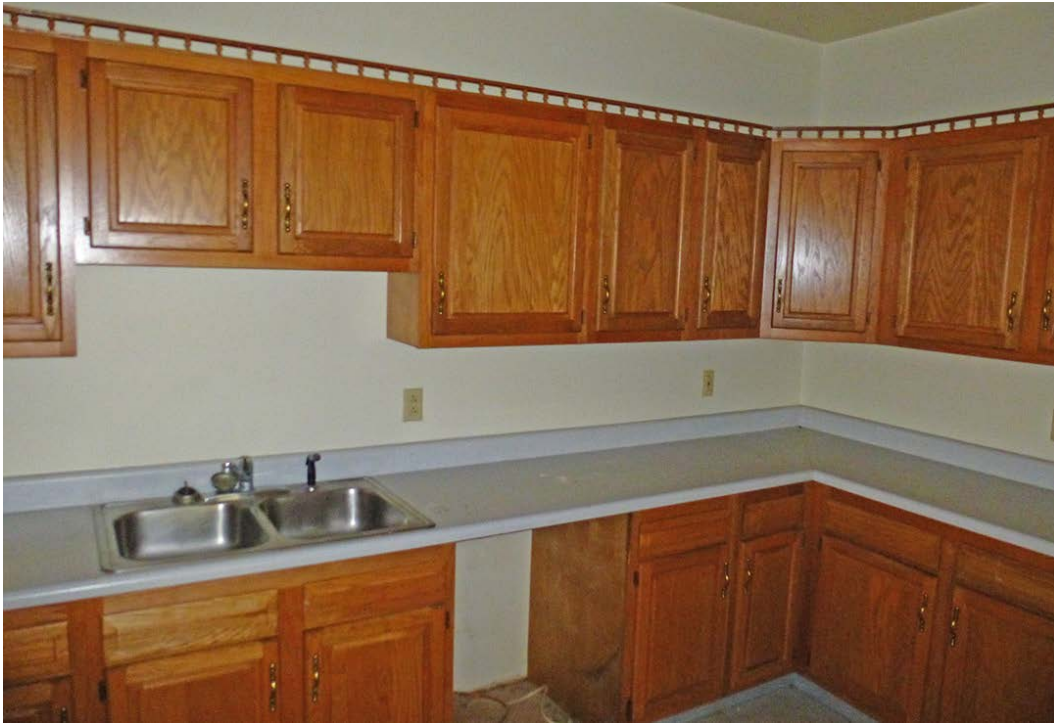
Figure 36. Kitchen in the ell (ERDC-CERL, 2012).

The kitchen is a small room between the north porch and the dining room (Figure 36). A door accesses a small hall that has a door to the basement and door out onto the north porch (Figure 37). It is more than likely that the kitchen and the adjoining dining room were together as the original kitchen of the house during the period of significance.

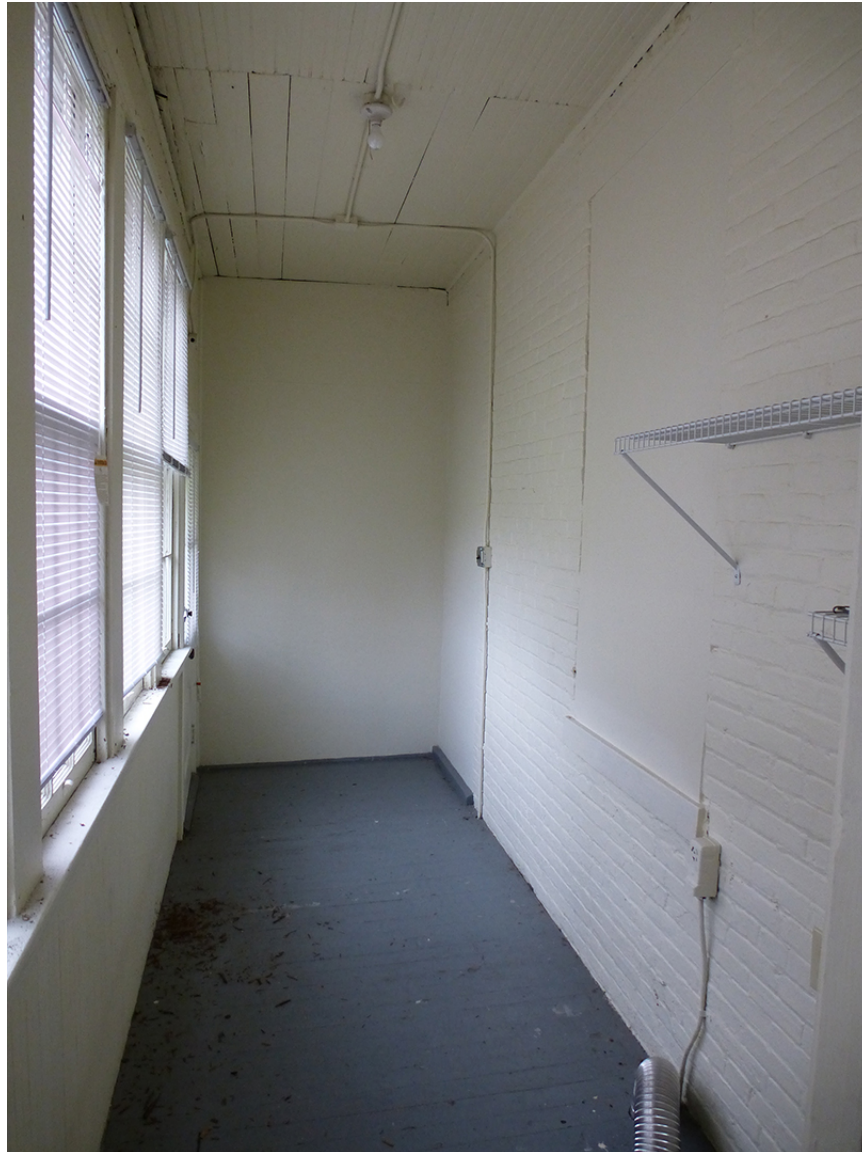
The back porch appears to date to the period of significance (Figure 38). An ell with two porches is a typical feature of Victorian-era houses in the region. Part of the porch is now utilized for a washer and dryer, while another part has been turned into a bathroom (Figure 39) that does not date to the period of significance.

Figure 38. North porch of the ell (ERDC-CERL, 2012).

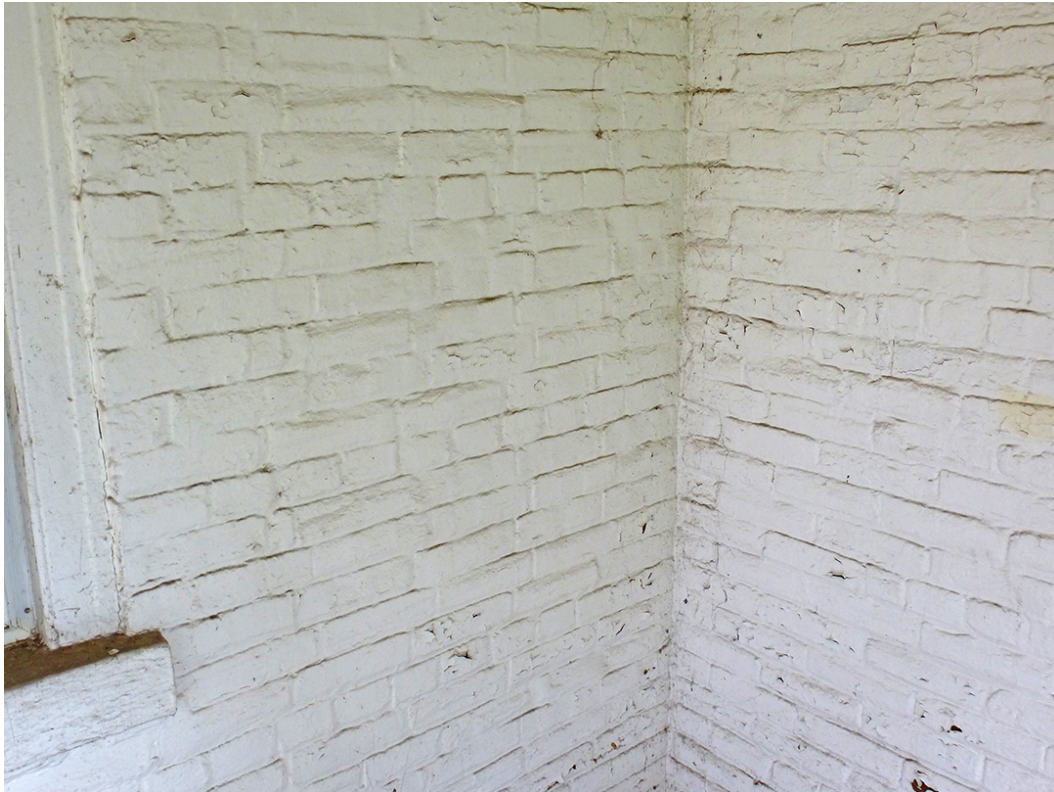
The workmanship of Building 839 is evident in the mortar joints of the brick walls (Figure 53), the rake boards (Figure 54–Figure 56), the front door (Figure 57), and the construction of the interior staircase on the southern (main) portion of the house (Figure 58). At some point, the original front porch was replaced with more stripped-down structural supports and also screened in (Figure 59).

Figure 53. Detail of the brickwork and mortar joints (ERDC-CERL, 2012).

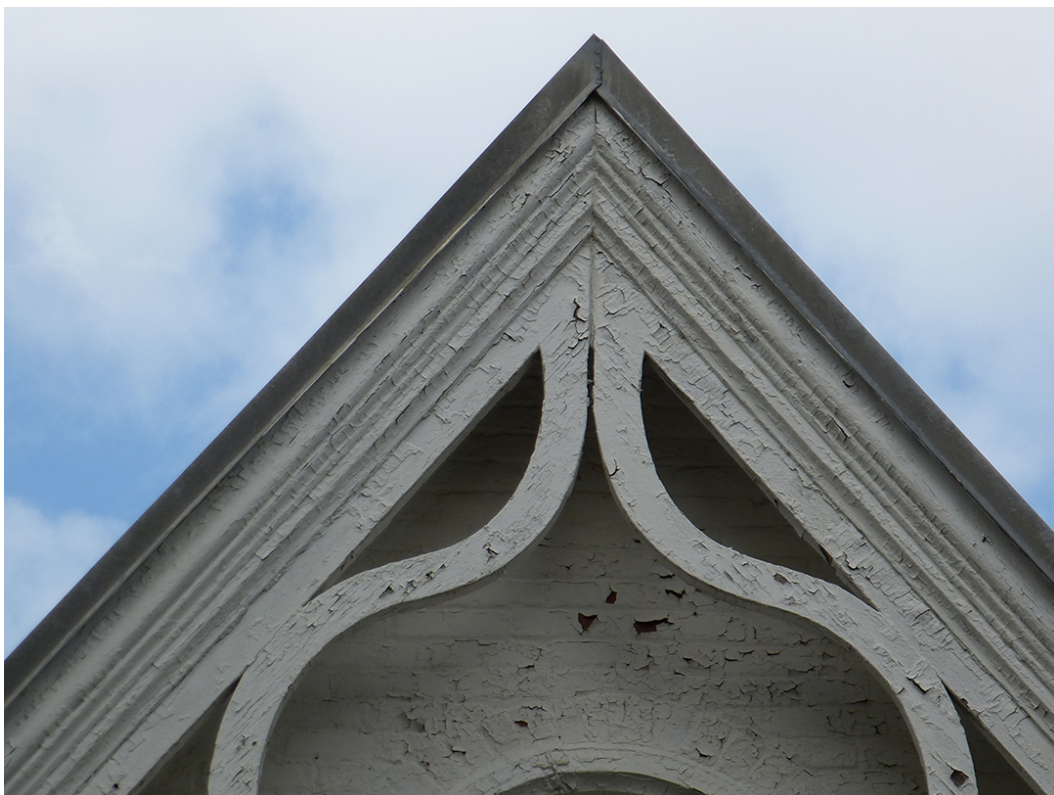
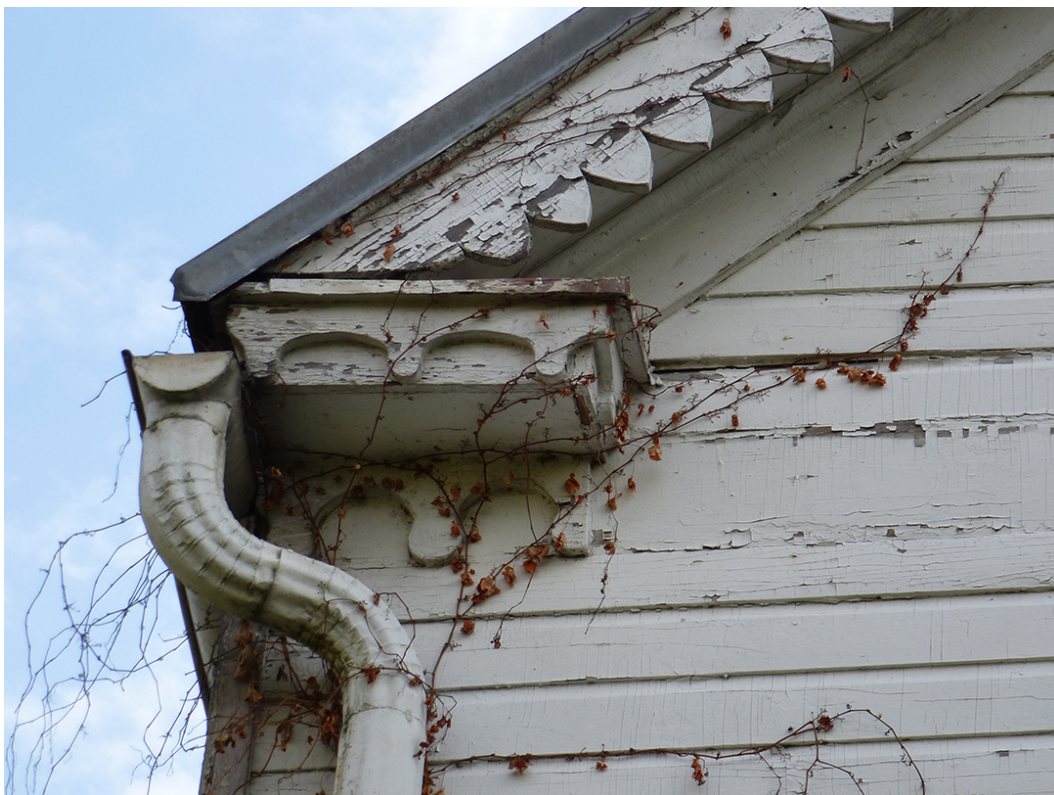
Figure 54. Detail of the rake boards on the front gable (ERDC-CERL, 2012).

Figure 56. Detail of the rake boards on the ell gable (ERDC-CERL, 2012).

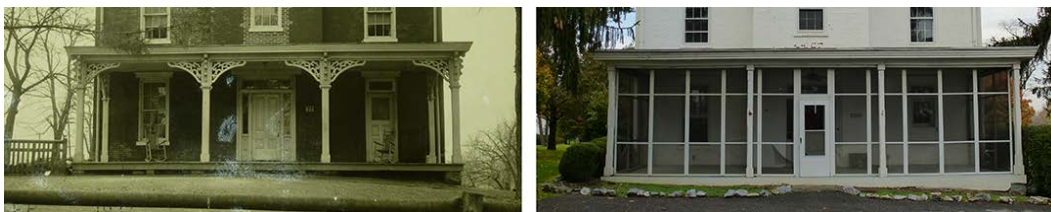
Figure 59. A comparison of the front porch from the 1920s (NARA) to present-day (ERDC-CERL, 2012).
