**U.S. DEPARTMENT OF DEFENSE  
Environmental Security Technology Certification  
Program (ESTCP)**

**Final Report**

**Electrospark Deposition for Depot- and  
Field-Level Component Repair and  
Replacement of Hard Chromium Plating**

**Project WP-0202**

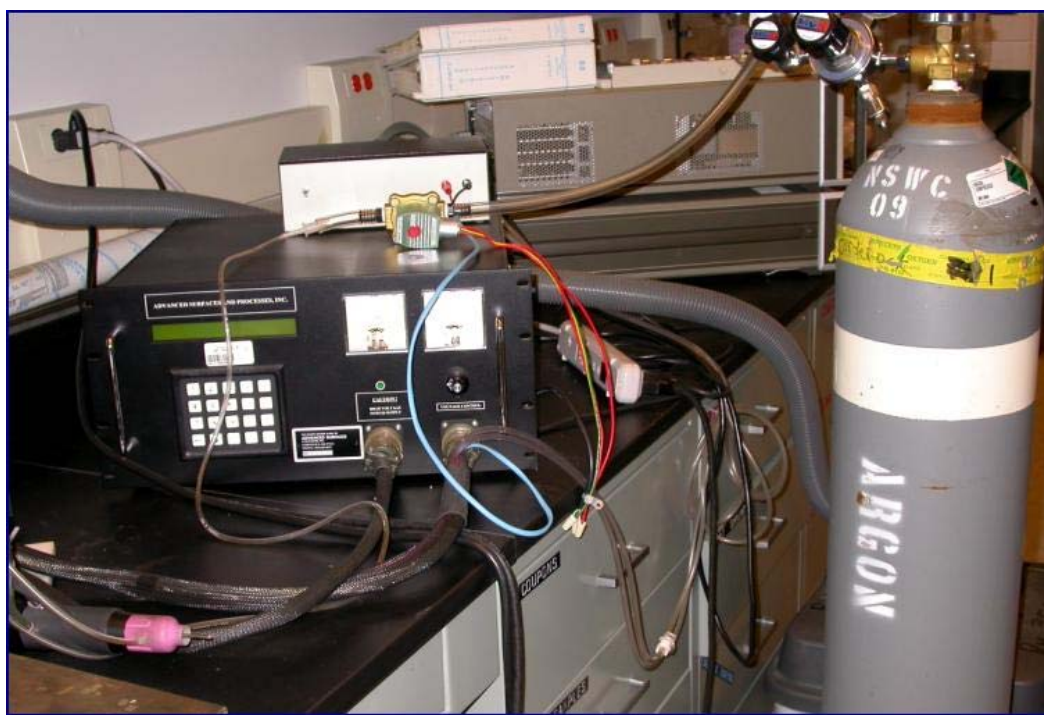
**Figure 6-4 ESD Equipment Located at NSWCCD Used for Materials Studies**

Electrospark depositions were performed using equipment located at NSWCCD (shown in Figure 6-4), which was acquired from ASAP, Inc. Initially nitrogen was used as a cover gas to prevent oxidation of the deposited material but this was later changed to argon. Figure 6-5 shows application of an ESD coating to a test coupon with a low-power microscope positioned to examine the deposit and the image displayed on a monitor.
