# Propeller Component Project Update

**Robert Kestler**  
**Materials Engineer-Inorganic Coatings**  
**Naval Air Depot Cherry Point, NC**

| Report Documentation Page | | | | Form Approved<br>OMB No. 0704-0188 | |
|---|---|---|---|---|---|
| 13. SUPPLEMENTARY NOTES<br><b>24th Replacement of Hard Chrome Plating Program Review Meeting, July 20-21, 2004, Park City, UT.<br/>Sponsored by SERDP/ESTCP.</b> | | | | | |

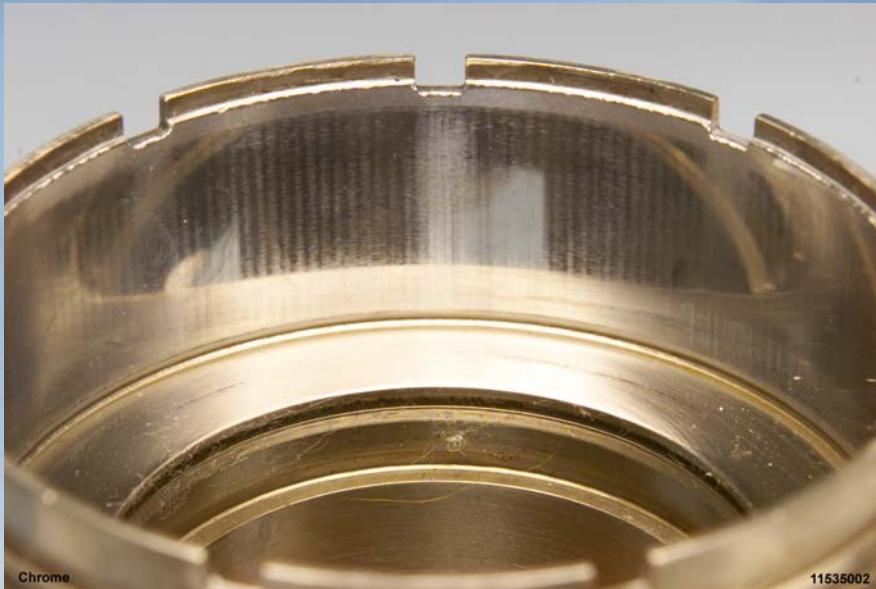
## Lever Support Sleeve

Cr-Plated LPSLS

- **Cylinder Appearance**
  - **Chrome Plate - Appearance of wear on chrome plate but no significant adhesive wear or scoring**
  - **WC-17Co - Appears untouched**
- **Piston Ring Appearance**
  - **Chrome plate - Signs of use but no substantial wear**
  - **WC-17Co - Signs of use but no substantial wear**

- **Quantitative Results**
  - **Cr-Plate Surface Finish 2.7 Ra at start, 1.4 Ra at completion**
  - **WC-Co Surface Finish 7.2 Ra at start, 7.2 Ra at completion**
  - **Ring weight loss 3 times higher with Cr plated bore**

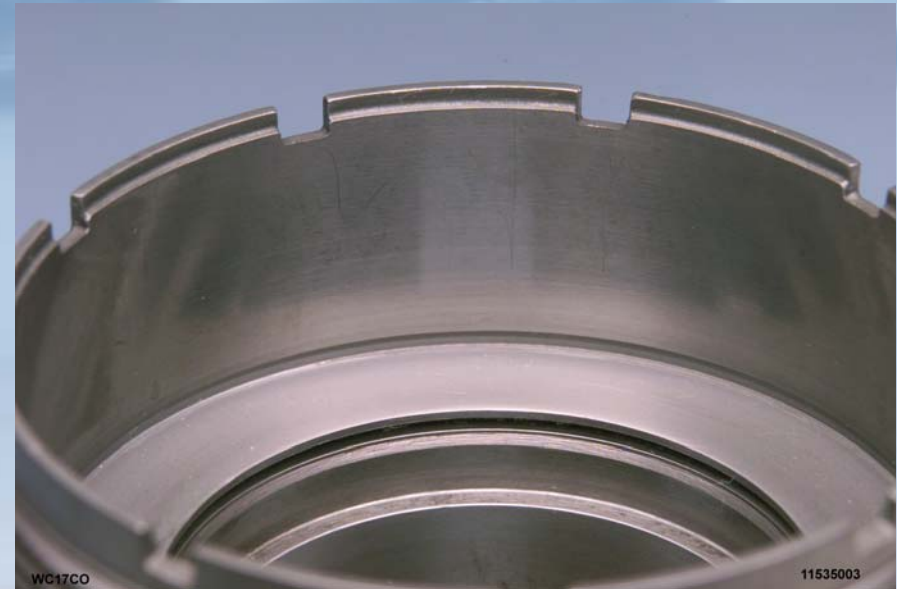
WC-Co Coated LPSLS
