0203 DCIEM (REPORT NO. -850)

04a HUMAN FACTORS EVALUATION OF  
- THE ARGUS (CP-107) AIRCRAFT (U)

DEFENCE AND CIVIL INSTITUTE OF ENVIRONMENTAL MEDICINE,  
1133 Sheppard Avenue West, P.O. Box 2000

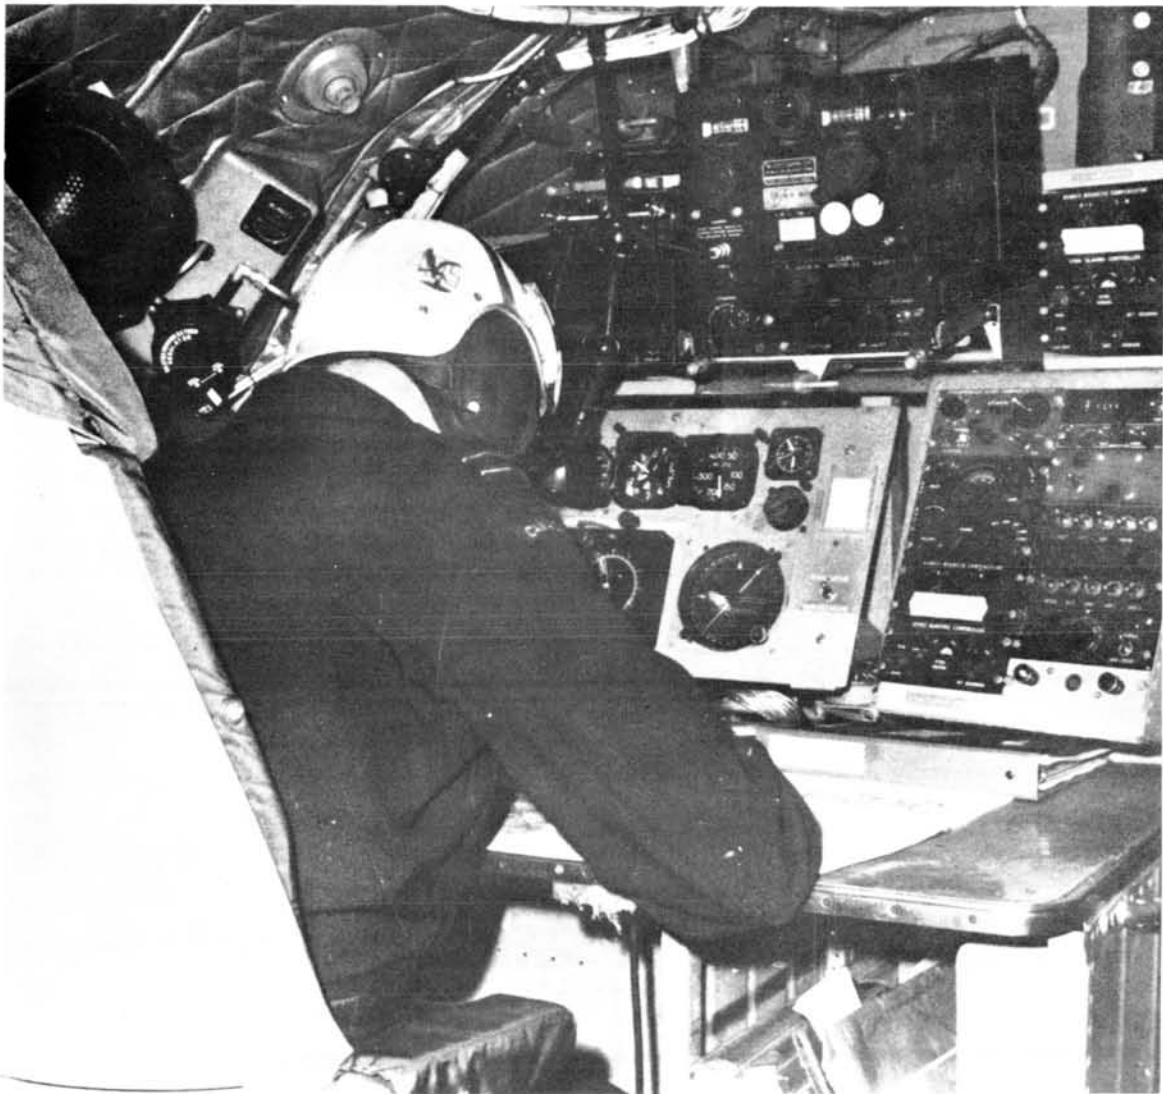
obscures a number of displays (see Figure 3). Legibility of some dials is extremely poor and additional information is required to eliminate dependence on the Pilot or Tactical Navigator. Grouping of equipment by function is substandard, there are far too many manual controls, and some controls are susceptible to accidental switching. The capabilities of the instrumentation do not appear adequately matched to the aircraft's present role. Some personal equipment, particularly the helmet, are sources of discomfort in the Navigator's working posture.

*Figure 3. The lamp obscures displays and controls at the turbine navigator's station.*

Short-term improvements are not really the answer to the inadequacies of this station. It would be possible to realign the main displays and controls more closely at right angles to the line of sight, position them within easier reach and provide them with individual, glare-free sources of illumination. However, there would probably be minimal gain from these efforts, unless attention was also given to improvements in seat design and in environmental conditions of noise, vibration and temperature.

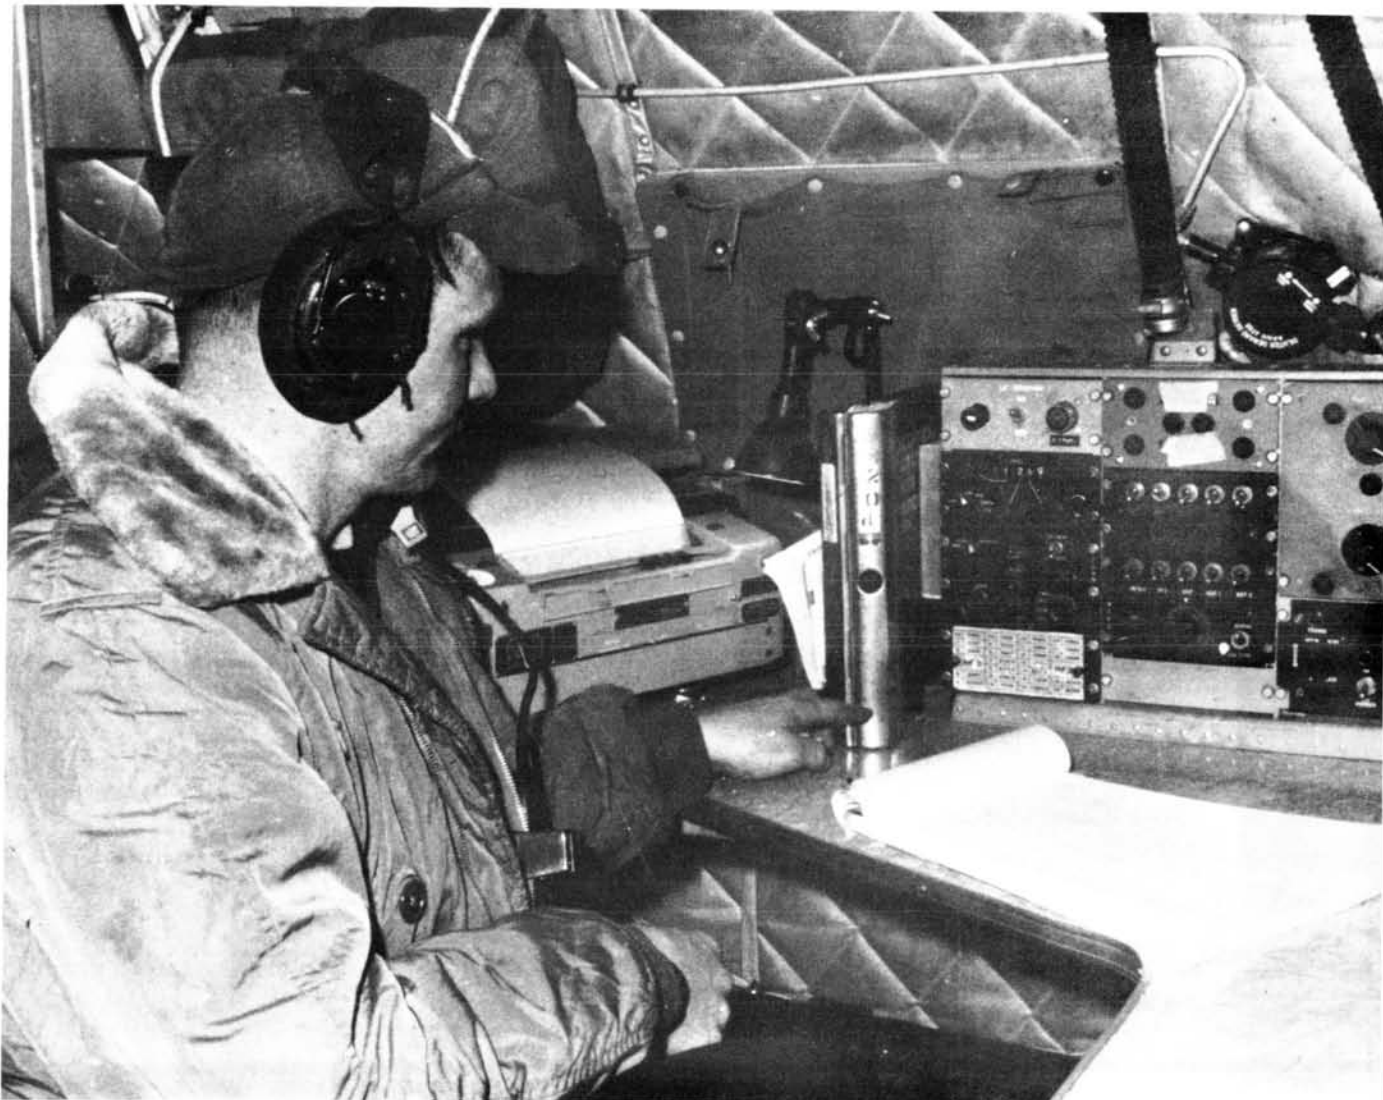
*Figure 5. Displays and controls extend beyond easy reach at the radio operator's station.*

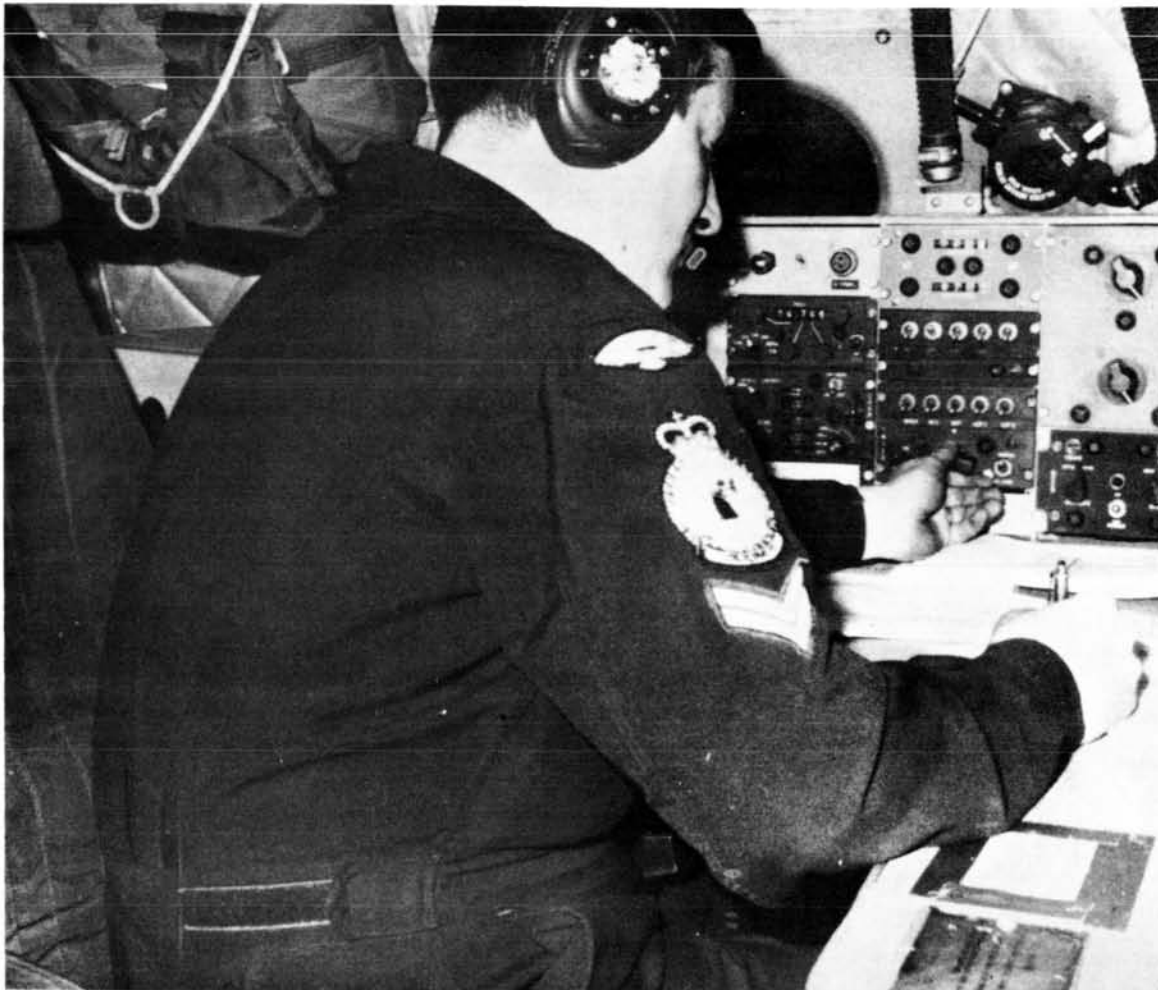
*Figure 6. The L-shaped layout of the radio operator's station imposes a tiring posture.*

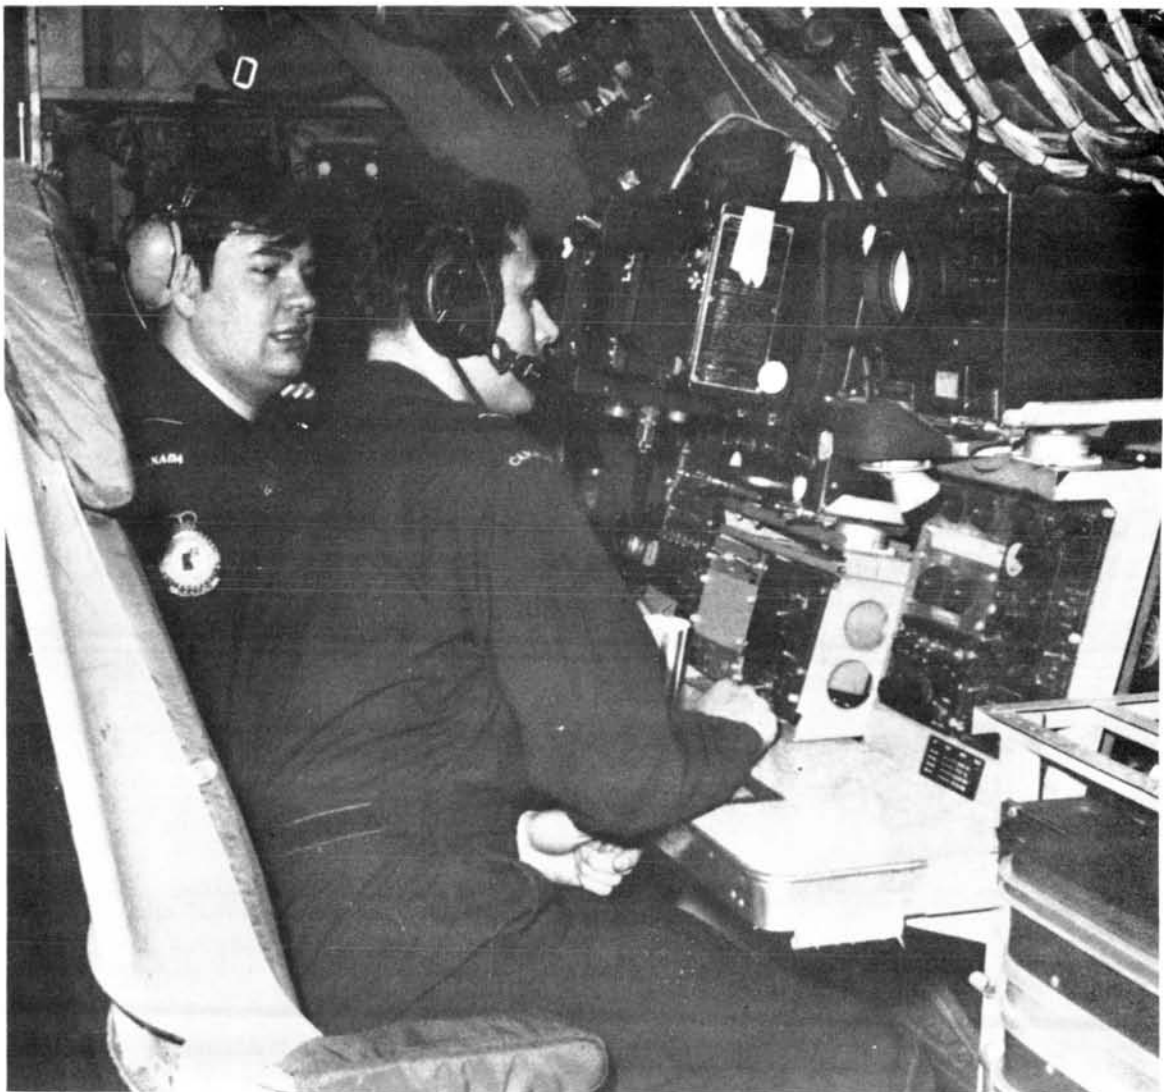
The outstandingly bad feature of this station is the positioning of the main displays. Even with the seat adjusted to its highest position, there is a 33-inch difference in height between the depressed seat cushion and the centre of the APA 69A. Data presented by Woodson and Conover (1966, Table 5-17) indicate that 95% of the male population would need to look *up* at this display, a fatiguing posture to maintain for long periods, especially when wearing the Gentex helmet. Figure 8 illustrates the point and also shows the awkward positioning of the KD2 camera. Figure 9 emphasises both points, but illustrates, in particular, the extremely tiring posture it is necessary to assume when checking the APA74 analysis scope. Controls are badly positioned for reliable operation during visual monitoring of the displays and the probability of accidentally operating the wrong control seems high. Little confidence was expressed in the detection capability of the equipment, because of its narrow bandwidth. Workspace is limited. Some operators experience difficulty in orienting themselves with respect to the display datum, rather than to aircraft heading, in this sideways-facing position. The combination of a side-facing position with a task which requires gross head and eye movements is also conducive to motion sickness (see Section V). The high levels of noise and vibration, and the large vertical temperature gradient, cause discomfort here (as at most other stations).

*Figure 8. The main displays of the ECM operators are too high for comfortable monitoring over long periods.*

vertically and in side elevation, and the upper display centred no higher than 33 inches above the level of a maximally extended seat. This modification would require relocation of controls on either side of the displays. It may also require the displays and controls of the other position to be comparably laid out, to prevent confusion. Attention should be given to shape-coding the presently identical control knobs, to facilitate selection while the operator is viewing the display. Obsolete equipment should be removed from the station.

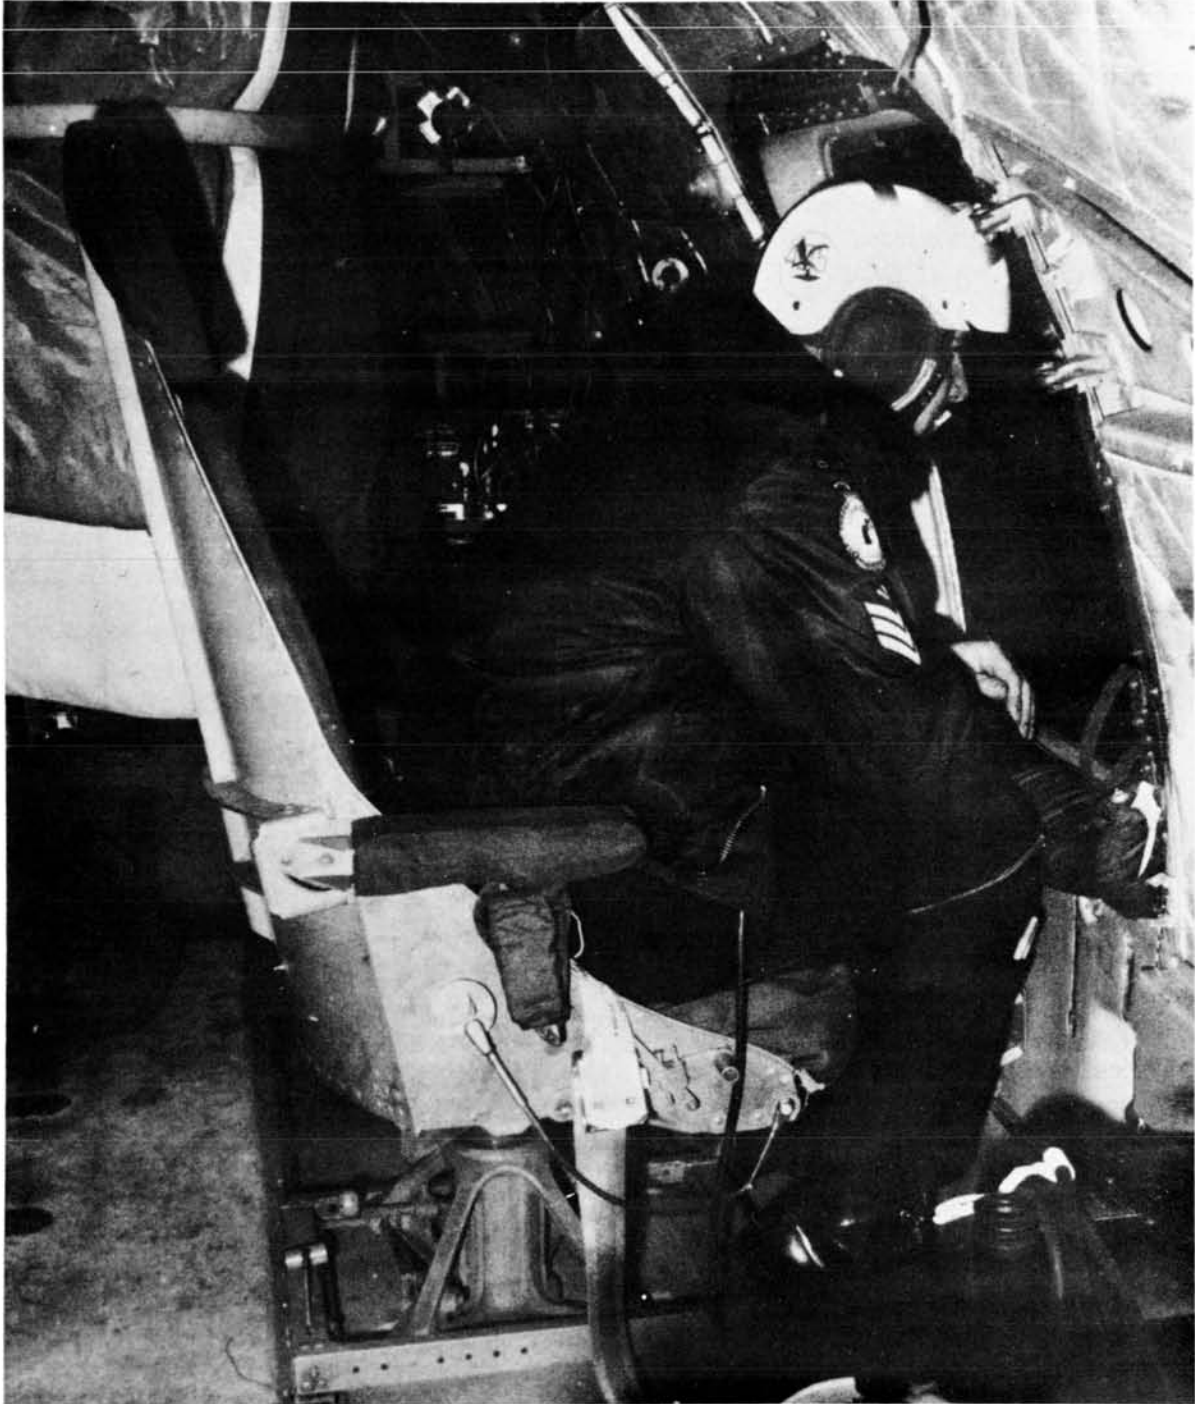
*Figure 11. There is inadequate foot-space for the beam observers.*

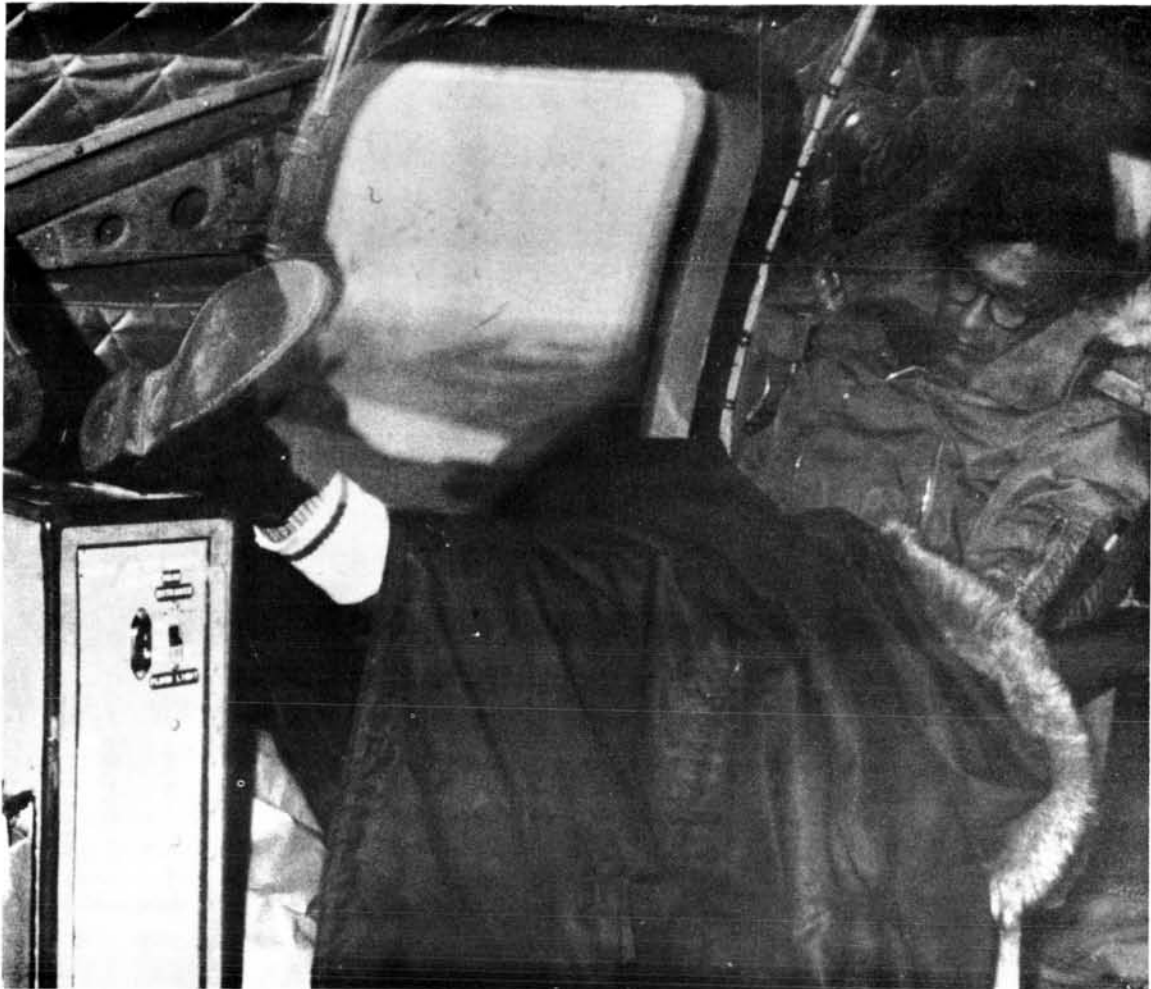
*Figure 18. Additional ground crew attempt to relax in the beam search station seats.*

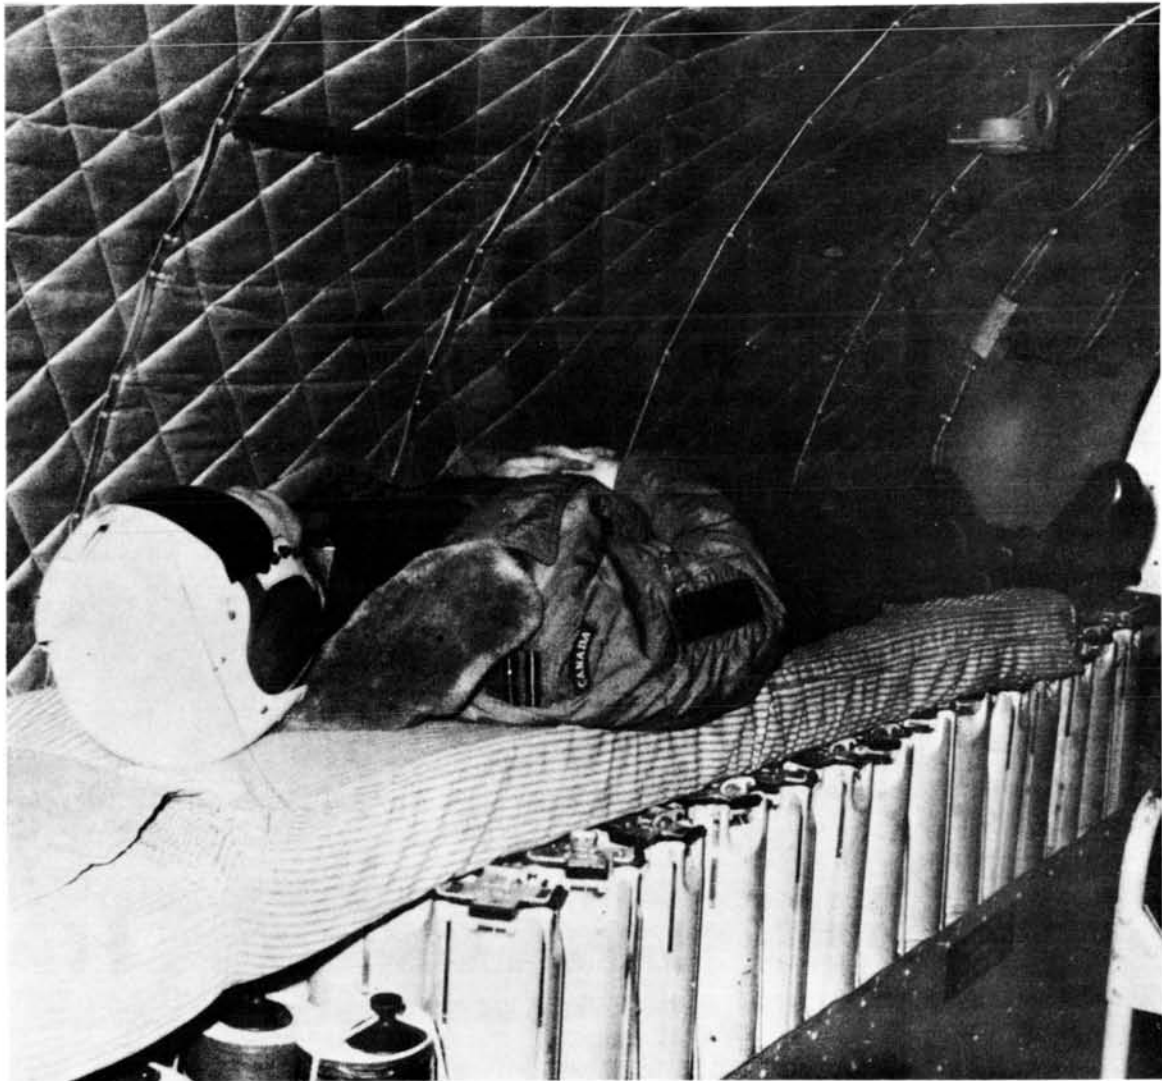
*Figure 17. Additional sleeping facilities are provided by throwing spare mattresses over the aft sonobuoy storage.*

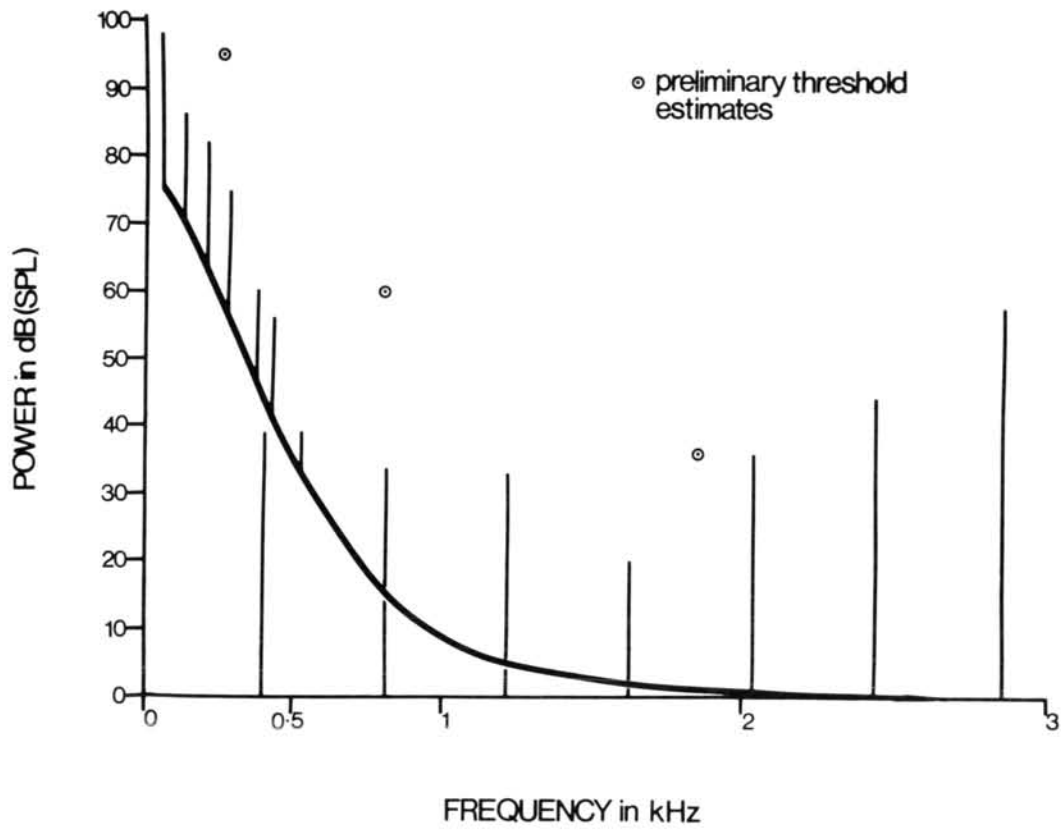
Figure 15. Estimated spectrum of the Argus aircraft noise at the observer's ear.

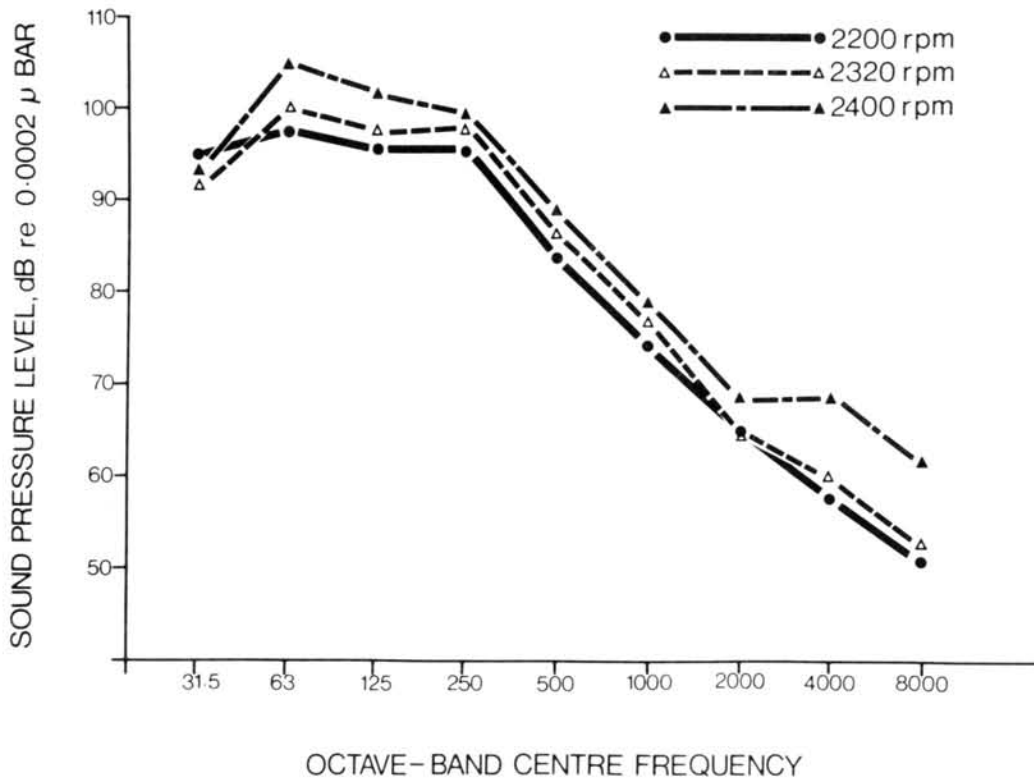
Figure 13. Octave-band sound pressure levels at the MAD Operator location in the Argus aircraft as a function of engine speed.

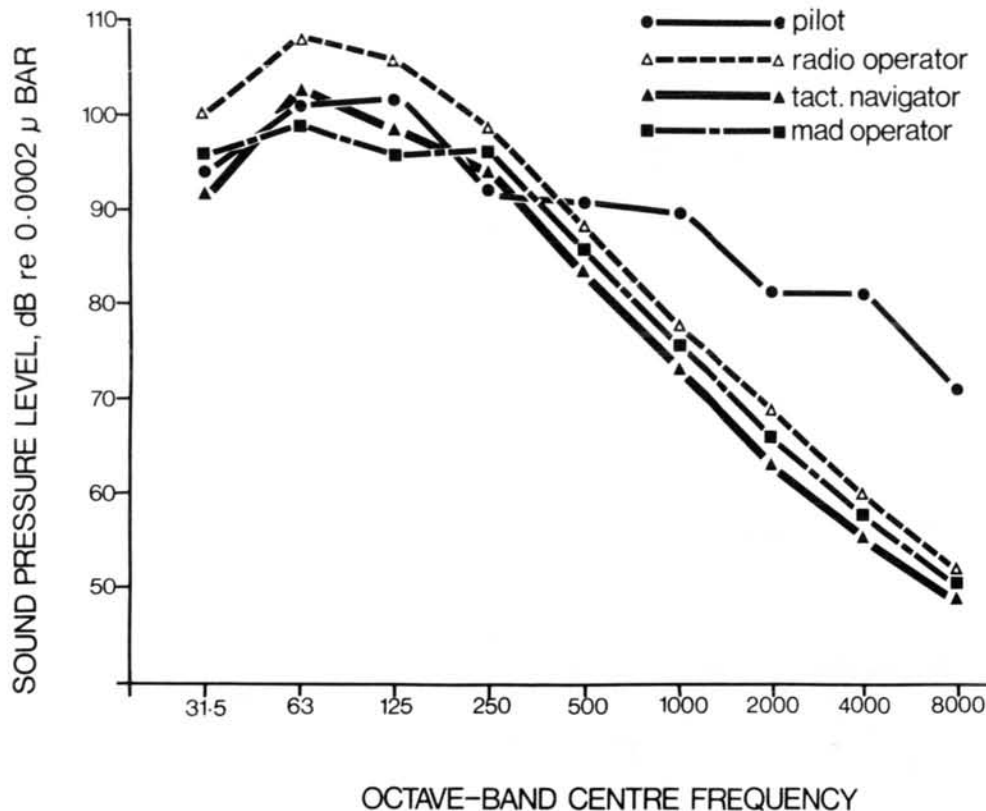
Figure 12. Octave-band sound pressure levels at four crew work locations in the Argus aircraft (engine speed = 2100-2200 rpm).
