## Cost and Performance Report

(CP-9503)

### Fury: Robotic In-Situ Inspection/Condition Assessment System for Underground Storage Tanks

August 1999

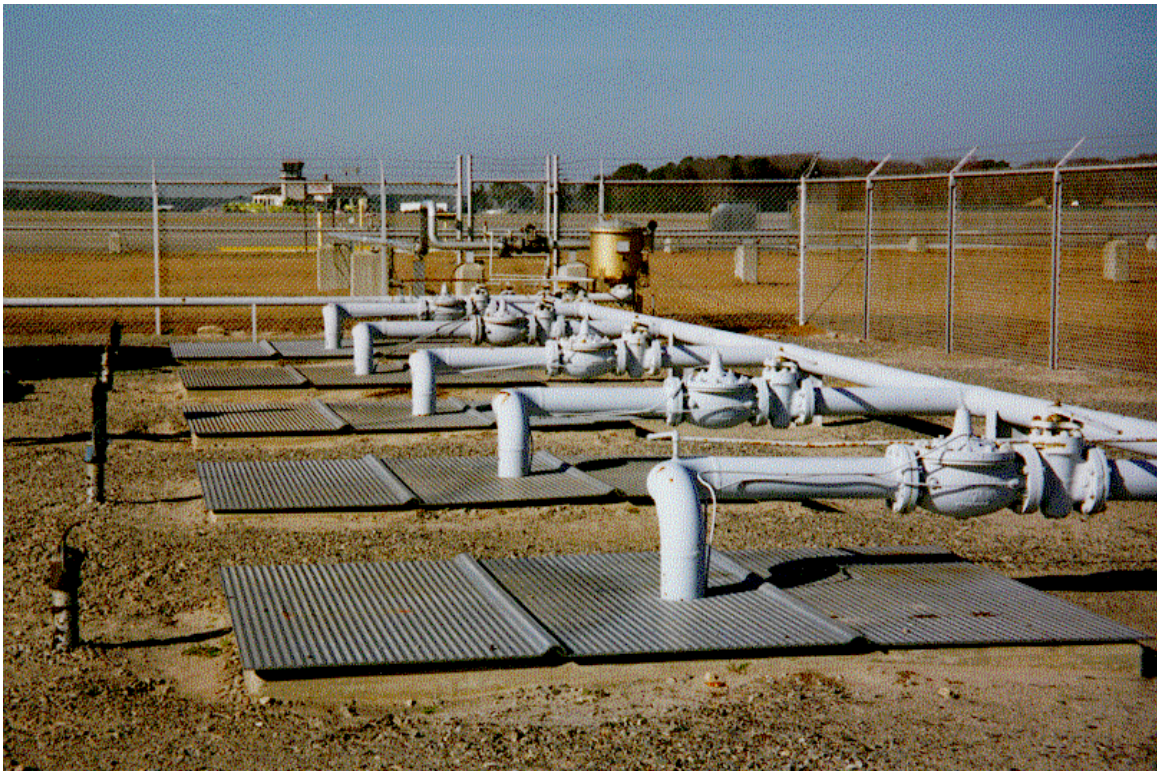
**Figure 2. Photograph of Hunter Army Airfield Underground Storage Tanks**

The second demonstration was conducted at the Hunter Army Air Field (a sub-installation of Ft. Stewart, GA) from February 18 to March 7, 1997. *Fury* performed the remote, *in-situ* assessment of the condition of three 50,000 gallon USTs (from a total of thirty-one 50,000 gal. USTs at the site) according to ASTM ES40-94 [5]. These tanks were thought to be in good condition based on the condition of some previously removed tanks. Each of the tanks was selected from three separate pump stations, each consisting of a bank of 10 tanks. Emphasis was on measurements on the bottom one-third of the tank (the most susceptible to pitting) in order to provide a conservative assessment.
