**NAVAL
POSTGRADUATE
SCHOOL**

THESIS

**DEVELOPMENT OF CARBON NANOTUBE-BASED SENSOR
TO MONITOR CRACK GROWTH IN CRACKED ALUMINUM
STRUCTURES UNDERNEATH COMPOSITE PATCHING**

June 2014

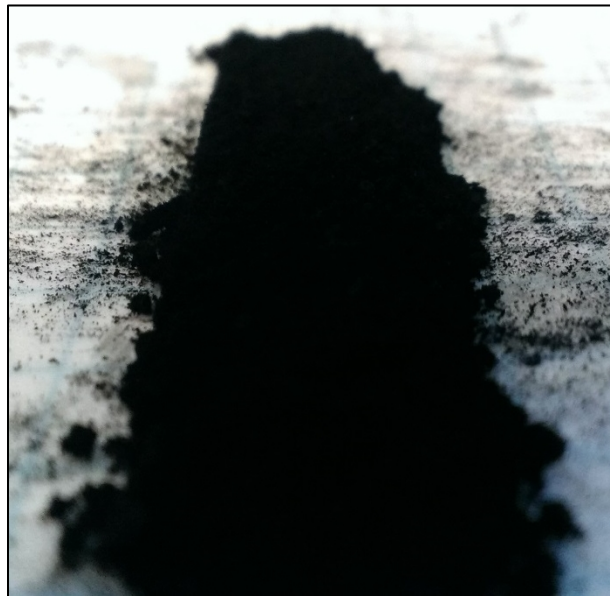
Figure 1. CNTs formed in a line two inches in length (top to bottom)

In order to measure the resistance between the two ends of CNTs, the current must travel through the CNTs. There must be a connection from one CNT to another,

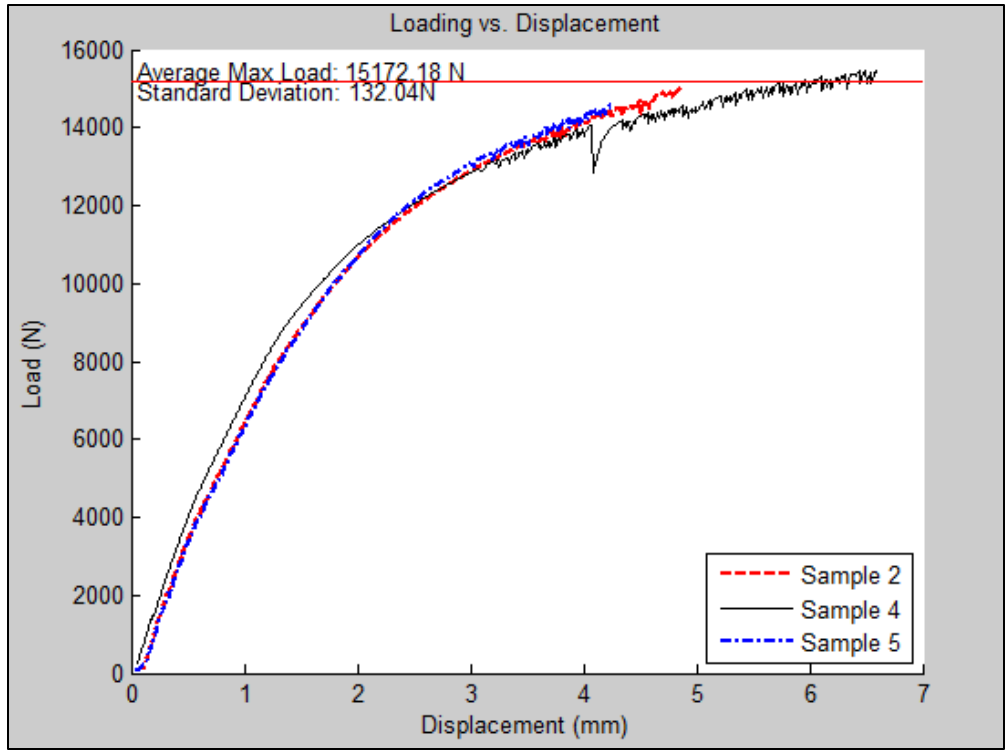
Figure 8 shows the loading versus displacement curves for 3 out of 5 samples tested with a composite patch attached to the aluminum. Similar to Figure 7, only three out of five samples were graphed as samples 2 and 5 matched graphically but were removed to prevent overcrowding of the figure. Sharp drops in loading can be seen in each sample near higher loads. This is due to delamination occurring at the ends of the samples at this higher loading. The delamination occurs suddenly causing a rapid drop in loading as shown by the downward drop of sample 4 in Figure 8. Figure 9 shows an image of sample 4 at the end where the delamination occurred.

Figure 8. Loading curves for composite samples

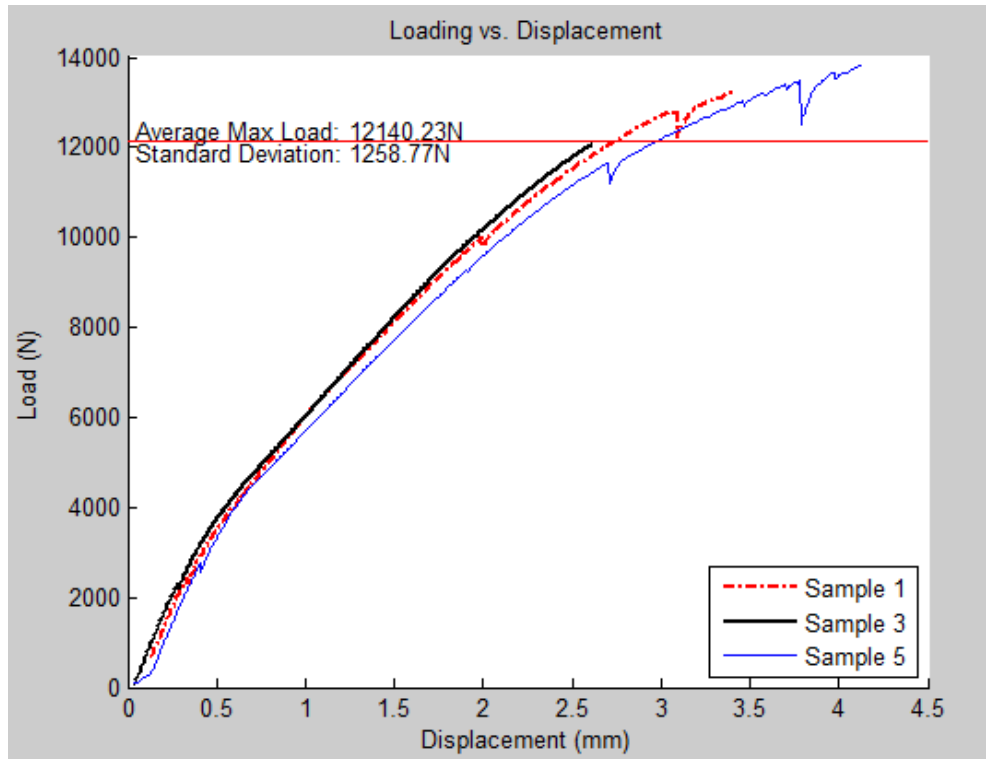
Figure 13 shows the loading versus displacement curves for 3 out of 5 samples tested with CNTs added to the composite patch attached to the aluminum. Similar to Figures 7 and 8, only three out of five samples were graphed as samples 2 and 4 matched graphically but were removed to prevent overcrowding of the figure. Similar to the composite samples shown in Figure 8 sharp drops in loading occurred due to rapid delamination at either the edges or near the pre-crack of the samples. This did not affect the samples near the crack location as there was no delamination between the base resin layer and the aluminum as shown in Figure 14. Cracking did occur in the base resin layer but only where connected to the composite.

Figure 13. Loading curves for CNT samples

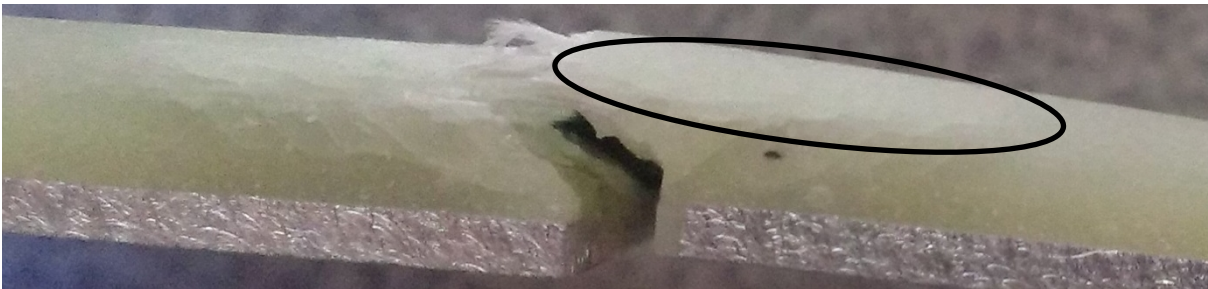
Figure 16. Side view of CNT sample 5 showing small delamination in composite

Figure 15 shows the delamination growth in sample 5 as the loading was increased to a max load of approximately 13,838N. Similar to Figure 10, delamination is shown as the white area within the sample. This delamination is within the composite itself as shown in Figure 16.

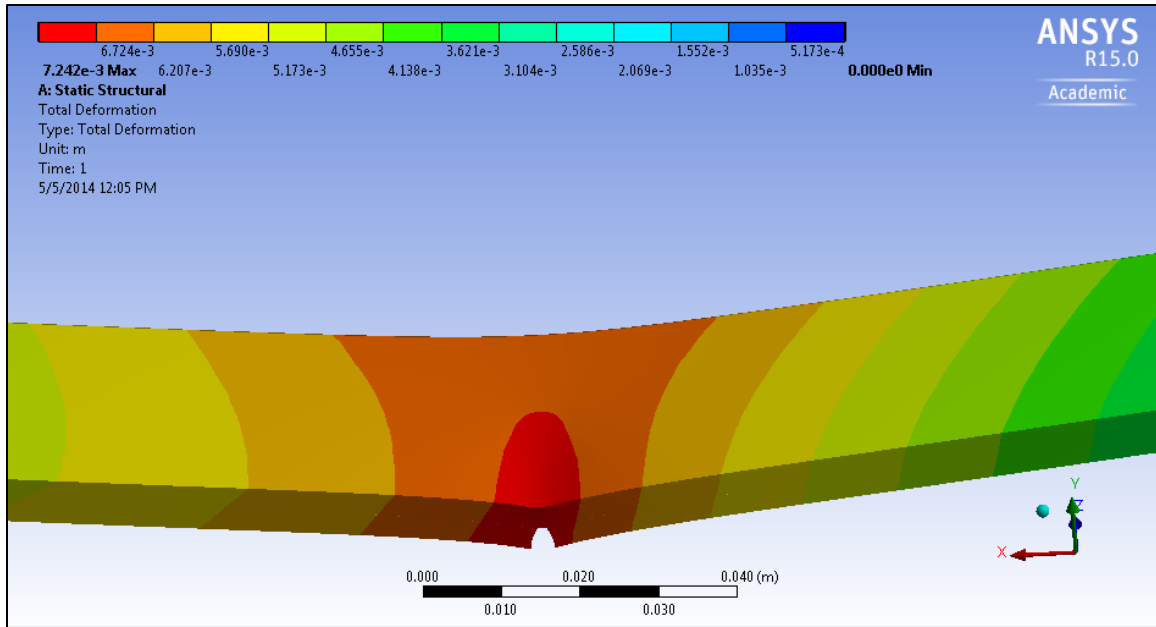
Figure 18. Deformation for composite sample

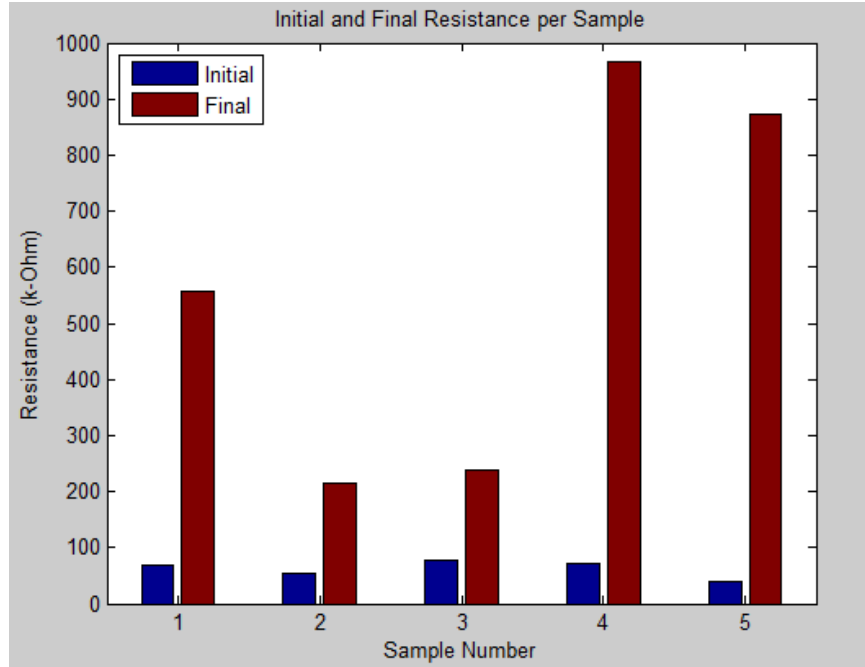
Figure 19 shows the initial and final resistance for each CNT sample. It is shown graphically in Figure 19 and numerically in Table 6 that the resistance increases greatly as compared to its initial resistance. The crack propagation was measured at the end of testing and was compared to the change in resistance to give a change in resistance per crack length growth shown in Table 6.

Figure 19. Tensile loading resistance graph

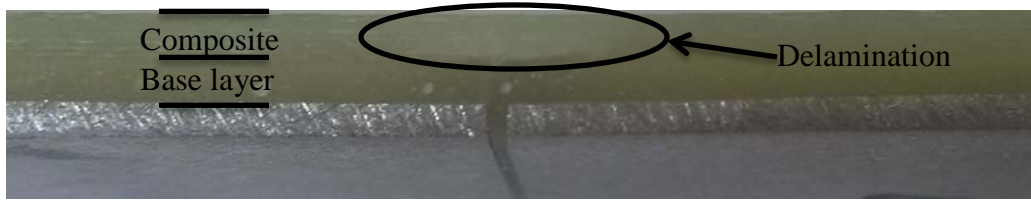
Figures 22 and 23 are side views of sample 4 showing that the delamination is only in the composite. There is no delamination between the aluminum and the base layer of resin or between the base layer and the composite. Figure 23 shows an intact bond between the aluminum and the base layer and it is visible that there is no cracking of the base layer as compared to and shown in the tension samples.

Figure 22. Sample 4 showing delamination within the composite only

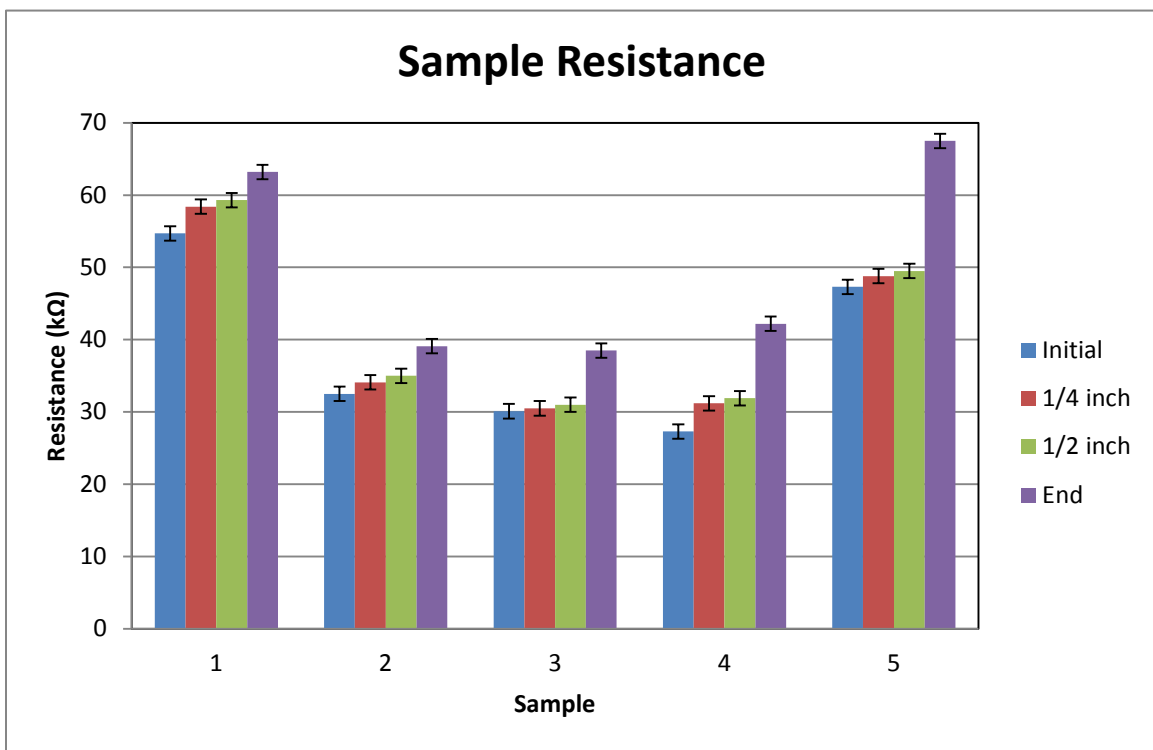
some cases it is not a large change. It is important to note after the aluminum failed the resistance did not change greatly and the crack or separation of the aluminum was not very large as it was on around 0.05 mm. For the resistance to change more the crack must be larger. Furthermore, upon unloading the sample the resistance typically decreased back down to around the resistance recorded at the 1/2 inch location. This is also important as the resistance change must be large enough to notice an appreciable change in order to not have a false reading where someone would think the crack is growing when it is not.

Figure 32. Cyclic fatigue resistance change for each sample

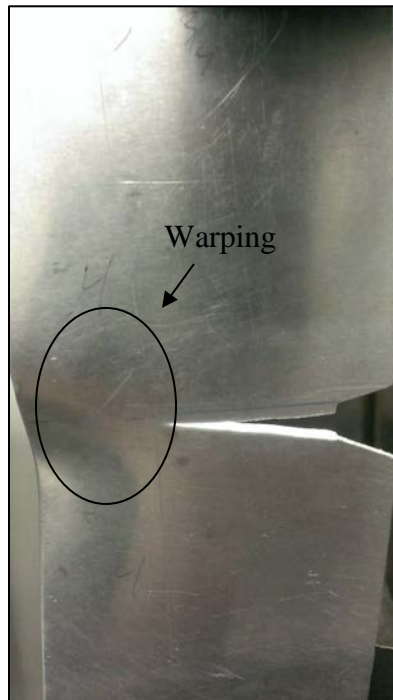
Larger widths of aluminum were utilized during initial bare aluminum testing. As seen in Figure 34 warping occurred on the left side due to the sample being in compression. This was an undesirable outcome which did not match any fleet responses, and thus the sample width was decreased to 1 and ½ inches.

Figure 34. Bare aluminum sample with 3-inch width, warping can be seen on left side

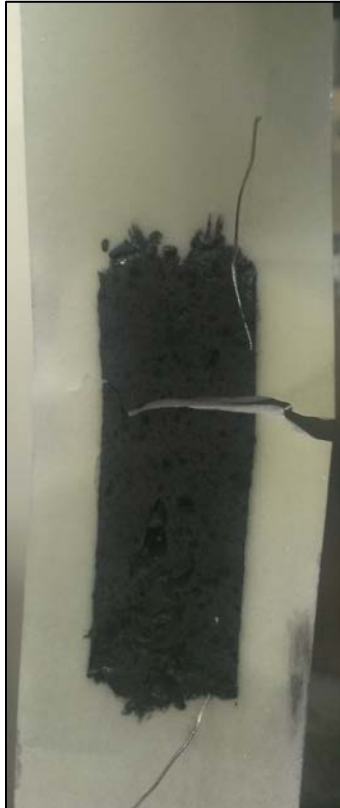
Figure 35. CNT sensor utilization and proof of usability

length in the aluminum. It could be seen though at this initial stage, delamination occurred underneath the CNT sensor between the initial resin layer and the aluminum. This would be later contributed to the bonding agent and the overall curing time process as seen in Figure 36.

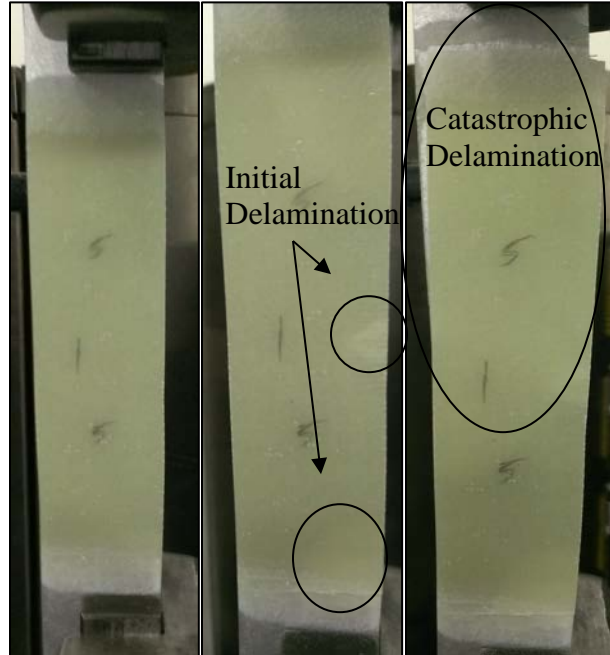
Figure 36. Eight inch samples, before testing (left), initial delamination (middle), final catastrophic delamination (right)
