Corrosion/Degradation Monitoring Technology for Composite Materials Used to Extend Building Service Life

Final Report on Project F07-AR03

July 2014

Under Project F07-AR03, "Corrosion/Degradation Monitoring for FRP Composites
Used for Service Life Extension of Buildings"

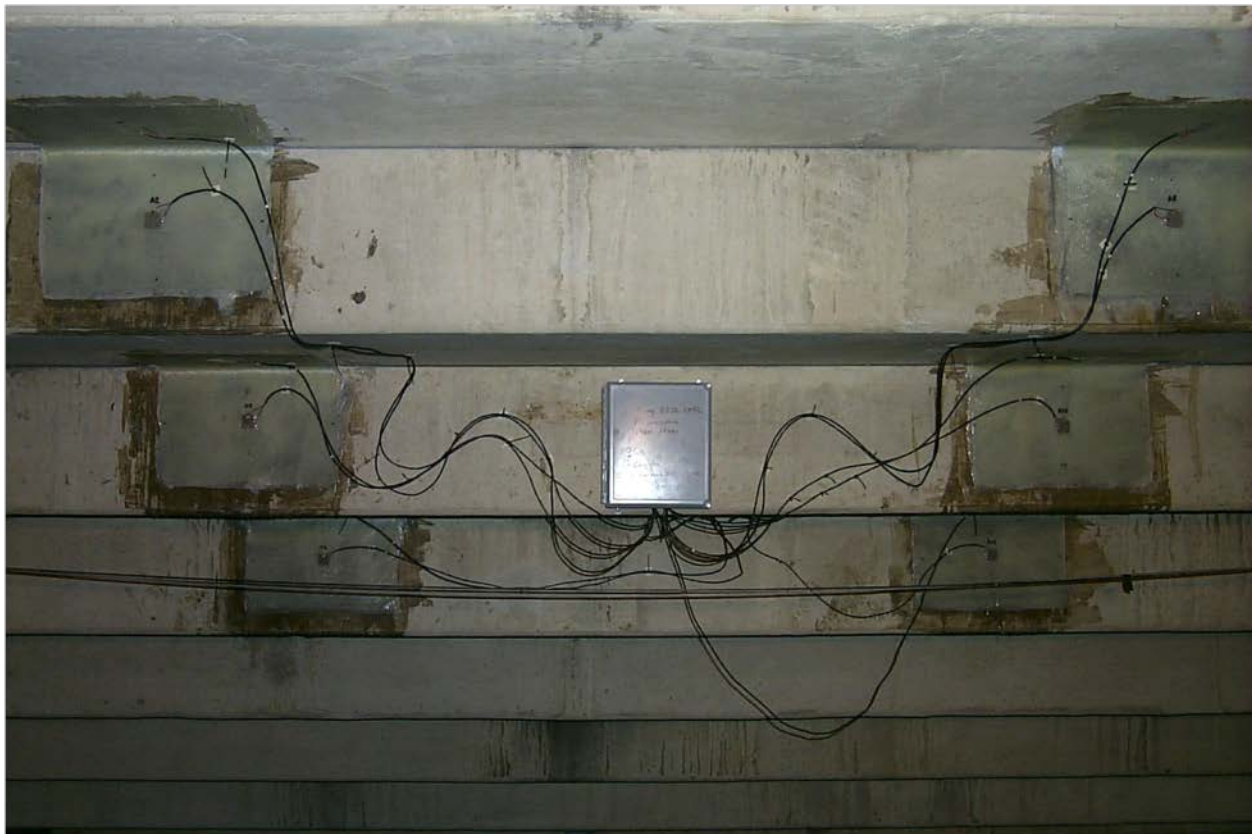
Figure 1. Structural support beams with FRP composite patches and piezoelectric sensors under Michie Stadium.

The U.S. Military Academy (USMA) has installed FRP composite structural upgrades for Michie Stadium at USMA, West Point, NY. This stadium, constructed in 1924, is a historically significant structure. The upgrades are intended to help restore the stadium's resistance to seismic motions that can accelerate structural degradation, often in difficult-to-detect locations. The structural patches need to be monitored using a method that can predict long-term degradation rates on the basis of short-term nondestructive testing. Several of the stadium upgrades were originally installed with embedded piezoelectric sensors (Figure 1), but those can affect the strength and performance of composites. An improved, nondestructive evaluation (NDE) method—one that does not affect material perfor-

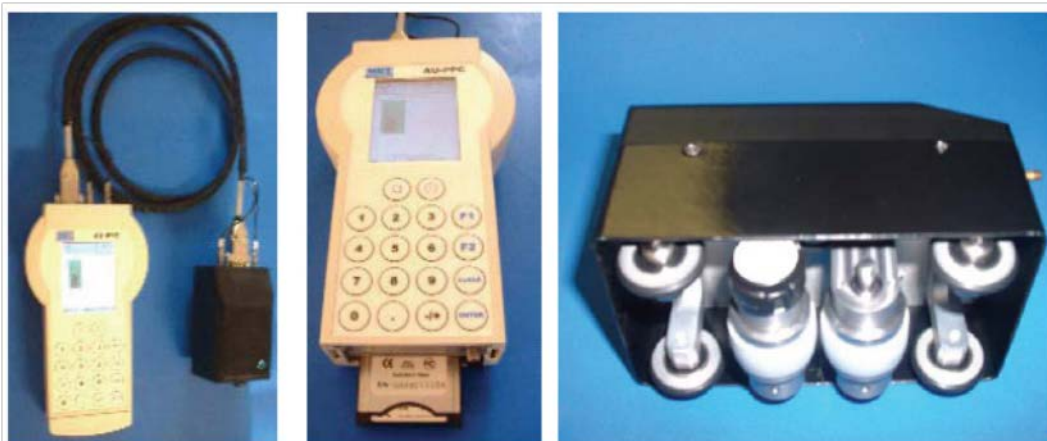
Figure 2. Pocket AU scanning system.

The scanning system used in this demonstration was the Physical Acoustics Pocket Guided Wave Acousto-Ultrasonics (AU) system (Figure 2), which is designed for NDE of composite materials that are difficult to inspect using conventional ultrasonic or other evaluation methods. The Pocket AU system includes a scanner unit with 1 Gb onboard flash memory and a USB computer interface (see center picture below). A-scan or C-scan data can be exported as ASCII files so a third-party application can be used to view and analyze the data. The exported ASCII files are saved in *.TXT format.

The Pocket AU system includes a unique dry-coupled rolling-sensor probe (Figure 2, right-hand picture) that contains two wide-band acoustic rolling sensors—one working as a pulser and the other as a receiver. These sensors are spring loaded to maintain a constant contact pressure of 20 lb against the structure, while four guide wheels are used to stabilize the scanner during the inspection procedure.

The rear guide wheels incorporate a rotary encoder that tracks the distance the scanner travels during the scanning process. The position information is necessary to generate the C-scan images.

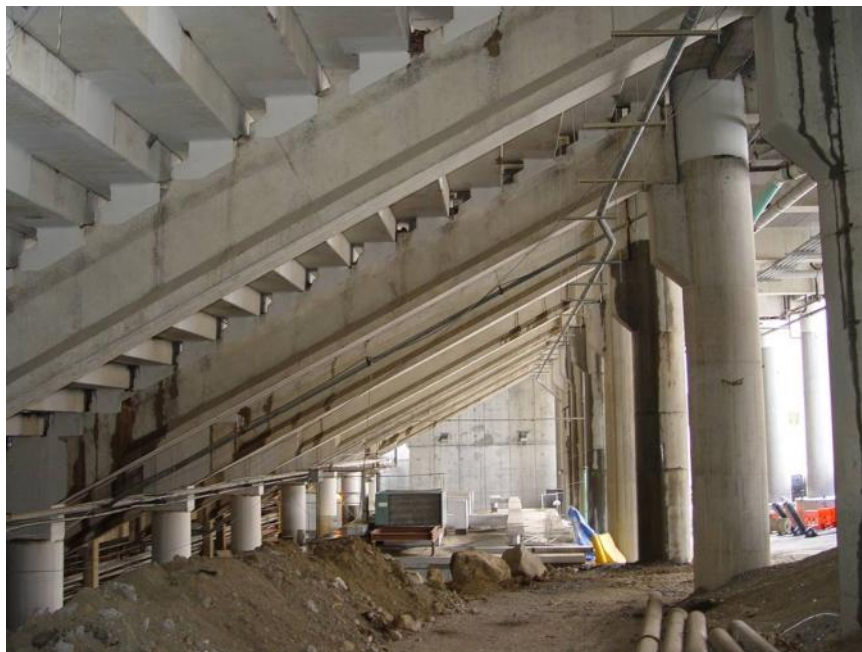
Figure 3. Workspace for composite patch evaluation.

Access to the patches, which are installed at the underside of the stadium structure, was provided with a scissors lift and an articulating manlift. The use of ladders was not acceptable because two hands and a stable platform are required to operate the scanning instrument. Scaffolding was not feasible because the uneven ground and debris in the work space would hinder scaffold assembly and relocation. The manlift provided the best combination of stability and mobility between work locations; an entire section between support columns could be completed by moving the arm without repositioning the lift. Figure 3 shows one of the space-constrained work locations. Figure 4 shows examples of the composite wraps (light-gray bands) at the tops of columns beneath the seating.

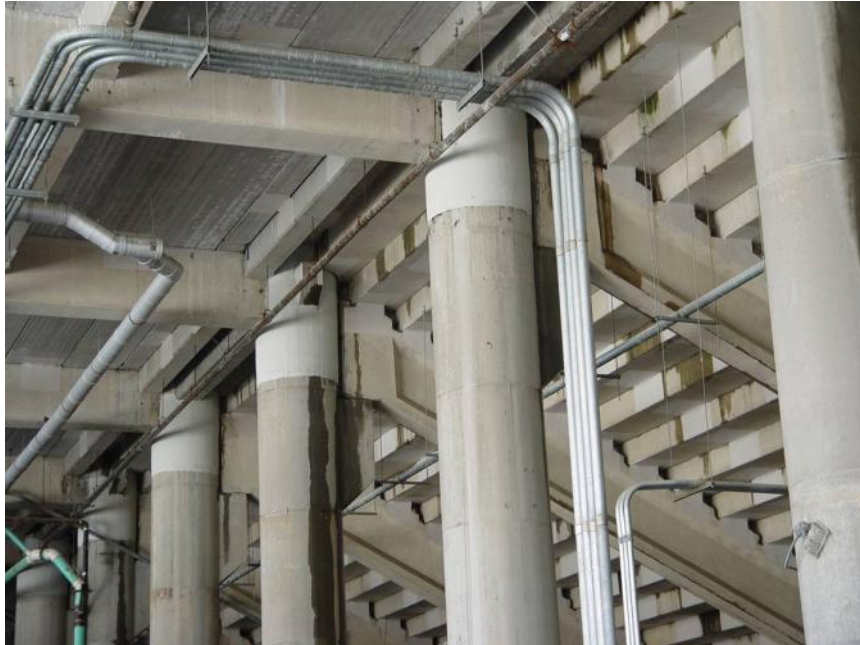
Figure 4. Composite wraps at column tops.

Two technicians and two support personnel inspected 250 FRP composite patches over 24 days from 15 October to 8 November 2007. The technicians operated the scanning systems while the support personnel operated the lifts. When all tasks and delays in the field operation are included (set-up, staging, scanning, teardown, rain, humidity), the average inspection time was about 1.5 hours per patch.

For the inspection of the Michie Stadium patches, the pulser waveform was a 230 kHz square wave of 50 μ S duration. Five random FRP patches were selected in the lower tier to calibrate the unit. The received amplitude from all five patches was recorded, and the patch returning the maximum amplitude was used as the calibration benchmark. (The maximum-amplitude return signal corresponded to a good patch—one with minimal to no debonding or delamination.) The A-scan screen height was then adjusted to the maximum detected amplitude of the waveform. The AU unit was used to generate A-scan and C-scan images for each of the inspected patches.

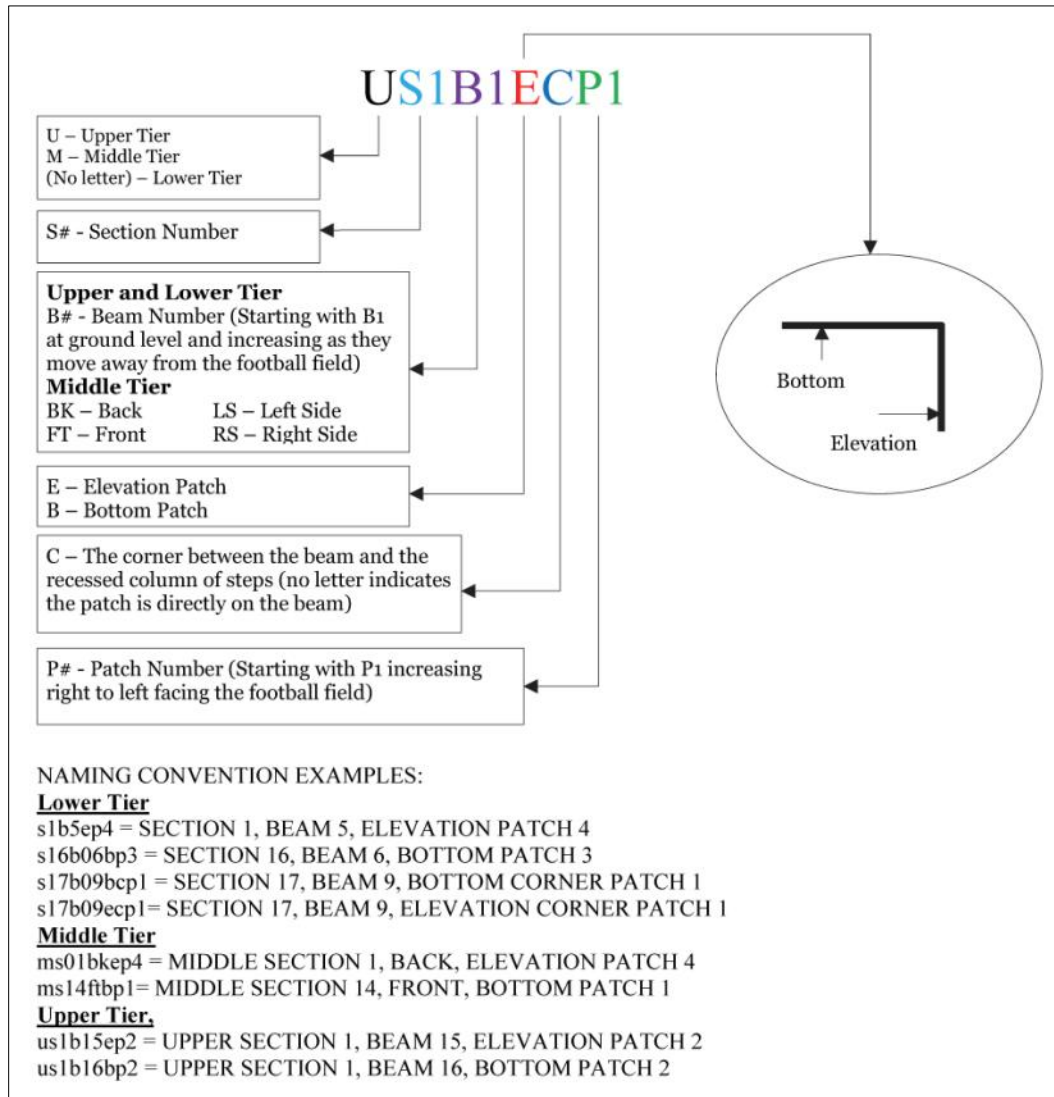
Figure 5. Patch naming convention for data logging.

inspected. Diagrams of inspected locations and fully marked stadium tier drawings are shown in Appendix A and Appendix B, respectively.

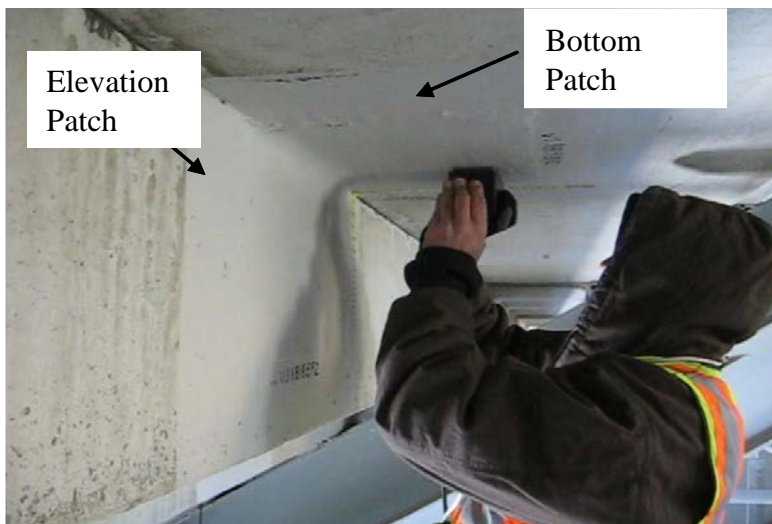
Figure 7. Inspection in progress.

Each inspection was subdivided into two scans: one for the bottom patch and one for the elevation patch. Figure 7 shows the inspection of a bottom patch, with labels indicating both the bottom and elevation patches.

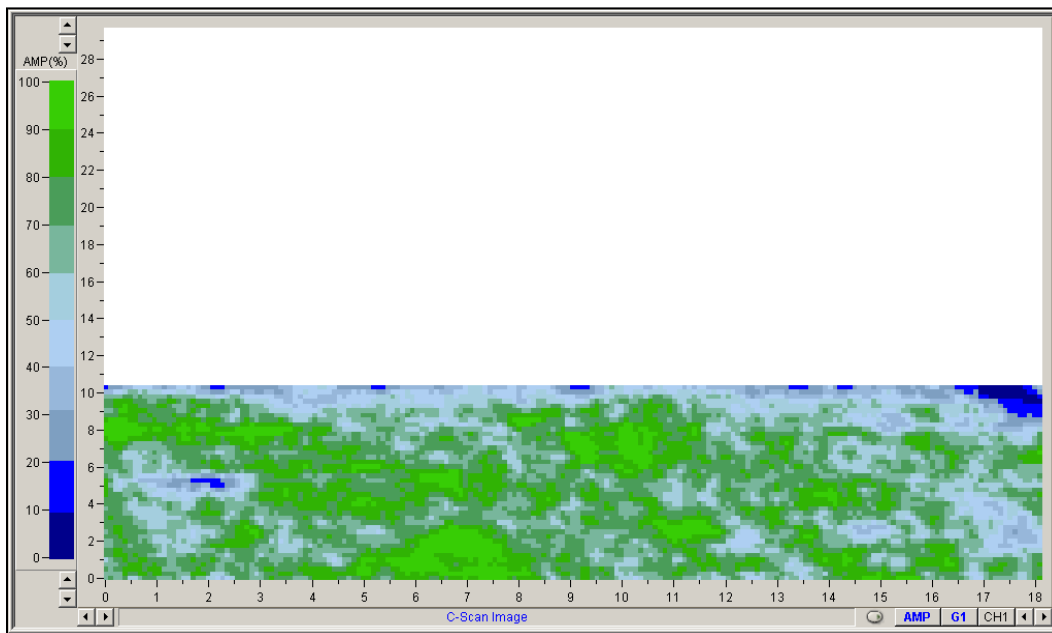
Figure 9. C-scan image.

The C-scan image provides information in terms of time of flight and amplitude of the received signals as a raster scan along the X-Y plane of a test sample. Figure 9 shows a C-scan image of a scanned FRP patch. The acquired data are post-processed using UTwin*, a Windows-based data acquisition, imaging, and analysis software system for C-Scan images. (Note that this software required much time and effort to configure before reading the exported data file produced by the AU scanner unit.)

Figure 10 shows the AU scanner bar scale that is used to plot the C-scan image. Generally, blue or light-blue colors signify lower AU signal amplitude values that indicate defect-containing areas; and greenish or bright-green colors represent defect-free regions.

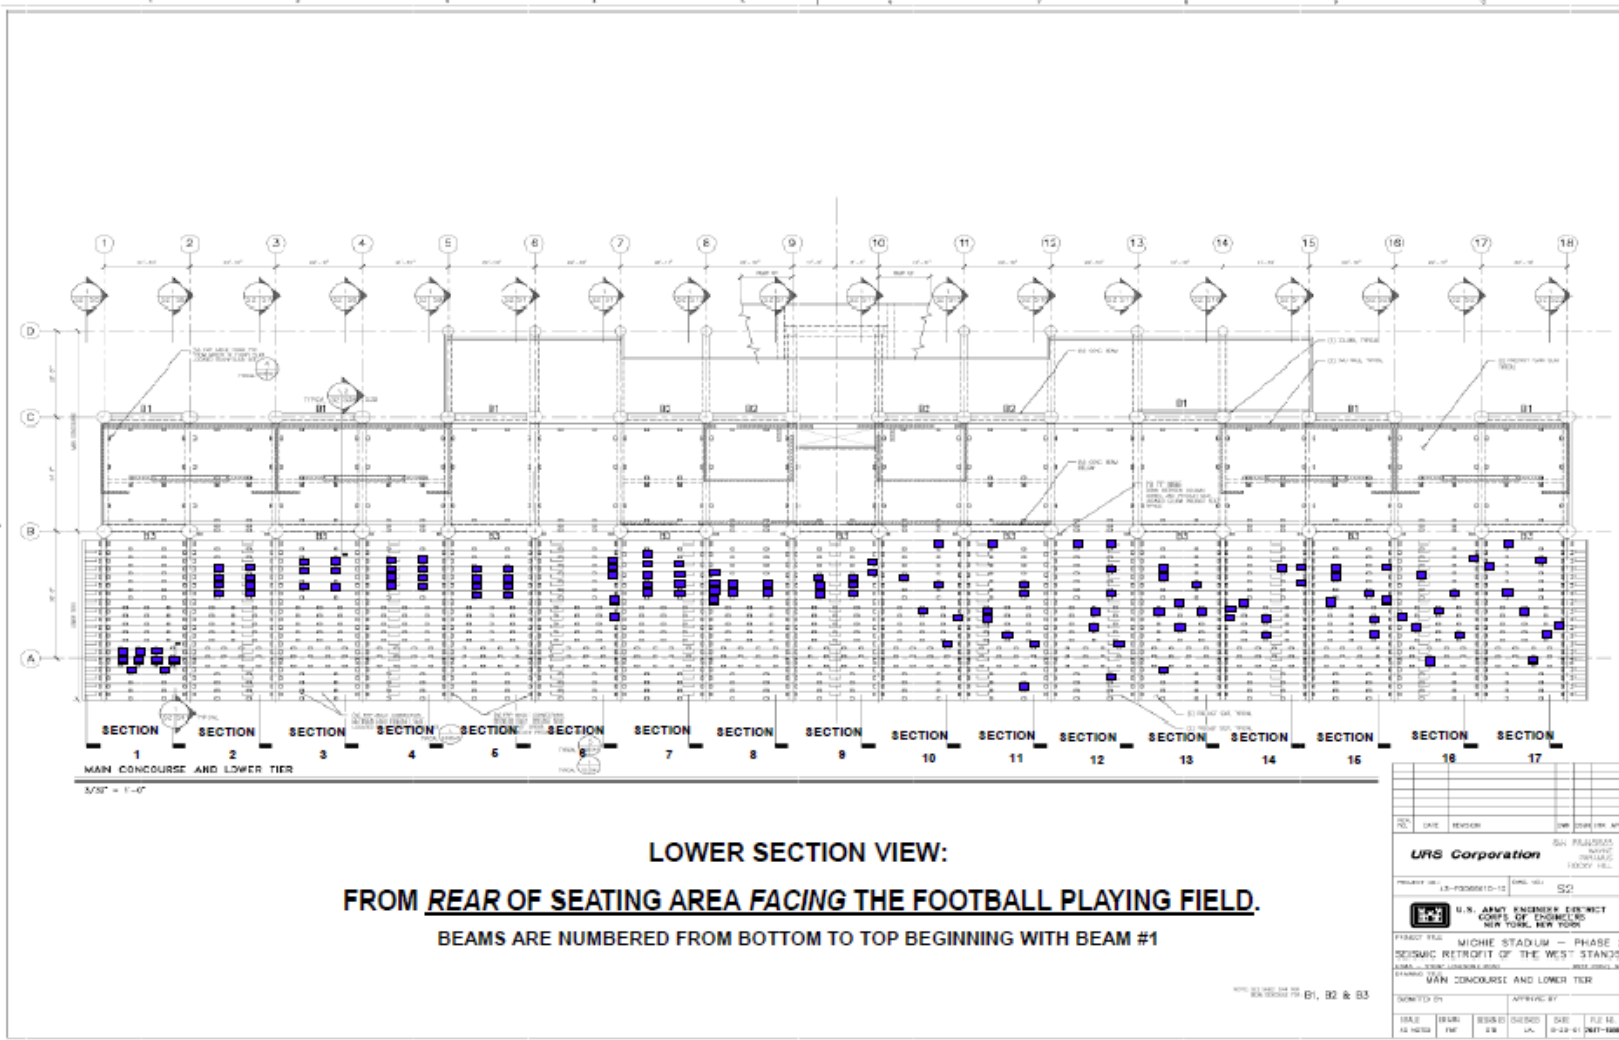
The drawings in Appendix A show the inspected locations as small blue rectangles in the context of each entire tier. The Lower and Upper Tiers are numbered from left to right, as if the viewer were standing behind the seats looking toward the playing field. The view adopted for the Middle Tier was oriented as if the viewer were standing on the football playing field looking toward at the stands. This “flipped” view was selected for the Middle Tier because rear access to it did not allow an observer to accurately identify the inspected locations using the marked drawing while simultaneously looking at the tier.

Six of the inspected locations are not indicated on these drawings. They are L7 and L8 in Section 3 of the Lower Tier, L9 in Section 5 of the Lower Tier, L6 and L7 in Section 6 of the Lower Tier, and L10 in Section 7 of the Lower Tier. These data gaps are addressed in section 3.3.4 under “Lessons learned.”
