**NAVAL
POSTGRADUATE
SCHOOL**

THESIS

**IMAGING GALLIUM NITRIDE HIGH ELECTRON
MOBILITY TRANSISTORS TO IDENTIFY POINT
DEFECTS**

March 2014

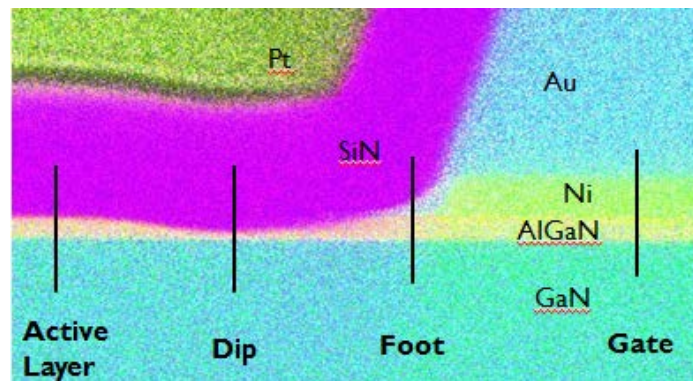
Figure 1. Ni/Au gate edge with four line scan areas labeled.

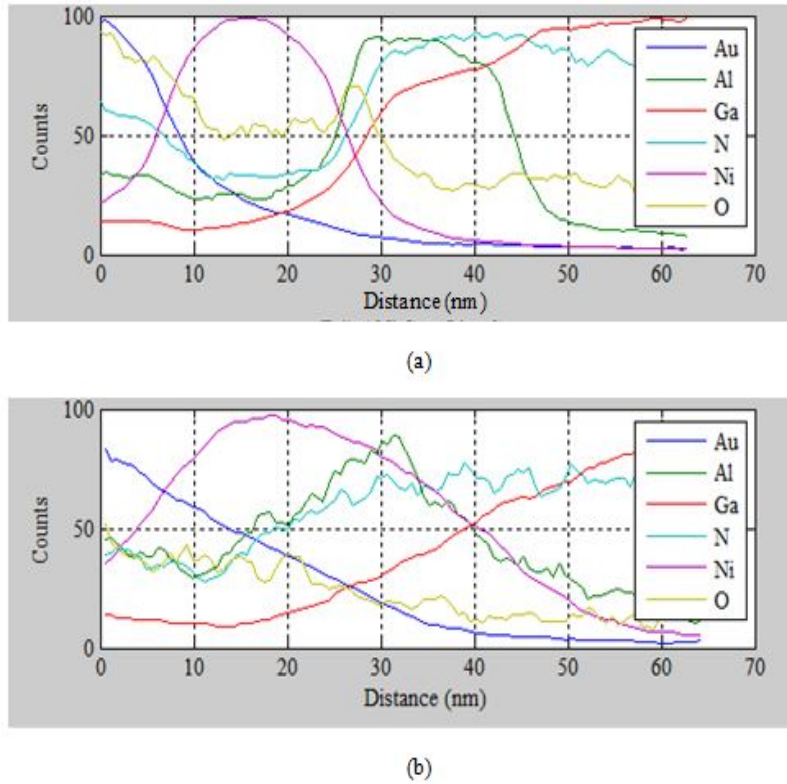
provided the necessary information to identify specific elements present across the edge of the gate. From the seven samples analyzed, 26 line scans were compared to identify trends. The line scans were individually analyzed and compared to ascertain trends. One trend identified was the gate metal diffusion when the device was stressed, as seen in Figure 2.

Figure 2. Frsh (a) and failed (b) Ni gate line scan data sets in distance versus detector percentage counts. The graphs depict a change in the location of Ni in the same region underneath the gate.

Based on the line scan results, we concluded there is a dominant melting defect creating an amorphous area composed of both gate metals at the gate edge and the Pt device exhibited a more noticeable melting defect in all three samples compared to the nickel samples. In all six device samples, the 2nm protective GaN cap layer was not present but was present in the preprocessed epitaxial layer sample. We also did not notice any change in the chemical composition of either the Pt or Ni samples at 100nm away

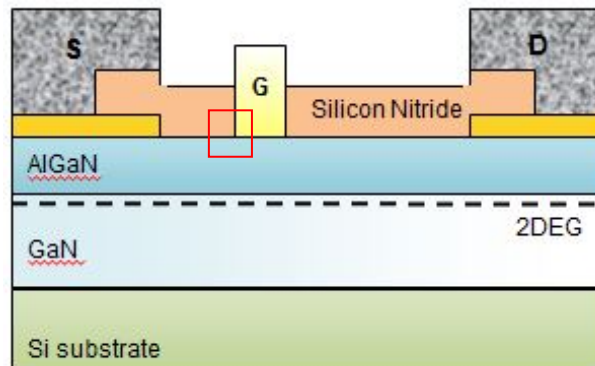
The GaN HEMT takes advantage of the intrinsically superior performance of GaN while utilizing a secondary effect of lattice mismatch, which occurs at the interface between GaN and (Al, Ga)N alloys of varying Al composition. This lattice mismatch between two layers of GaN and (Al, Ga)N creates a lattice strain thus generating a charge via the piezoelectric effect as discussed in [8]. The resulting charge is proportional to the mole fraction x of Al in the $\text{Al}_x\text{Ga}_{1-x}\text{N}$ material where x must be less than 30 percent [4]. Polarization charge is produced at the heterojunction between the two layers. Free electrons concentrate near the polarization region to electrostatically screen the polarization charge, creating a two dimensional gas (2DEG) region at the GaN/(Al, Ga)N interface [11],[13]. The 2DEG region is visible in Figure 1 and denoted by the dotted line.

Figure 1. GaN HEMT with focus area highlighted and material layer types identified (from [15]).

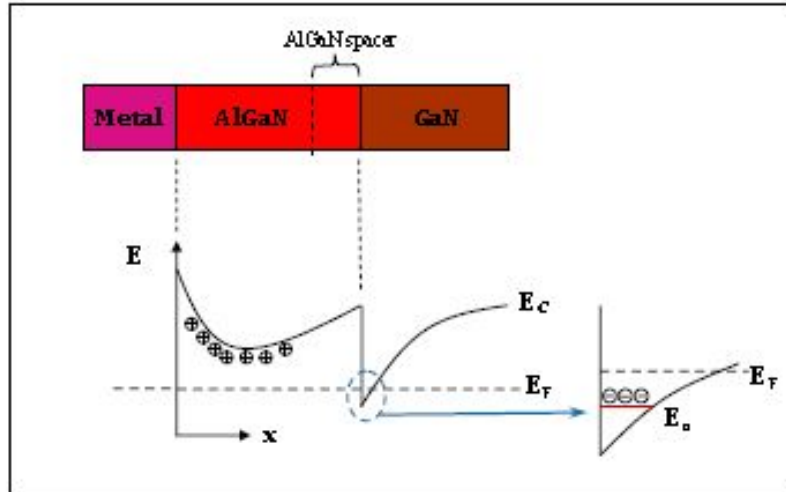
The GaN HEMT uses the channel forming the 2DEG at the (Al, Ga)N /GaN interface with an applied gate voltage to be able to create a field effect transistor (FET) [4].

Figure 2. Energy Band diagram displaying 2DEG area (from [9]).

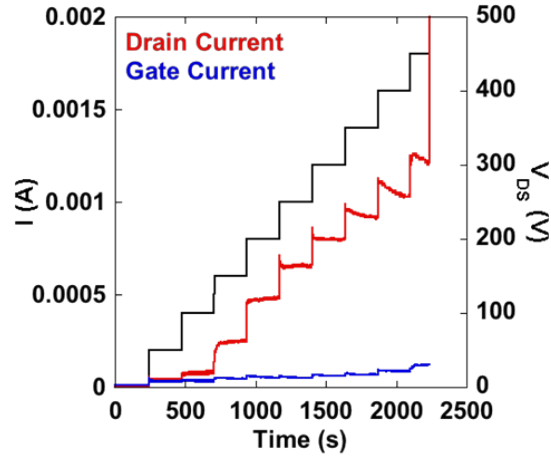
The reliability of devices of both gate metallization types was tested electrically at NRL under two gate stress conditions. First, the device was placed under a stepped gate voltage stress until a 0.1mA gate current was observed, which did not correspond to irreversible failure of the device. Second, the device was stressed until the device reached catastrophic failure. The sample set in Table 3 outlines the stressing parameters of each device. Typical current leakage seen as the voltage was stepped on the gate is shown in Figure 4.

Figure 4. Current/voltage plot of the electrical stress test performed on Ni and Pt devices (from [15]).

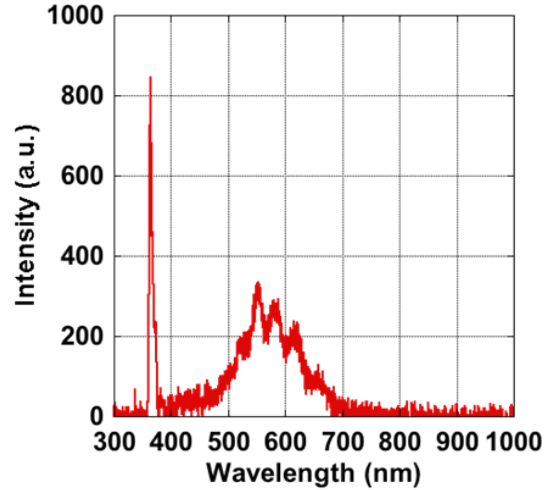
Stressed devices were then tested for electroluminescence phenomena. Electroluminescence is the emission of light in areas of high electron-hole recombination due to a presence of charge carrier trap states in the bandgap. The wavelength of the emitted light is directly related to the energy levels of the traps. Thus, the presence of electroluminescence can be used to infer a greater chance for defects in the area in which the phenomenon occurs. Several peaks over the visible light area of the electroluminescence spectrum are observed, as seen in Figure 5. The origin of this “yellow” luminescence is discussed in [18], and is related to defects in the GaN material. Points in the device structure where the luminescence spectra was similar to that shown in Figure 5 helped to identify where our sample slices would be extracted.

Figure 5. Wavelength intensity of defected GaN region gives rise to photoluminescence evidence (from [15]).

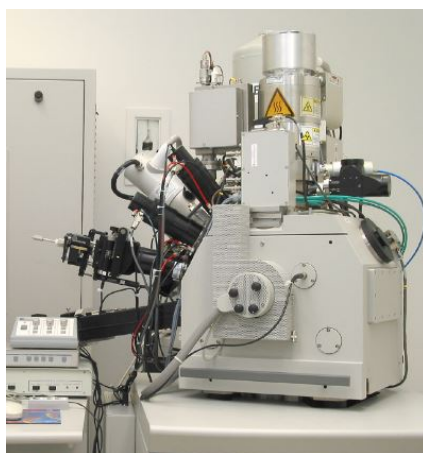
The FIB has multi-tool capabilities with SEM imaging, an Oxford Instruments OmniProbe[®] manipulator, chemical deposition as well as ion etching. The instrument is seen in Figure 7. Therefore the sample under preparation can be etched at the micrometer level. The tight control over the emission rate of ions from the source means the ability to keep the ion current low enough to minimize further damage to the sample. The FIB, combined with a fine control sample manipulation system (the OmniProbe) allows performing a lift out where the 20 μ m long sample is removed and welded to a copper port for further thinning, transportation and evaluation.

Figure 7. FIB with OmniProbe on the left with the SEM stack on the top.

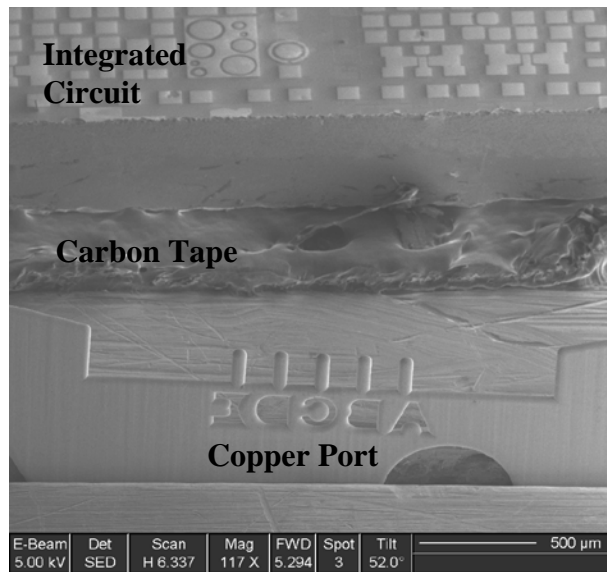
The sample holder inside the FIB rotates and moves and therefore the integrated circuit (IC) needs to be properly secured to the mount prior to loading into the machine. Carbon tape was used to secure the (IC) to the mount because permanent adhesion of the IC to the mount was not feasible. In order to make sure that the IC was more secure, the ends of the tape were rolled up to the edge of the IC. The sample that would be cut from the IC was required to be mounted. The chosen mount was a five fingered copper port. In a later process, the EDS TEM sample holder will have three metal options, copper, molybdenum and nickel. A five fingered port was chosen in order to provide protection during transportation as well as the metal type. The copper five fingered port was mounted fingers pointed straight up as seen in Figure 8.

Figure 8. SEM image of five fingered copper port used to hold the lamella with the IC in the background with rolled carbon tape securing the IC.

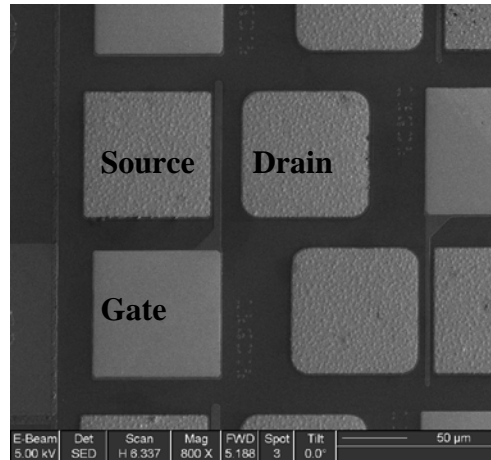
degradation to the device. Once we achieved a clear picture as shown in Figure 9, the tilt angle was adjusted from 10° to 52° in order to achieve the eucentric height. Eucentric height is the working distance in the z-axis of the mounted device where focus is achieved independent of the underlying tilt angle of the sample.

Figure 9. SEM image of properly aligned E-beam image indicating sample is at eucentric height and therefore focused.

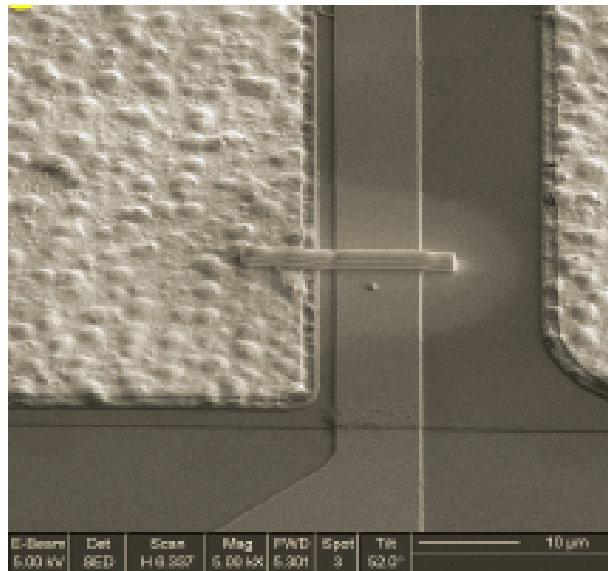
Figure 10. SEM image of $1\mu\text{m}$ Pt protective layer over the device source edge and gate.

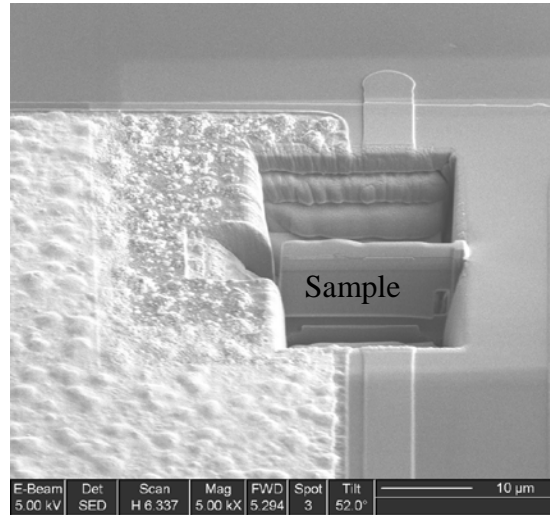
Figure 11. SEM image of $5\mu\text{m}$ deep trenches etched around the sample.

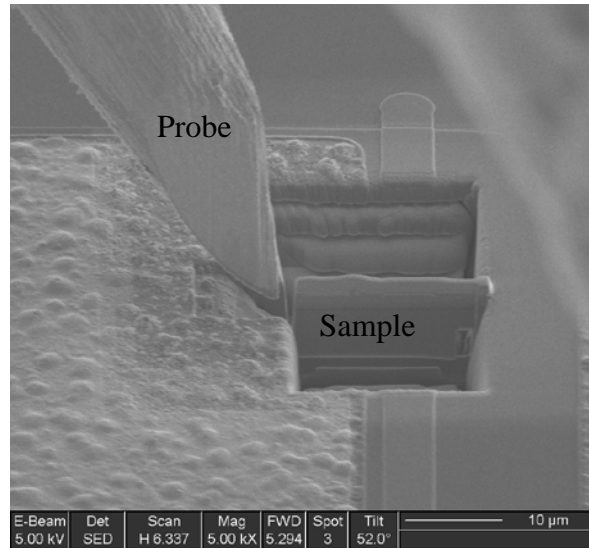
Figure 13. SEM image of OmniProbe shown in position for welding the sample.

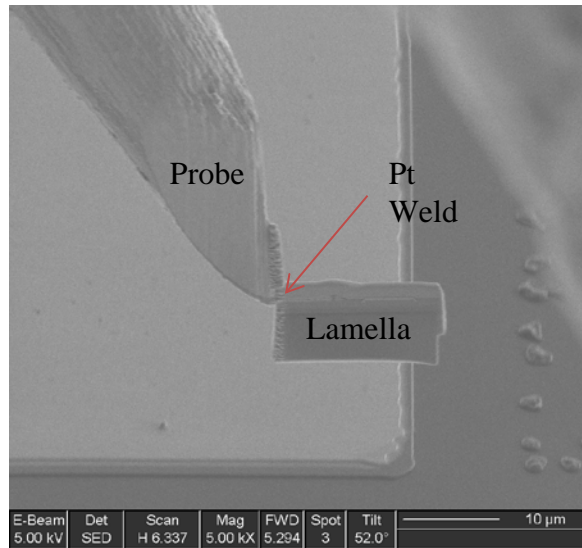
Figure 14. SEM image of lamella welded onto the probe with Pt.

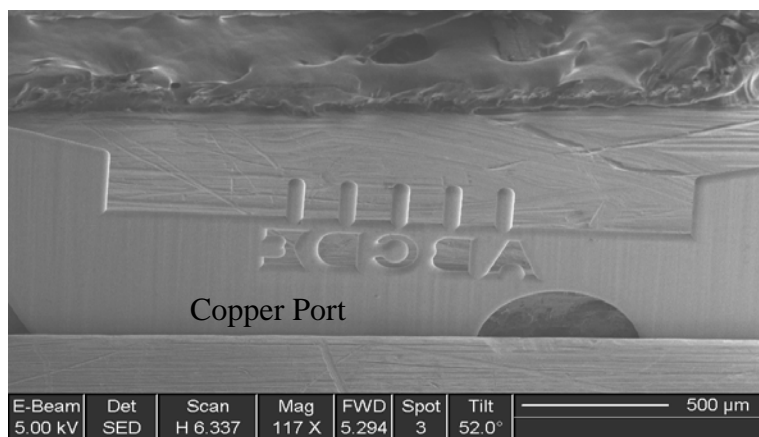
Figure 15. SEM image of the copper port properly mounted and in correct field of view. The orientation of the port is the same for every sample.

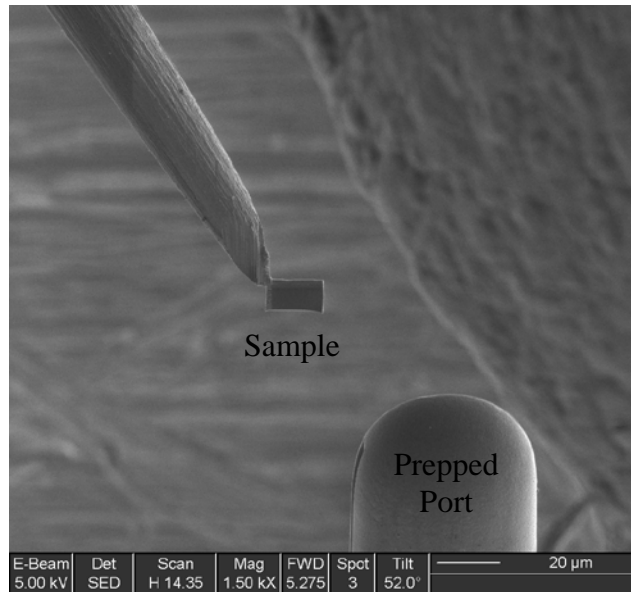
Figure 17. SEM image of welded sample moving into position to the prepped port.

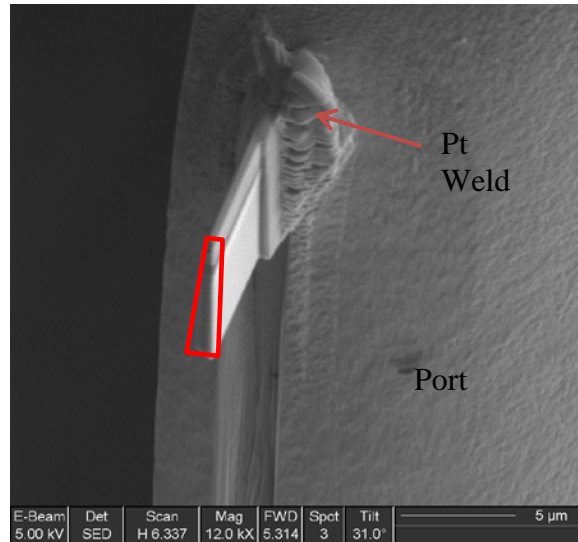
Figure 18. Final SEM image of the sample welded to the port. The top of the device is much thinner than the bottom creating a trapezoidal shape.

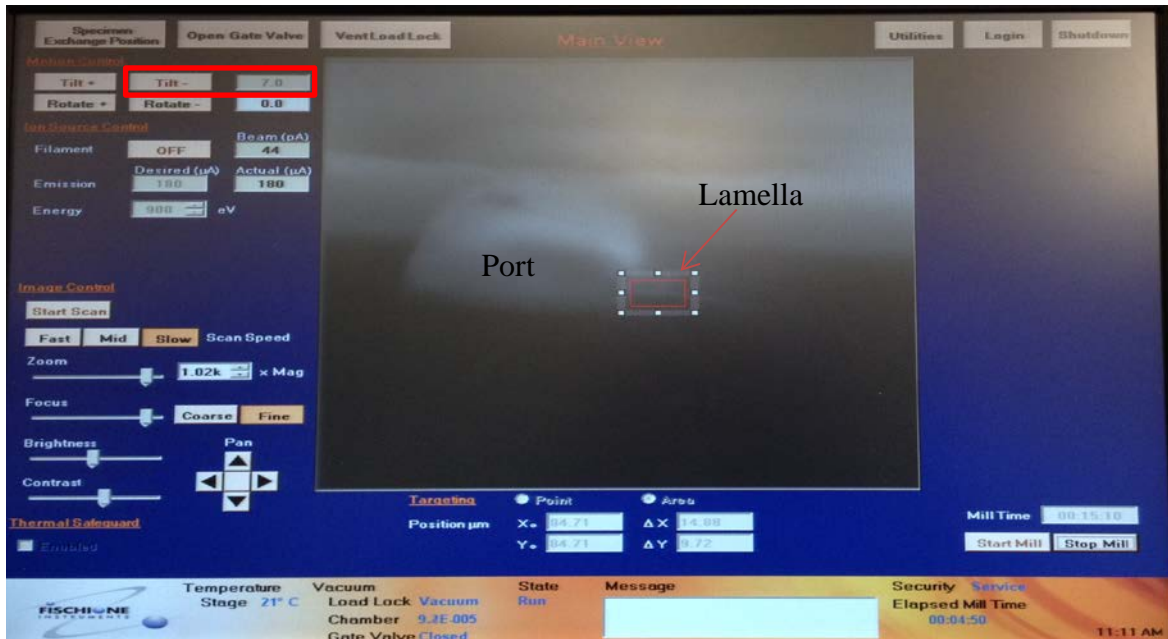
Figure 20. NanoMill control screen showing parameters for the milling process and monitor screen.

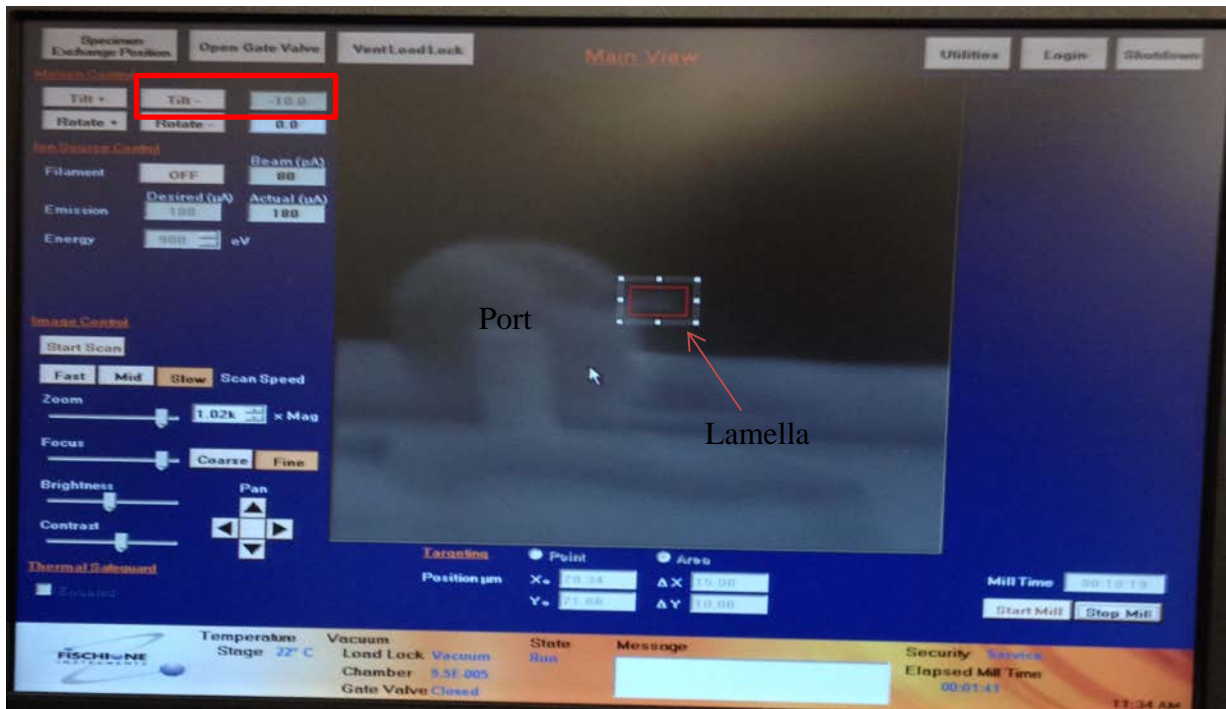
Figure 21. NanoMill control screen depicting the -10° tilt angle and underside of the port.

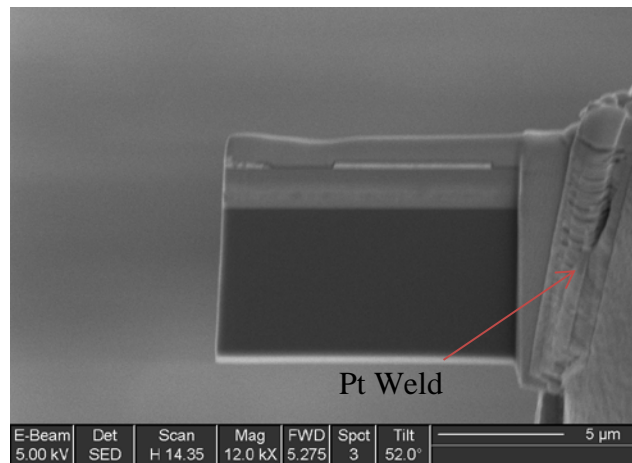
Figure 22. SEM image of sample properly welded, thinned and mounted to the port.

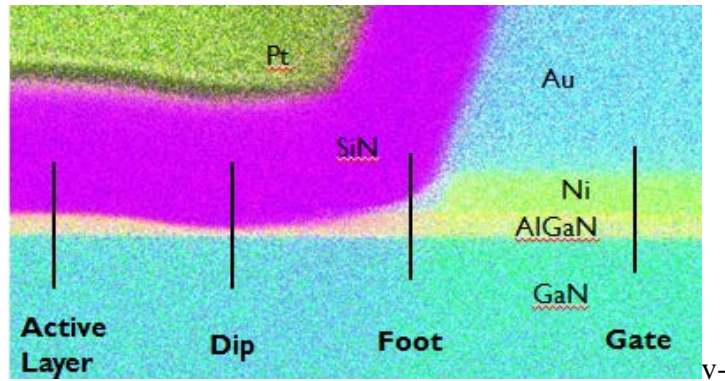
Figure 23. Ni/Au gate edge with the four line scan areas labeled.

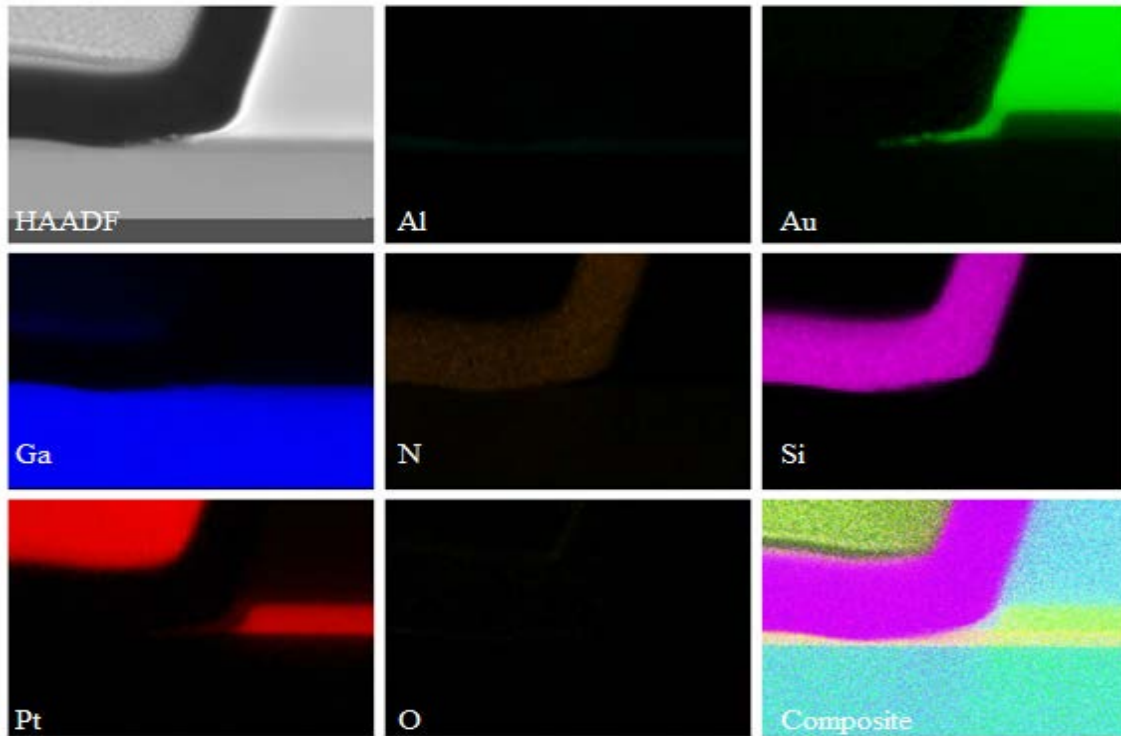
Figure 25. STEM image from the EDS of the fresh Pt gated device broken into each element of focus.

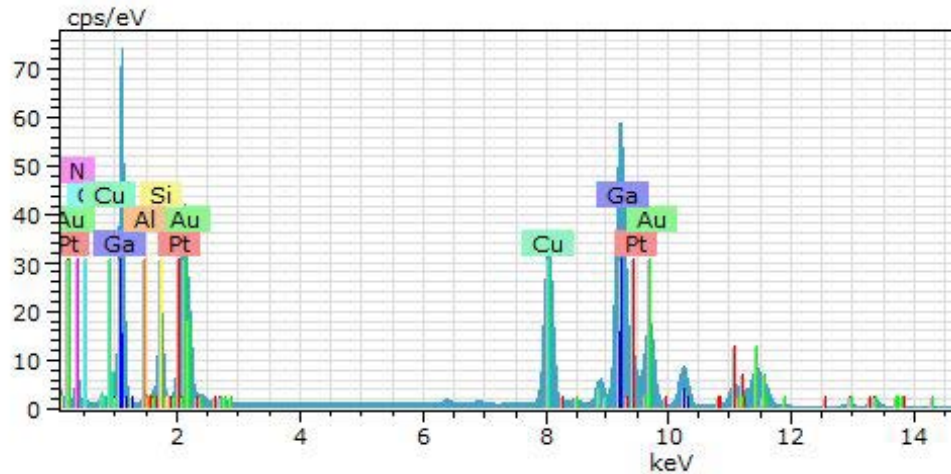
Figure 26. Elemental spectrum display of electron volts versus photon counts of the fresh Pt sample. The peaks in the spectrum correspond to individual elements present in imaged area.

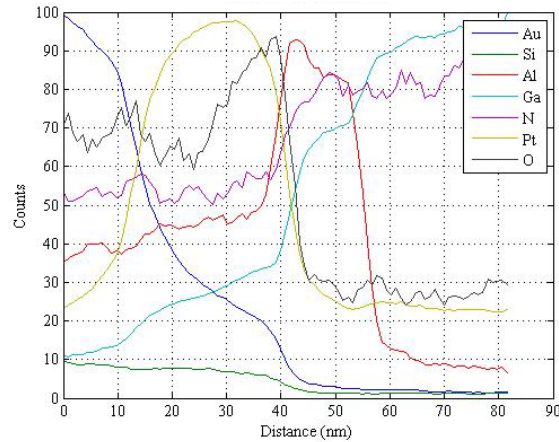
Figure 27. Line scan data from the fresh Pt gate line scan depicting the rise and fall of each element presence analyzed.

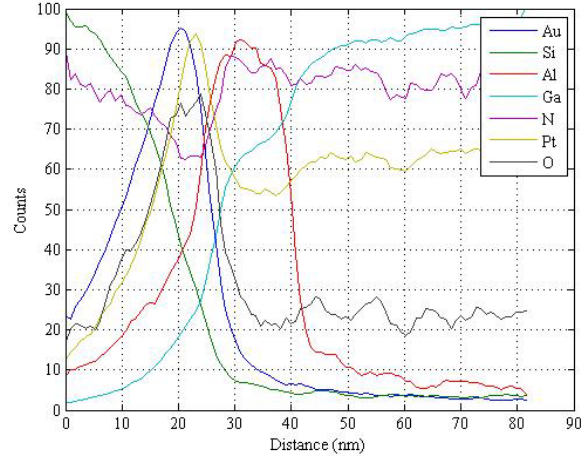
Figure 28. Line scan data from the fresh Pt foot line scan depicting the presence of each element analyzed.

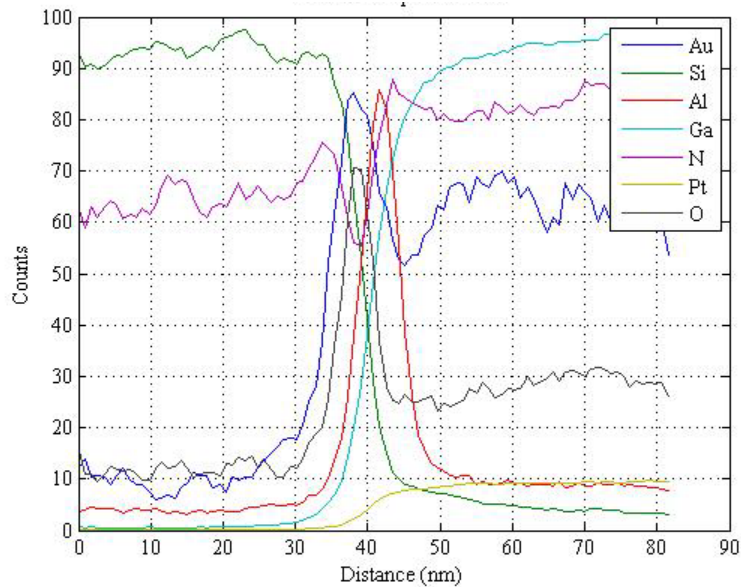
Figure 29. Line scan data from the fresh Pt dip line scan depicting the presence of each element analyzed.

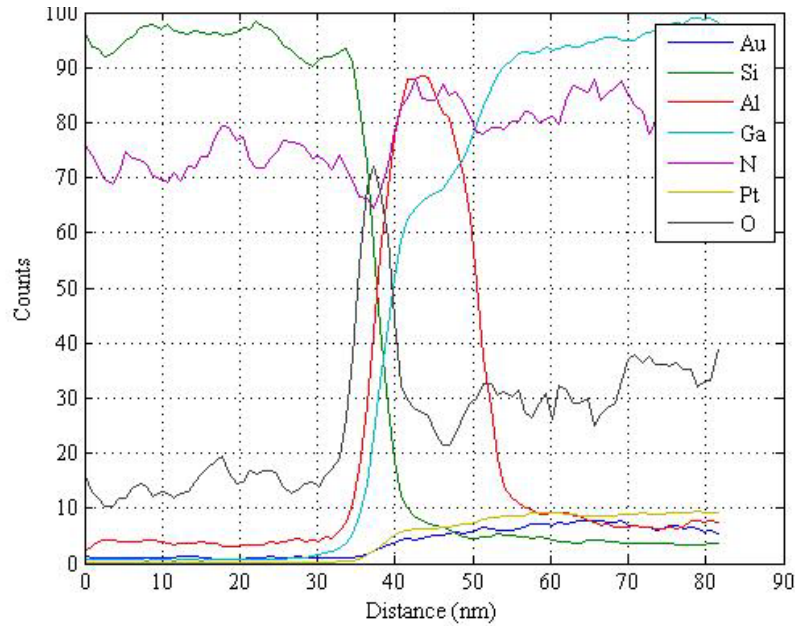
Figure 30. Line scan data from the fresh Pt Active layer line scan depicting the presence of each element analyzed.

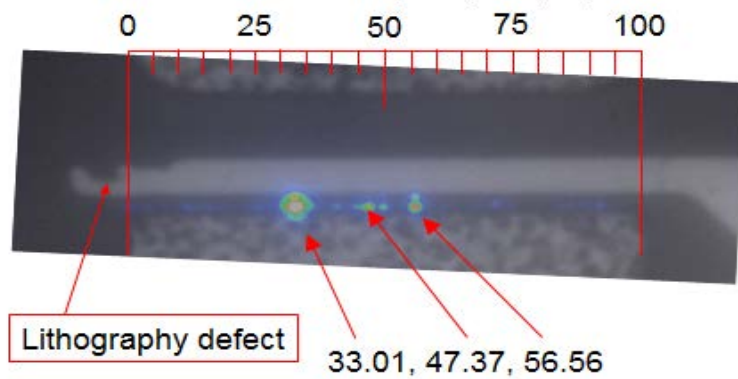
Figure 31. Electroluminescence intensity on degraded Pt gate. The arrows correspond to the distance across the gate in μm beginning at the edge of the source indicating areas of higher intensity.

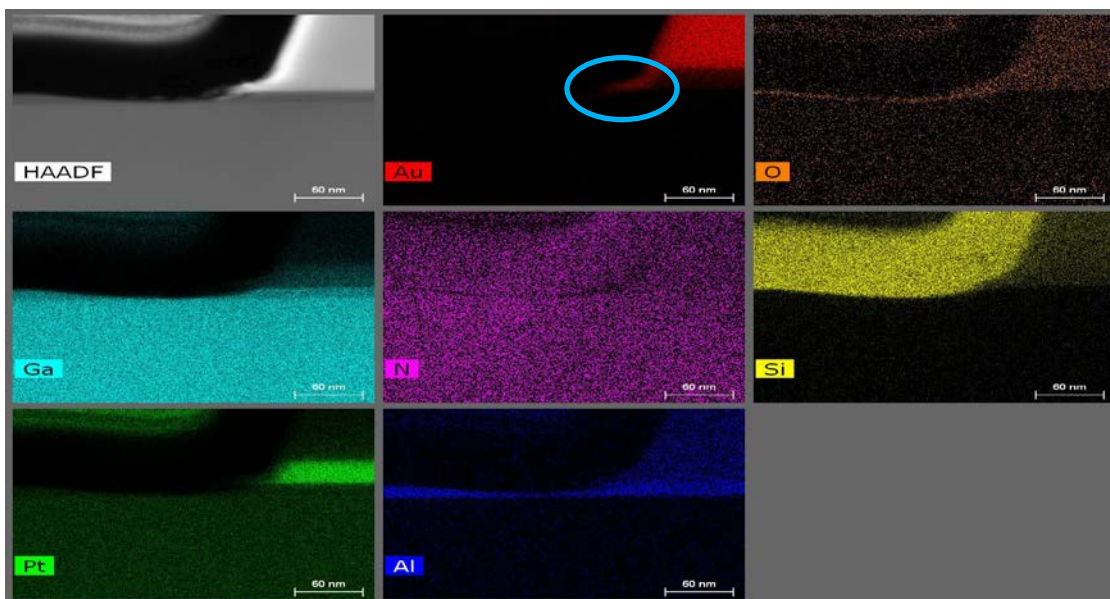
Figure 32. Elemental scans from the EDS for the degraded Pt device. The top left image is the HAADF followed by the seven singular elemental pictures (Au, O, Ga, N, Si, Pt, and Al).

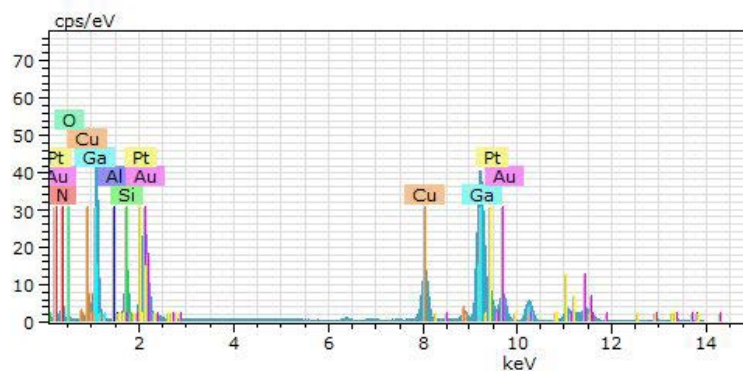
Figure 33. Elemental spectrum display of electron volts versus photon counts of the degraded Pt sample. The peaks in the spectrum correspond to individual elements present in imaged area.

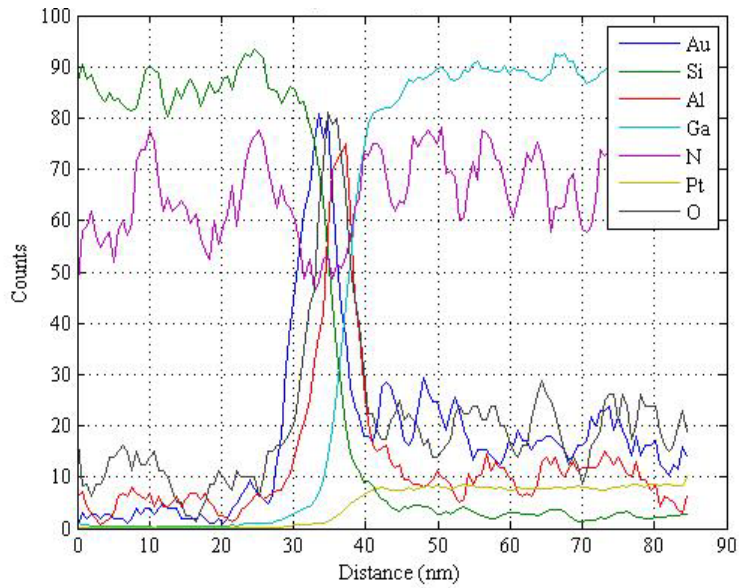
Figure 36. Line scan data from the degraded Pt dip line scan depicting the presence of each element analyzed.

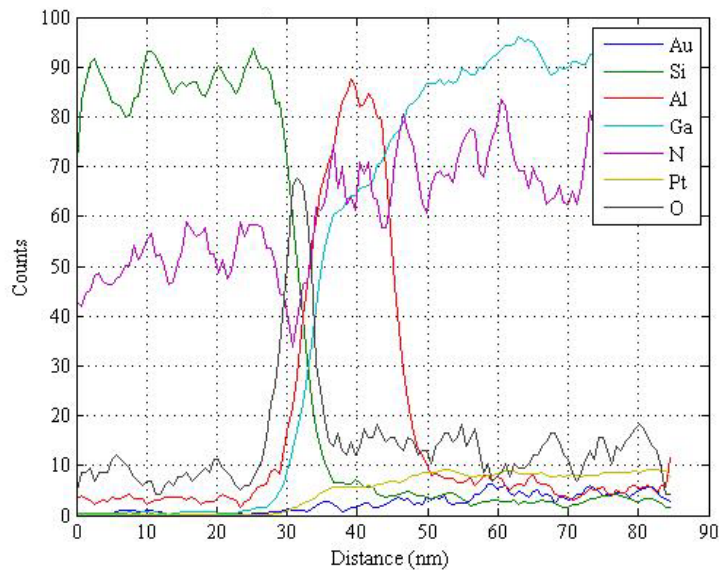
Figure 37. Line scan data of the degraded Pt active layer line scan depicting the presence of each element analyzed.

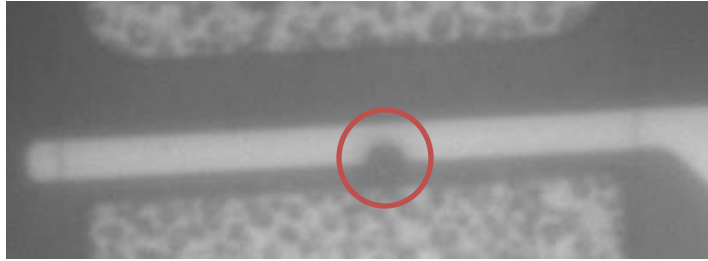
Figure 38. SEM image from NRL of failed Pt device after catastrophic failure. The breakdown area is circled in red.

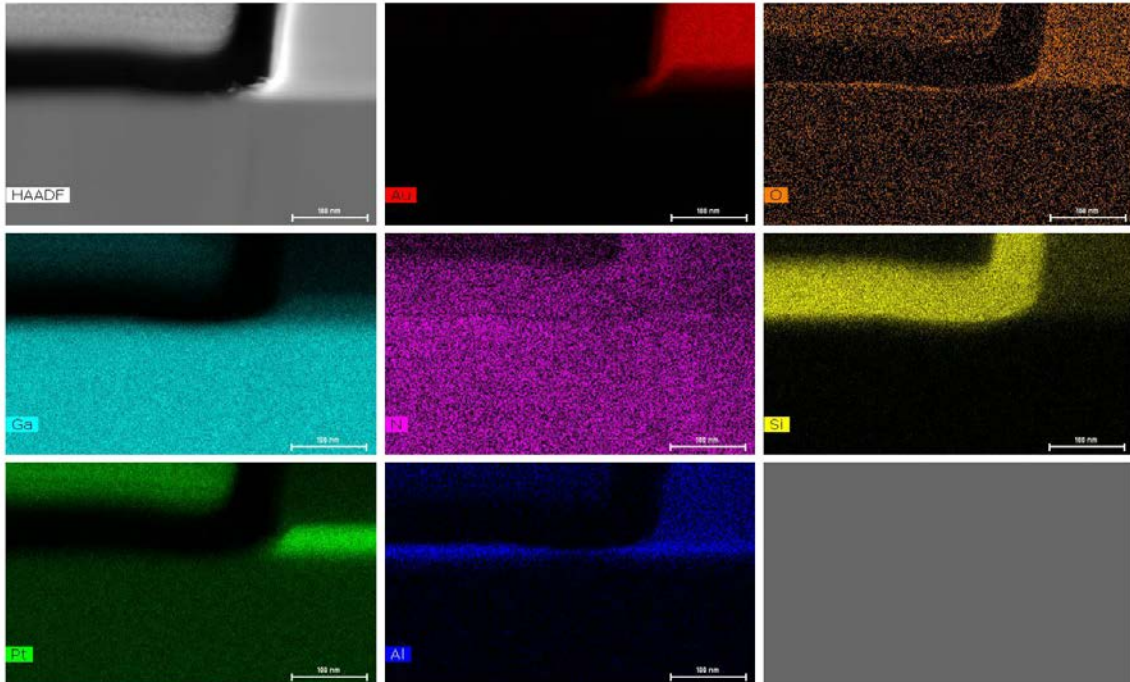
Figure 42. Elemental scans from the EDS for the failed Pt gated device. The first image is the HAADF followed by the seven singular elemental pictures (Au, O, Ga, N, Si, Pt, and Al).

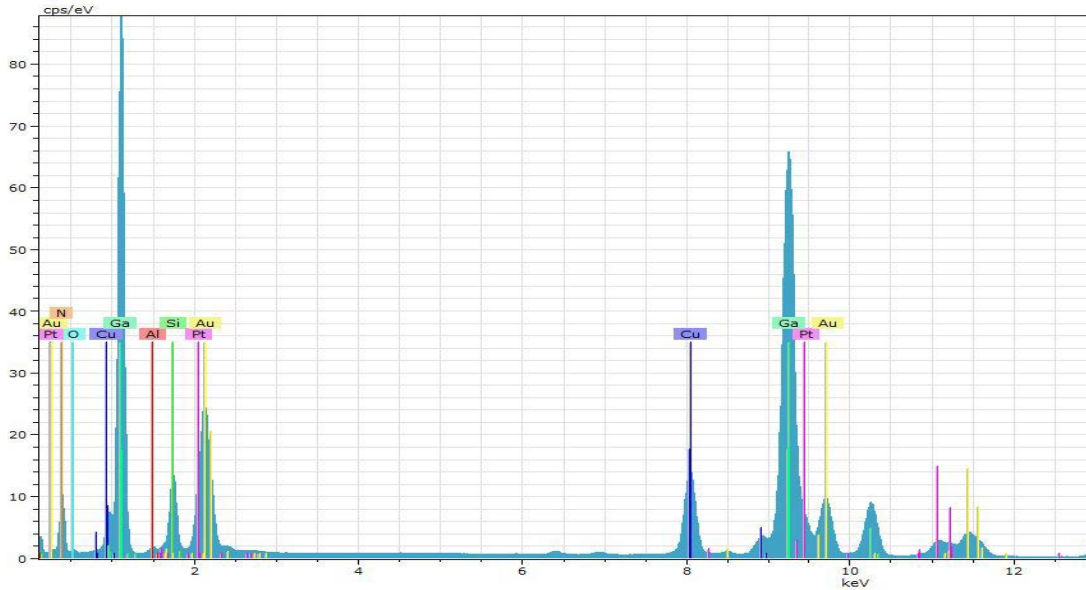
Figure 43. Elemental spectrum display of electron volts versus photon counts of the failed Pt sample. The peaks in the spectrum correspond to individual elements present in imaged area.

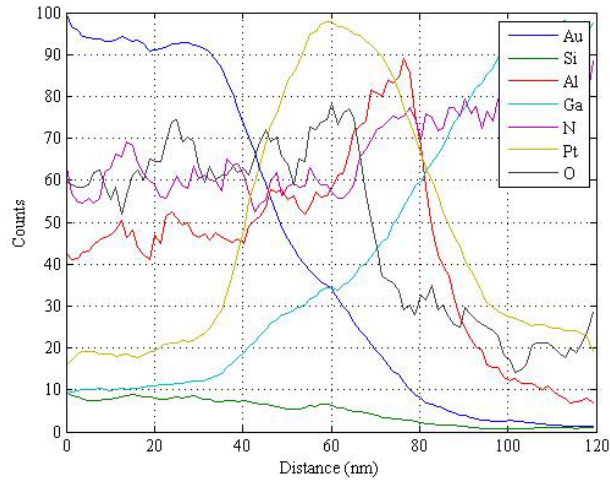
Figure 44. Line scan data for the failed Pt gate line scan depicting the presence of each element analyzed.

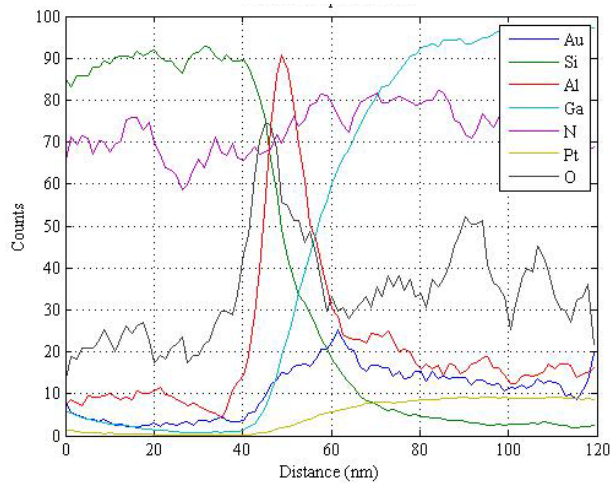
Figure 46. Line scan data of the failed Pt dip line scan depicting the presence of each element analyzed.

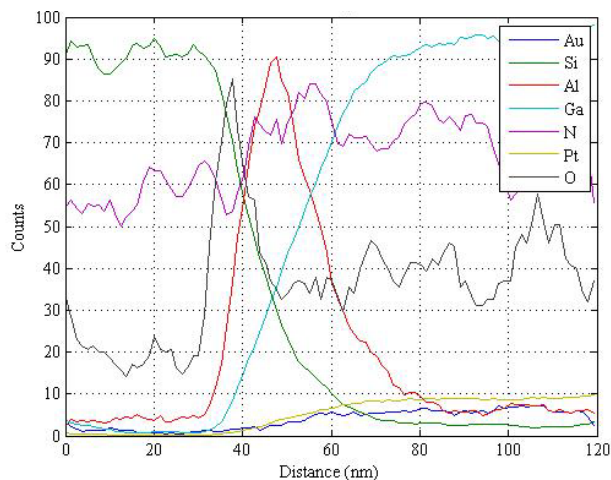
Figure 47. Line scan data of the failed Pt active layer line scan depicting the presence of each element analyzed.

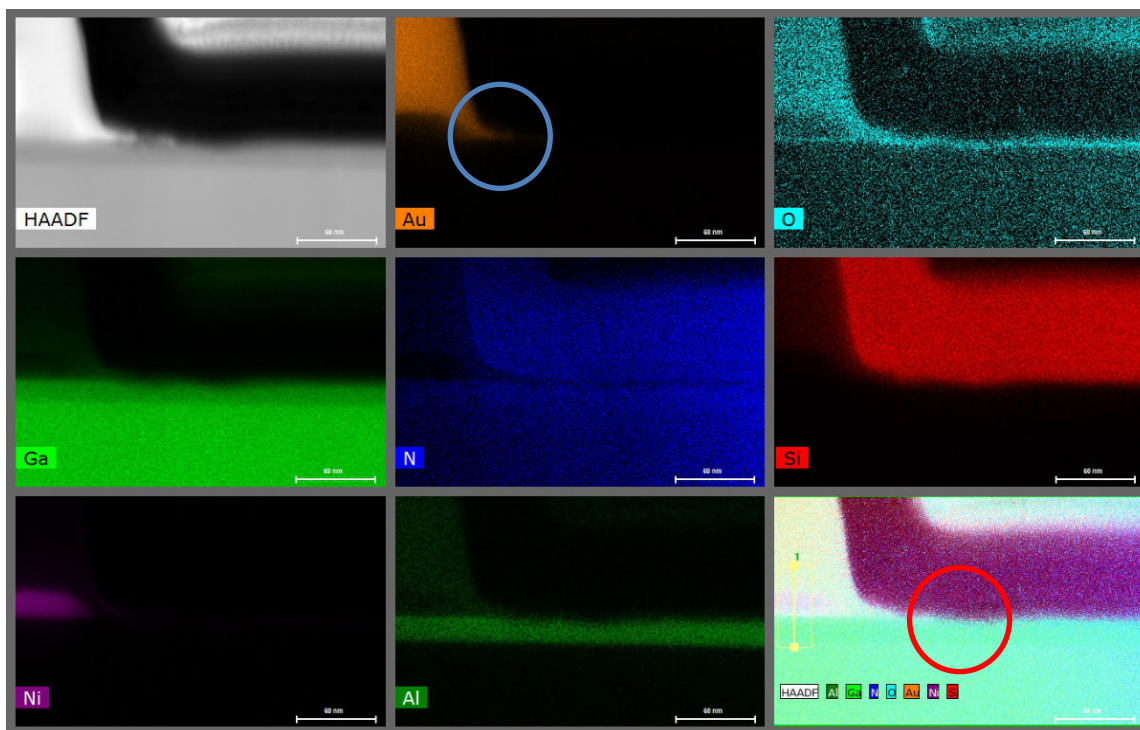
Figure 48. Elemental scans from the EDS for the fresh Ni gated device. The First image is the HAADF followed by the seven singular elemental pictures (Au, O, Ga, N, Si, Ni, and Al), ending with the composite picture of those seven elements.

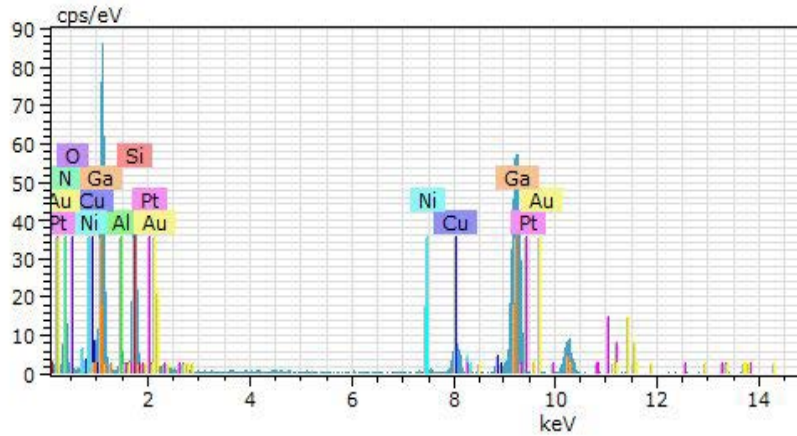
Figure 49. Elemental spectrum display of electron volts versus photon counts of the fresh Ni sample. The peaks in the spectrum correspond to individual elements present in imaged area.

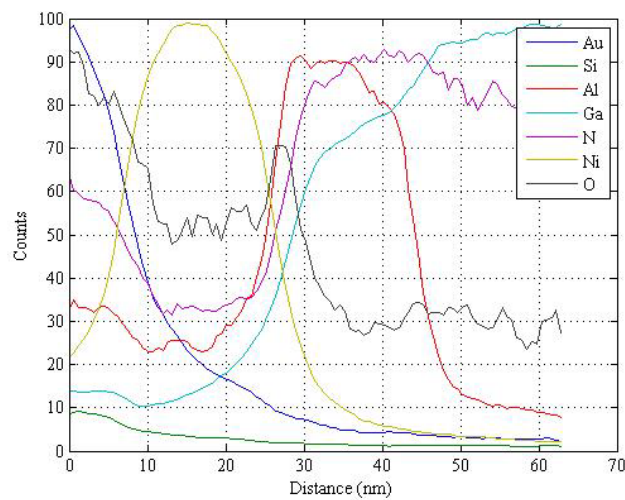
Figure 50. Line scan data for the fresh Ni gate line scan depicting the presence of each element analyzed.

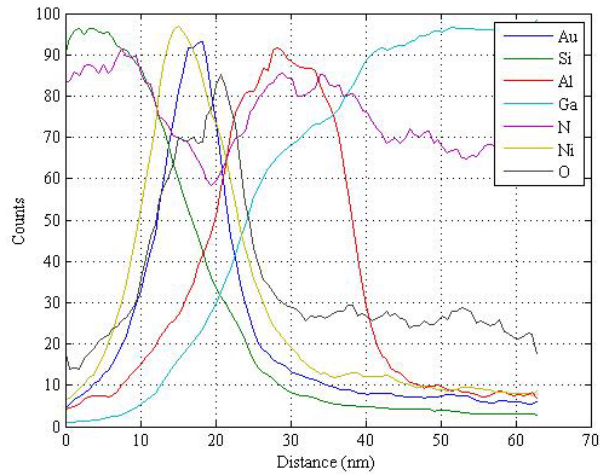
Figure 51. Line scan data for the fresh Ni foot line scan depicting the presence of each element analyzed.

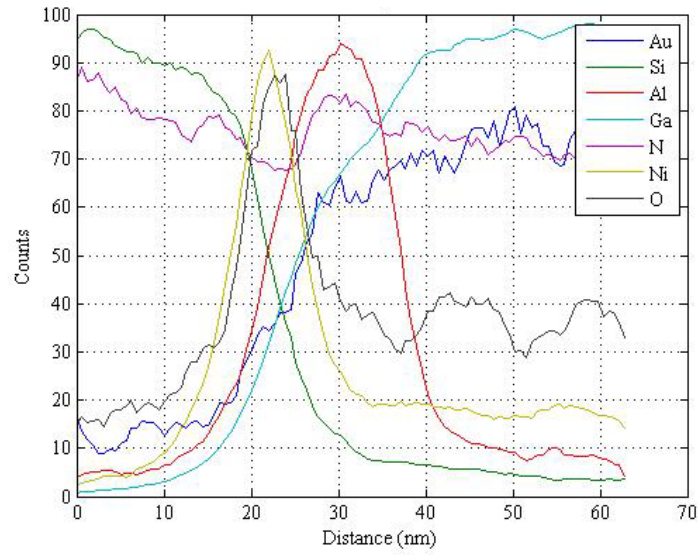
Figure 52. Line scan data of the fresh Ni dip line scan depicting the presence of each element analyzed.

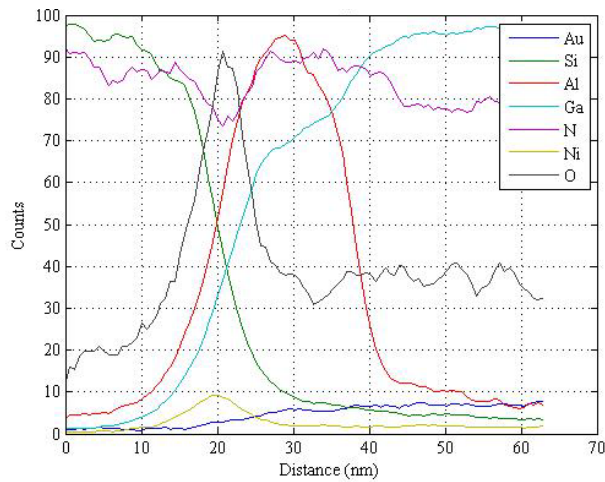
Figure 53. Line scan data of the fresh Ni active layer line scan depicting the presence of each element analyzed.

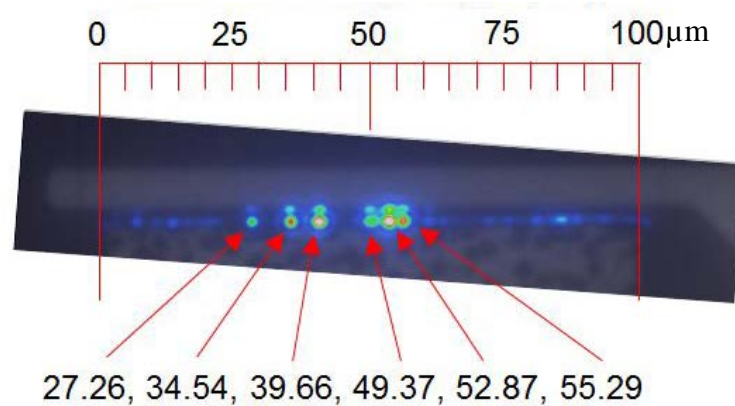
Figure 54. Electroluminescence after stressing on the degraded Ni gated HEMT. The arrows correspond to the distance across the gate in μm beginning at the edge of the source indicating areas of higher intensity.

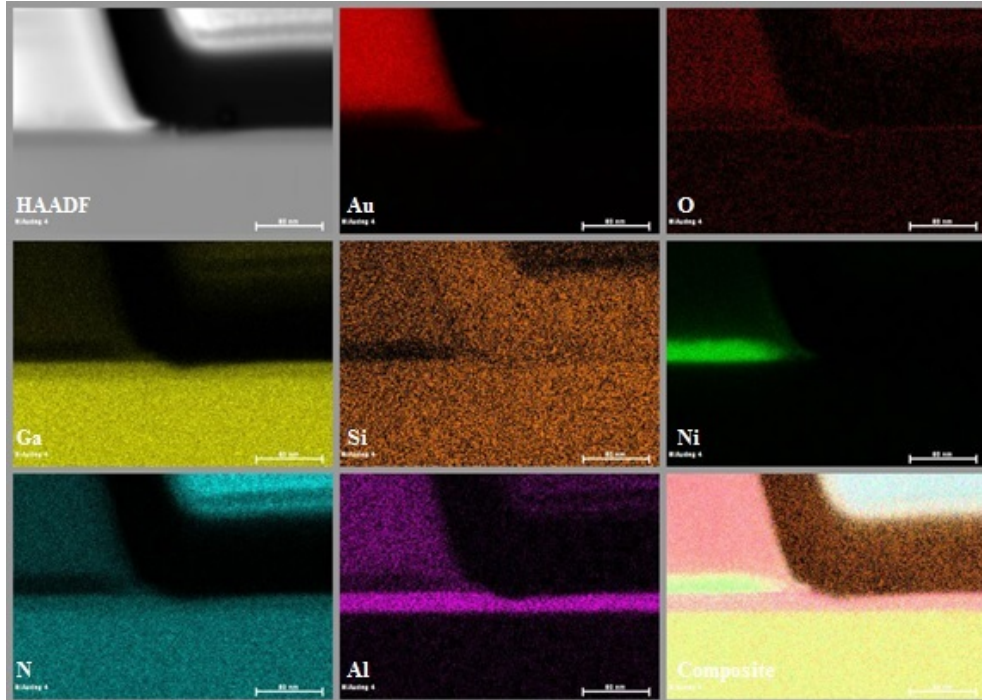
Figure 55. Elemental scans from the EDS for the degraded Ni gated device. The first image is the HAADF followed by the seven singular elemental pictures (Au, O, Ga, Si, Ni, N and Al), ending with the composite picture of those seven elements.

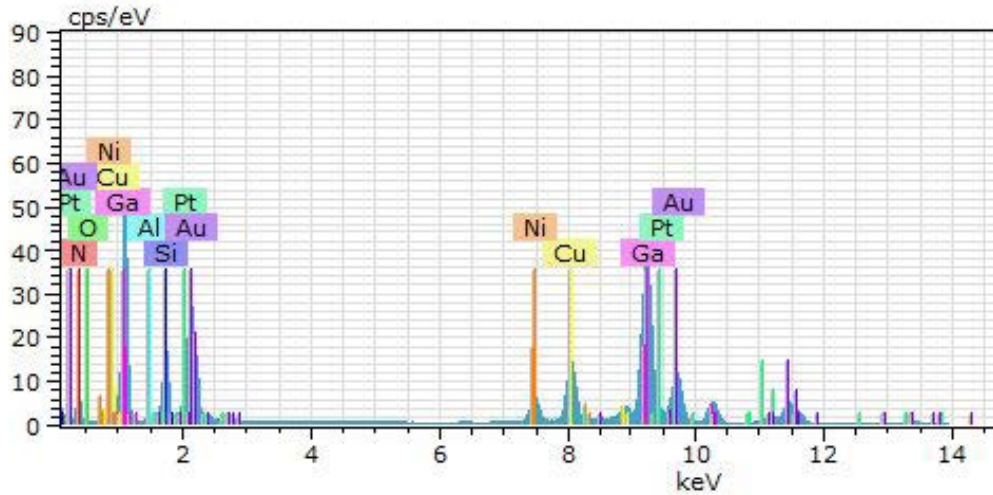
Figure 56. Elemental spectrum display of electron volts versus photon counts of the degraded Ni sample. The peaks in the spectrum correspond to individual elements present in imaged area.

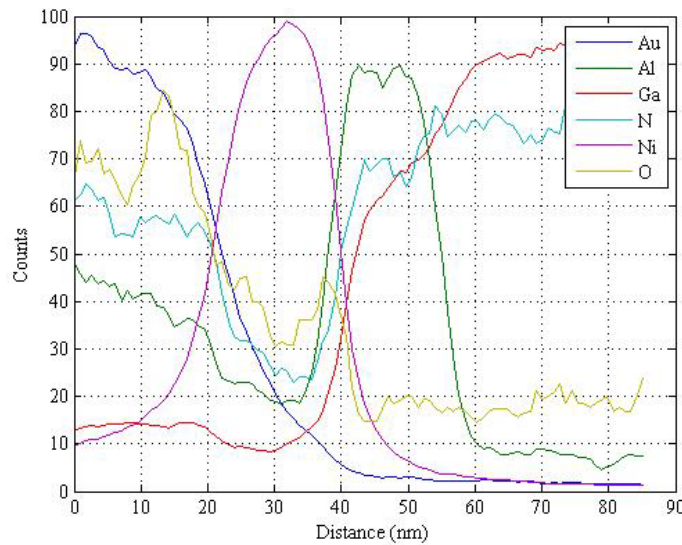
Figure 57. Line scan data of the degraded Ni gate line scan depicting the presence of each element analyzed.

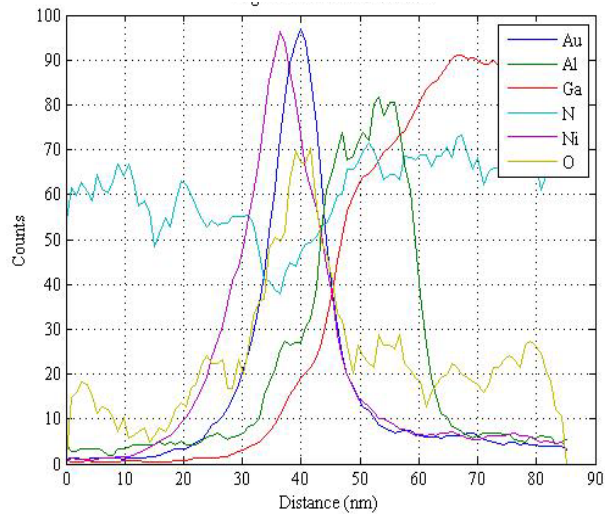
Figure 58. Line scan data of the degraded Ni foot line scan depicting the presence of each element analyzed.

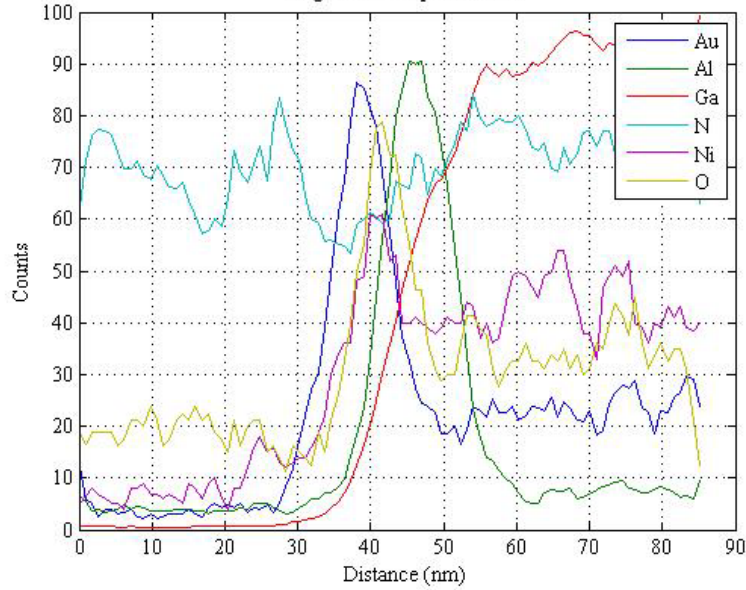
Figure 59. Line scan data of the degraded Ni dip line scan depicting the presence of each element analyzed.

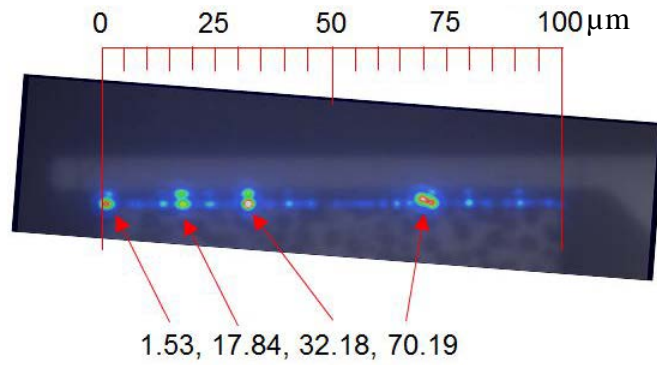
Figure 61. Electroluminescence after stressing on the failed Nickel gated HEMT. The arrows correspond to the distance across the gate in μm beginning at the edge of the source indicating areas of higher intensity.
