**NAVAL
POSTGRADUATE
SCHOOL**

THESIS

**IMAGING GALLIUM NITRIDE HIGH ELECTRON
MOBILITY TRANSISTORS TO IDENTIFY POINT
DEFECTS**

March 2014

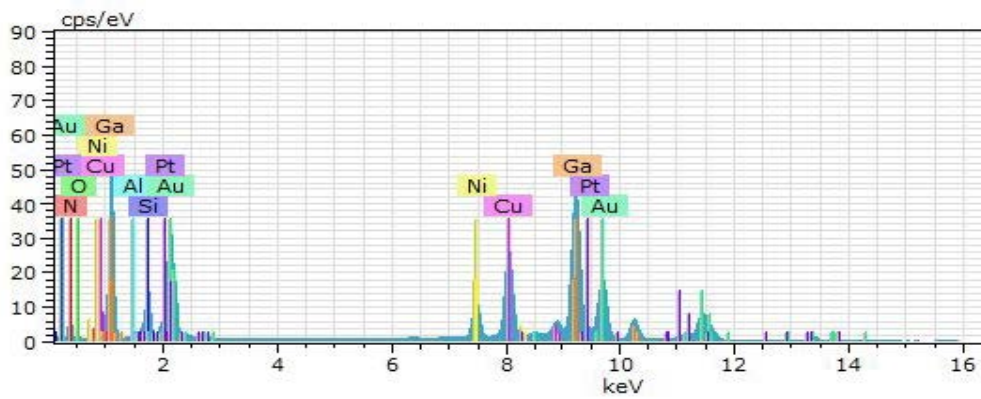
Figure 63. Elemental spectrum display of electron volts versus photon counts of the failed Ni sample. The peaks in the spectrum correspond to individual elements present in imaged area.

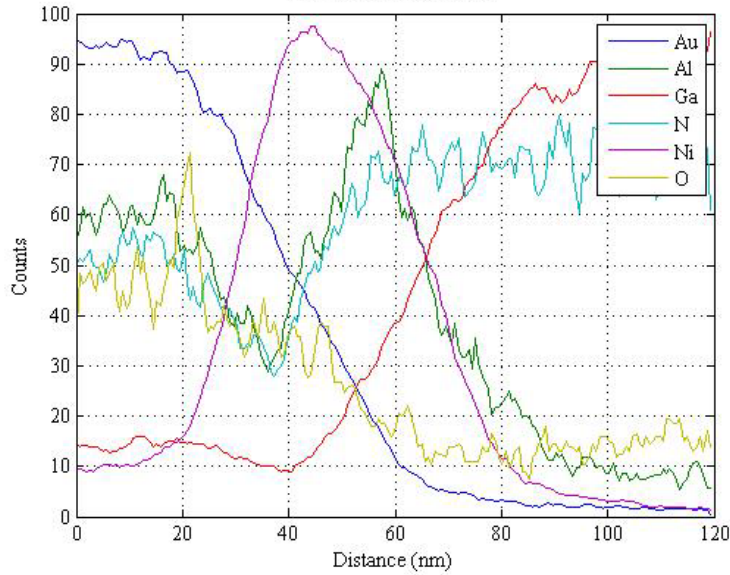
Figure 64. Line scan data for failed Ni gate line scan depicting the presence of each element analyzed.

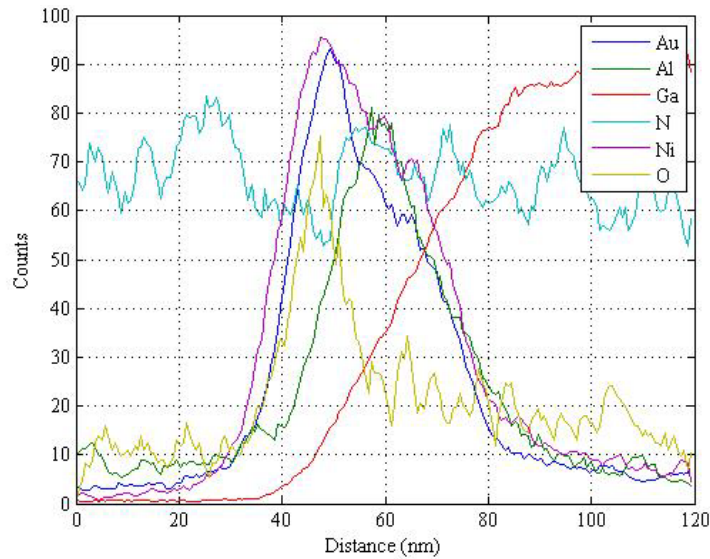
Figure 65. Line scan data of the failed Ni foot line scan depicting the presence of each element analyzed.

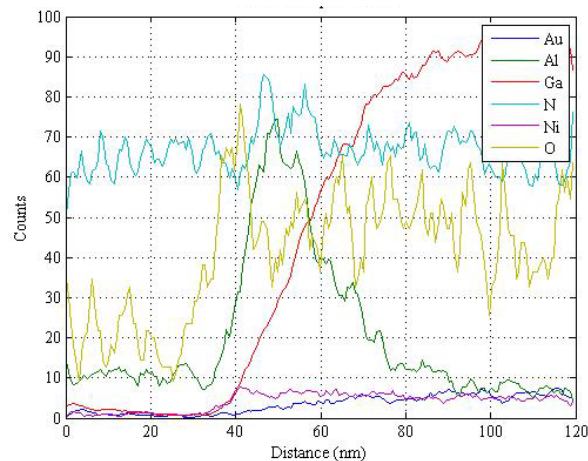
Figure 66. Line scan data for the failed Ni dip line scan depicting the presence of each element analyzed.

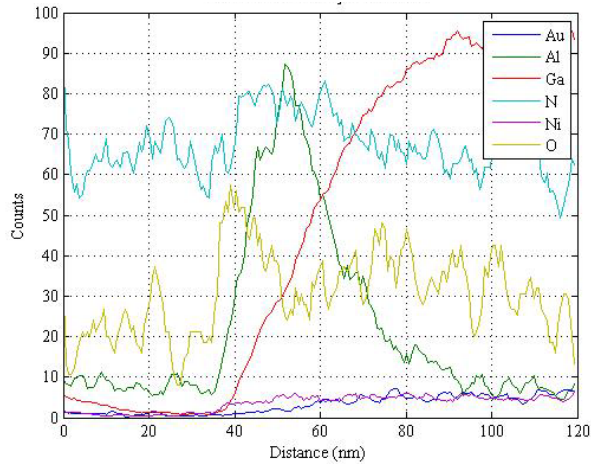
Figure 67. The line scan data for the failed Ni active layer line scan depicting the presence of each element analyzed.

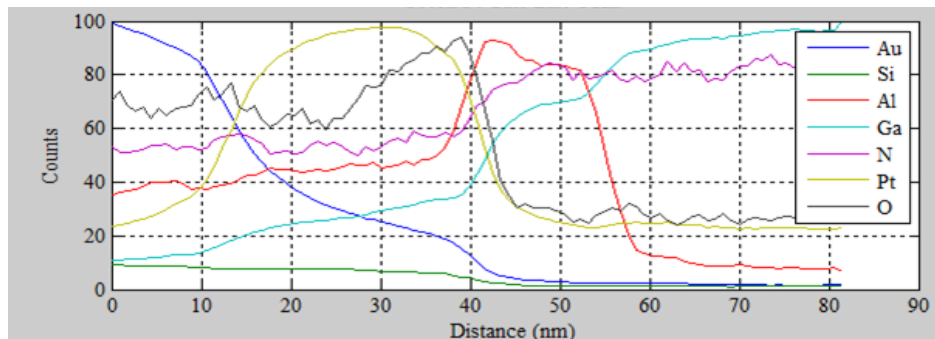
Figure 68. Fresh Pt gate line scan data.

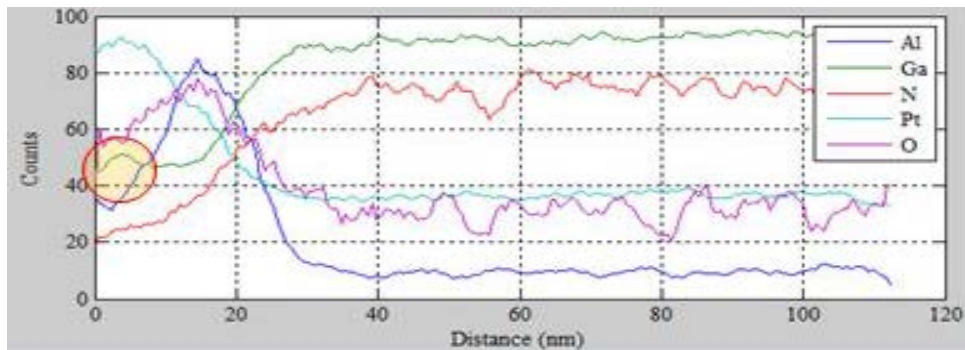
Figure 69. Epitaxial line scan with GaN cap present in highlighted area.
