# **BALLISTIC TESTING OF AGED NIEDNER RIFTS CONDUIT**

**INTERIM REPORT  
TFLRF No. 431**

**U.S. Army TARDEC Fuels and Lubricants Research Facility  
Southwest Research Institute<sup>®</sup> (SwRI<sup>®</sup>)  
San Antonio, TX**

**December 2012**

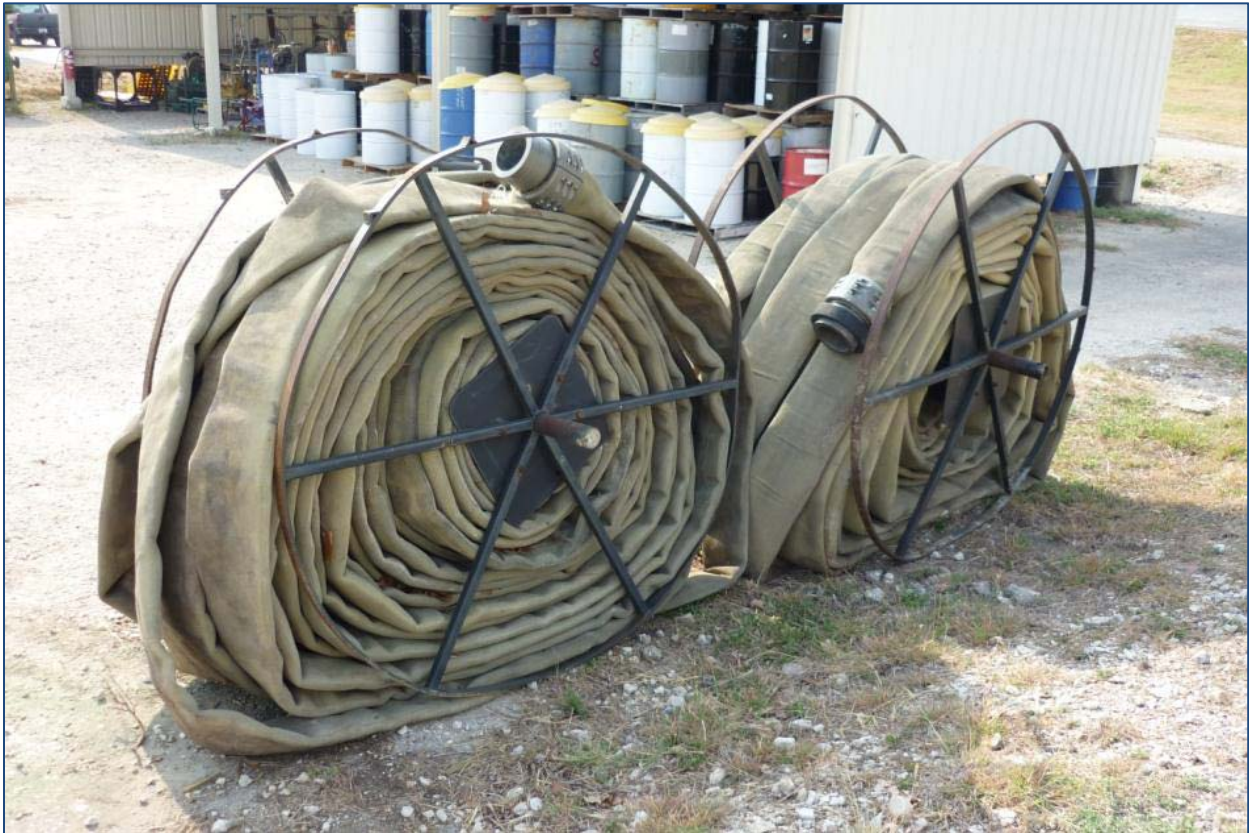
Figure 1. Niedner Hose Reels as Delivered to SwRI

The two reels of hose delivered to SwRI from Fort Lee are shown in Figure 1. The hoses were soiled but appeared to be in otherwise good condition.

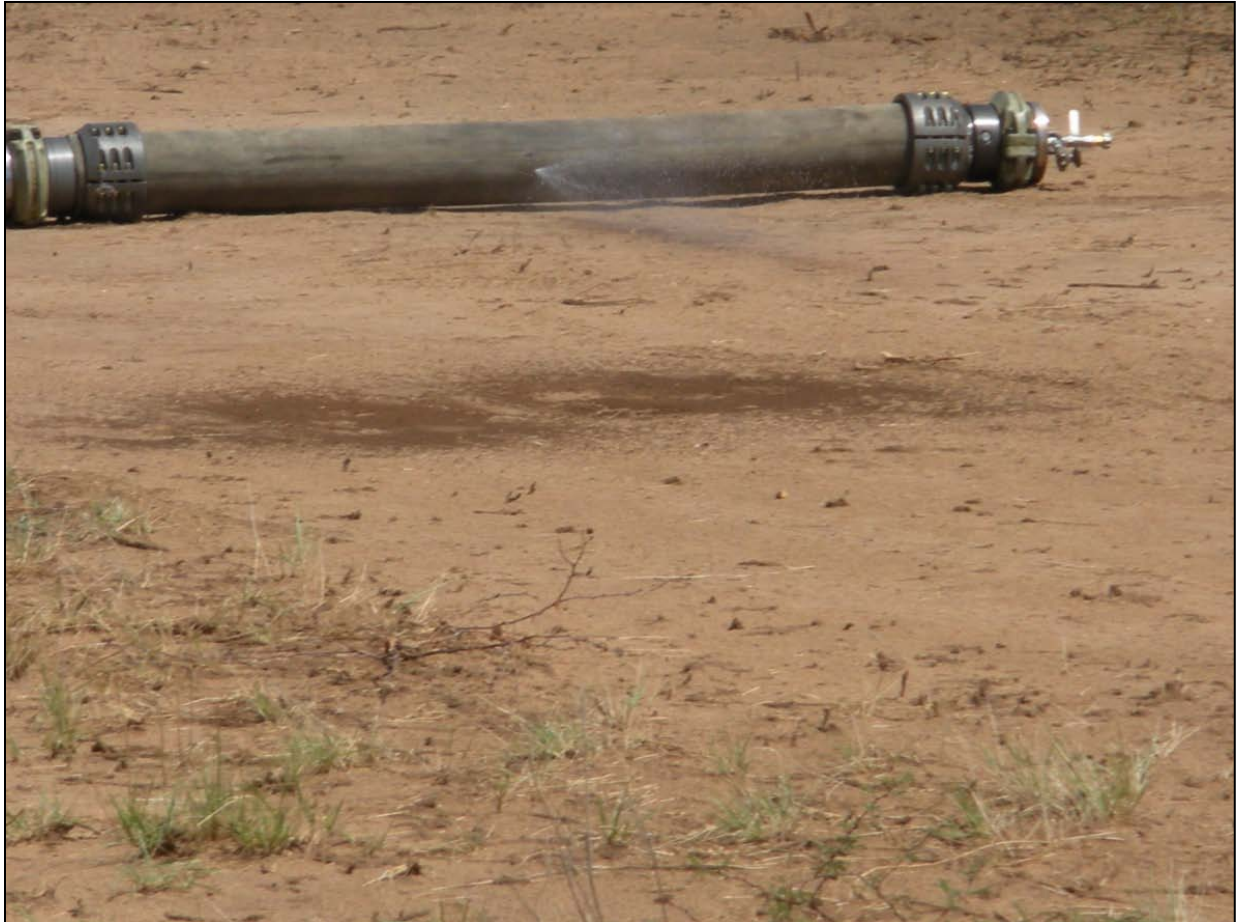
Figure 2. .308 Caliber, 90° Impact

Post impact inspection indicated that penetration had occurred and the slug had exited on the opposite side, as shown in Figure 2.

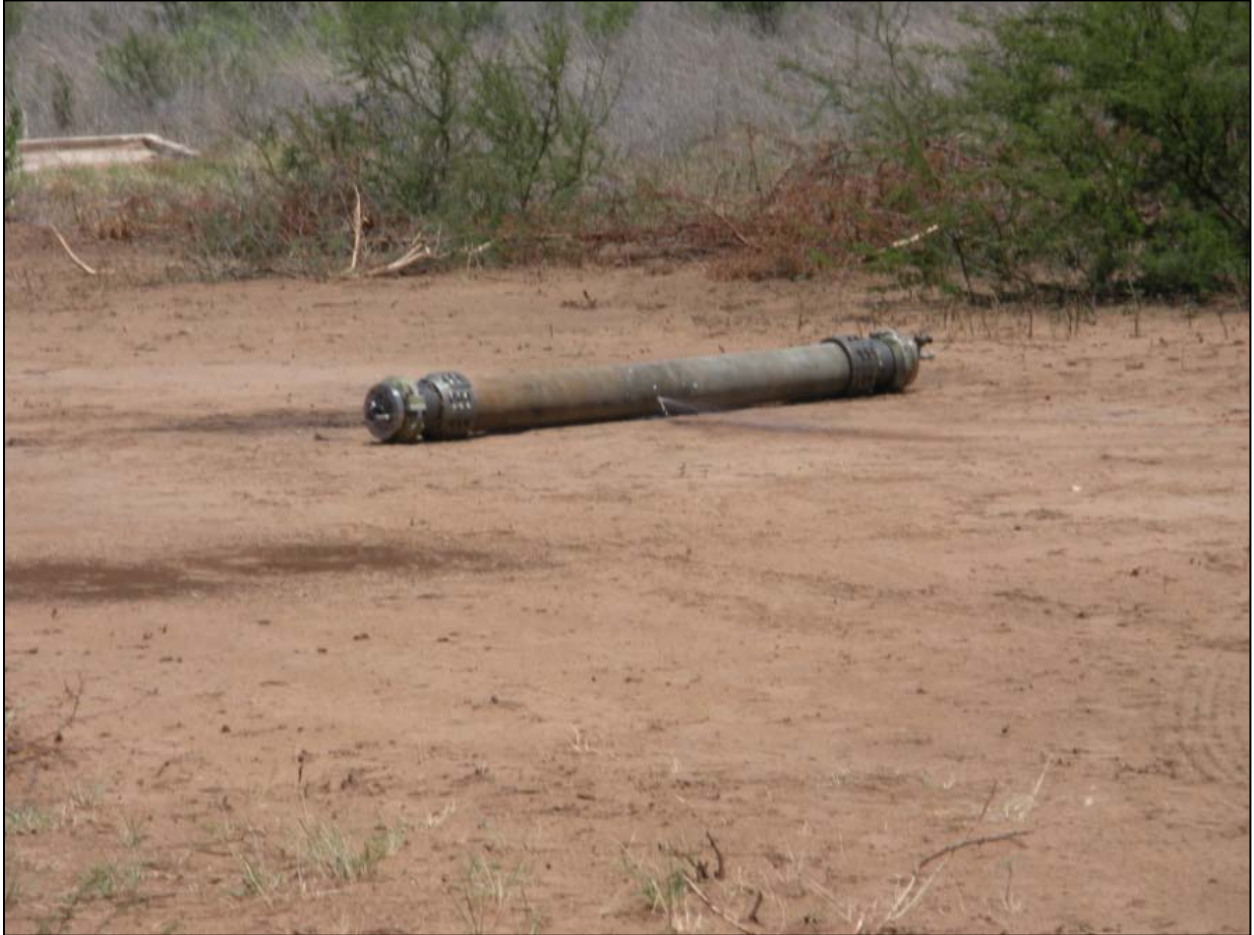
**Figure 3. .308 Caliber, 45° Impact**

Post impact inspection indicated that penetration had occurred and the slug had exited on the opposite side, as shown in Figure 3.

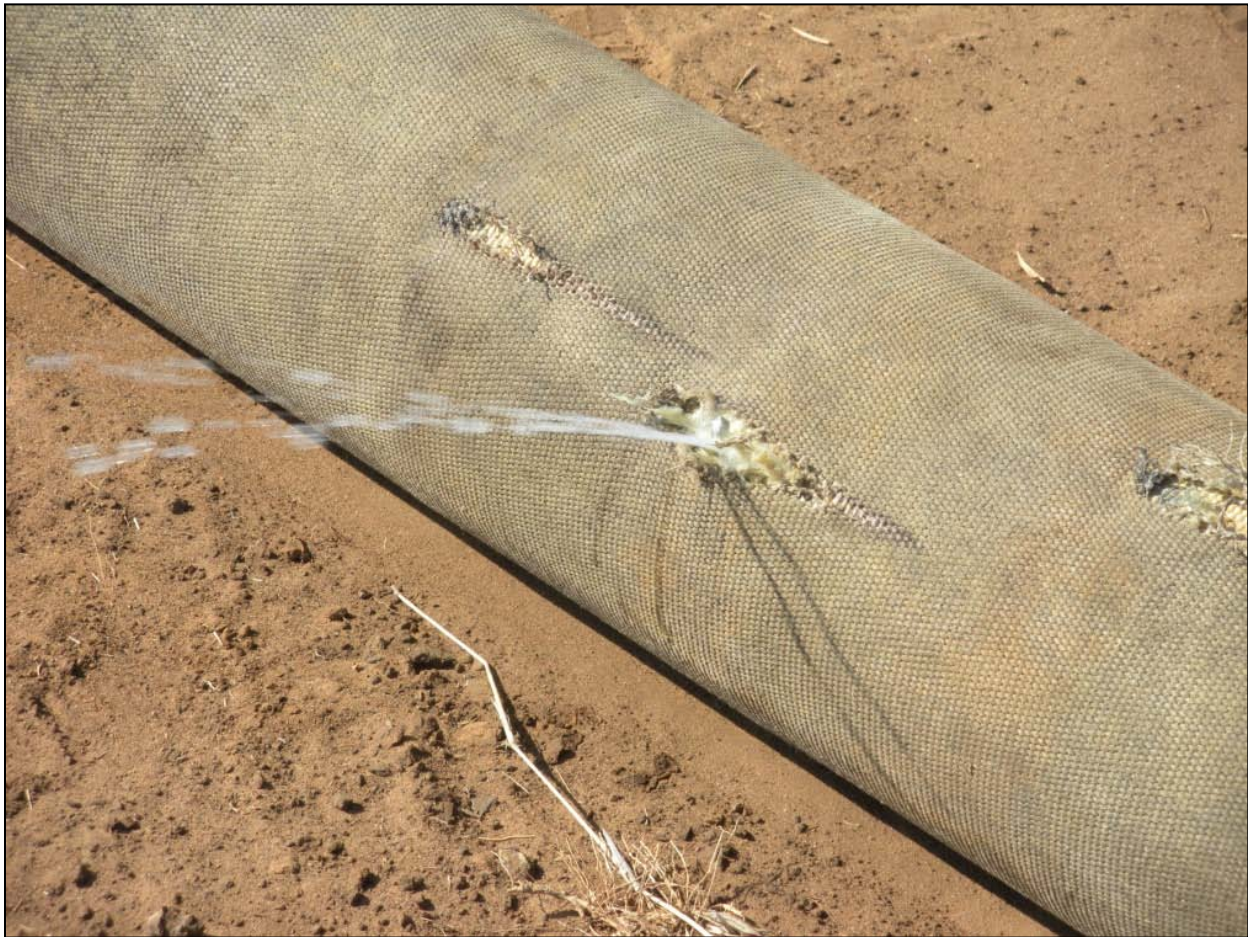
**Figure 4. .308 Caliber, Longitudinal Impact**

Post impact inspection indicated that only after the second impact at the same point did penetration occur but did not exit the opposite side of the hose, as shown in Figure 4.

In addition to the shot direction and caliber, documentation of ballistic impact was recorded on penetration at impact point, and then whether the bullet exited the opposite side. It was determined that only the larger caliber slug penetrated both sides except for the longitudinal test. The longitudinal test of the .308 caliber bullet had two impacts at the same impact point and only then did penetration occur.

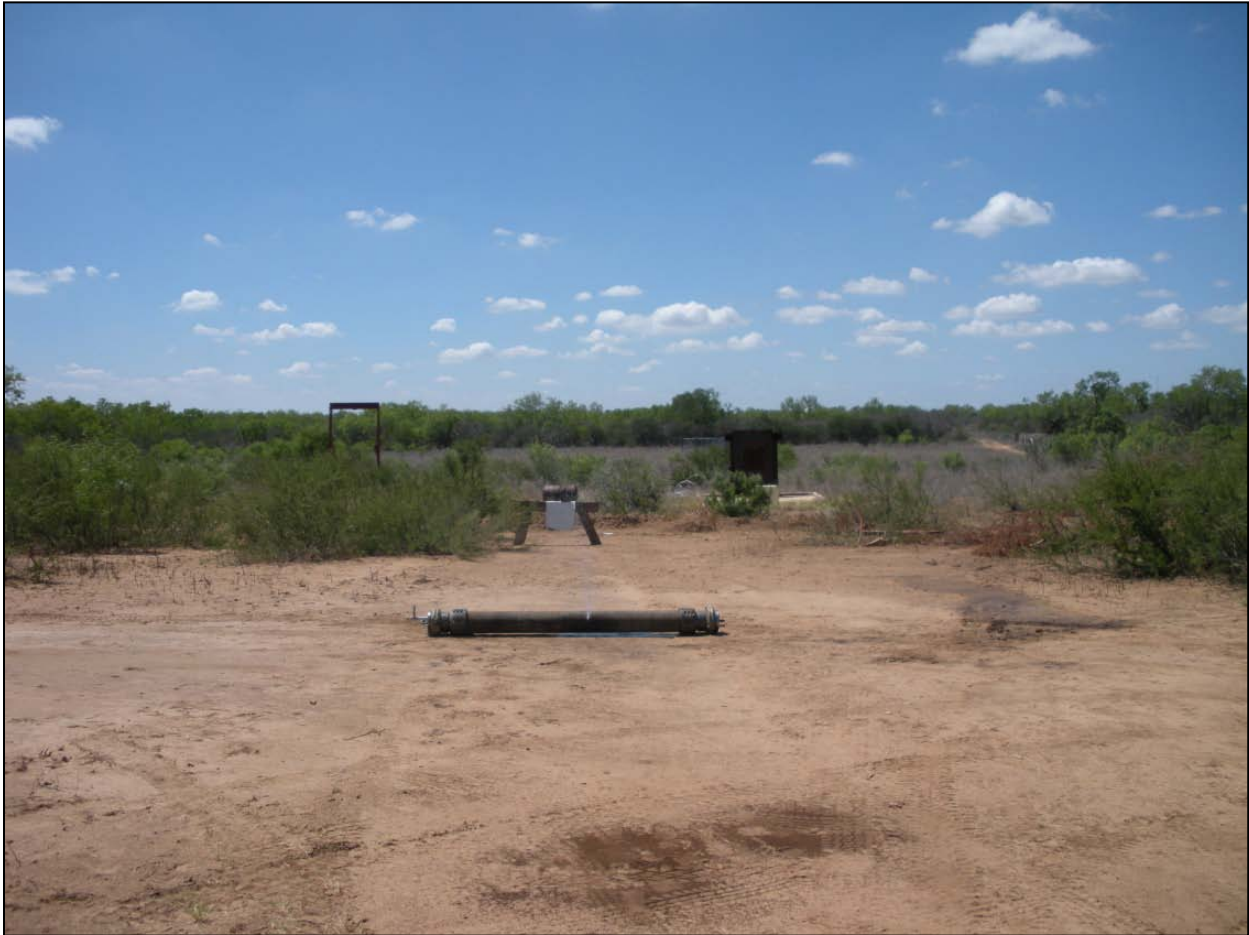
**Figure 5. .223 Caliber, 90° Impact**

Post impact inspection indicated that penetration had occurred but did not exit on the opposite side, as shown in Figure 5.

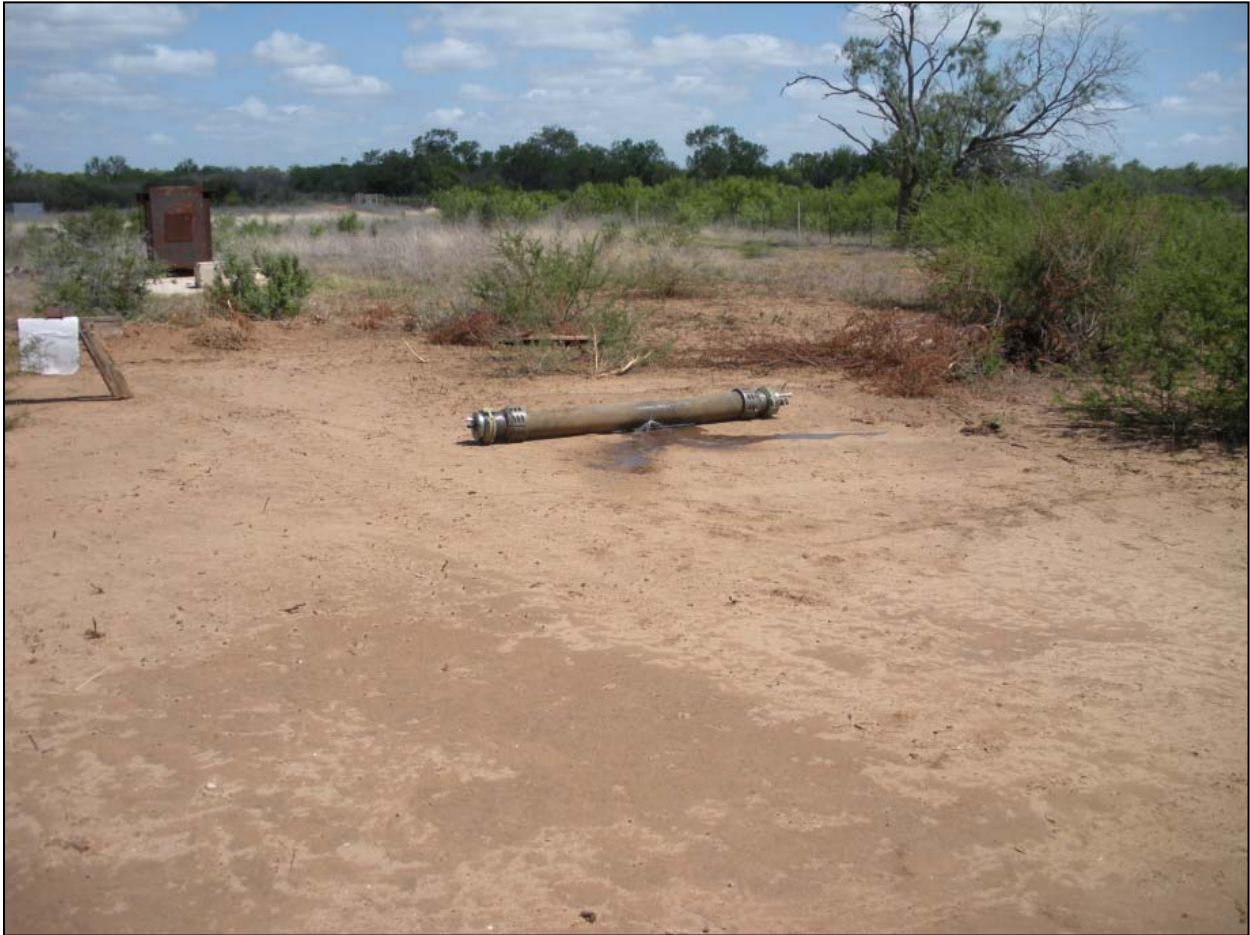
**Figure 6. .223 Caliber, 45° Impact**

Post impact inspection indicated that penetration had occurred but did not exit on the opposite side, as shown in Figure 6.

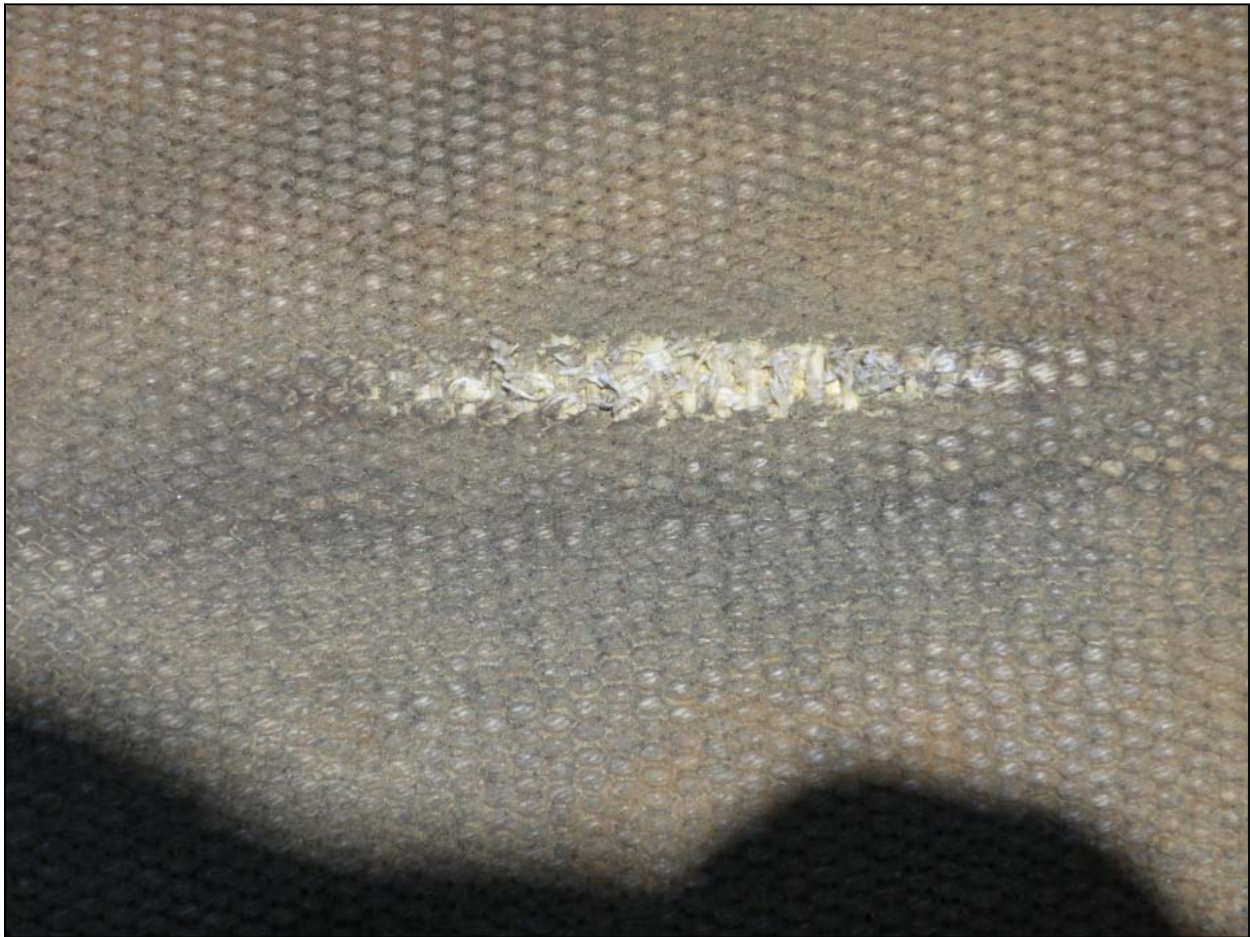
**Figure 7. .223 Caliber, Longitudinal Impact**

Post impact inspection indicated that penetration had not occurred following impact, as shown in Figure 7.

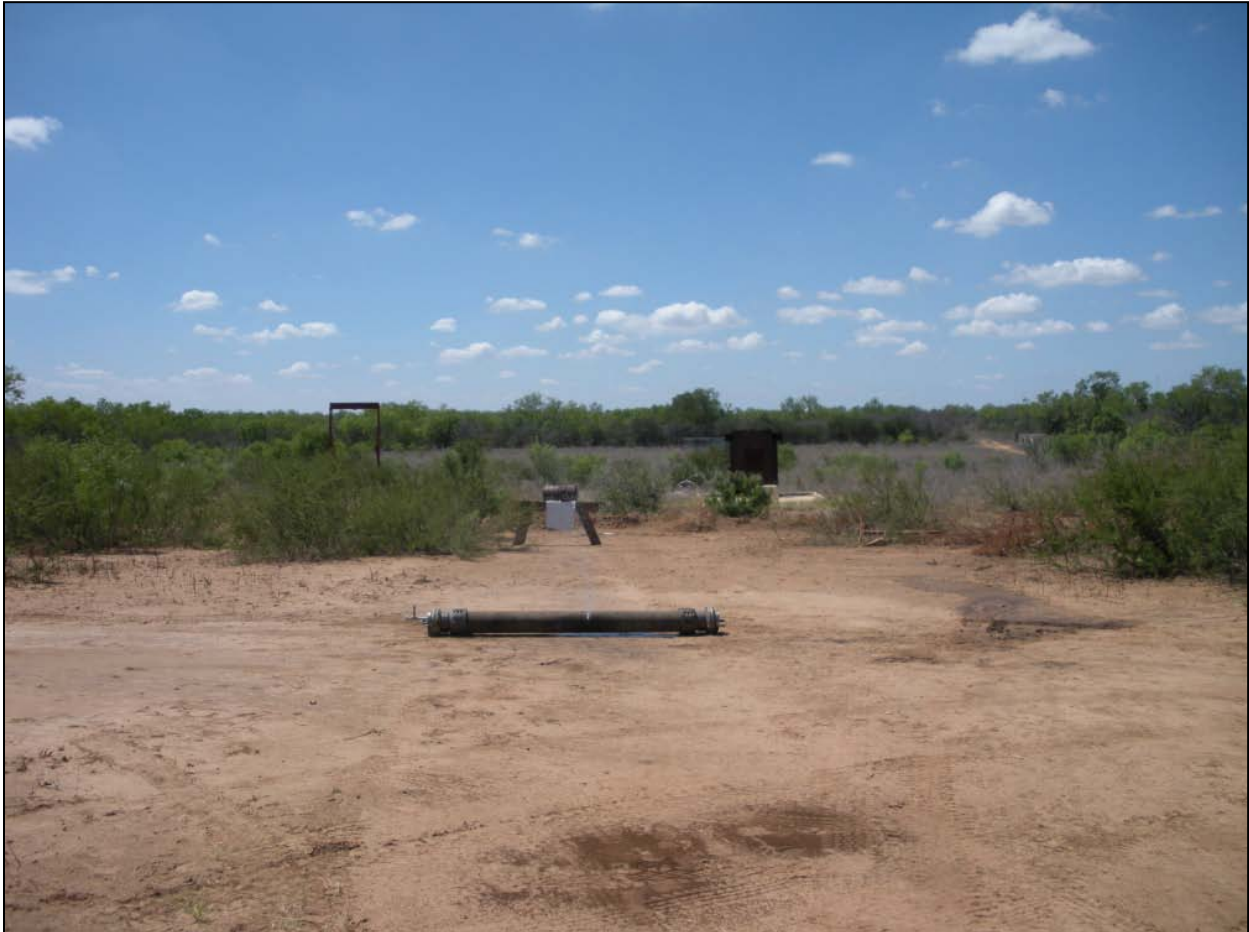
**Figure 8. 9 mm, 90° Impact**

Post impact inspection indicated that penetration had occurred but did not exit on the opposite side, as shown Figure 8.

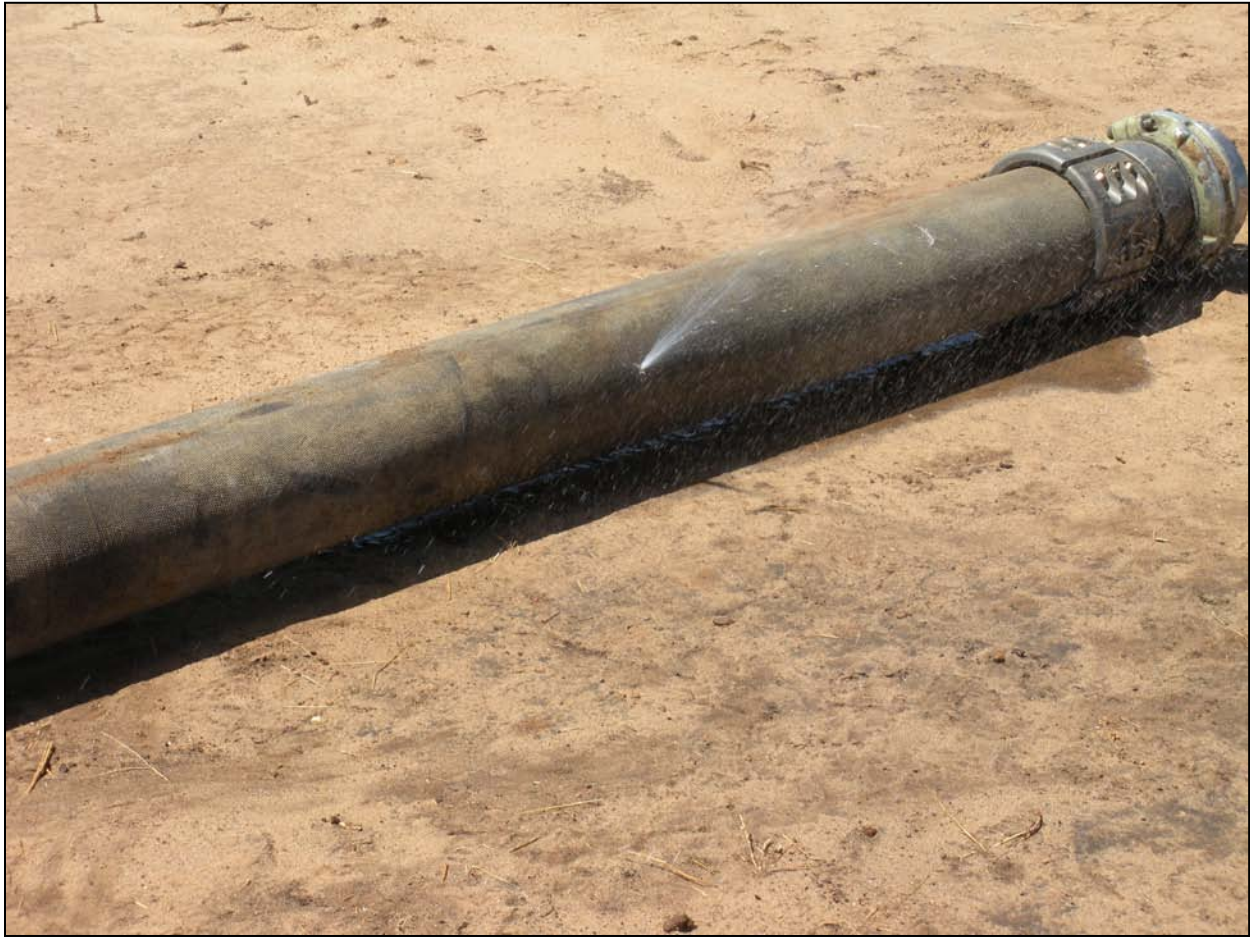
**Figure 9. 9 mm, 45° Impact**

Post impact inspection indicated that penetration had occurred but did not exit on the opposite side, as shown in Figure 9.

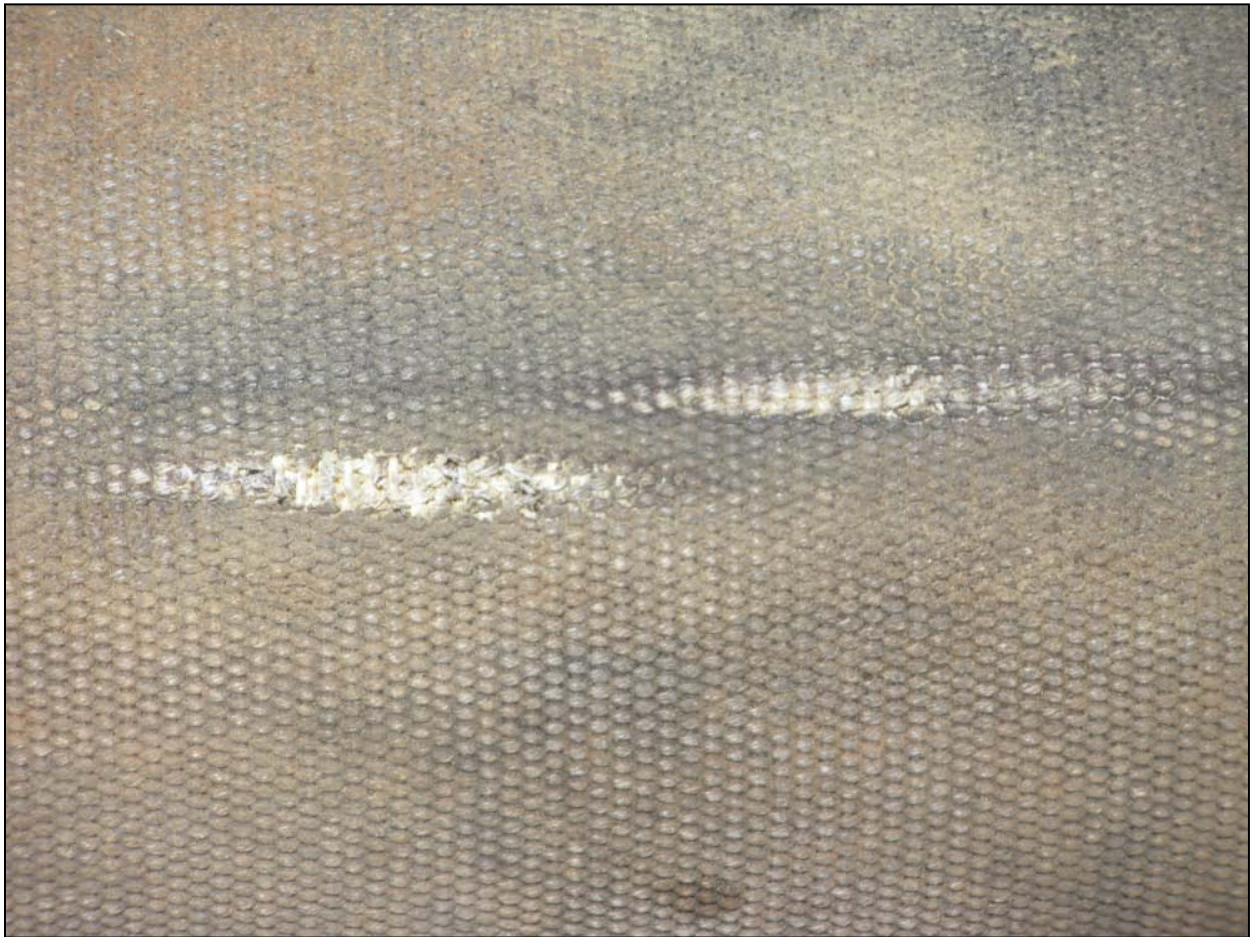
**Figure 10. 9 mm, Longitudinal Impact**

Post impact inspection indicated that following impact, penetration had not occurred, as shown in Figure 10.

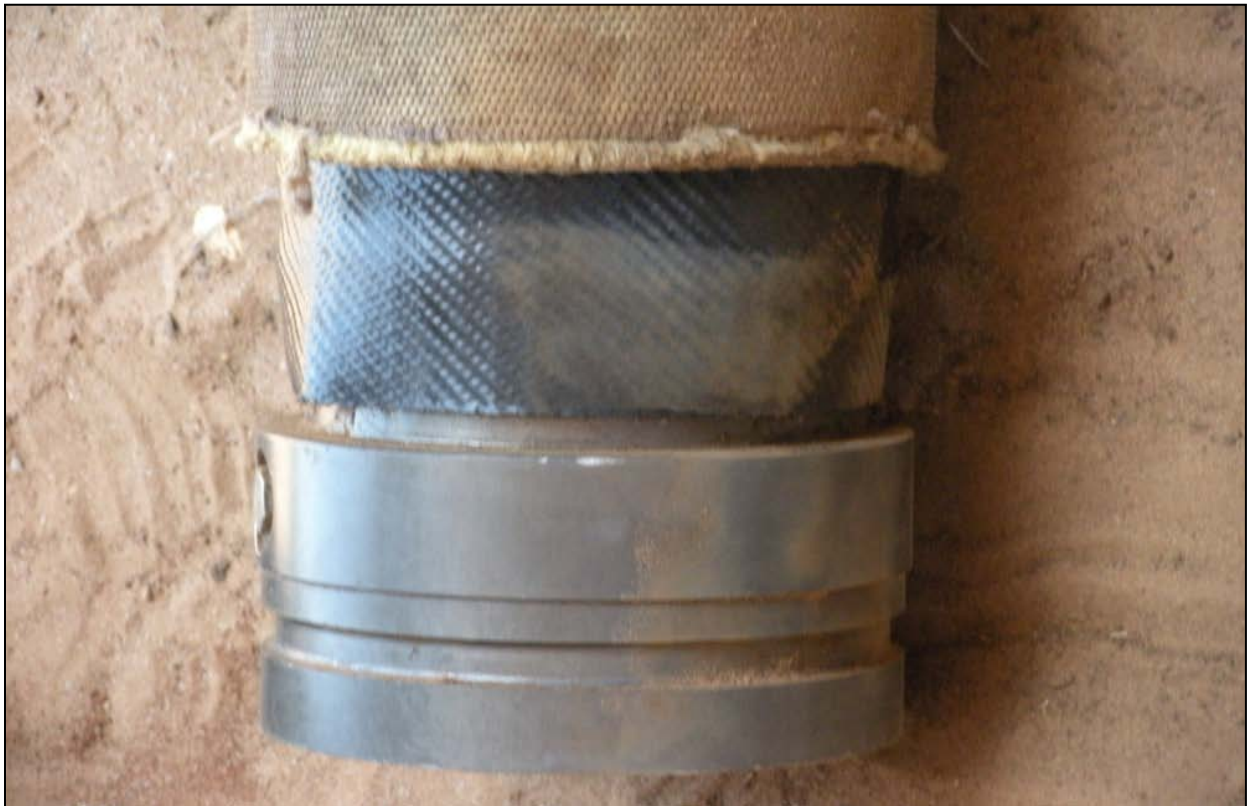
It was noted while the hose sections were being prepared for testing that the inner liner randomly extended beyond the Aramid jacket of the 6 ft sections of hose that were to be used in the ballistic testing. Figure 11 shows approximately a 1½ –2 inch extension beyond the Aramid jacket. This was not easily explainable since this was only a 6 ft piece of hose cut with a horizontal band saw. There were still several sections that had not been tested. Figure 12 shows a distinct random expansion in sections of hose that came from the same hose reel. It was theorized that this hose expansion, with both ends clamped on the end coupling, demonstrates the theory of hose bunching, preventing the fuel from being pushed through to empty the hose prior to placing in on the reel.

**Figure 11. Niedner Rifts Conduit Liner Extending 1½-2” beyond the Aramid Jacket**

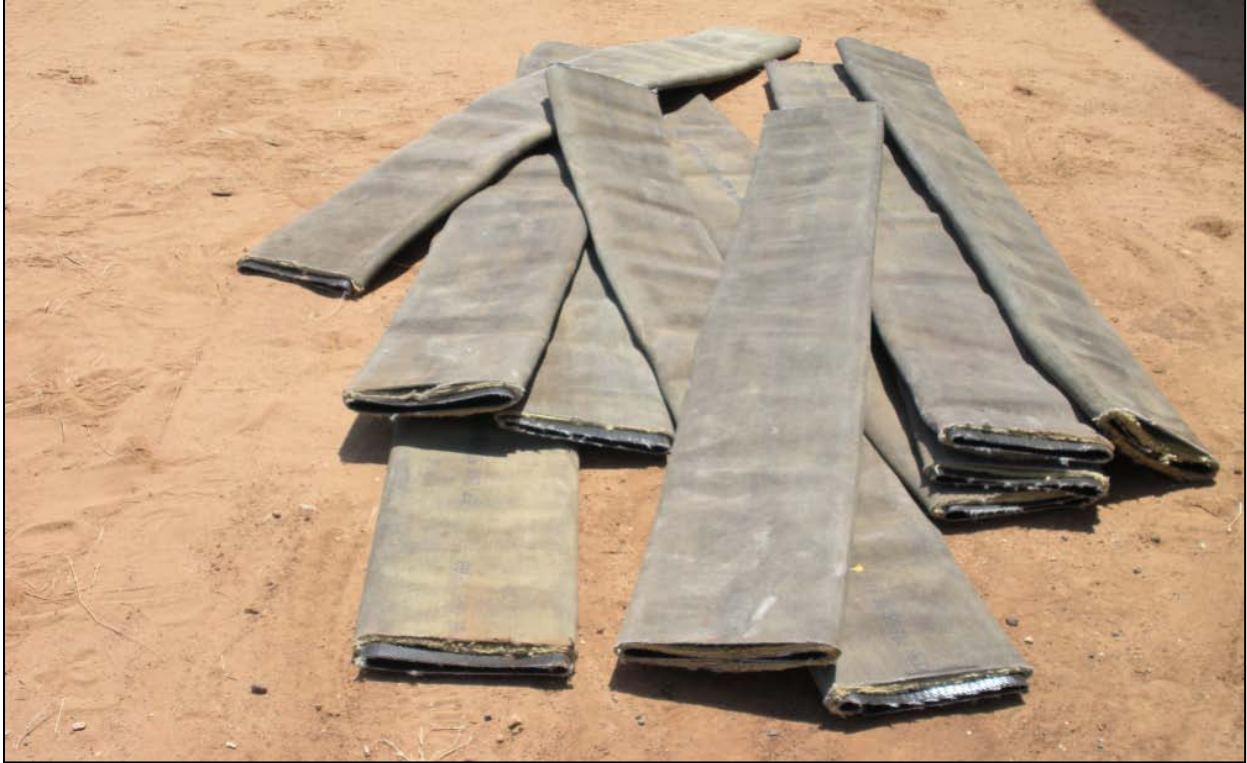
**Figure 12. Niedner Rifts Conduit Liner from Same Reel with Random Expansion**
