**A Comparison of Afghanistan, Yuma, AZ, and Manufactured Sands Melted on  
EB-PVD Thermal Barrier Coatings**

THESIS

AFIT-ENY-T-14-S-18

**AIR FORCE INSTITUTE OF TECHNOLOGY**

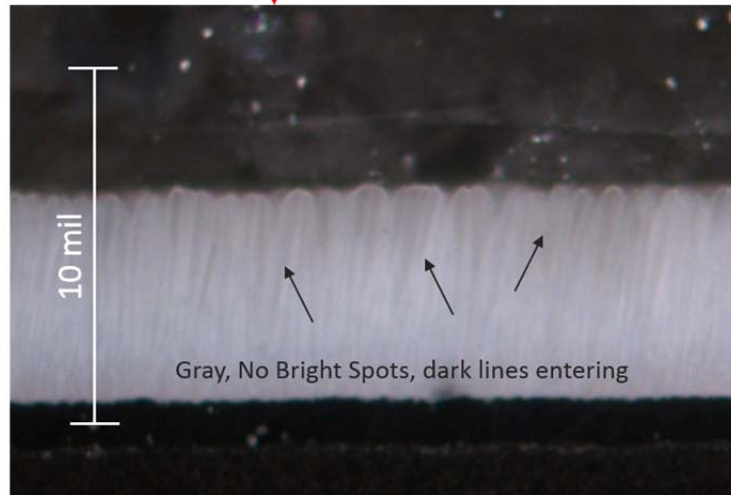
**Figure 36: Optical cross-section of A1 and AFM sample heated to 1200 °C by dark field microscopy. A1 sample has a gradual boundary indicating where sample wet the surface. AFM sample presents colors typical of**

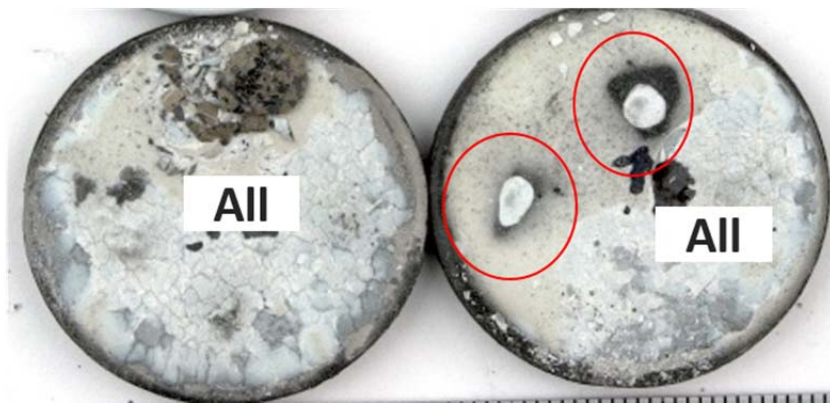
**Figure 48: Button B illustrates missing TBC, indicated by the red circles, and in “All” regions.**
