NRL/MR/6180--14-9563

# Demonstration of Experimental Infrastructure for Studying Cell-to-Cell Failure Propagation in Lithium-ion Batteries

September 11, 2014

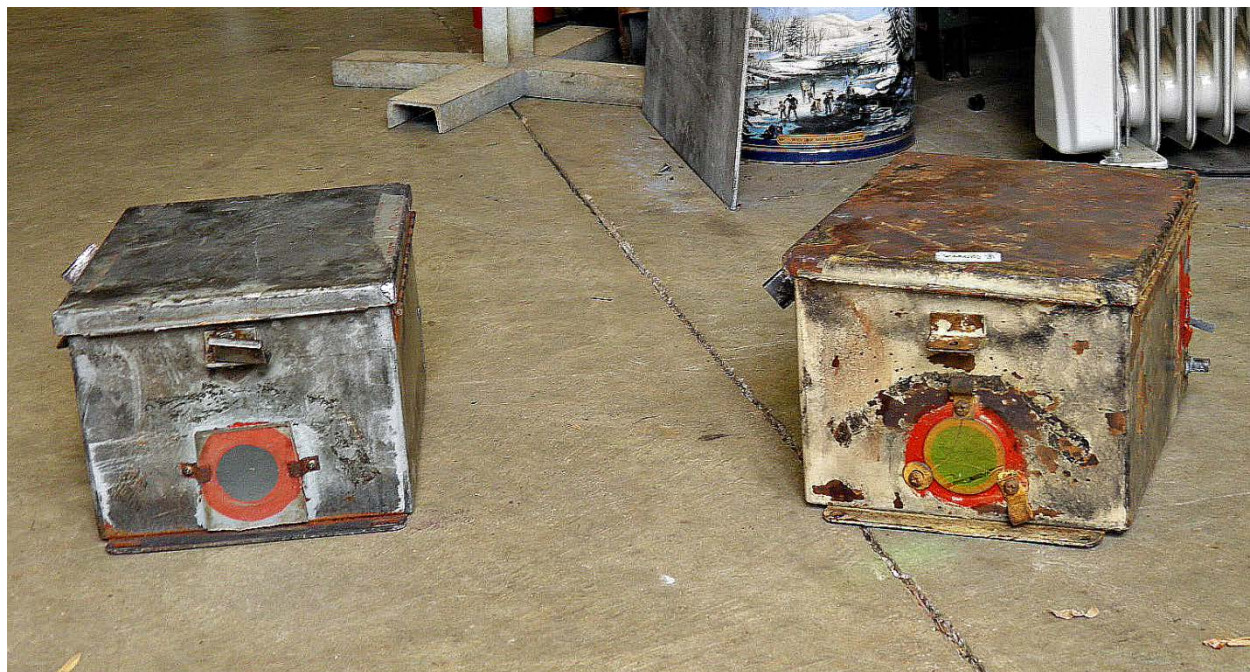
**Figure 9:** The IR and high speed cameras mounted in their protective enclosures. The IR camera enclosure (right) was affixed with a ZnSe window which is transparent to IR light, and the high speed camera enclosure (left) contained a soda lime glass window. Both cameras inside their respective enclosures were placed inside the chamber during experiments.

Initially, there were concerns about the cameras overheating since they were operating in closed, low-volume environments inside their respective enclosures. In an attempt to mitigate this potential issue, 1/4 in. Swagelok™ bulkhead tube connectors were mounted on each enclosure. Plastic tubing (1/8 in. ID, 1/4 in. OD) was plumbed from the vacuum pump connection inside the chamber through the plate on Port 3 to both camera enclosures. The vacuum pump was used to draw ambient air from the room into the enclosures to convectively cool the cameras. After some initial experiments, it was determined that there was no significant temperature rise inside the enclosures (monitored by embedded temperature sensors in the two cameras) regardless of whether or not the forced air cooling mechanism was activated. The air cooling system was

therefore removed and the bulkheads capped to prevent harmful fluids from entering the enclosures. However, to ensure safe operation of all instrumentation and equipment, the camera temperatures were still actively monitored during testing.

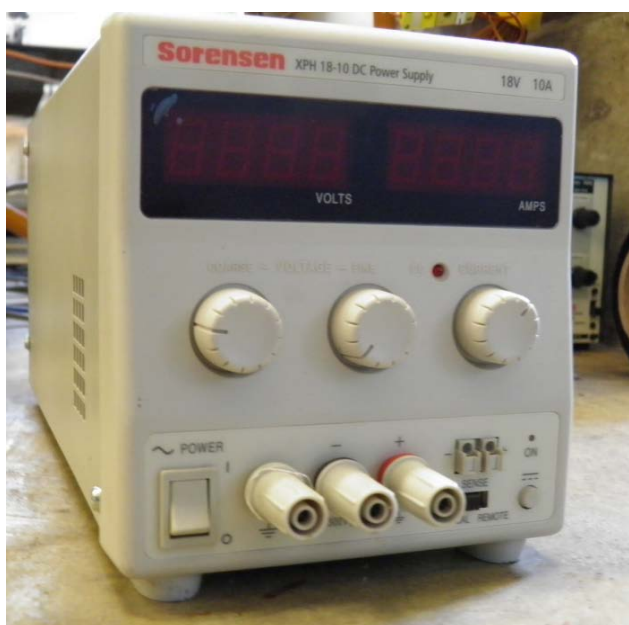
**Figure 16:** An image of the power supply used to overcharge the cells.

In addition to temperature monitoring via the two CompactRIOs, active cell voltage was monitored using a channel in the eight-slot CompactRIO. Cell voltage was also controlled using an 18V-10A power supply (AMETEK, Sorensen XPH Series 18V 10A, San Diego, CA, USA) to initiate overcharge abuse tests. The power supply, which is pictured in Figure 16, was connected to the active cell via one of the BNC bulkhead connectors installed in Port 4 of the chamber. In all cases, simple overcharge abuse resulted in significant heat generation from the active cell, but not complete thermal runaway or a credible failure event. For this reason, surrogate heater cells were implemented in the hexagonal cell packages so that thermal abuse could ensure a failure event would eventually take place. The cartridge heater inside the surrogate heater cells was controlled using a Variable Transformer (3PN1010B 140V 10A output, Staco Energy Products Co., Miamisburg, Ohio, USA) and it was modulated using one of the outlets on the sixteen-channel trigger box to allow precise command over when to turn the heating process on and off.
